ARBORICULTURAL REPORT

The Long Point,
Lake Road,
Knockanima,
Loughrea,
Co. Galway
53.185619, -8.561930

Helena McElmeel Architects.

2nd July 2025

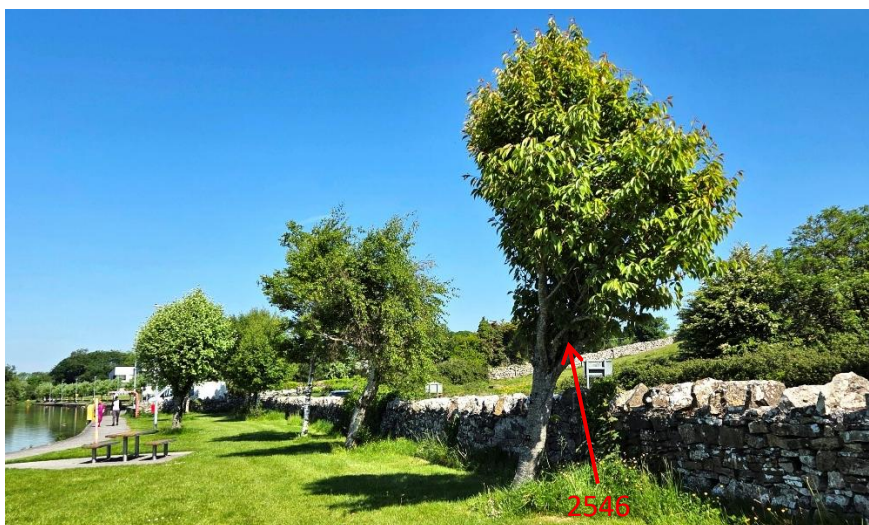
- 5.4** The northeast of the site is a grass area located between a concrete walkway and a dry stone wall bordering the main road - R351 (Image 1). The trees in this area are semi mature and low-quality (Category C). Several of the trees in this area have been poorly managed in the past and have been heavily topped, leaving large wounds and poorly structured multi stem regrowth. The trees provide screening value to the site from the busy road but due to their close proximity to the wall, they will need regular maintenance to avoid conflict with the road (Image 2). Due to their proximity to the wall and compacted road surface, it is likely that roots have developed more to the west where better soil is present.

Image 1: Looking north at the line of trees beside the road, with Tag No. 2546 in the foreground.

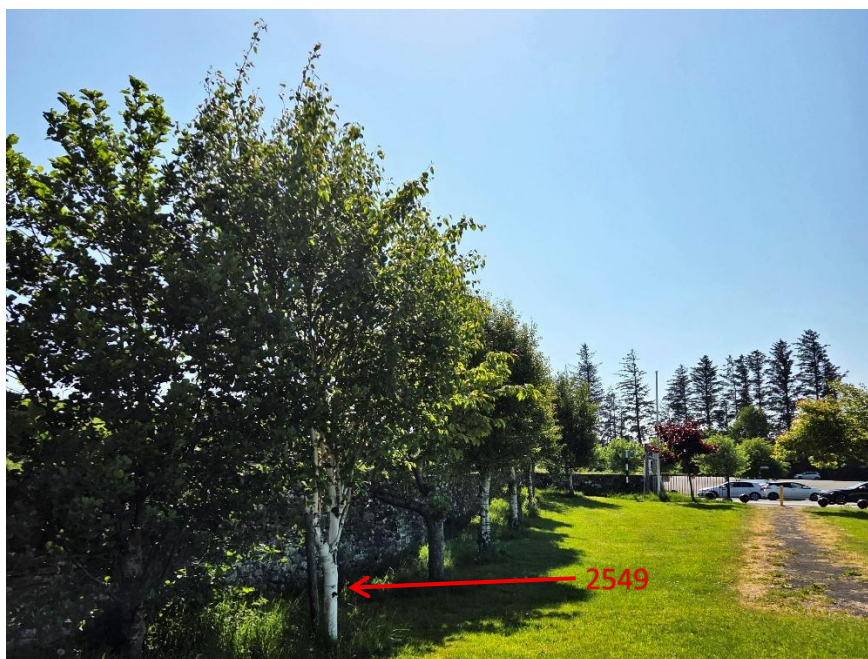
Image 2: Looking south along the line of trees beside the road, with Tag No. 2549 in the foreground.

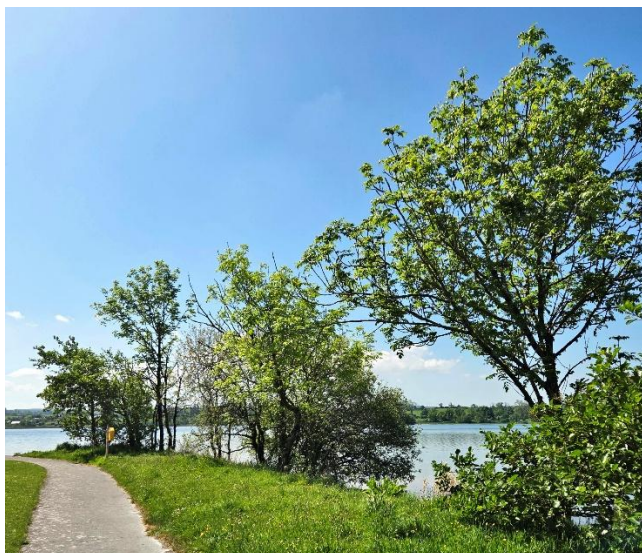
- 5.5** The west of the site contains two tree lines (Tree line Nos. 1 & 2) which create a partial border between the lake and the open green space. Tree Line No. 1 is located directly along the edge of the lake (Image 3) and contains several, poor-quality (Category U) ash trees with symptoms of ash dieback (*Hymenoscyphus fraxineus*). Some trees in the tree line have exposed root flare likely due to erosion from the lake, which may further compromise root stability and long-term structural integrity. Tree Line No. 2 (Image 4) is slightly farther from the water and generally appears healthier, with better canopy development and less visible root exposure. However, there are some ash trees with symptoms of ash dieback in the line which will need remedial work. Both tree lines provide a buffer from the lake with the tree roots likely helping to stabilise the soil and reduce erosion.

Image 3: Looking south along Tree Line No. 1 at declining ash.

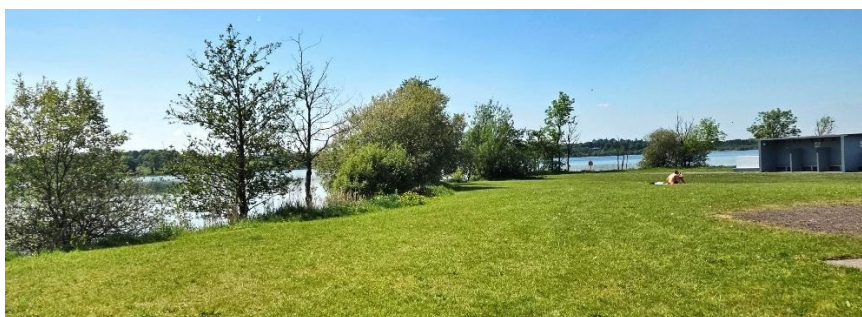
Image 4: Looking west along Tree Line No. 2.

- 7.9** To mitigate impacts on the roots of Tree Line No. 2, the proposed footpath along this boundary should be moved farther north. These are younger trees without an expansive root system, so just tweaking the path's route a couple metres north would have a beneficial effect on their development.

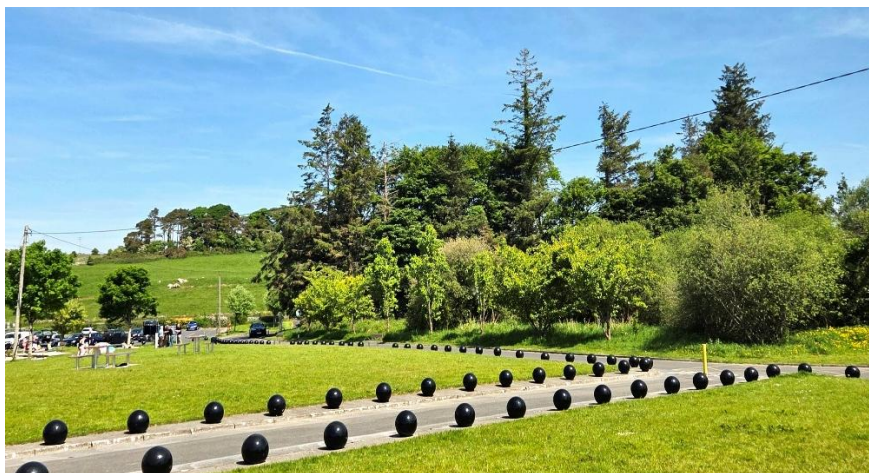
- 5.6** The southwest of the site contains several trees growing in proximity to a small roadway - Tag Nos. 2573, 2574 & 2575. A line of maintained wild cherries (Tree Line No. 3) runs between the road and woodland to the south (Image 5). Tree Group No. 1 grows in an unmaintained area of the park. It is outside the redline boundary but worth noting as it provides aesthetic and ecological value to the area. Tree Group No. 1 is predominantly willow, which reflects a naturally regenerating mix, with species composition suited to a damp, low-lying environment such as Lough Rea. All the trees in this section are low quality (Category C), except a moderate quality Category B), semi mature oak (T1) which has potential to form part of the long term tree cover in this area.

Image 5: Looking east at Tree Line No. 3, with Tree Group No. 1 and Tree Line No. 4 in the background.

- 7.6** Tree Line No. 3 needs to be removed to facilitate a footpath running parallel to the woodland (Tree Group No. 1) to the east. There is already a proposed footpath on the opposite side of this road, so it is recommended that this footpath does not extend along the length of this woodland so that the cherry tree line can be retained and soil and root damage is not caused to Tree Group No. 1. See location of where the footpath should end in TPR-LP-01 – Appendix 3.

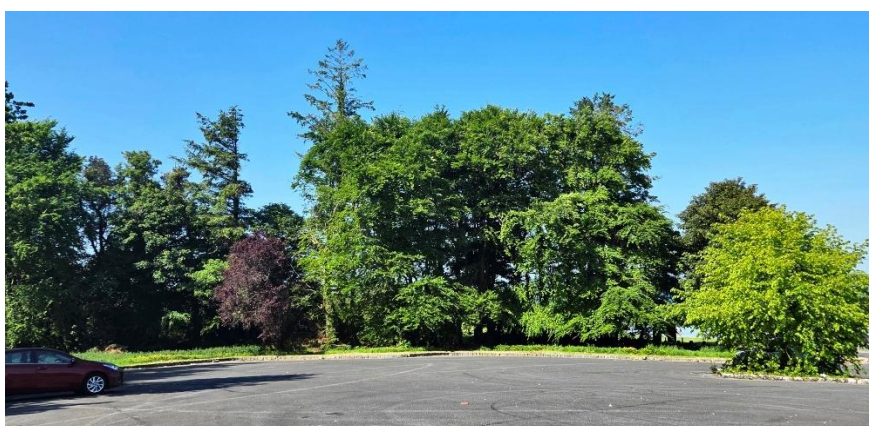
Image 6: Looking west at Tree line 4 comprising of beech and spruce, some of which require immediate attention.

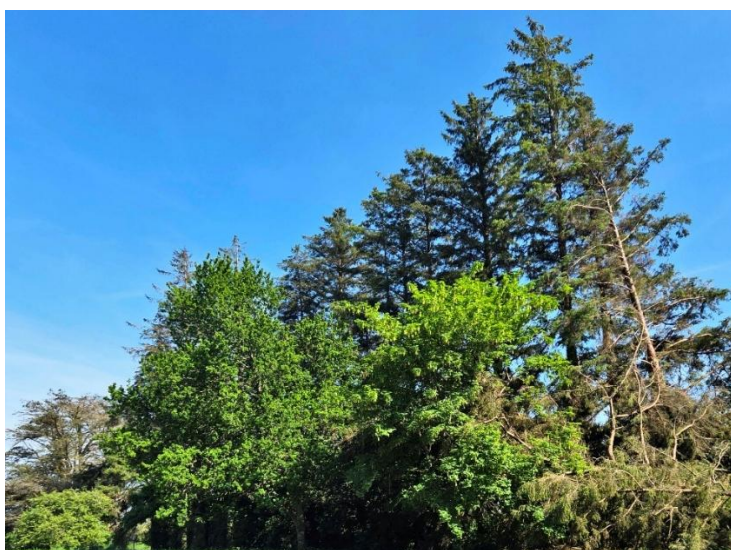
Image 8: Looking southeast at Tree Line No. 5, with windblown Tree Group No. 3 to the right of the picture.

- 7.8** The RPA of the Tree Line No. 5 along the southern boundary may be at risk of root damage due to the construction of the proposed car park and foot/cycle path. These trees are structurally significant and contribute to screening and site character. Sitka spruce typically develops a relatively shallow root system with long lateral roots, rather than deep anchoring taproots, making it particularly vulnerable to root disturbance from excavations. No-Dig methods and cellular confinement surface techniques should be used in be used (see sec 8.6 & 8.9 for ground protection details and TPR-LP-01 – Appendix 3 for where ground protection is to be positioned).

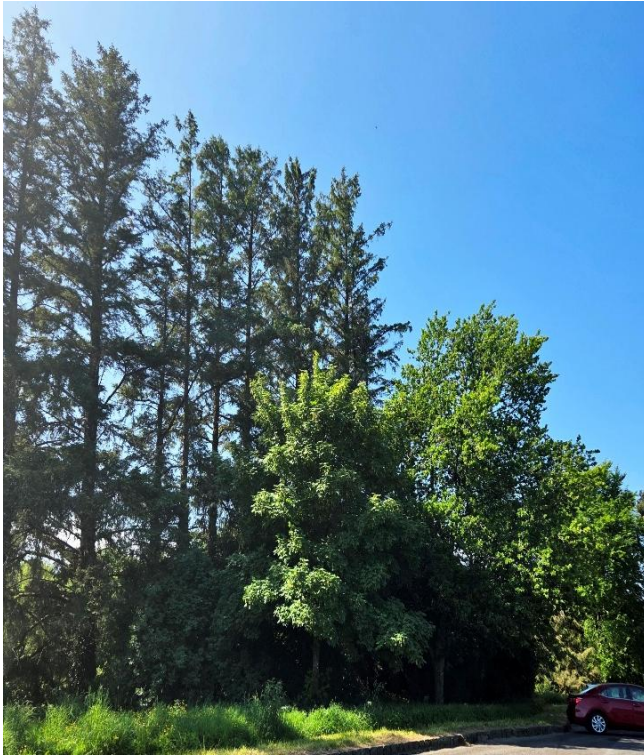
- 5.8** The line of mature Sitka spruce trees (Tree Line No. 5) (Image 9) forms a border between the car park and the adjacent scrubland, providing visual screening. The moderate quality (Category B) grade assigned to these trees is due to their landscape value as a tree line. A physical boundary of barbed wire runs along the line and into the trees at points. The trees are tall and relatively uniform in structure (Image 8), but several on the western side were windblown in recent storms. These fallen trees present a safety and access issue and will require removal. The remaining trees will also be more susceptible to windblow from the loss of these trees. They will need to be inspected annually for any signs of weakness. The windblown spruce are also damaging the crown of Tag No. 2585.

Image 9: Looking south at Tree line 5 with Tag Nos. 2585, 2586 & 2587 on the right in the foreground.

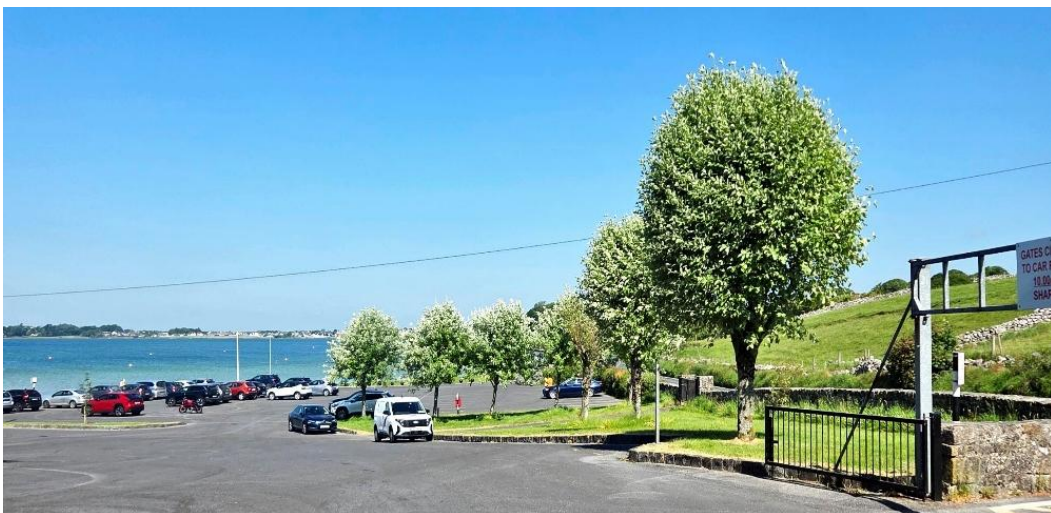
- 5.9** The remainder of the south of the site contains some planted semi mature trees that hold little aesthetic value in the car park and were likely planted as landscape features. Some of the trees have been previously managed through crown reduction, which has helped maintain clearance from vehicles and pathways, however, this has left pruning wounds, which are beginning to occlude, and affected structure. Ongoing maintenance will be necessary to avoid conflict with cars and pedestrians (Image 10).

Image 10: Looking north at landscape feature trees Tag No. 2590 to 2597.

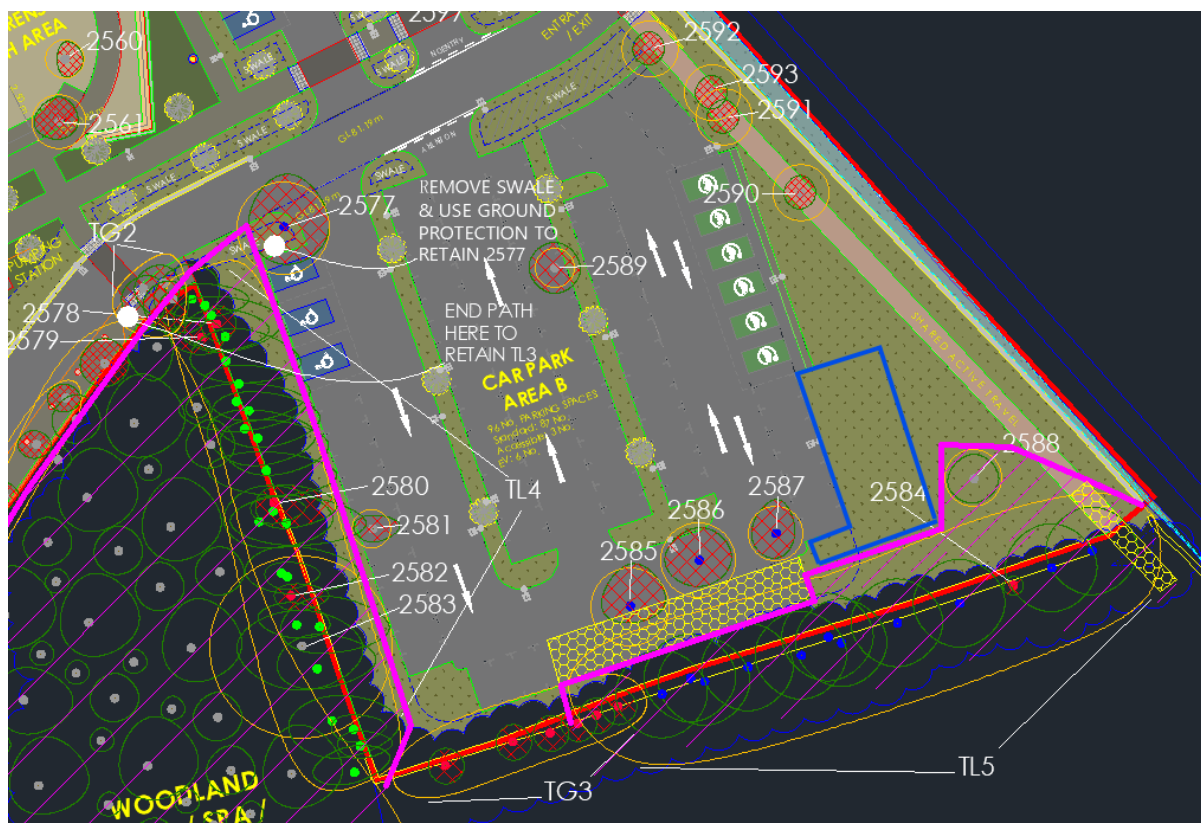
Figure 1: Excerpt from TPR-LP-01 showing how Tag Nos. 2577, 2585, 2586 & 2587 conflict the design layout. If the swale was removed from around Tag No. 2577, and ground protection (see sec 8.6 & 8.9) was used over the RPA, this tree could be retained. And the space outlined in blue to the southeast should be utilised so that Tag Nos. 2585, 2586 & 2587 could be retained.

- 7.7** Four moderate quality (Category B) trees (Tag Nos. 2577, 2585, 2586 & 2587) will need to be removed under the current design layout. These trees are of good arboricultural value and should be retained where possible. These trees contribute positively to the site's character, provide ecological benefits, and are in good structural and physiological condition. If the car park layout can be reconfigured to allow for their retention, it would be a more sustainable and responsible outcome (see Figure 1).
