## Appendix No 8

Third Party Planning Appeal of the decision by Meath County Council to  
grant planning permission for development Planning Reference Number:  
22331 Meath CoCo.

# WHY MINE WASTE IMPOUNDMENTS EXPERIENCE STABILITY FAILURES

**W. Allen Marr**

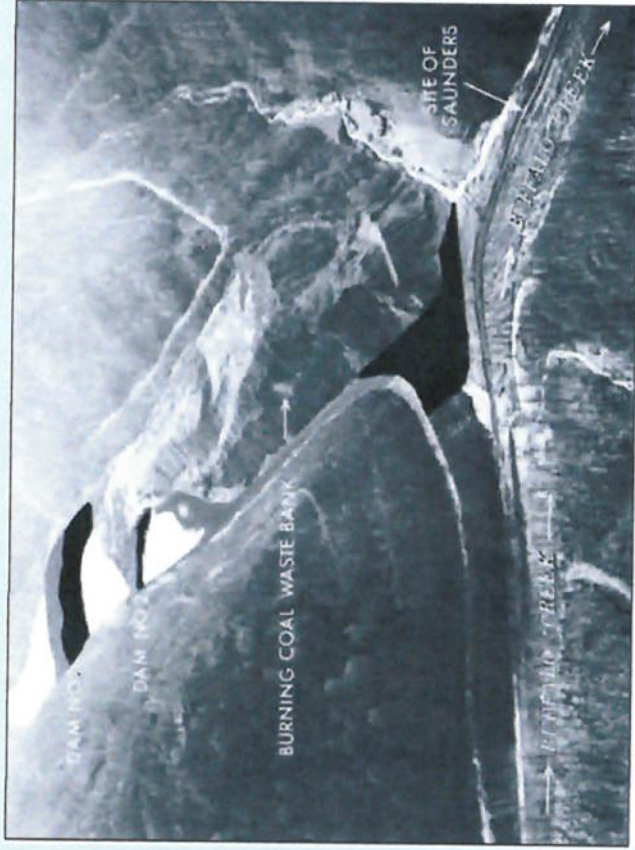
Figure 61. Reconstructed view of the damsite.  
Source: U.S. Geological Survey, Circular 667

| Failure Mode: | Collapse of dam by slumping and sliding of downstream after heavy rain ( <u>water flow through the dam</u> ) |

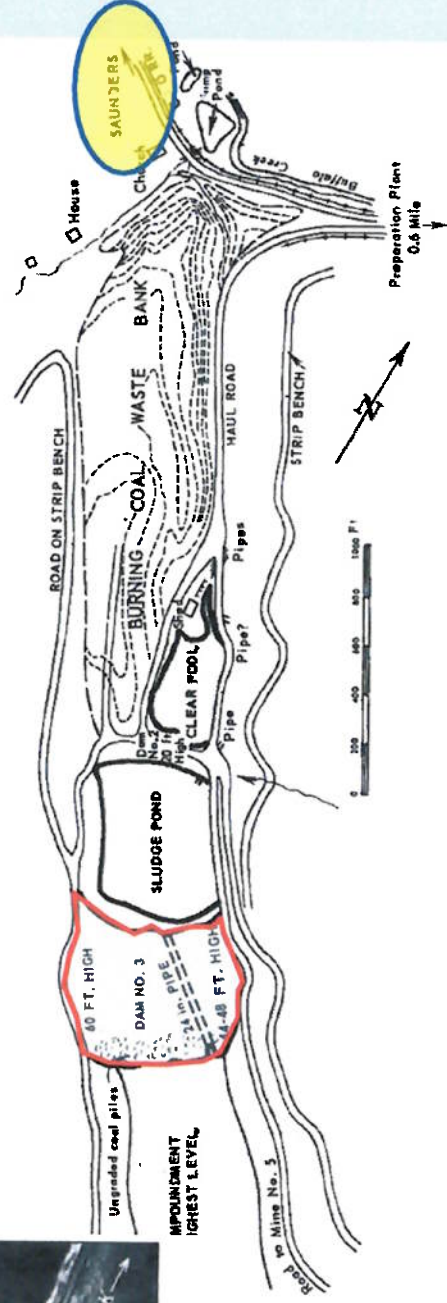
FIGURE 3.—Sketch map of Middle Fork, February 1972, before dam broke.

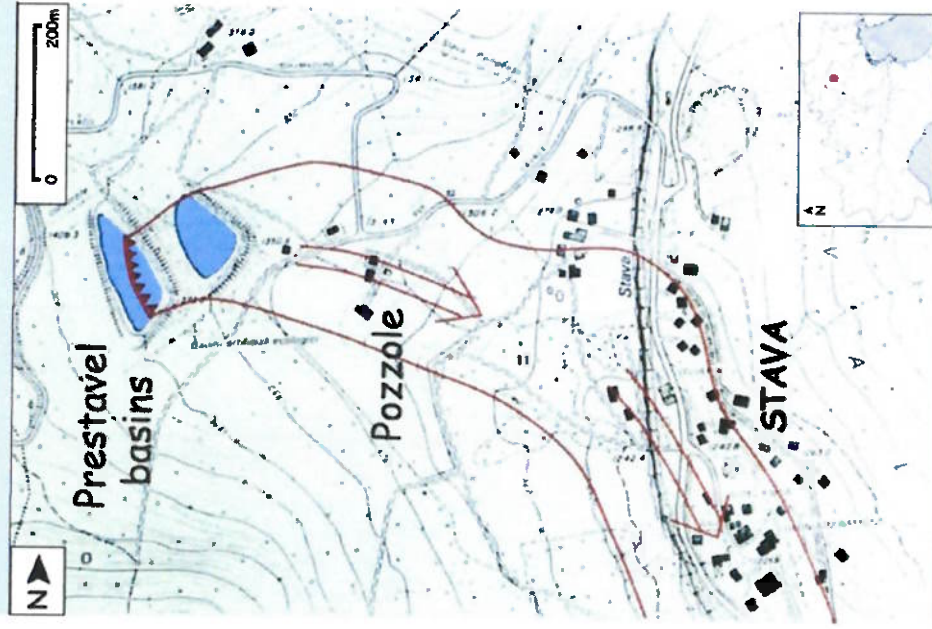
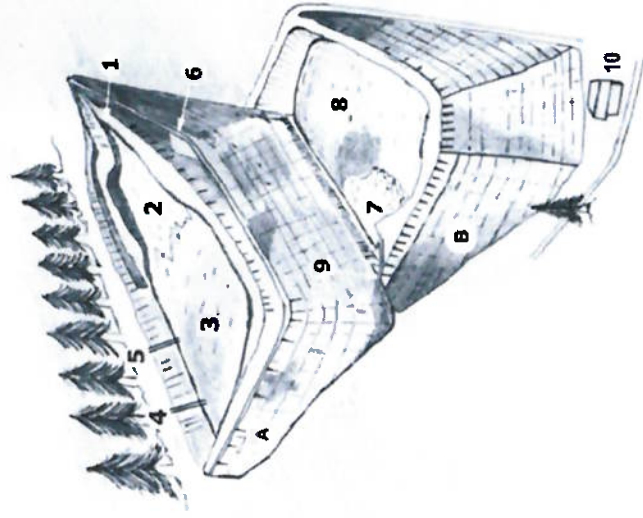
**Fig. 2.** Graphical representation of the Prestavel basins: (A) upper basin; (B) lower basin; (1) cyclone, (2) sandy deposit, (3) silty deposit, (4) drainage service, (5) emergency drainage, (6) service road, (7) sand cone, (8) silty deposit, (9) drainage from the upper basin, (10) caretaker's house.

| Failure Mode: | <u>Failure through silt foundation</u> followed by mud flow |

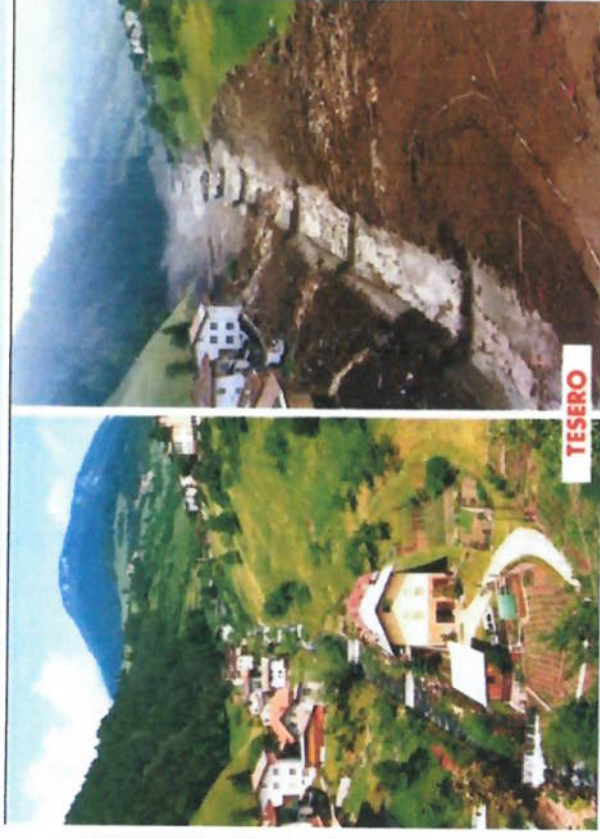
**Fig. 13.** Before and after the passage of the mudflow in the Tesero village at section 20 in Fig. 8 (postcard – Foto Trettel, P., edited by: Artesan, Tesero).

| Consequence: | Mud flows killed 268 people, destroyed 82 buildings |

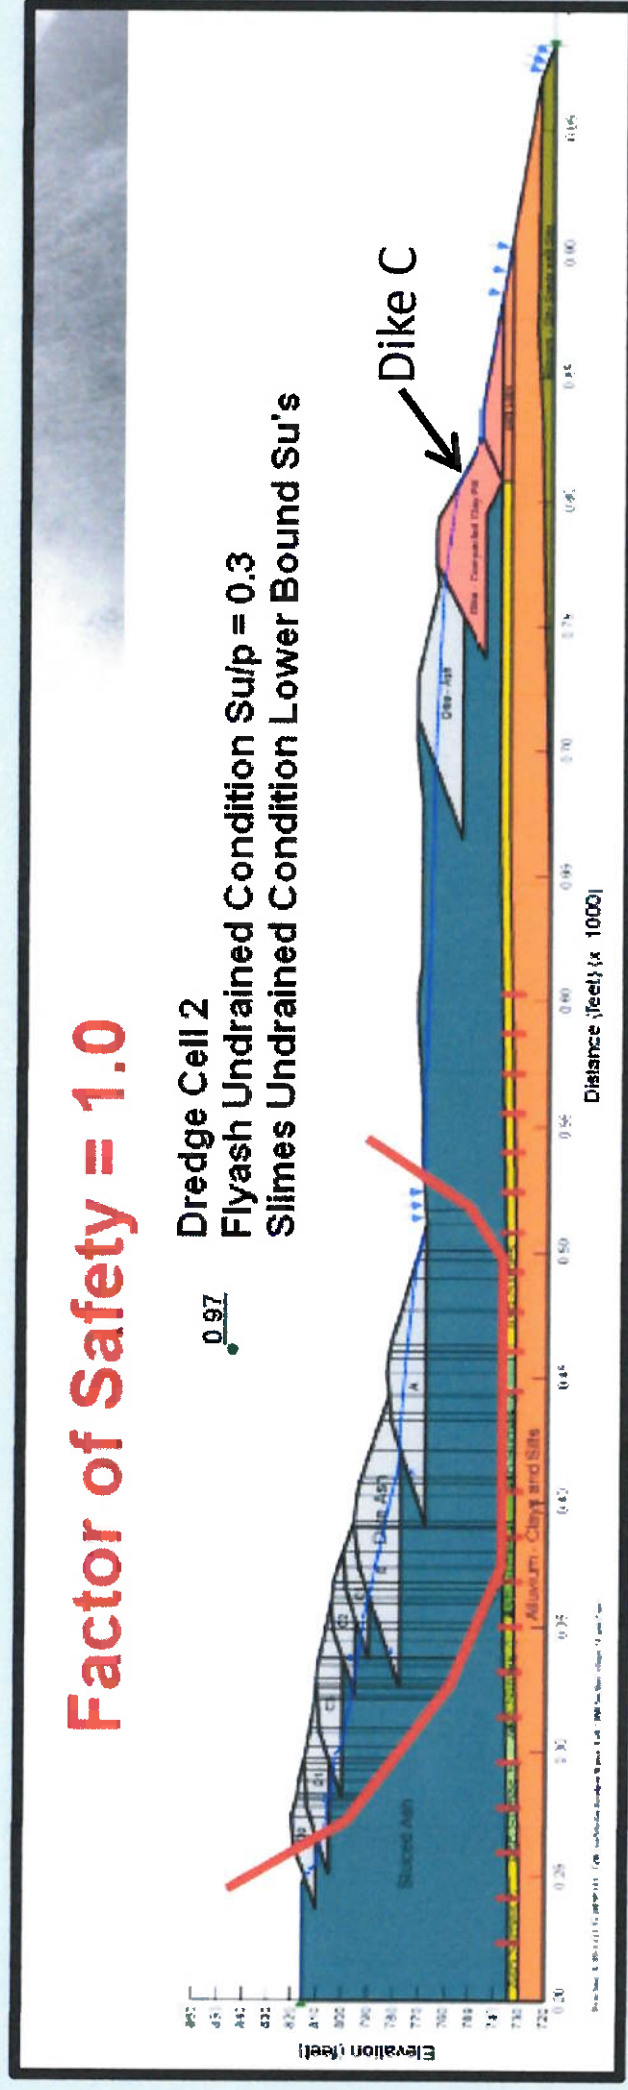
Kingston, TN, USA (2008)

Undrained creep shear failure of 6" layer of interbedded silt, clay and slimes at high water content with load being added. Triggered shear slide then liquefaction of the sluiced ash tailings.

| Failure Mode: | <u>Undrained failure through thin weak foundation layer</u> , leading to liquefaction of stored ash, followed by mud flow |

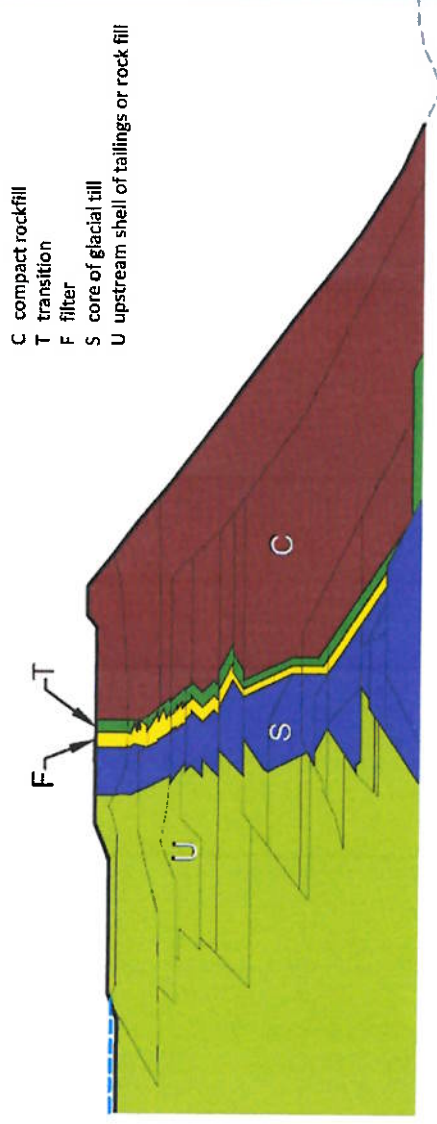
FIGURE 6.2.1: DETAILED SECTION USED FOR LIMIT EQUILIBRIUM ANALYSIS (HIGH WATER TABLE, UNDRAINED STRENGTH RATIO 0.27)

Piezometer types were not able to measure undrained pore pressures induced by shearing during the last stage.

- ...indicate that the foundation [GLU] was brought to failure under *fully drained* conditions, until the undrained strength was reached...

| Failure Mode: | <u>Undrained stability failure through foundation</u> of containment dam<br>built over varved clay, leading to liquefaction of stored tailings,<br>followed by mud flow |

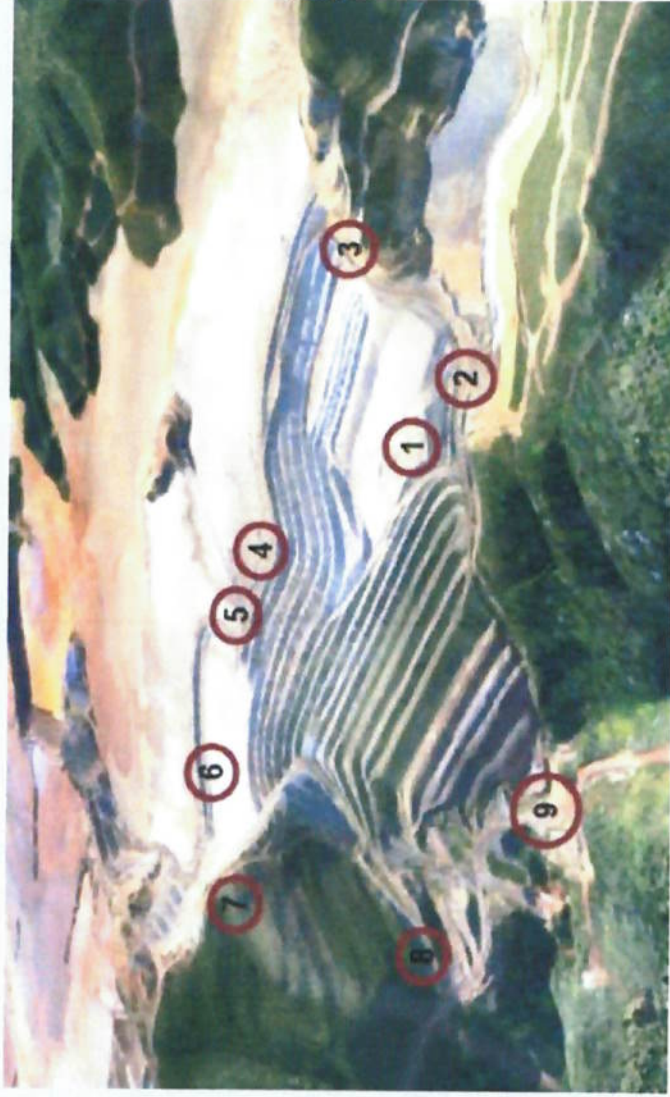
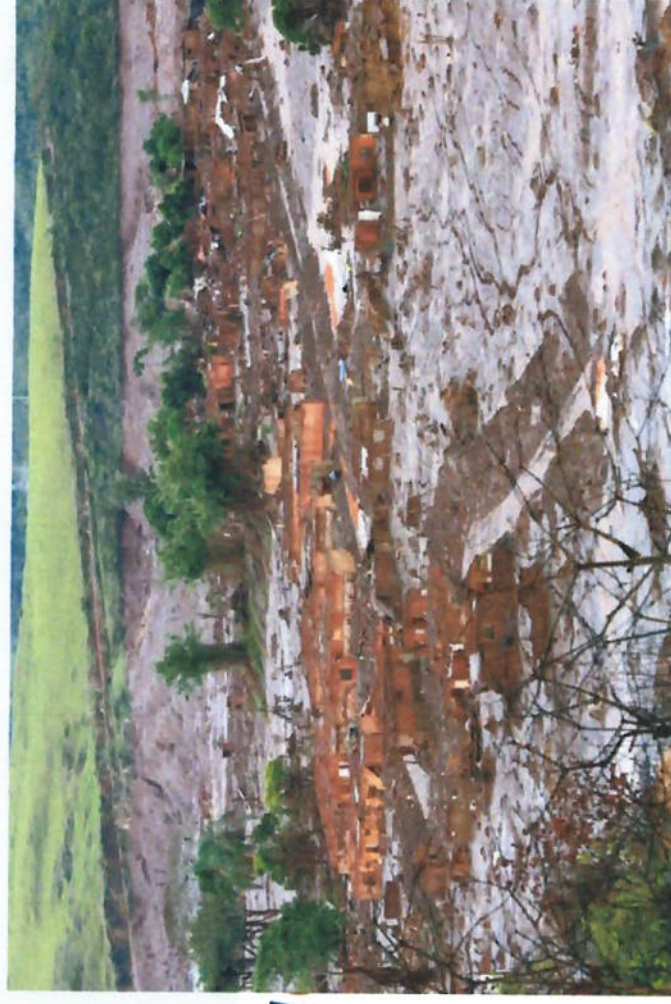
Figure 2-17 Eyewitness locations on the afternoon of November 5, 2015

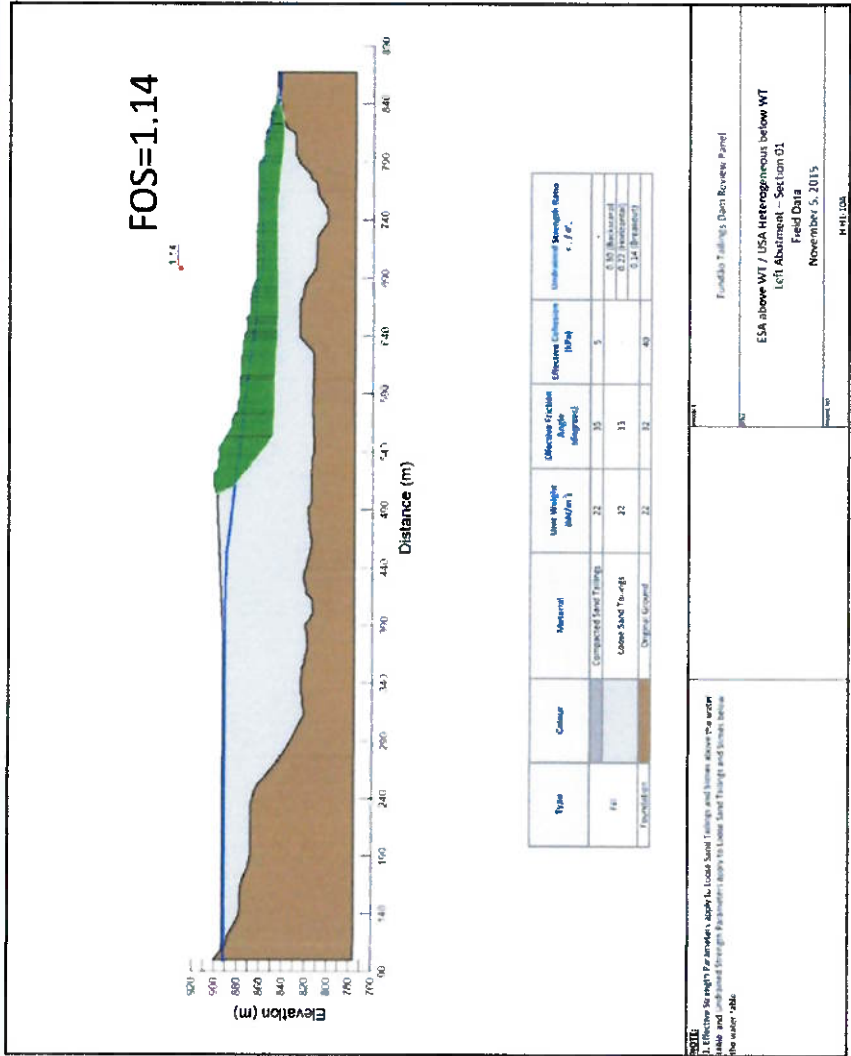
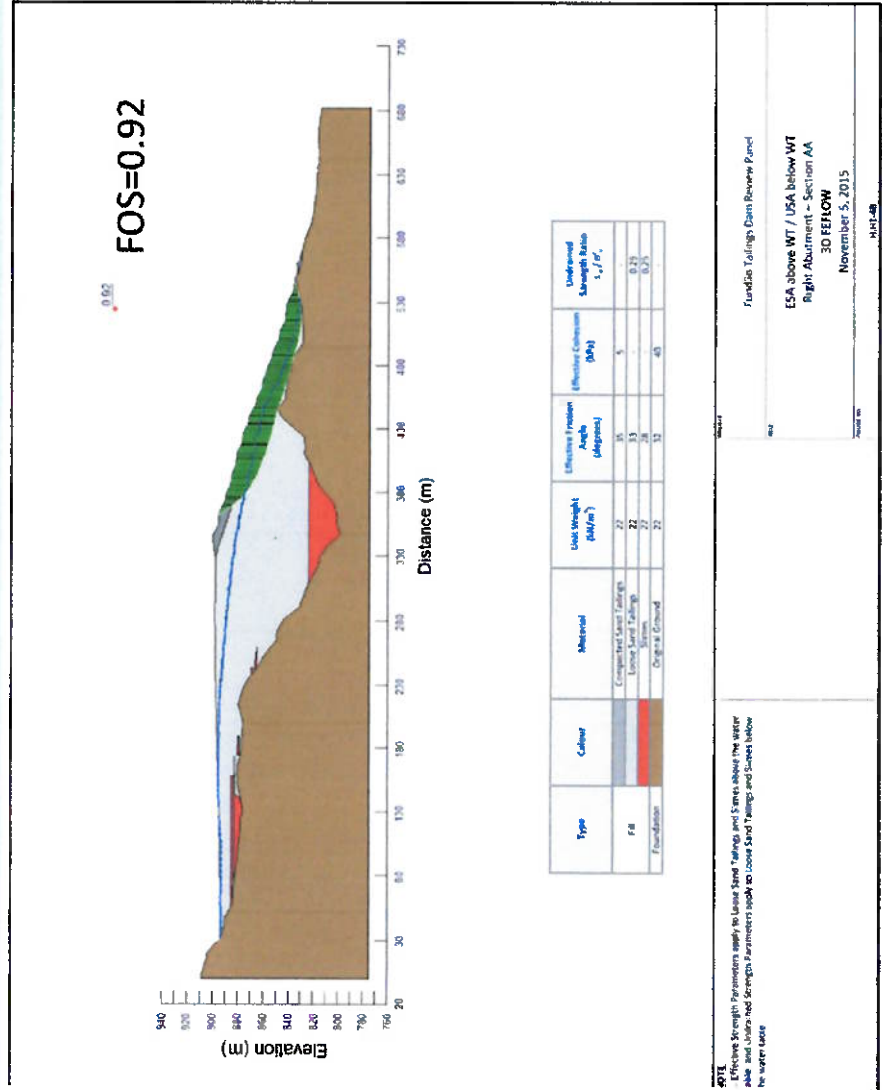
High pore pressures in the tailings from filling lowered the stability of the dam

| Failure Mode: | <u>Undrained failure of containment dam built over tailings from rapid filling, leading to liquefaction of stored tailings, followed by mud flow</u> | |

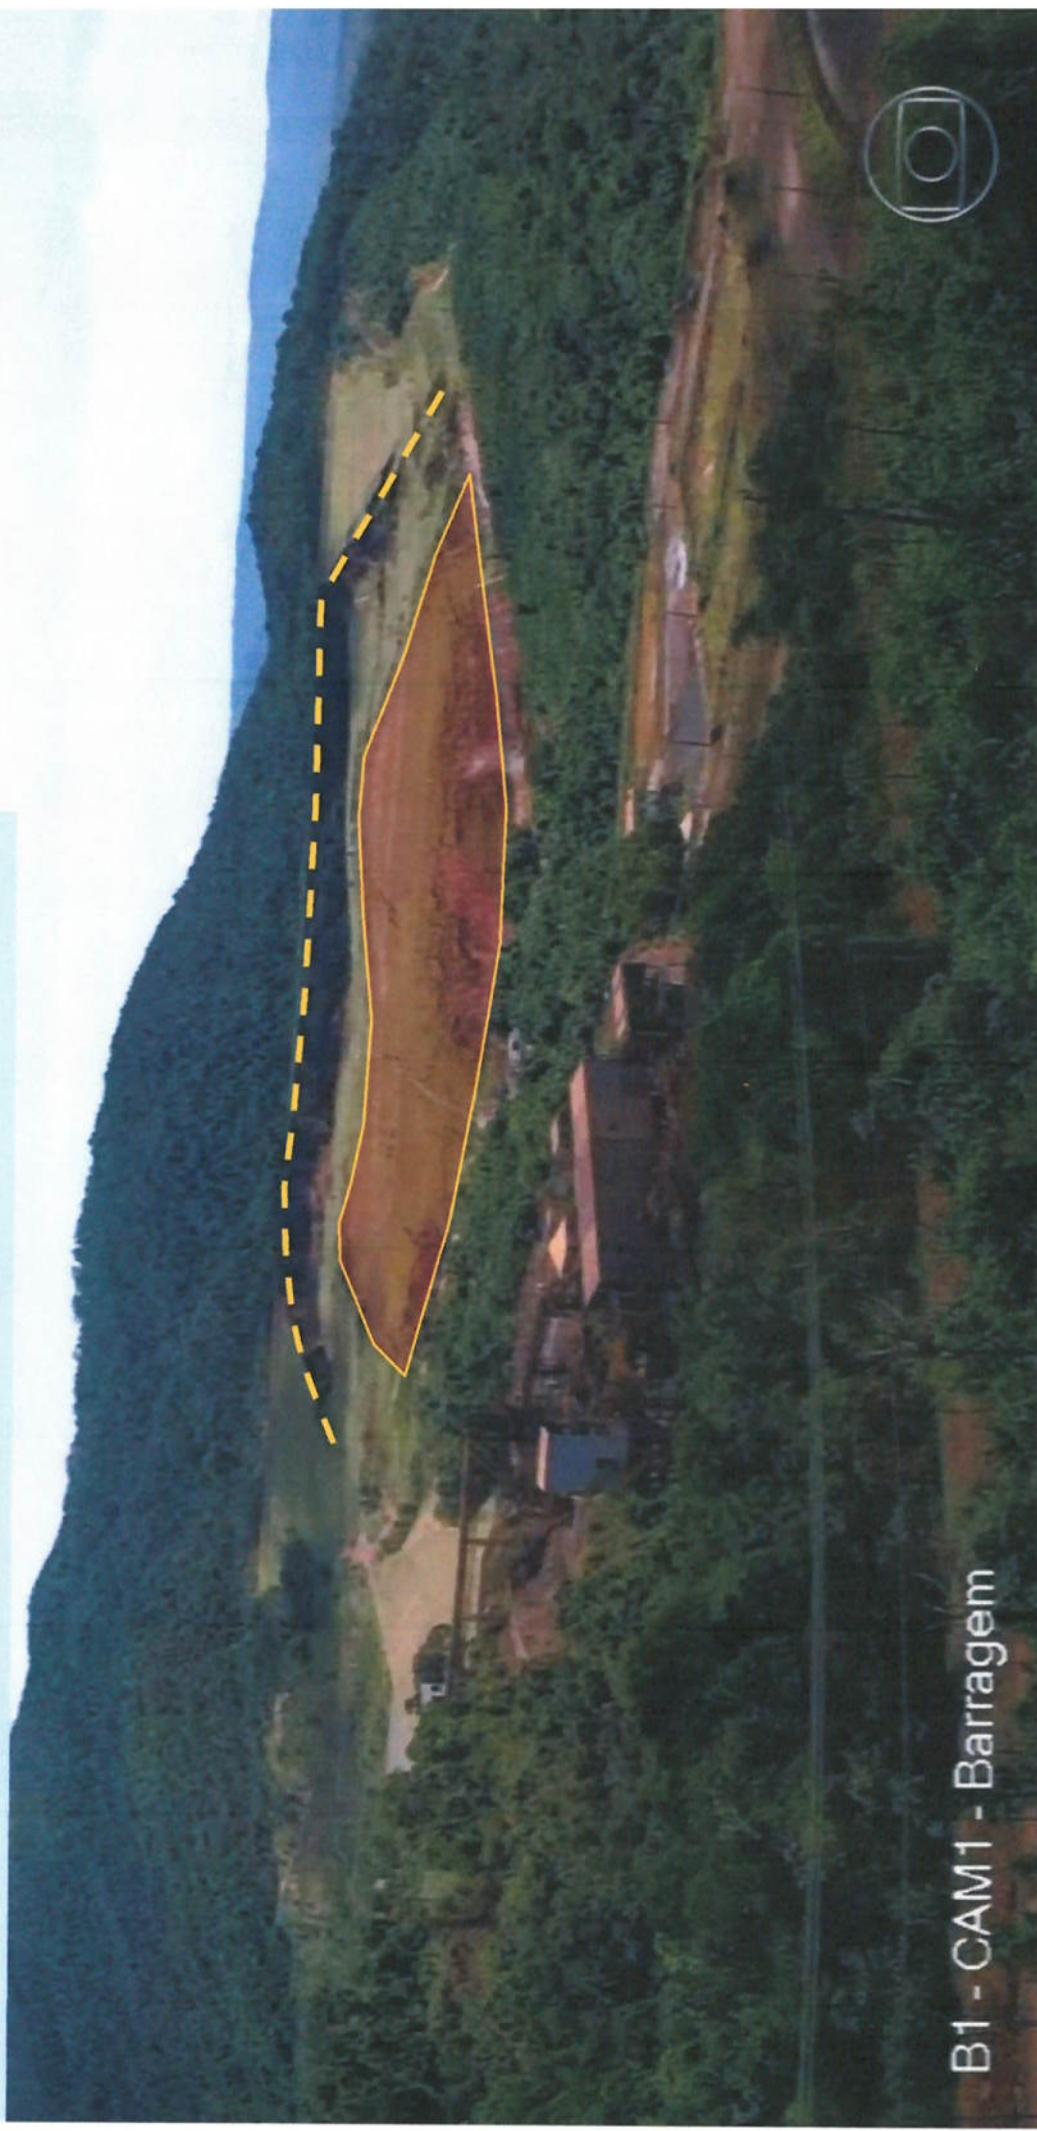
B1 - CAM1 - Barragem

700 m long, 86 m high

248+ deaths; 22+ missing; >\$5 billion damages??
