Appendix A13.6 Road Safety Audit

Stage 1

PROPOSED ACCESS

GDD WASTEWATER TREATMENT PLANT

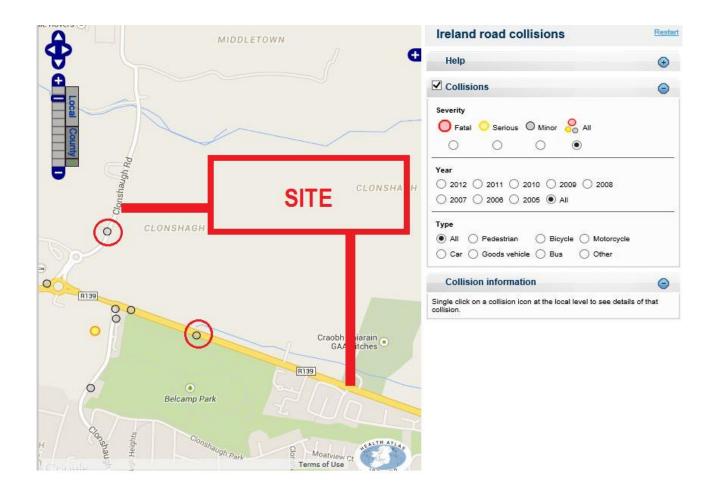
Figure 1: Collision Plot for Road Network surrounding site (2005-2012 incl)

- 2.1.1 The designers have not advised of any departures from standard.
- 2.1.2 There was no information provided relating to cross sections or long sections.
- 2.1.3 A preliminary review of collision data in the vicinity of the site was carried out. A review of the Road Safety Authority (RSA) online collision database indicates that there was one minor collision involving a car and a pedestrian approximately 500 west of the proposed site access on the R139, and one minor collision involving a car and a rear end shunt on the Clonshaugh Rd, approximately 100m south of the proposed site egress as highlighted in figure 1 below.

There was an additional cluster of collisions (3 minor collisions, 1 serious collision) noted in the vicinity of the junction with the R139 / Clonshaugh Rd (South), which is located approximately 900m west of the proposed site access, and an additional cluster of collisions (one of which resulted in a motorcyclist fatality) in the vicinity of the Northern Cross signal controlled junction with the Malahide Rd, which is located approximately 1km to the east of the proposed site access.

It should be noted that the RSA database is not a comprehensive record of collisions, and should be reviewed in conjunction with the Local Authority / Gardaí records for the site. Additional information was provided with reference to Fingal County Council (FCC) collision data, which indicated that there was a record of a serious collision on the R139 in 2002, and a record of two additional collisions occurring in 2002 close to the proposed access junction, both of which resulted in minor injury. The precise locations for these collisions are unknown, and have not been included in Figure 1.
