Appendix A. Survey Record Sheet

Address: 48 Prospect Avenue, Botanic, Dublin 9

Property ID No: ML BS-002-B120

Area: Immediately east of the alignment. Alignment intersects/passes under the north west corner of the building. Situated north of proposed Glasnevin Station.

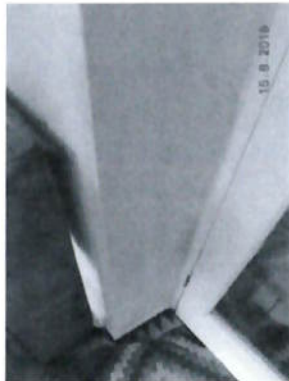
Damp staining to front wall of dining room area. Owner is aware of issue.

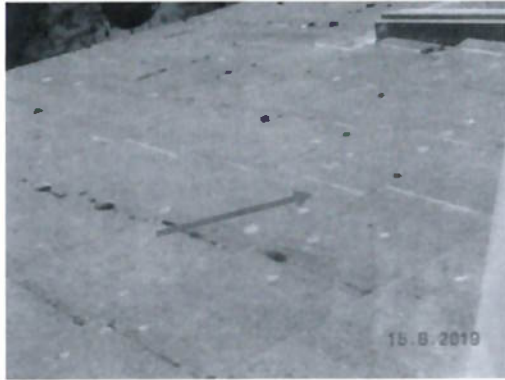
Mastic seal noted to some joints of the roof tiles to the rear extension lean-to roof. Owner has advised there was a previous leak around the velux roof light serving the kitchen, but has not manifested after remedial works where undertaken.

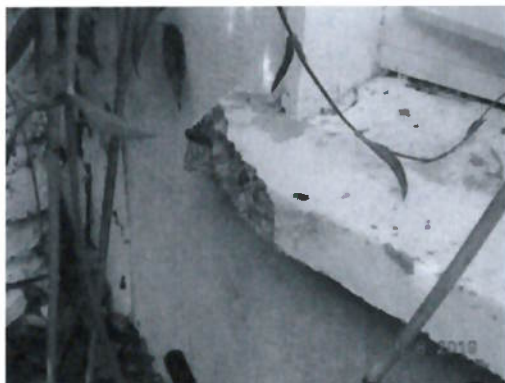
Blown concrete to kitchen window cill. Exposed rebar to same.

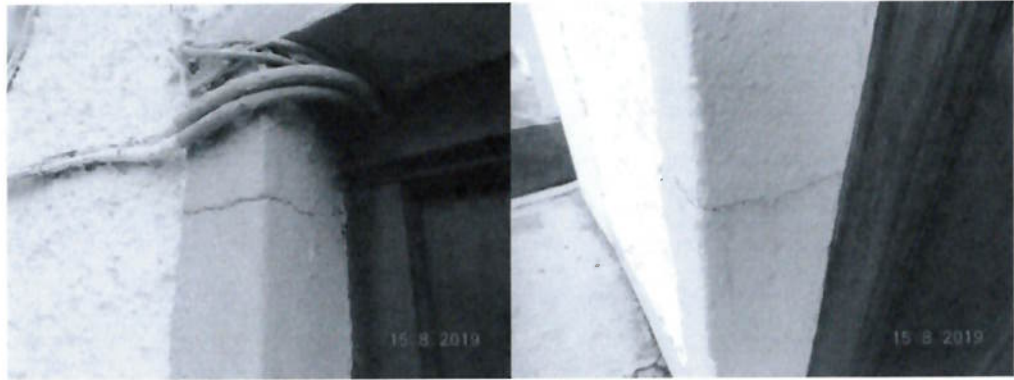
Slight cracking to reveals of front main entrance door.

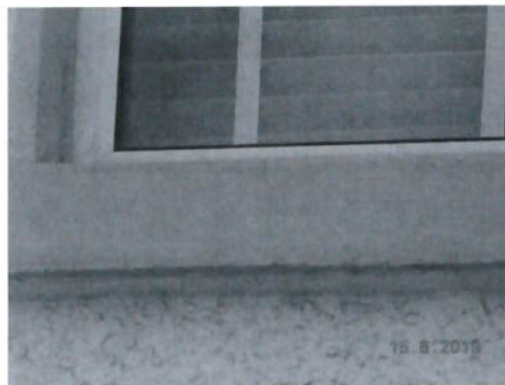
Very fine cracking through the first floor level window cills as viewed from the front elevation.
