AN BORD PLEANÁLA

facade consultants

Ground Settlement.

ML1-JAI- EIA-ROUT-XX-DR-Y-21146 rev P02

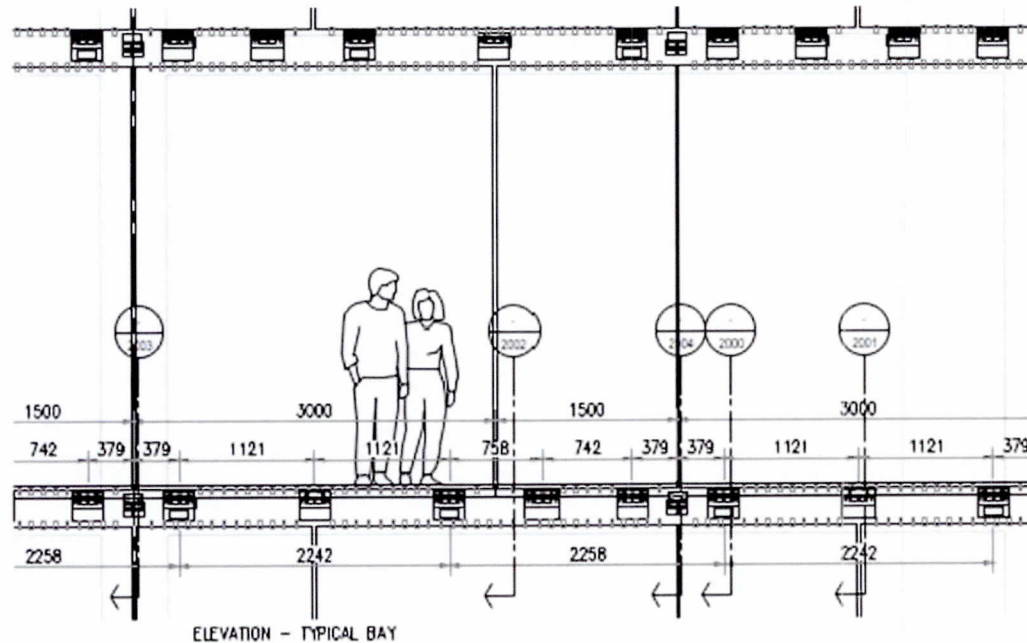
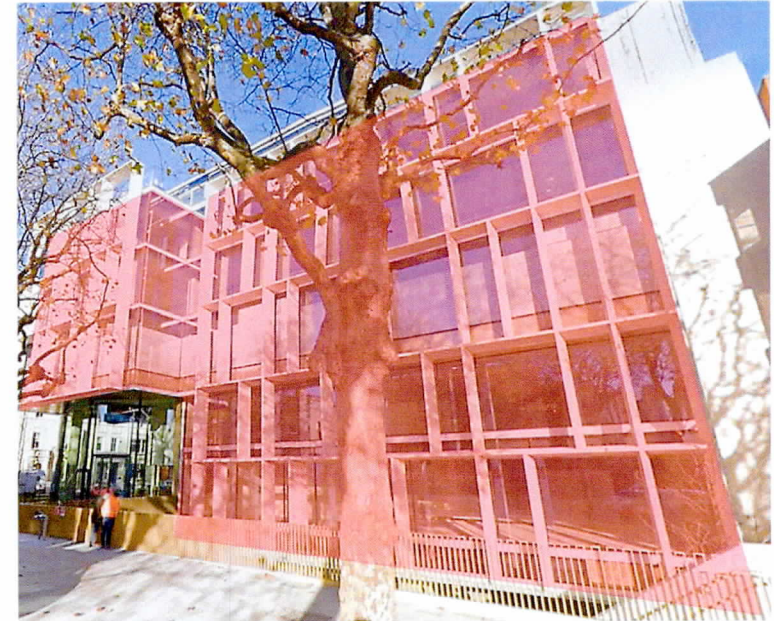
EWS-001 Window Wall.

It consists of large double glazed units free-spanning from floor to floor. Each pane of glass is only restrained by hidden toggles at the top and bottom edges of the double glazed units. The panels are all 3.5m tall. Panel widths range between 1.2m and 3m.

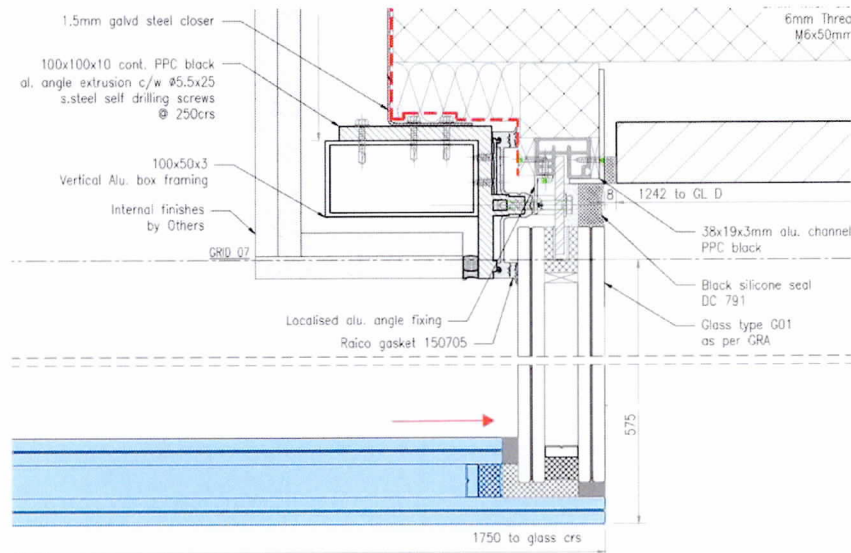
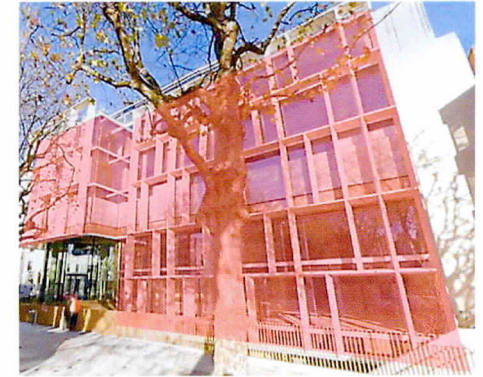
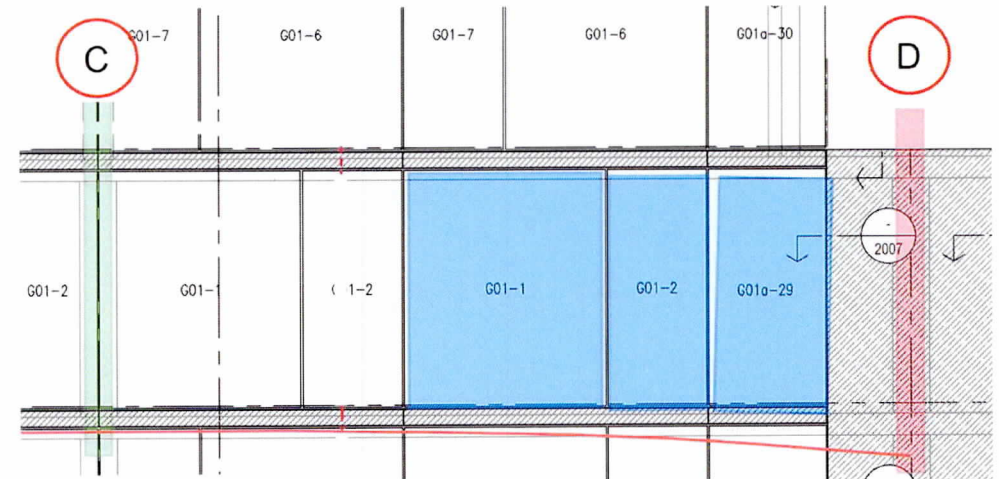
EWS-001 Window Wall. South Elevation. Worst Case.

Due to the aspect ratio of the panels closest to gridline D on the South elevation, the TII predicted differential settlement of **25mm from Gridline C to D** would result in **1.75m** wide panels rotating in plane not less than **3.6mm** at their base. As each panel is **3.5m tall this translates into 7mm rotation** at the top corner of the panel. Such rotation would exceed the design parameters of the structural sealant at the glass to glass joint crushing and tearing the sealant and inducing stress in the glass. It may not cause breakage but will apply long-term stress into the structural sealant joint which may cause failure of the structural connection.

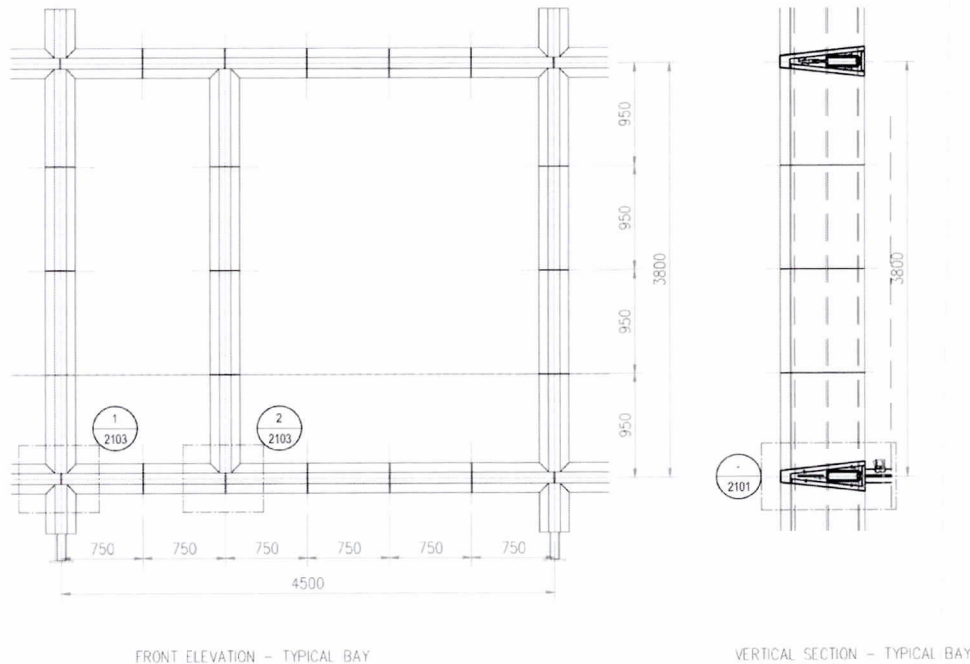
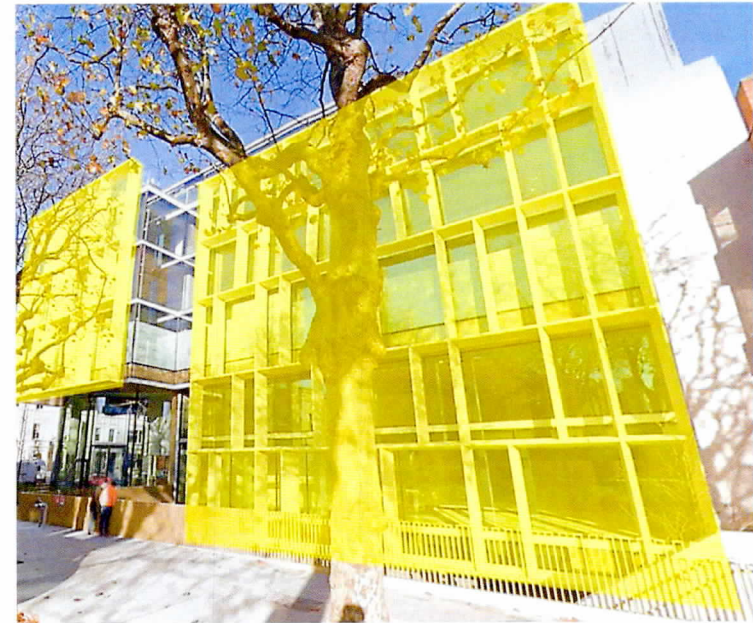
EWS-002 Suspended Stone Veil.

The stone veil is supported from the terrace slab at fifth floor level. The veil consists of individual pieces of hand-set limestone with undercut anchors and aluminium support rails fixed back to a bespoke stainless steel and galvanised steel suspension structure. Differential movement (racking) of the primary structural floors causes the veil suspension structure to deform out of square.

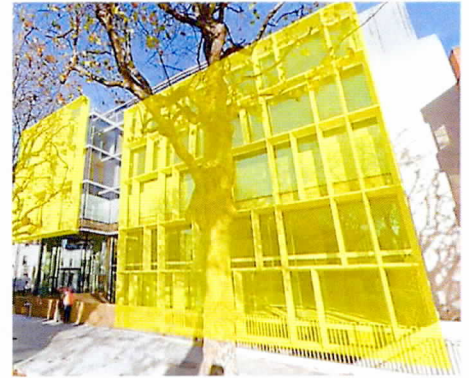
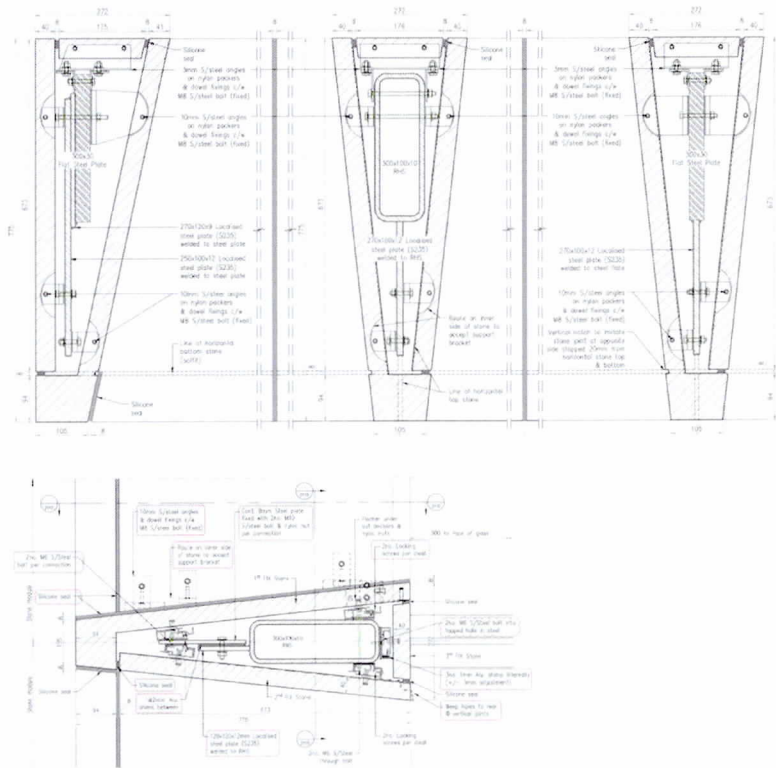
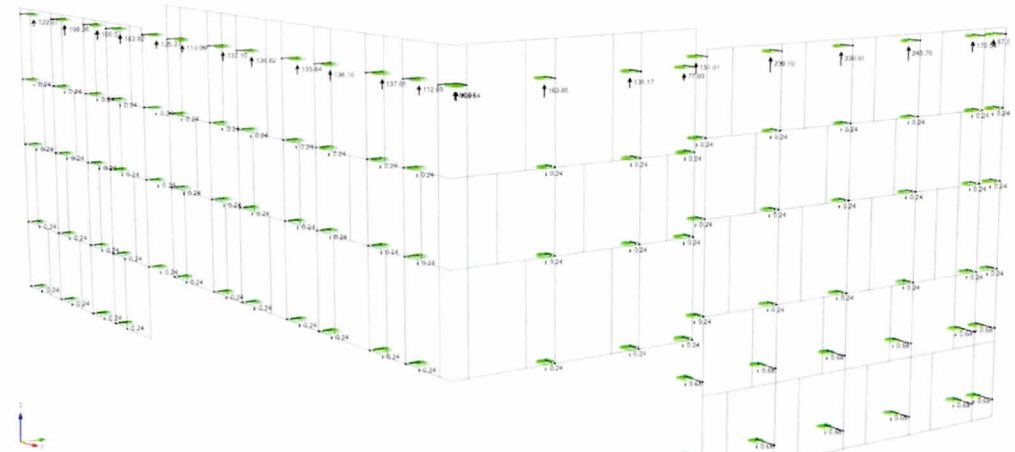
EWS-002 Suspended Stone Veil. South Elevation. Worst Case.

The stone veil is supported from the terrace slab at fifth floor level. The veil consists of individual pieces of hand-set limestone with undercut anchors and aluminium support rails fixed back to a bespoke stainless steel and galvanised steel suspension structure. Differential movement (racking) of the primary structural floors causes the veil suspension structure to deform out of square.

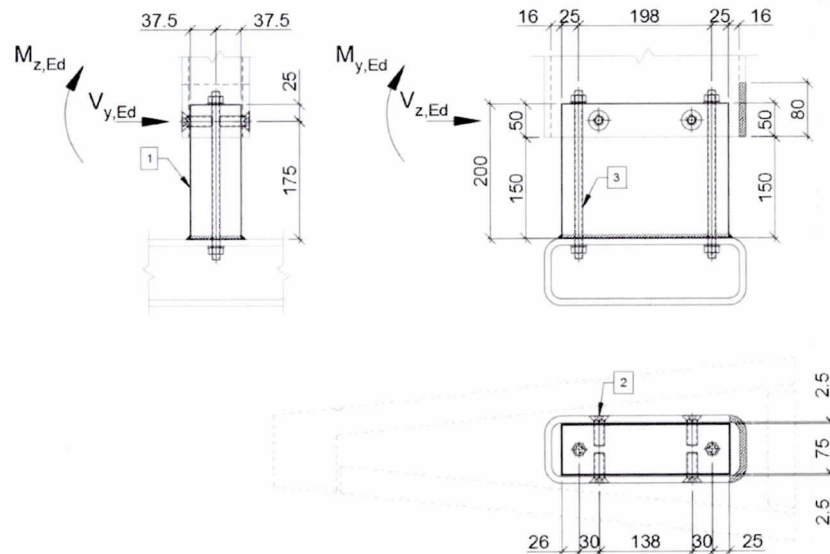
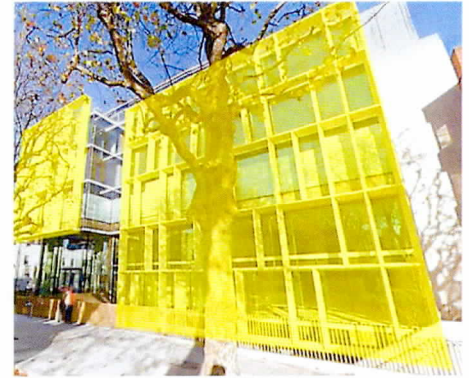
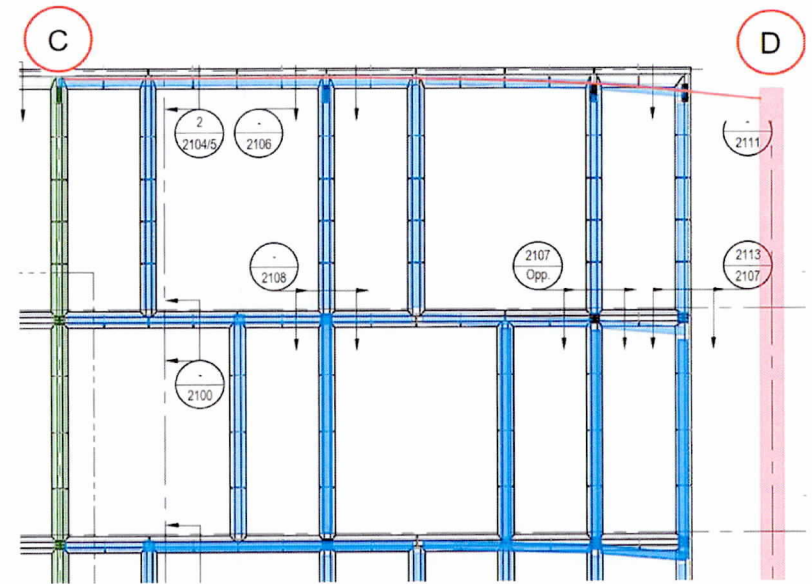
EWS-002 Suspended Stone Veil. South Elevation. Worst Case.

The differential settlement of a column **25mm from Gridline C to D** causes rotation of the connection between horizontal and vertical veil elements. These connections are typically formed with countersunk fixings tapped into a block of stainless steel. These connections were not designed to accommodate significant rotation. Detailed analysis would be required to determine how these connections react and whether the horizontal beams of the veil would rotate at these connections or be forced to go into bending (**'S' shaped bend on elevation**). If over-stressed the connections could fail.

If the horizontal beams or vertical mullions go into bending due to differential settlement, this could cause **over-stressing of the fixings in the stone exceeding permissible safety factors and/or causing cracking of the stone.**

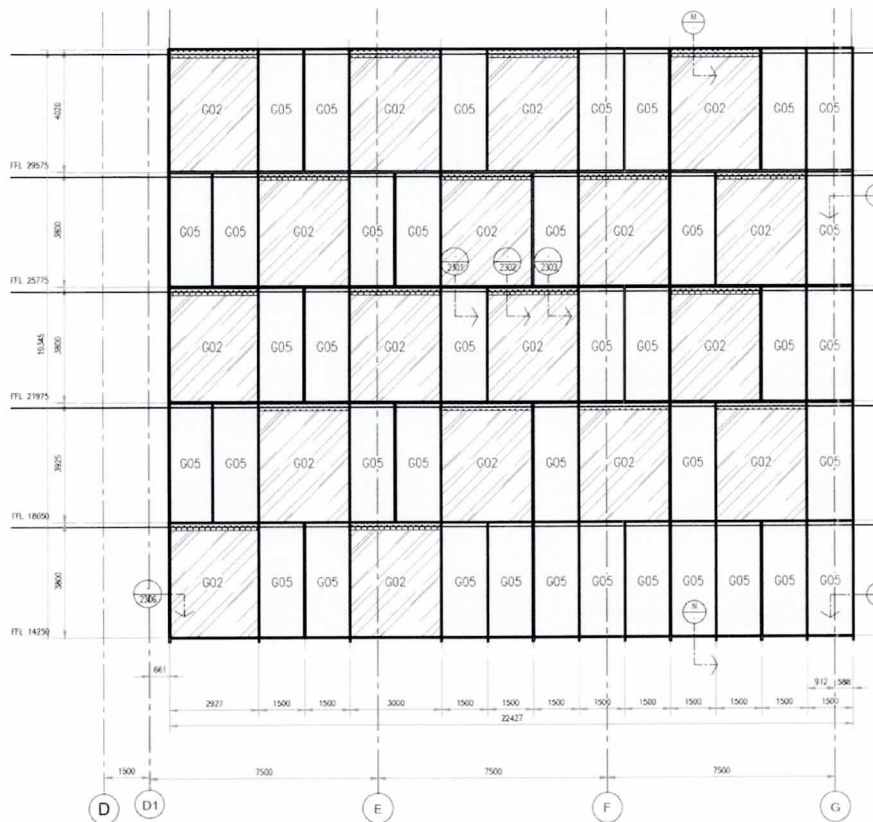
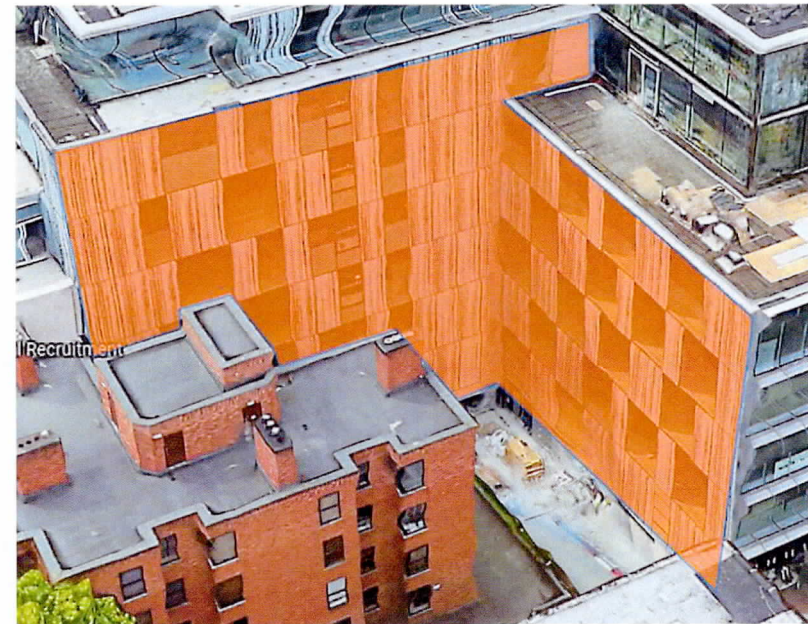
EWS-003 Stick System Curtain Wall.

It is a bespoke solution dead-loaded at each slab. It consists of large double glazed units, some opacified with insulated panels behind, toggle-glazed into aluminium profiles on four sides. Each pane of glass is restrained by hidden toggles around the perimeter of each double glazed unit. The panels are all 3.5m tall. Panel widths range between 1.5m and 3m.

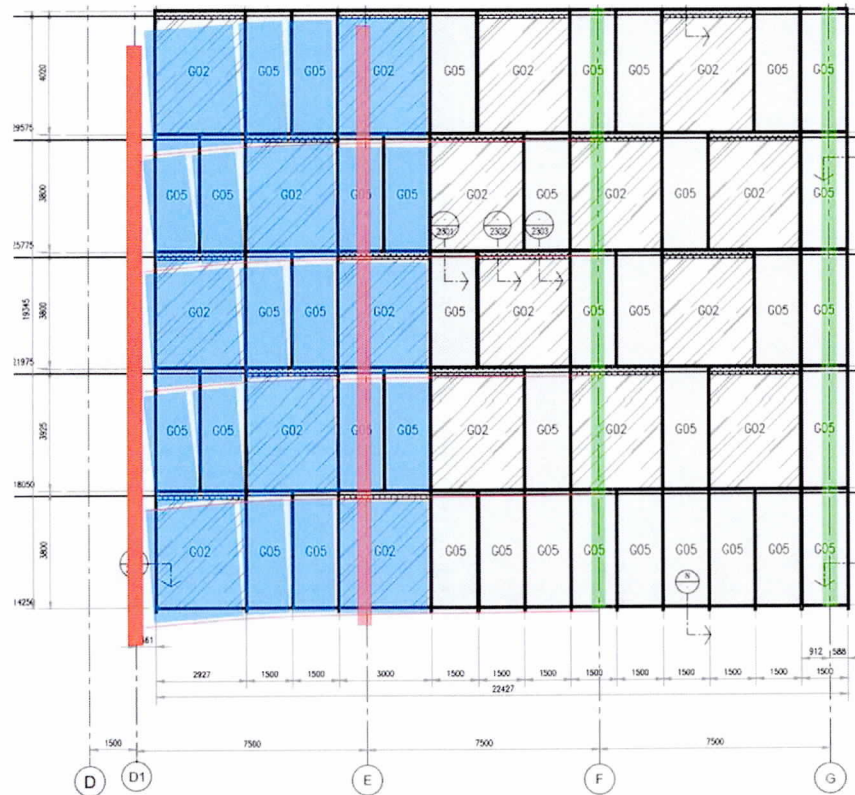
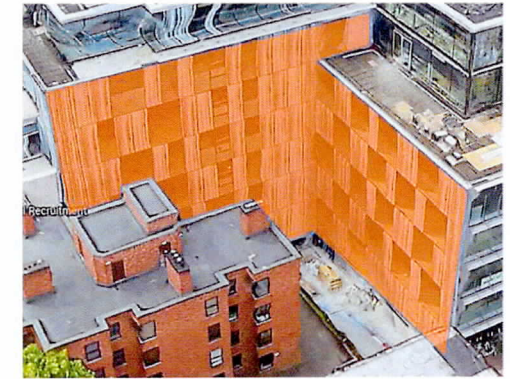
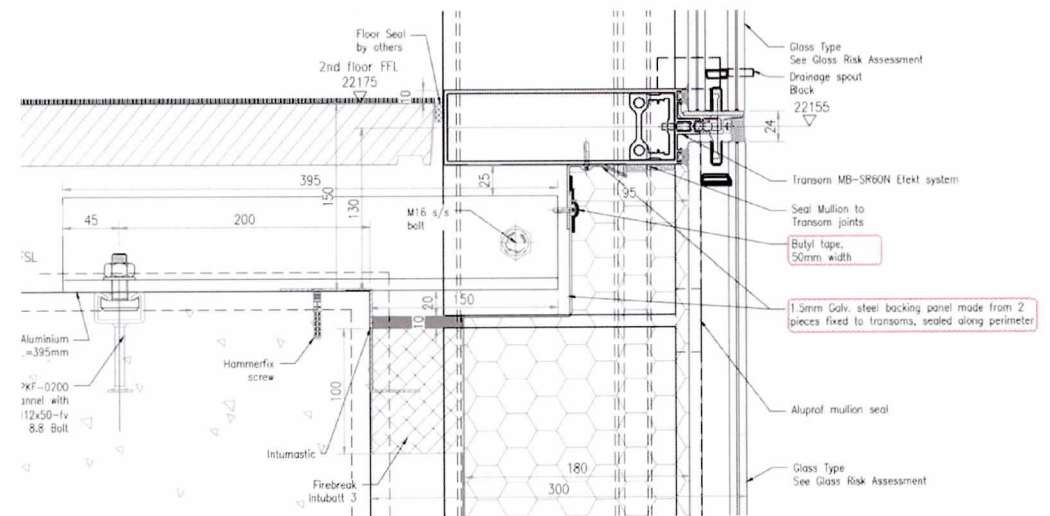
EWS-003 Stick System Curtain Wall. Worst Case Recessed South Elevation

When the structure moves differentially, the mullions remain vertical and the transoms rotate in plane. As each glass unit sits on a transom, the glass rotates with the transom. Based on the TII diagram there is approximately **30mm of differential settlement across quite a small width of approximately 10m.** Due to the aspect ratio of the panels closest to gridline D1 on the South elevation, the TII predicted differential settlement of **30mm in this area** would result in **1.5m wide panels** rotating in plane not less than **4.5mm at their base**. As each panel is **3.8m tall** this translates into **11mm rotation** at the top corner of the panel. The toggle glazed system does not have capacity for this degree of movement.

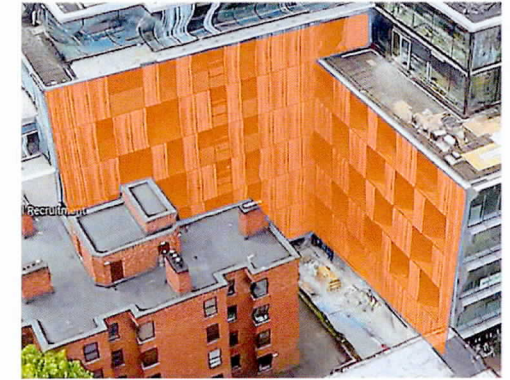
When the structure moves differentially, the mullions remain vertical and the transoms rotate in plane. As each glass unit sits on a transom, the glass rotates with the transom. Based on the TII diagram there is approximately **30mm of differential settlement across quite a small width of approximately 10m.** Due to the aspect ratio of the panels closest to gridline D1 on the South elevation, the TII predicted differential settlement of **30mm in this area** would result in **1.5m wide panels** rotating in plane not less than **4.5mm at their base**. As each panel is **3.8m tall this translates into 11mm rotation** at the top corner of the panel. The toggle glazed system does not have capacity for this degree of movement.

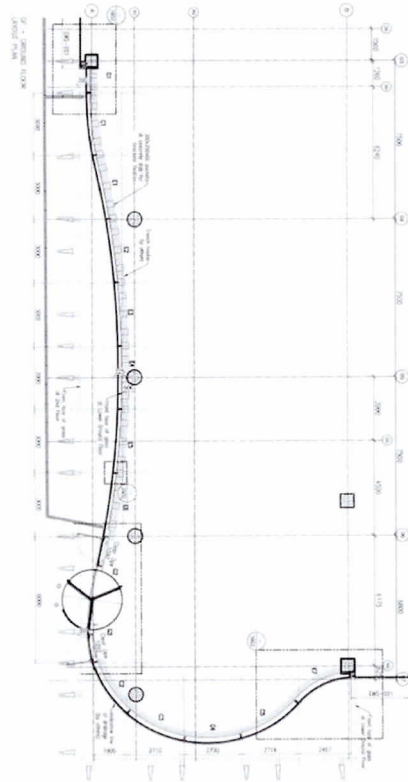
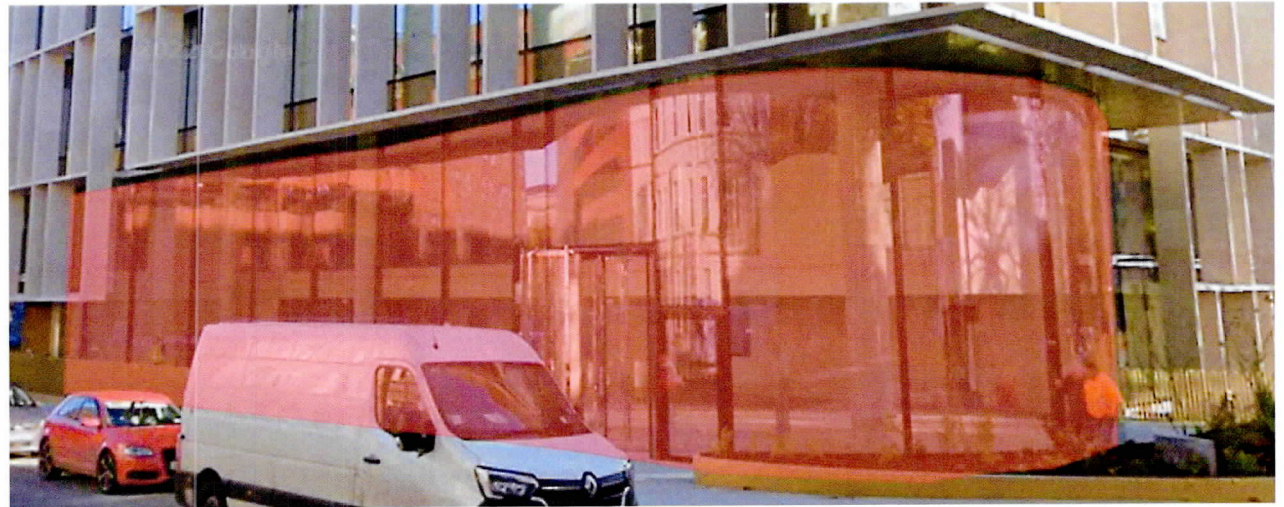
EWS-006 Entrance Glazing.

The entrance glazing is a bespoke glazing system formed from curved double-glazed units up to 6.7m tall restrained by stainless steel flat plates at glass to glass joints. Due to their size and shape, the double glazed units are formed from laminated annealed glass rather than heat treated or toughened glass. This makes the glass particularly susceptible to breakage due to localised stresses.

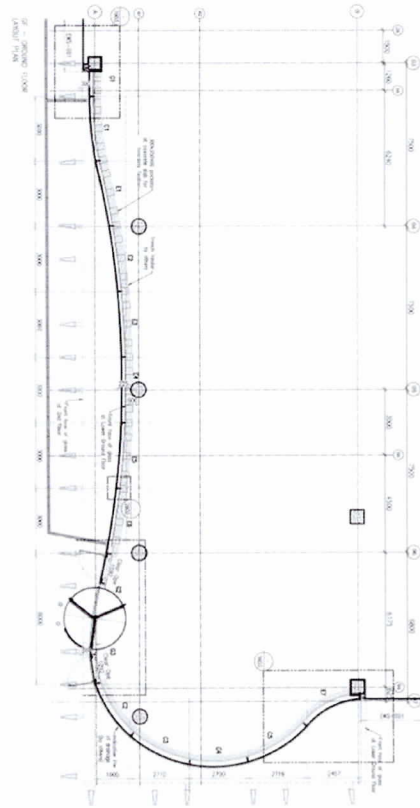
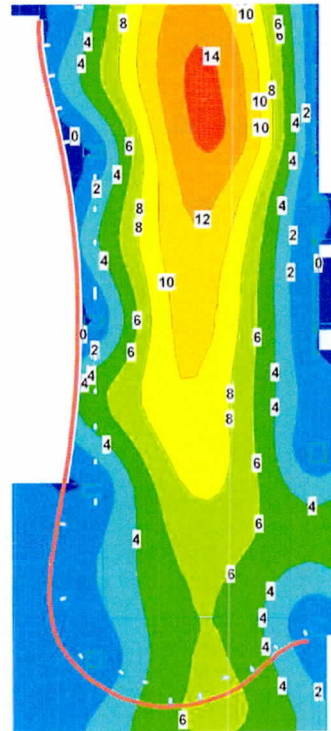
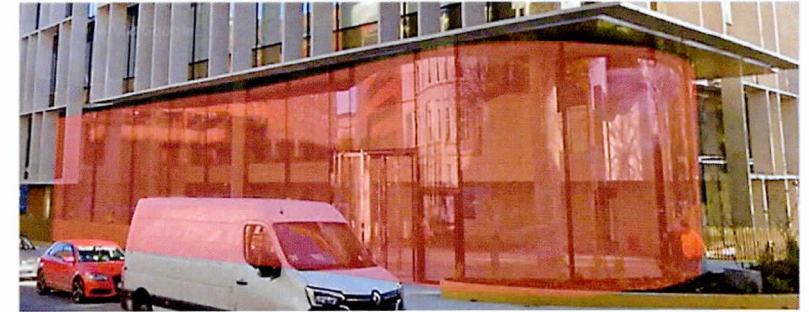
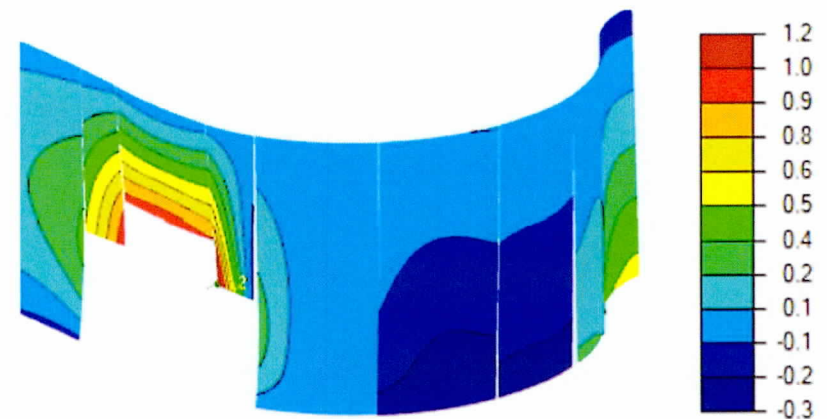
EWS-006 Entrance Glazing.

The entrance glazing is a bespoke glazing system formed from curved double-glazed units up to 6.7m tall restrained by stainless steel flat plates at glass to glass joints. Due to their size and shape, the double glazed units are formed from laminated annealed glass rather than heat treated or toughened glass. This makes the glass particularly susceptible to breakage due to localised stresses. **Maximum vertical deflections in 'mm' of the installed screen are shown on the right in the image above.**

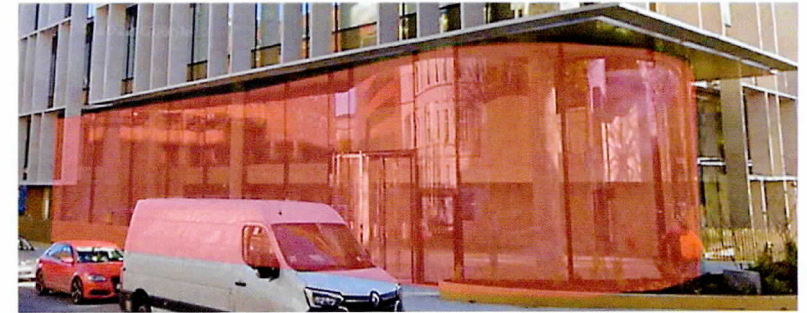
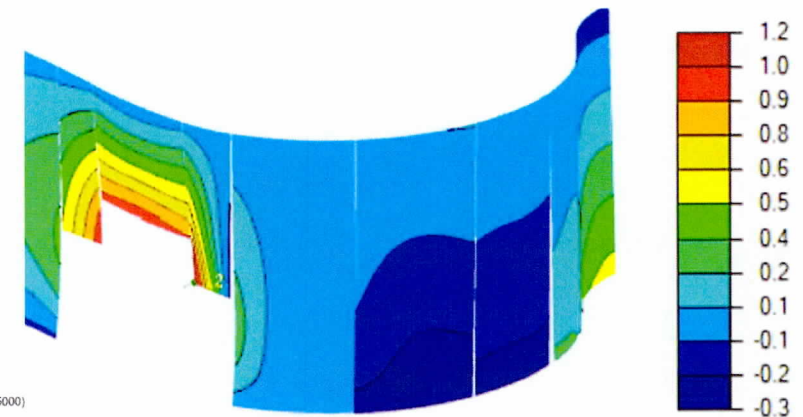
The entrance glazing is a bespoke glazing system formed from curved double-glazed units up to 6.7m tall restrained by stainless steel flat plates at glass to glass joints. Due to their size and shape, the double glazed units are formed from laminated annealed glass rather than heat treated or toughened glass. This makes the glass particularly susceptible to breakage due to localised stresses. **Maximum vertical deflections in 'mm' of the installed screen are shown on the right in the image above.**

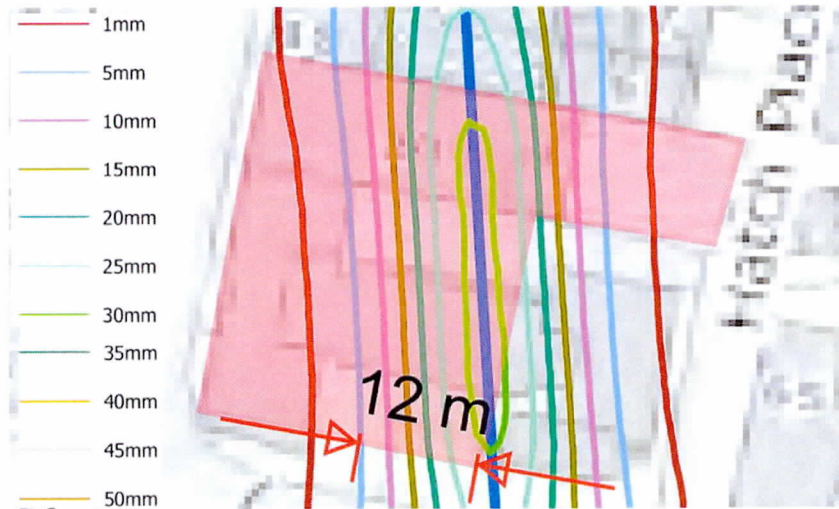
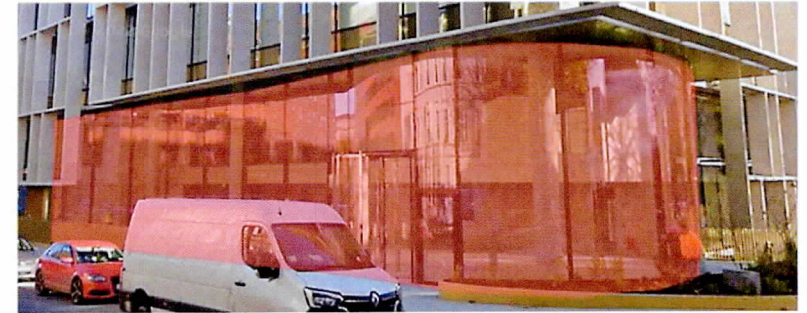
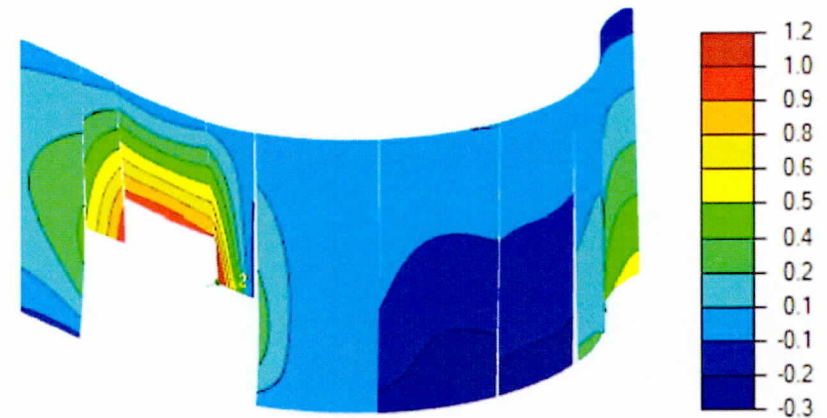
EWS-006 Entrance Glazing.

The entrance glazing is a bespoke glazing system formed from curved double-glazed units up to 6.7m tall restrained by stainless steel flat plates at glass to glass joints. Due to their size and shape, the double glazed units are formed from laminated annealed glass rather than heat treated or toughened glass. This makes the glass particularly susceptible to breakage due to localised stresses. **Maximum vertical deflections in 'mm' of the installed screen are shown on the right in the image above.**

If the tunnel is out of position to the West by 10m or 15m which we understand is within the TII's tolerances, you can see the curved glass screen will be in danger of experiencing **major differential settlement across the south** end of the screen which would cause breakage.
