**External Envelope:
Glazing, Insulated Render and
Stone Façade Elements**

AERCAP HOUSE METROLINK INTERFACE

Aercap House, St. Stephens Green, Dublin

**Document No:
PR-24-018-BDA-XX-ZZ-RP-Y-0001-C01**

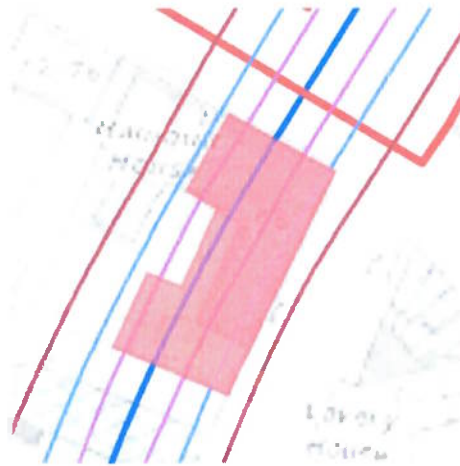
Figure 1 Plan of Aercap House with TII predicted ground settlement. Max. settlement is now predicted as 22.14mm

MetroLink has assessed the predicted "Settlement" and presents its findings on drawing no. ML1-JAI- EIA-ROUT-XX-DR-Y-21146 rev P02. This drawing indicates MetroLink will be causing a 10mm settlement directly under the location of our client's building which is unacceptable. We have not received an update of this drawing.

However, the new document 'Addendum to the EIAR – Downward Tunnel Realignment: St Stephen's Green Station to Charlemont Station (P01 06.03.2024)' indicates a revised settlement of maximum 22.14mm. Settlements of this magnitude cannot be accommodated by the building's facades. Such settlement, particularly if introducing differential settlement between columns, will cause damage.

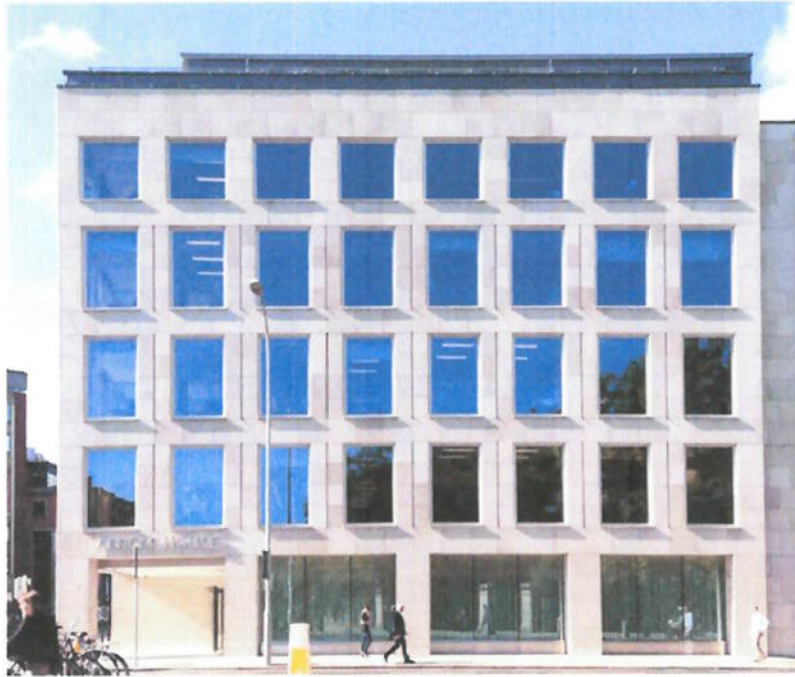
Figure 2 North Elevation Portland Stone

The stone on Aercap House is categorised as a low strength limestone. The stone on Aercap House is 50mm thick supported on stainless steel shelf angles at each floor level. Should the primary structure deform due to tunnelling below the building, there is a likelihood the façade system will suffer damage. Damage can occur due to differential settlement of a column along the elevation. With the current tunnel position as illustrated in Figure 1 above, the highest risk locations for damage to the Portland stone cladding are the North and South elevations.

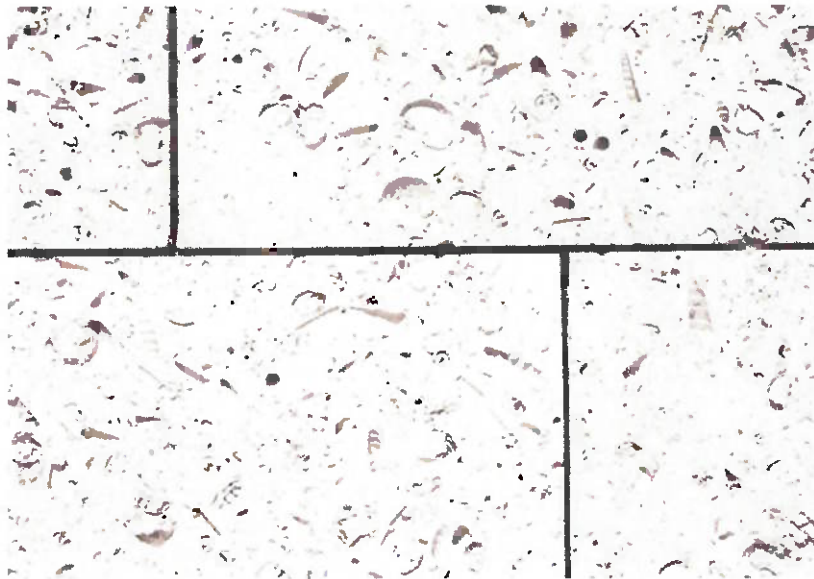
Figure 3 Portland Stone close-up

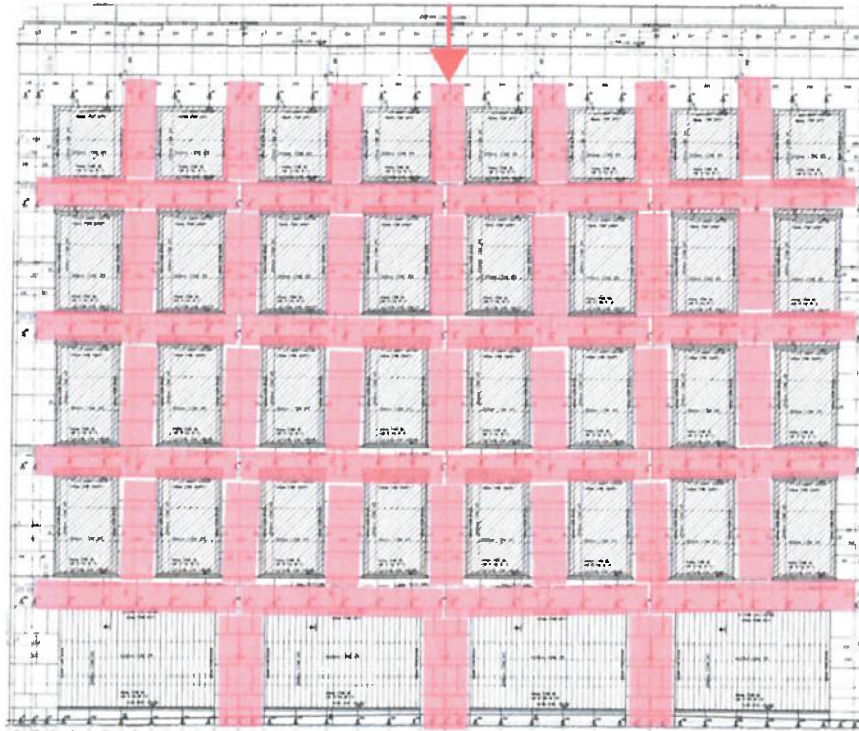
Figure 4 South elevation. Differential settlement causes rocking of stone piers.

Racking of the stone piers is caused by rotation of the slab as a result of differential settlement between columns. Assuming a 22mm drop along a 12m width (to be confirmed by TII) from centre-line of tunnel to perimeter of settlement, we could expect the base of a stone pier which is 1000mm wide to rotate approximately 1.8mm at its base. Each pier is approximately 3.8m tall. The pier of stone will want to rotate 7.2mm at the top.

As the stone is restrained by local stainless steel rods which can accommodate some bending, the stone is likely to move less than this, but as the structure moves, stress in the stone to fixing interface will increase. The stone to stone joints are open and such racking could result in closing of joints at interfaces with canopies on the South elevation. Stone to stone contact could result in cracking. In worst case scenario, stone could be over-stressed locally, crack and fall.

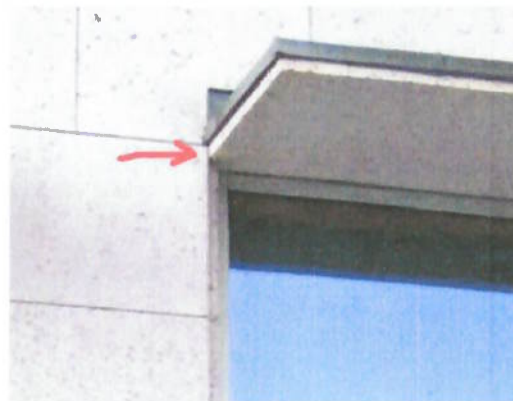
Figure 5 Stone pier to stone canopy interface. Possible contact-stress location.

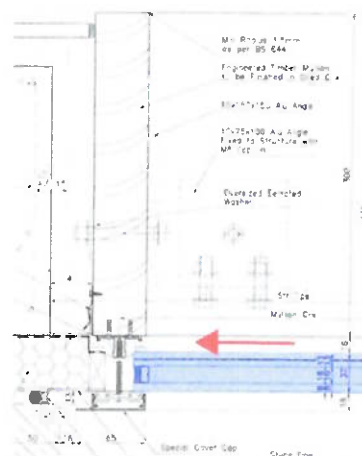
Assuming a 22mm drop along a 12m width (to be confirmed by TII) from centre-line of tunnel to perimeter of settlement, we could expect the base of a typical window which is 1800mm wide to rotate approximately 3.3mm at its base. Each window is approximately 2.8m tall. The glass within the frame will want to rotate approximately 5mm at the top corner. Due to the fact the system is a gasket net, this rotation would result in glass to epdm profile contact rather than glass to metal contact.

However, as the inner glass is 12.8mm laminated annealed glass, it is susceptible to edge damage and has very limited capacity for edge stress. As a result, there is a risk of the inner glass cracking.

Figure 7 Timber framed curtain wall. Racking of glass within frame

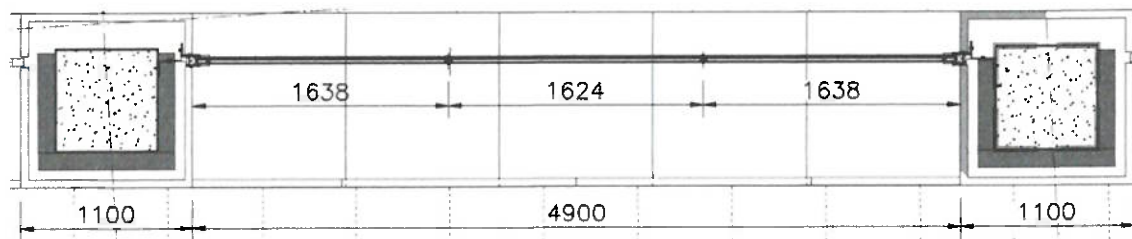
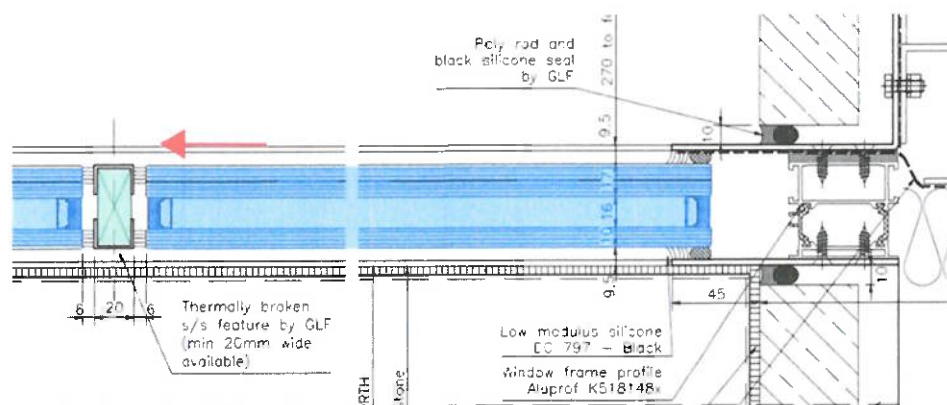
The ground level glazing to the North elevation will suffer racking due to the predicted ground settlement. The individual panels of glass are approximately 1.6m wide and 2.9m tall. They are free spanning from floor to ceiling.

Assuming a 22mm drop along a 12m width (to be confirmed by TII) from centre-line of tunnel to perimeter of settlement, we could expect the base of a typical glass panel which is 1630mm wide to rotate approximately 3mm at its base. Each panel of glass is approximately 2.9m tall. The glass will want to rotate approximately 5.3mm at the top corner. Due to the fact the system is a bespoke shuffle-glazed solution, the perimeter glass at the column should be free to rotate in the channel.

However, as the inner glass is 15.5mm laminated annealed glass, it is susceptible to edge damage and has very limited capacity for edge stress. As a result, there is a risk, although low, of the inner glass cracking where it presses against the the stainless steel clad fin which will be caught between glass panels.

Figure 8 Plan view of North elevation ground level glazing

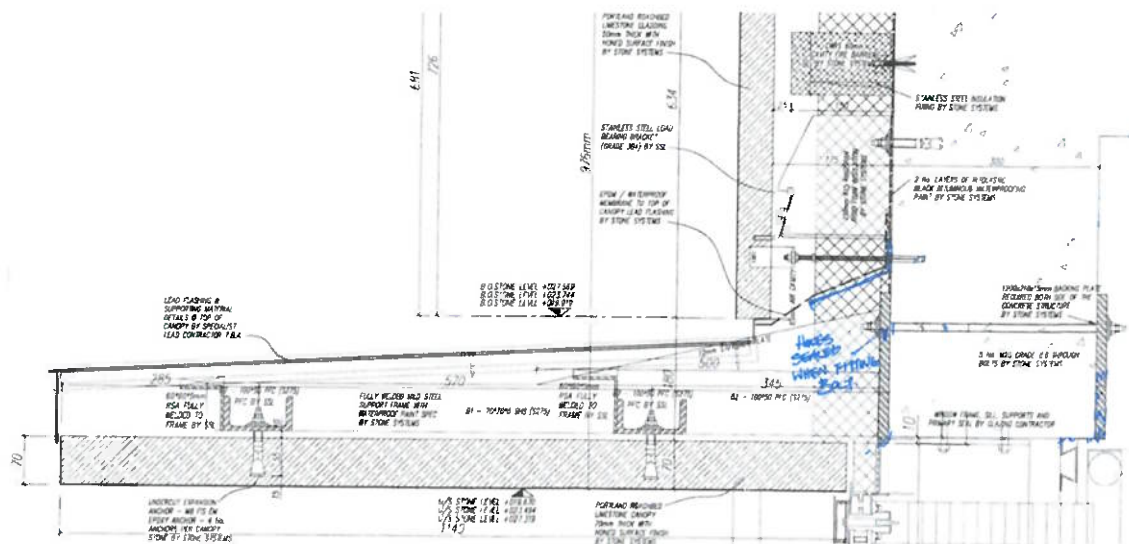
We would recommend careful consideration and monitoring, particularly of the canopies to the South and East elevations. We believe the South elevation will suffer significant vibration during the tunnelling under the building. The canopies are cantilever steel frames with 70mm Portland stone suspended from them. Any loosening of fixings due to vibrations could be hazardous.

Figure 10 Vertical section through the 70mm thick stone canopy

We recommend monitoring of each façade prior to tunnelling, during tunnelling and directly afterwards to ascertain any degradation of the systems.
