Long Point Outdoor Amenity Enhancement Project

Stage 1 Road Safety Audit

Galway County Council

August 2024

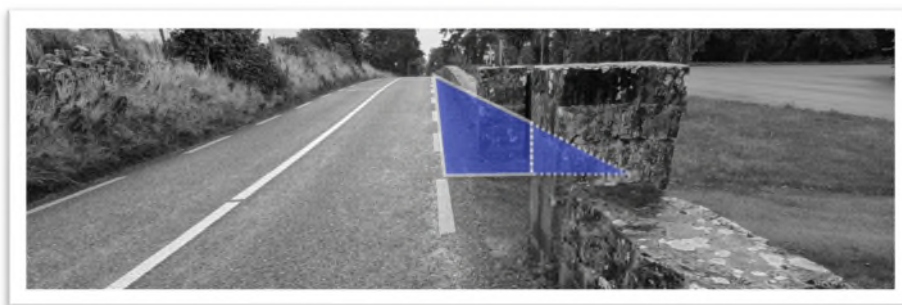
Figure 2.1 – Envelope of Visibility Looking to Right at New Car Park Access onto R351

2.1 Problem: Driver’s Sight Line to Right at New Access

Location: Improved Access onto R351

The sight line for emerging driver’s looking to the right appears to be partially obscured by a crest in the road. This could mask the presence of an approaching vehicle, which might lead to an increase in the risk of a collision at the car park access.

Recommendation

Drivers should be provided with an appropriate envelope of visibility at the location described.

2.1	Yes	Yes	It is acknowledged that there is a crest in the R351 to the right (south) of the proposed car park access. For this reason a detailed assessment of the visibility in the vertical plane was undertaken, as shown in Figure B3 provided. The figure demonstrates that the 90m visibility, appropriate for the 60 kph speed limit, to an object height of 1.05m is available from the proposed access junction, in accordance with DN-GEO-03060 TII Geometric Design of Junctions.	Designer comment noted & accepted.

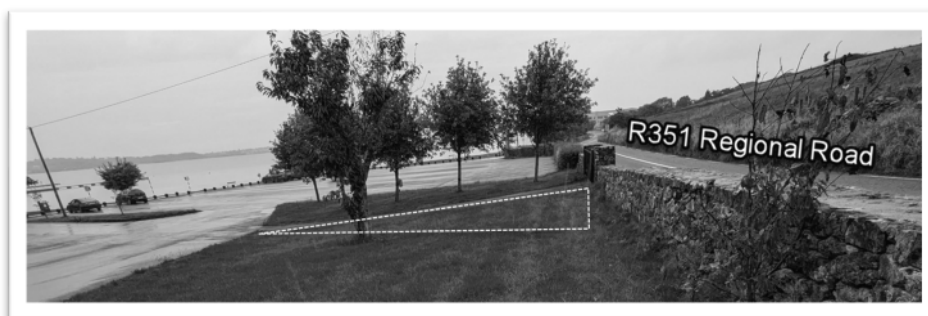
Figure 2.2 – Steep Approach to R351 Could Lead to Vehicle Stalls

2.2 Problem: Up-Hill Gradient at Connection to Regional Road

Location: Main Vehicle Access Connection to Regional Road R351

The unusually steep uphill gradient could lead to vehicles either rolling back or stalling as they attempt to join the R351. This is likely to increase the risk of a collision at the car park access.

Recommendation

A suitable dwell area (i.e. a short section of road in advance of the stop line where the gradient has been reduced) should be provided on approach to the connection point to the R351 Regional Road.

2.2	Yes	Yes	An appropriate dwell area of 7m with a maximum gradient of 2% will be provided in accordance with Recommendations for Site Development Works.	Designer comment noted & accepted.

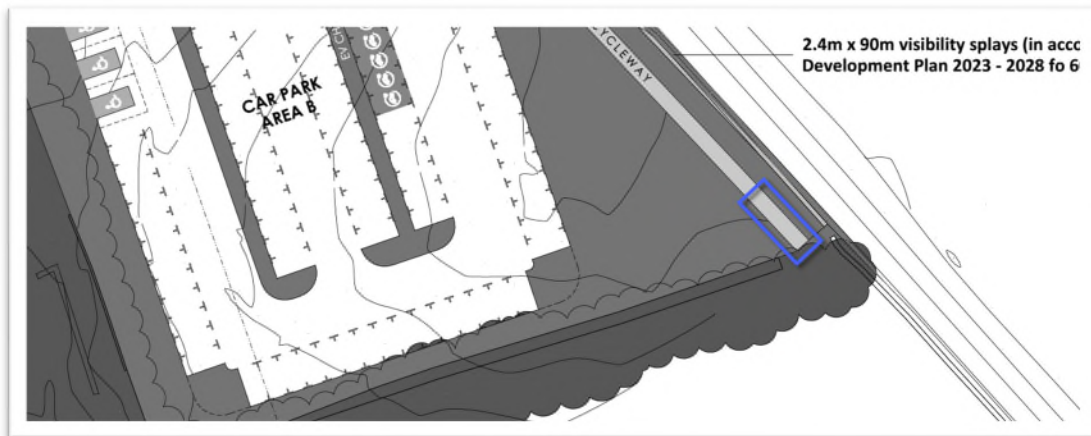
Figure 2.3 – Cycle Track Termination at Boundary of Car Park

2.3 Problem: Abrupt Cycle Track Termination

Location: Cycle Track Termination at Southern Boundary

The abrupt cycle track termination could lead to frustration for cyclists resulting in poor decision making. It could also lead to cyclists entering the R351 without warning, increasing their likelihood of coming into conflict with a vehicle.

Recommendation

An appropriate cycle track transition should be made onto the R351.

2.3	Yes	Yes	It is noted that this section of the R351 is indicated as a "Cycle Connects Inter Urban Route" in the Loughrea Local Transport Plan. It is agreed that continuation of the proposed cycle facility through the Long Point site will require to be addressed as part of both proposals.	Designer comment noted & accepted.
