## **Architectural Heritage Impact Assessment**

### **Bruree Bridge, Bruree, Co. Limerick**

for Punch Consulting Engineers / Limerick City & County Council

*23<sup>rd</sup> September 2025*

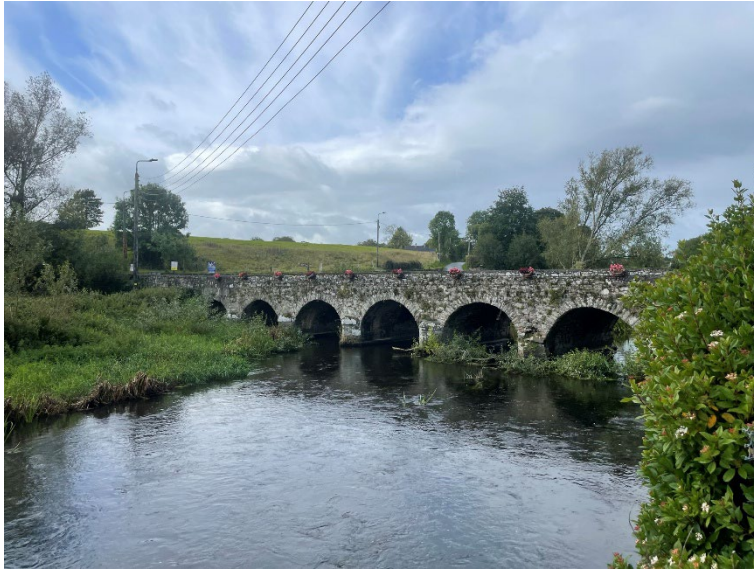
**Figure 7**  
*View of Bruree Bridge Upstream  
Elevation (East)*

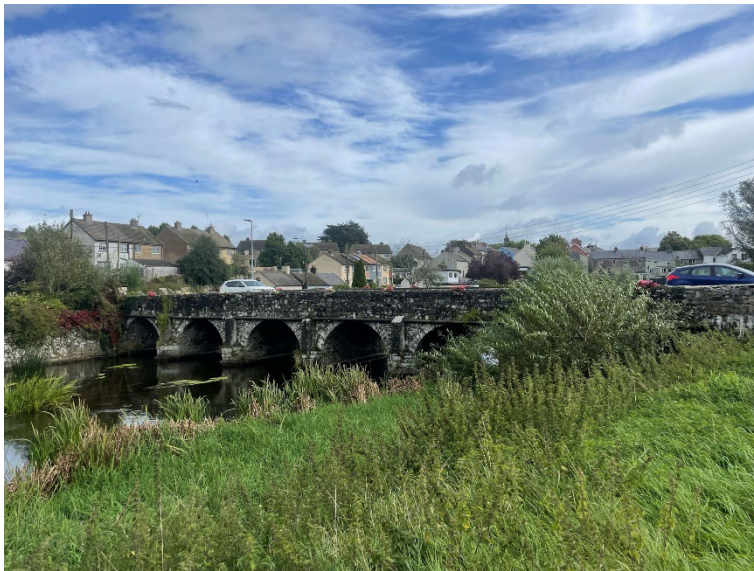
**Figure 8**  
*View of Bruree Bridge  
Downstream Elevation (West)*

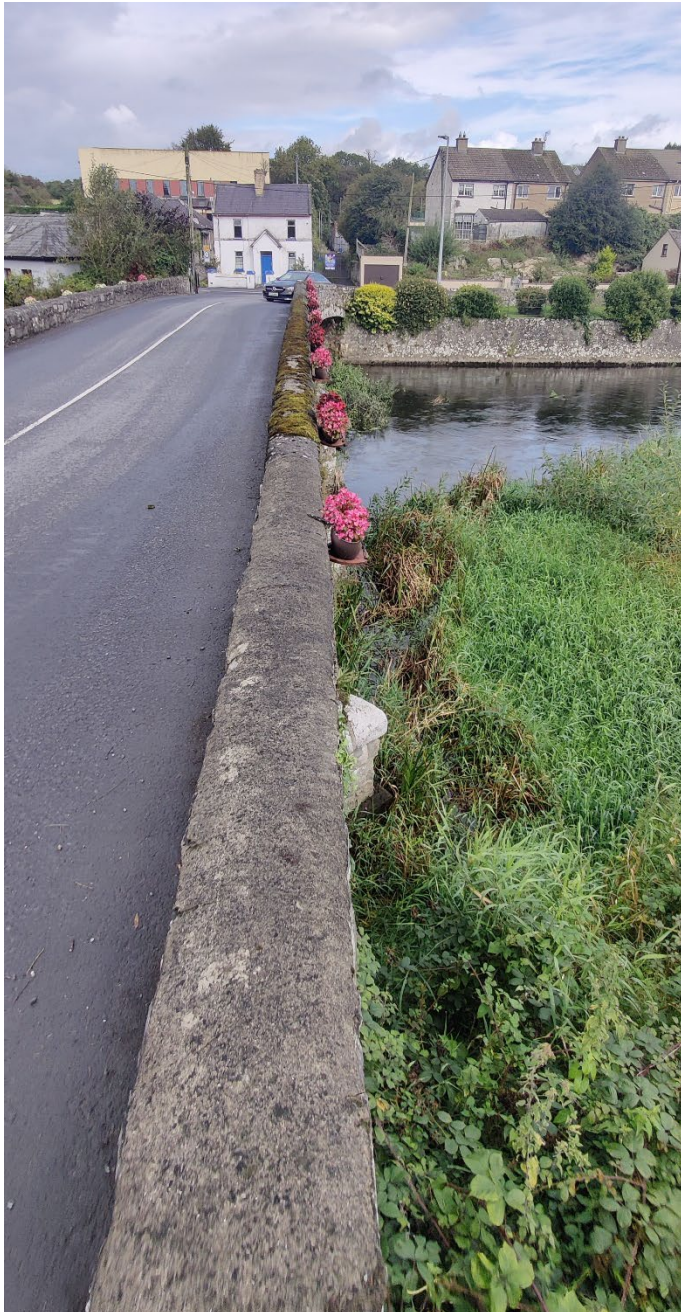
**Figure 11**  
*View to North from bridge surface.  
Cementitious Capping to  
Upstream Elevation Capping*

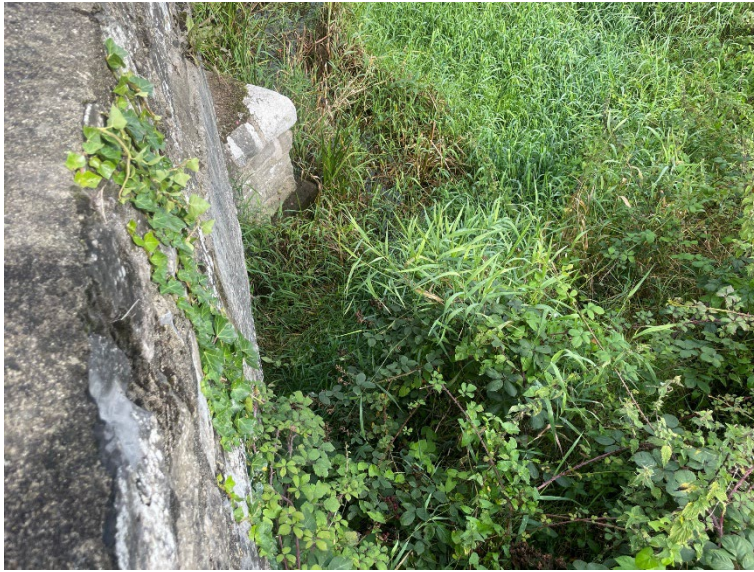
**Figure 12**  
*Concrete Capping to Cutwater.  
Common condition to all  
upstream cutwaters.*

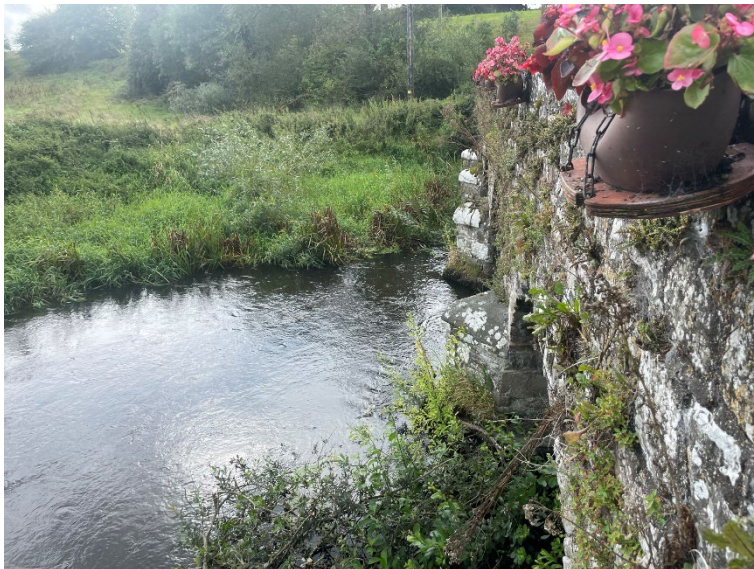
**Figure 13**  
*Upstream Cutwaters CW-01 to  
CW 04. Upstream Elevation with  
vegetation growth.*

- 1.1 Carefully remove vegetation and organic build up from the masonry bridge, ensuring damaging root structures of heavier growth are fully removed, this may require local dismantling of and rebuilding of existing stonework. Sporadic lighter growth to be handpicked. Apply approved biocide / herbicide treatment.
- 1.2 Low pressure steam wash, DOFF System or equivalent to remove any Debris and Loose Organic Growth may be considered.

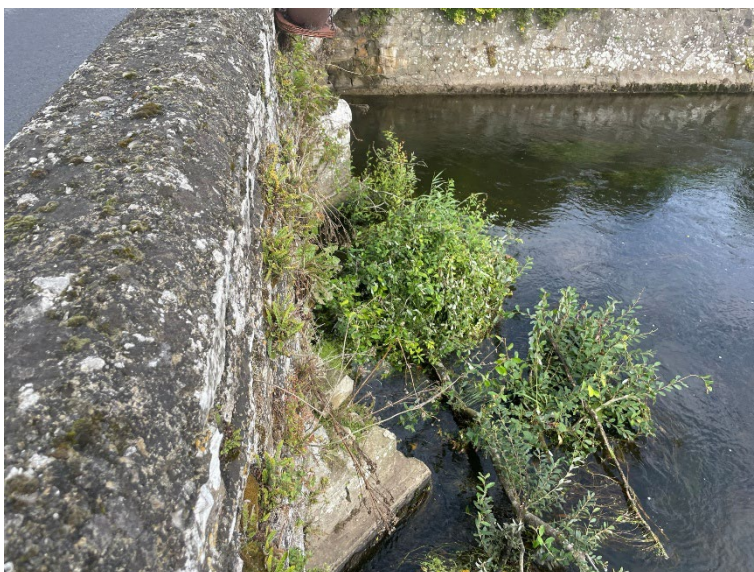
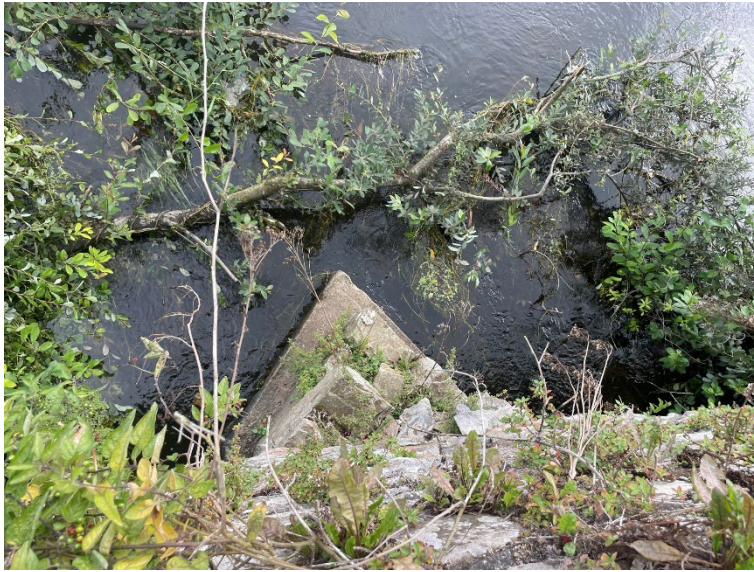
**Figure 14**  
*Damaged Cutwater 05 [CW-05]*

**Figure 15**  
*Damaged Cutwater 05 [CW-05]*

*Collapsed Cutwater Nos. 5 & 6 to be repaired using fallen limestone, if found, and bedded in appropriate lime based mortars. New concrete limecrete capping to match existing cutwater geometry. Where new ashlar limestone are required,*

- 3.1 Salvaged Stone from retrieved from riverbed to be stored for reinstatement.
- 3.2 Masonry to be reinstated with NHL 3.5 mortar.
- 3.3 New Cut Stone in Limestone to best match existing.
- 3.4 Cut Stones to be Carved, Dressed and Finished to match Existing Details.
- 3.5 Stone Samples to be provided to ensure best match.
- 3.6 Cutwater capping to be formed with limecrete mix -2 parts limecrete aggregate to 1 part NHL 5, adding sufficient water to make a stiff but workable mix. Reinforcement fibres are recommended. (1 bag per tonne of aggregate).

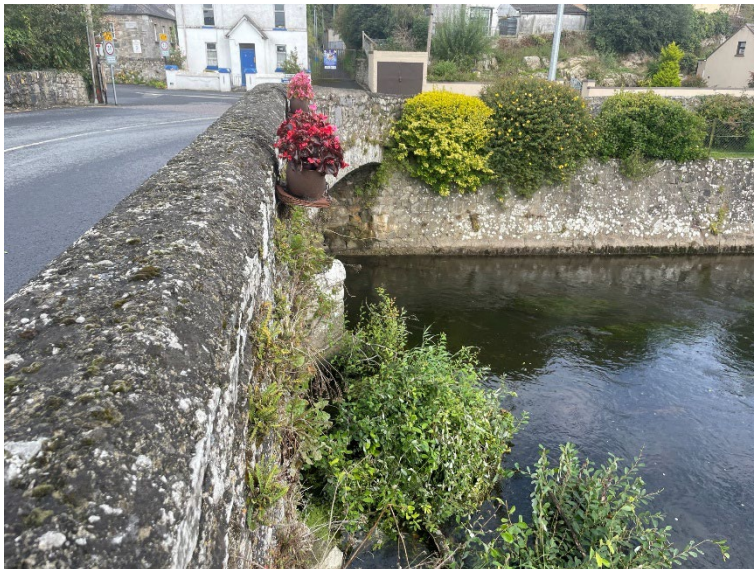
**Figure 16**  
*View to North of Splayed Arch  
AR-07 & CW-06.*

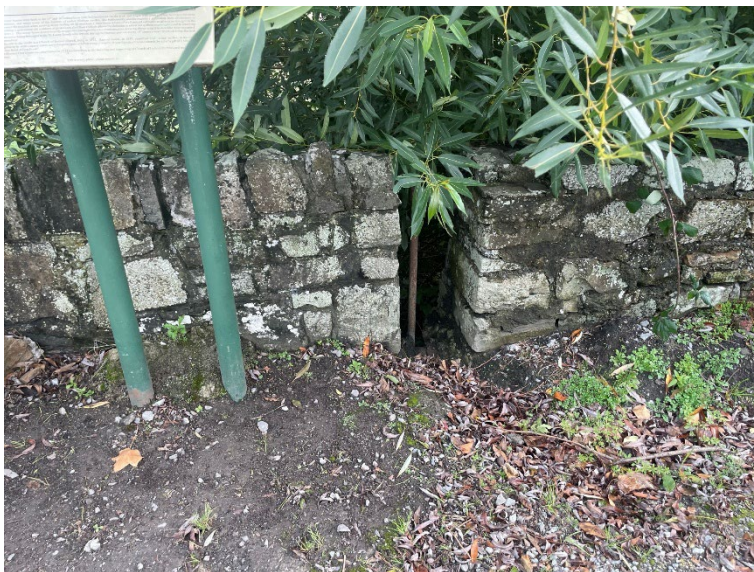
**Figure 17**  
*Gap in Parapet where bridge  
ends, masonry wall continuing  
along road.*

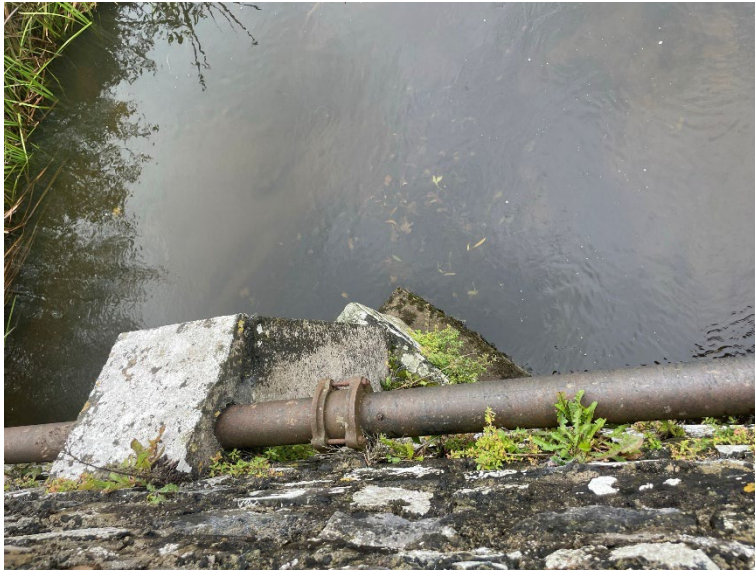
**Figure 18**  
*Downstream Cutwater CW-06  
with concrete pier supporting  
existing cast iron watermain.*

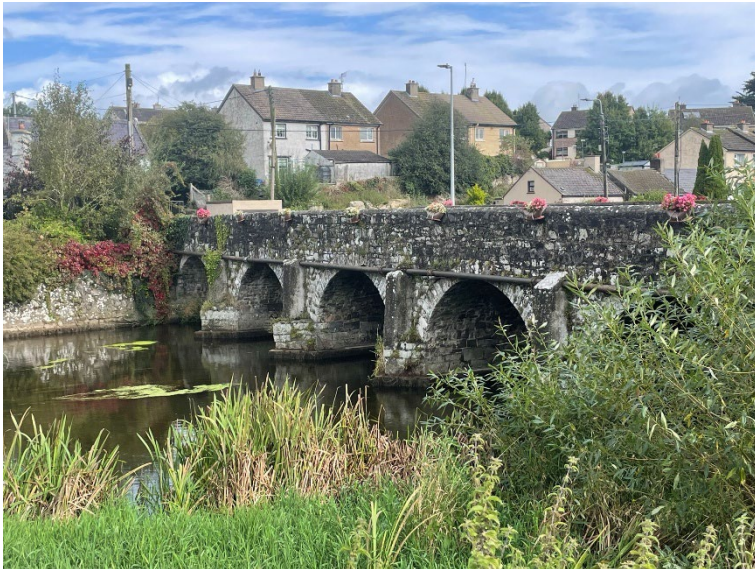
**Figure 19**  
*Downstream Elevation with cast  
iron watermain along elevation  
supported by concrete columns  
above masonry cutwater.  
Vegetation growth along  
elevation.*

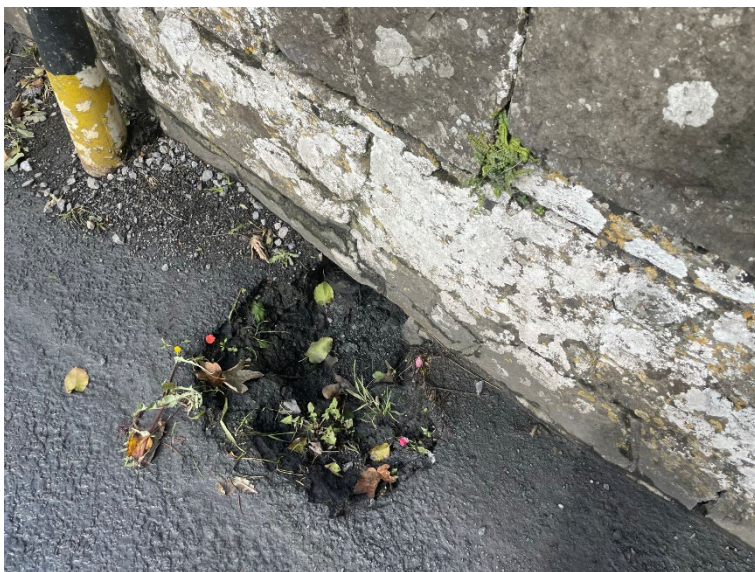
**Figure 20**  
*Damaged road surface.*

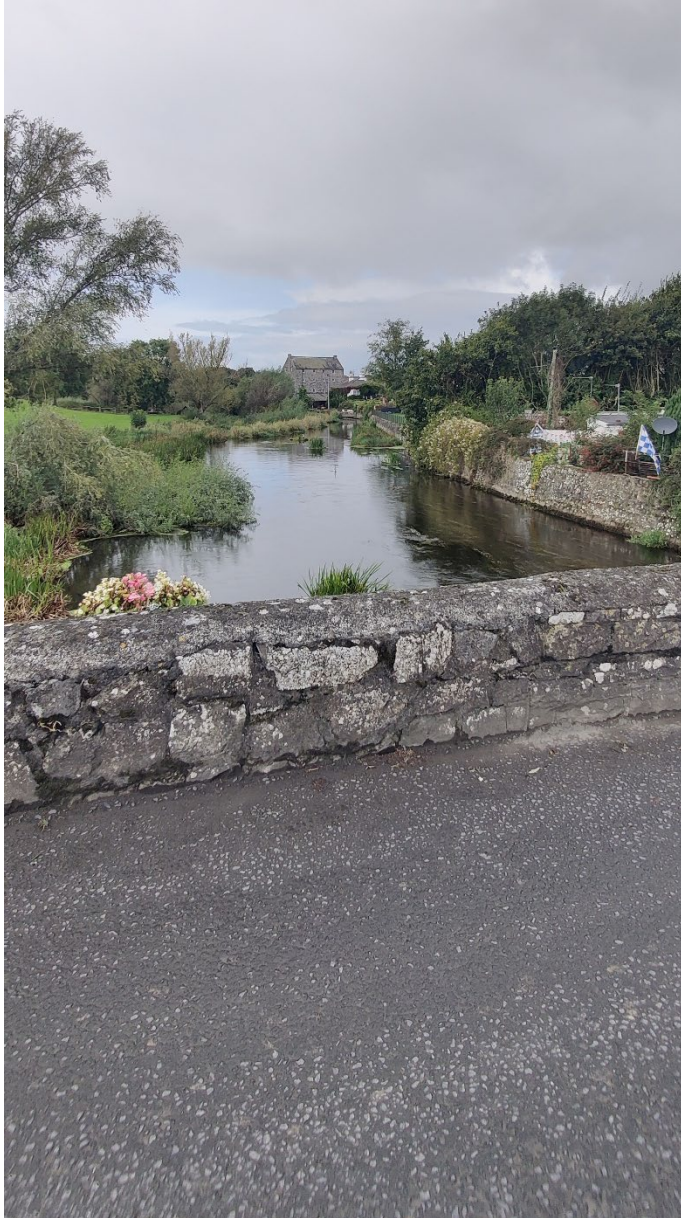
**Figure 21**

*View downstream from road surface and internal face of parapet wall with cementitious capping.*

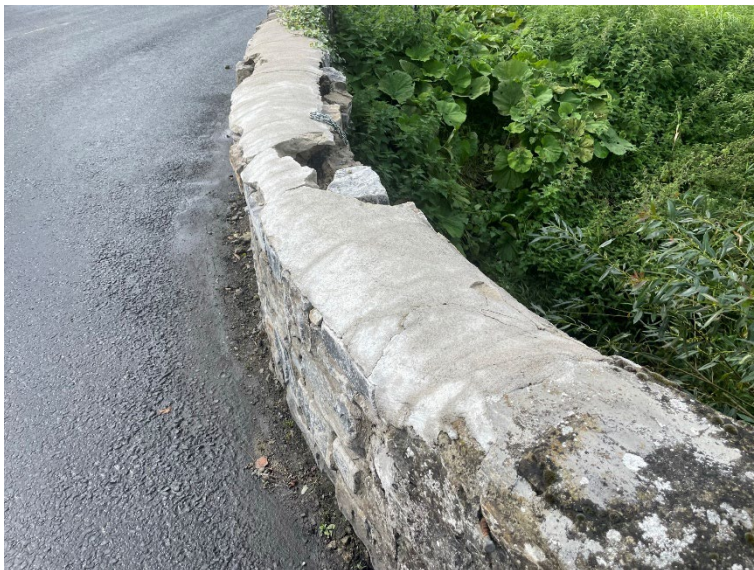
**Figure 22**

*Section of masonry wall previously rebuilt with cement based mortars / capping. Damage to capping.*

- 2.1 Selective and localised areas of repointing to be carried out with lime mortars. The existing mortar will act as a guide for the new mortars.
- 2.2 Raking out will commence mid-joint and work outward toward the arrises. Joints shall be raked out to a minimum depth of 25 mm or 1½ times the width of the joint, whichever is greater.
