Architectural Heritage Impact Assessment
Galbally Bridge, Moorabbey, Co. Limerick & Co. Tipperary
for Punch Consulting Engineers

23rd September 2025

Document Title: Architectural Heritage Impact Assessment

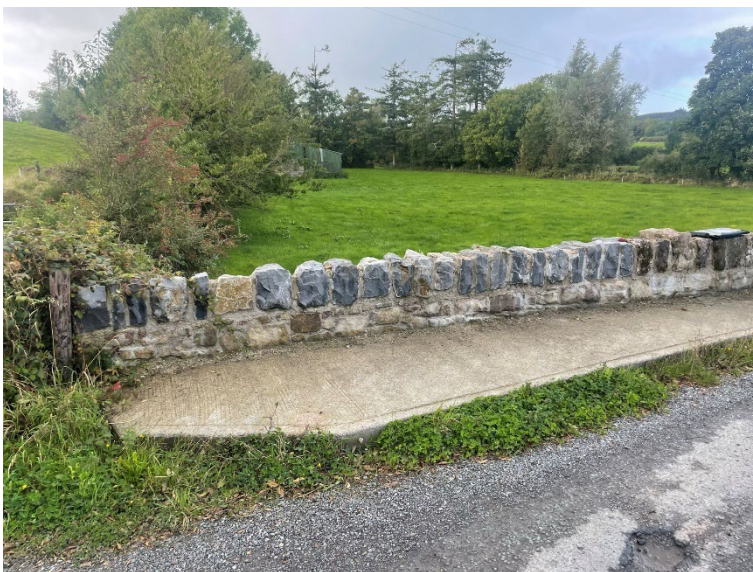
Figure 12
Section of modern masonry wall and concrete footpath.

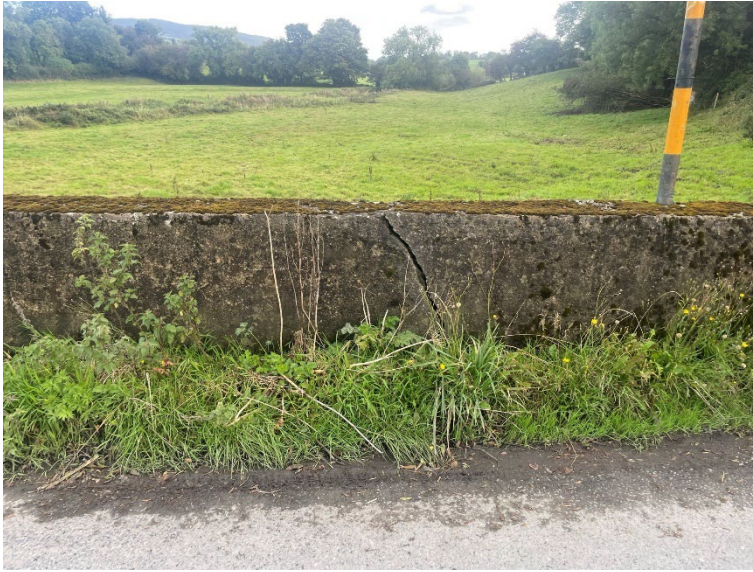
Figure 13
Internal face of concrete wall.

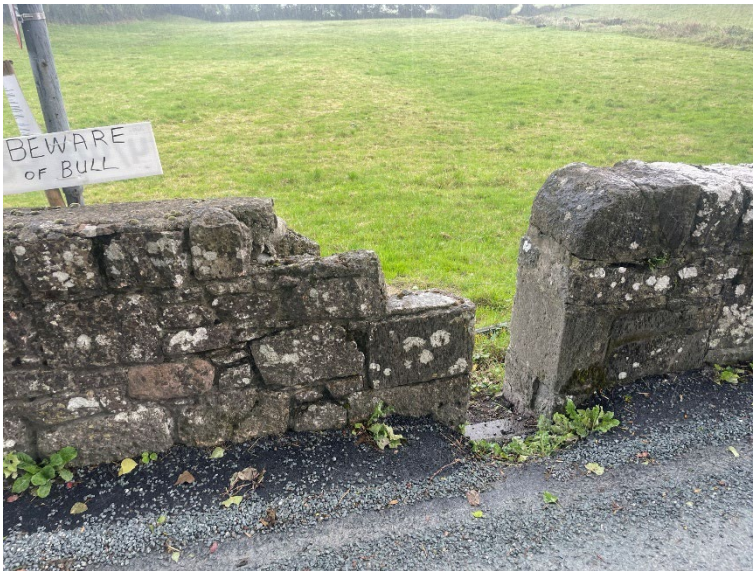
Figure 14
Gap between masonry wall and bridge parapet.

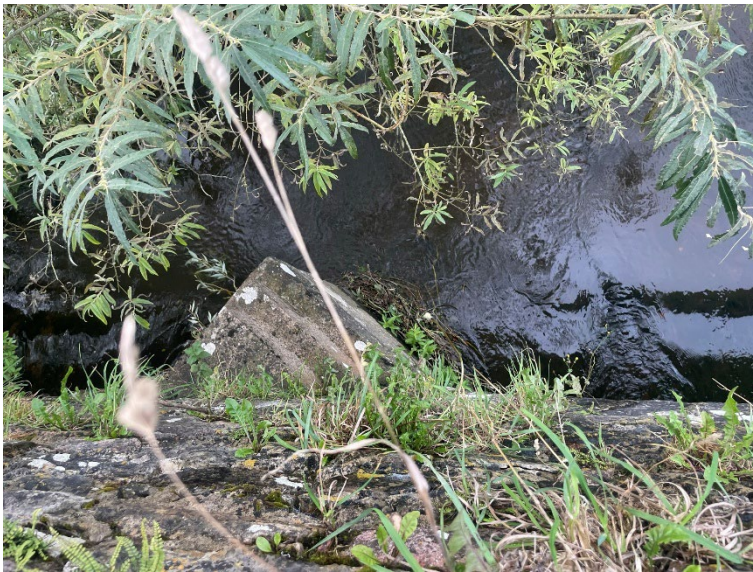
Figure 15
Upstream Ashlar Cutwater (CW-03) with cement render.

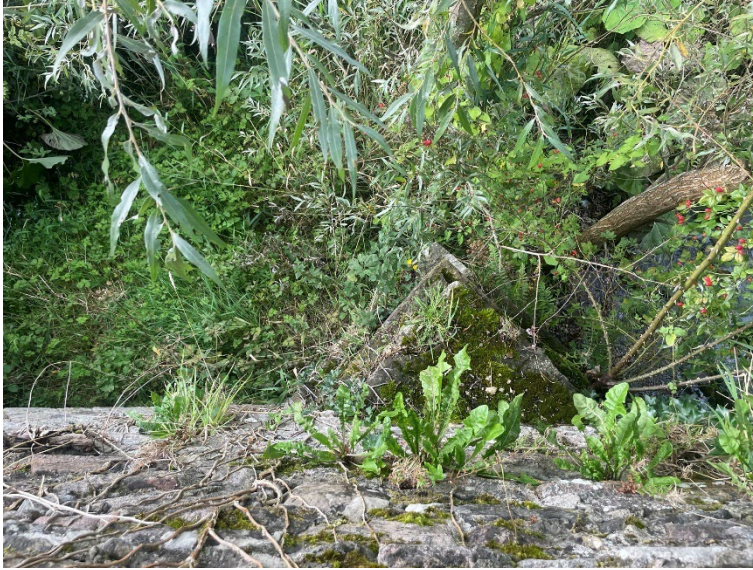
Figure 16
*Upstream Ashlar Cutwater (CW-02)
with cement render.*

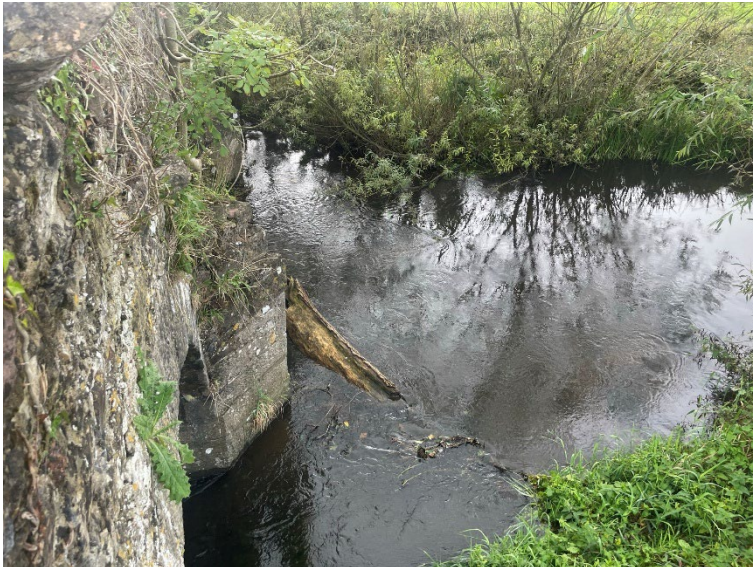
Figure 17
Upstream Ashlar Cutwater (CW-01).

The concrete base to the riverbed is displaying deep scours underneath and it is proposed to be underpinned in concrete. A concrete saddle is proposed to Cutwater 1.

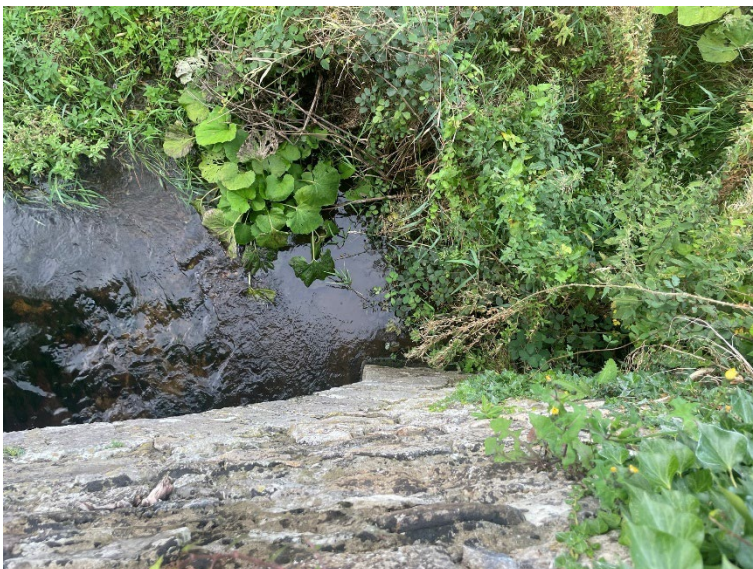
Figure 18
*Upstream Bridge Abutment with
vegetation growth.*

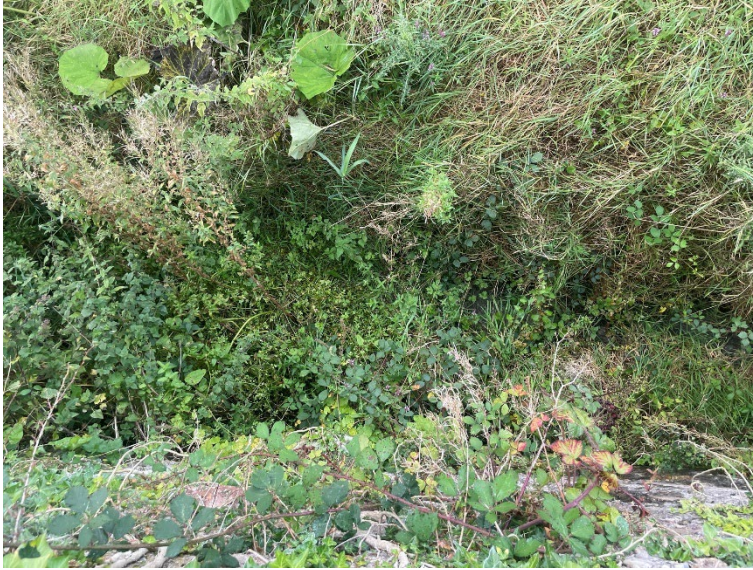
Figure 19
Upstream Bridge Abutment Wall with vegetation growth.

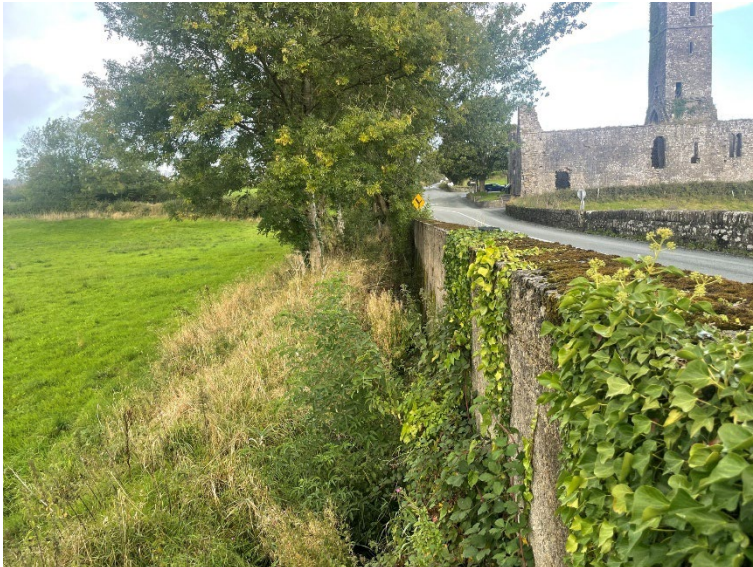
Figure 20
Upstream Bridge wing wall with vegetation growth and section with cement render. View North.

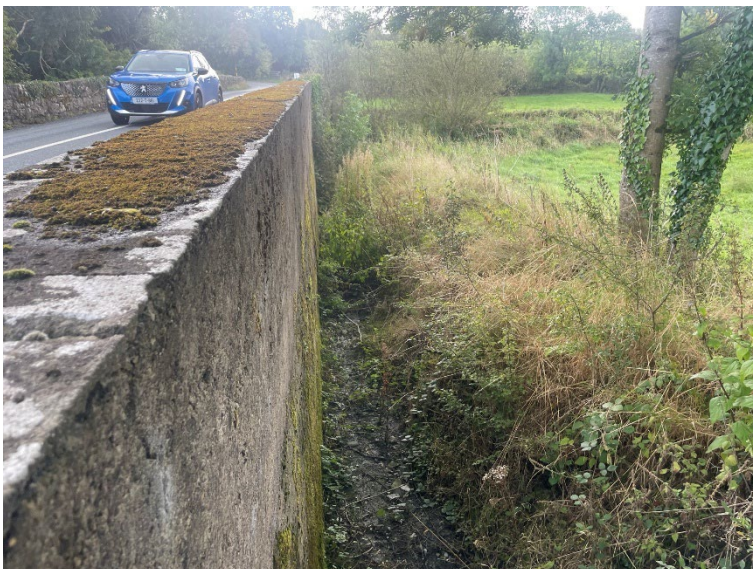
Figure 21
Upstream Bridge wing wall with vegetation growth and section with cement render. View South.

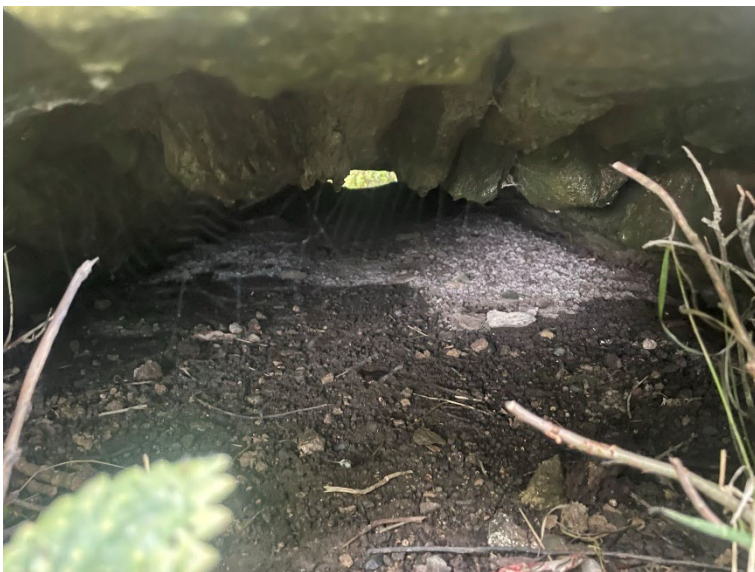
Figure 24
Flood relief arch to the North of the bridge with silt build-up.

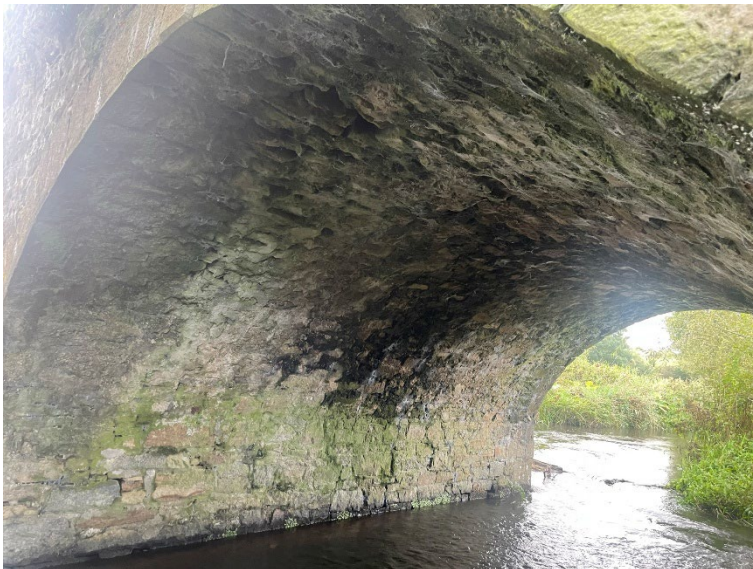
Figure 26
*Underside of Arch 1 viewed from
Downstream embankment.*
