Athlone Link Road Phase 2 Athlone, Co. Westmeath

Report No. RSA ST1.2 001

Stage 1/2 Combined Road Safety Audit Report

02 June 2025

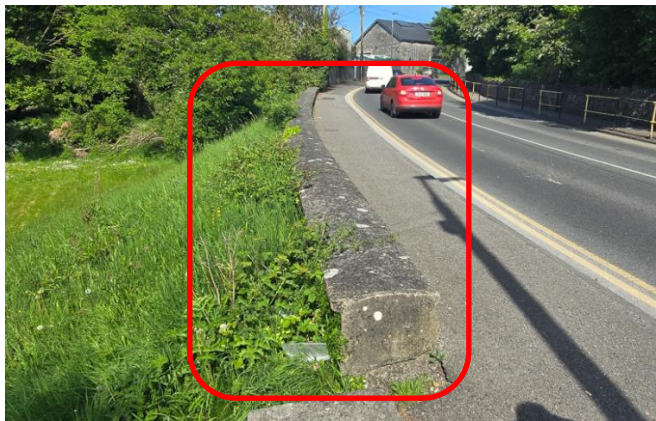
3.2.1 PROBLEM

Location: Proposed cycleway on Southern Station Road.

Summary: Risk of cyclist or pedestrian fall due to insufficient wall height

Detail: A low wall (approximately 300–500 mm high) is located immediately adjacent to the proposed cycleway on the northern side of Southern Station Road. The wall is not designed to function as a barrier and does not provide any containment or edge protection. In the absence of a suitable upstand, barrier, or guardrail, there is a risk that pedestrians, particularly children or those with impaired mobility, could trip or fall over the wall. Cyclists may also misjudge the edge, leading to a loss of control or fall, particularly during darkness or inclement weather. The hazard is further exacerbated if the adjacent level difference is greater than 600 mm.

RECOMMENDATION

Edge protection in the form of a suitable pedestrian restraint system or cycle-friendly barrier should be provided along the length of the wall where the level difference poses a fall hazard.

Alternatively, the footway/cycleway alignment should be revised to increase the lateral offset from the wall to reduce the likelihood of user interaction. Any proposed treatment should comply with relevant standards for containment and visibility.

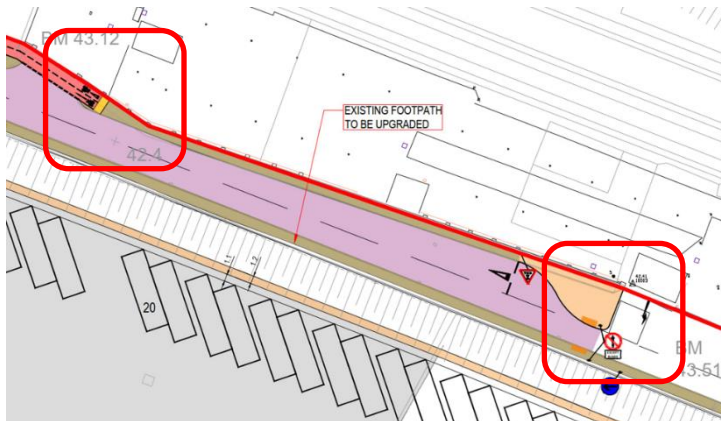
3.2.2 PROBLEM

Location: Proposed cycleway on Southern Station Road.

Summary: Abrupt start/end of cycle facility with no clear direction for onward movement.

Detail: The cycle lane terminates without any signage or physical guidance to indicate the appropriate onward route for cyclists. This can result in confusion for cyclists unfamiliar with the area and may lead to unsafe manoeuvres, such as swerving into live traffic lanes or mounting

footways to continue their journey. Cyclists travelling towards Coosan Point Road are required to cross the carriageway to join the cycle lane. The absence of clear route continuity compromises cyclist safety and may discourage use of the facility.

RECOMMENDATION

Provide appropriate signage, road markings, or physical infrastructure be provided to clearly indicate the onward route for cyclists when the cycle lane terminates. Where a designated continuation route is not available, advance signage should inform cyclists of the lane's termination and direct them to the nearest safe alternative. Suitable facilities should be provided for cyclists to cross the carriageway when travelling towards Coosan Point Road.

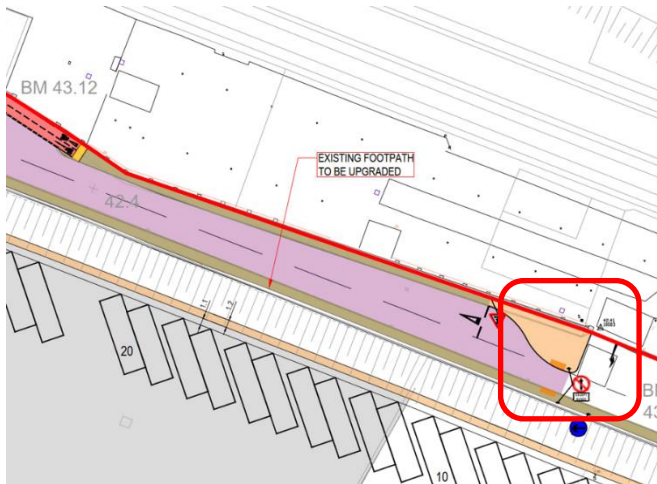
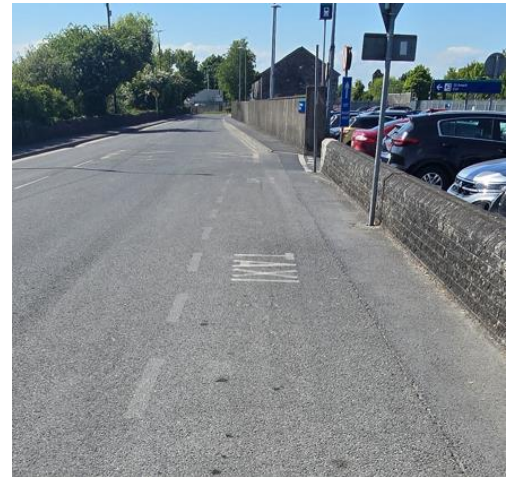
3.2.3 PROBLEM

Location: Termination point of footway on Southern Station Road.

Summary: Footway ends abruptly with no formal crossing or onward pedestrian provision.

Detail: The pedestrian footway terminates suddenly at the edge of the carriageway on the eastern side, with no dropped kerb, tactile paving, crossing point, or alternative pedestrian facility provided. On the western side the footway terminates at the start/end of the proposed cycle lane. Pedestrians, including vulnerable users such as children, elderly persons, or those with impaired mobility, are forced to step directly into the live carriageway travelling eastbound, increasing the risk of conflict with passing vehicles. Travelling westbound, pedestrians may enter the cycleway, increasing the risk of conflict with oncoming cyclists.

RECOMMENDATION

Provide a safe and accessible pedestrian facility at the termination point of the footway at the start and end point. This may include a dropped kerb with tactile paving and a formal or uncontrolled crossing point to the opposite side of the carriageway. If a crossing is not appropriate at this location, the footway should be extended through the car park entry/exit area (existing taxi waiting area) to connect with the existing footway approaching the train station, with appropriate signage or barriers to guide pedestrian movement and discourage unsafe desire lines across the carriageway.

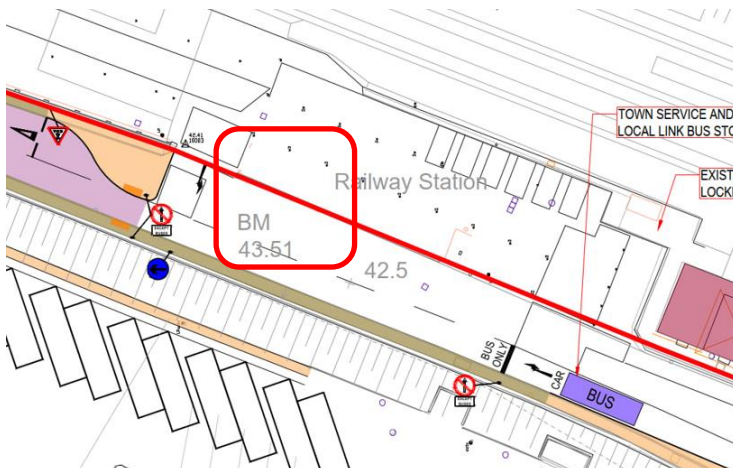
3.2.4 PROBLEM

Location: Exit from train station car park to Southern Station Road.

Summary: Restricted visibility for vehicles exiting car park onto main road.

Detail: Visibility from the car park access onto the main road is restricted due to the existing boundary wall to the right on exit. Drivers exiting the car park may have insufficient visibility of approaching traffic from the right. This increases the risk of side-impact collisions as drivers may emerge without adequate awareness of oncoming vehicles, cyclists, or pedestrians.

RECOMMENDATION

Visibility splays should be assessed and provided in accordance with appropriate design standards. If adequate visibility cannot be achieved, consideration should be given to relocating the access point, subject to further design review. If a footway is provided through the existing access point (refer to Problem 3.2.3), this may assist in achieving an improvement to the visibility splay to the right.

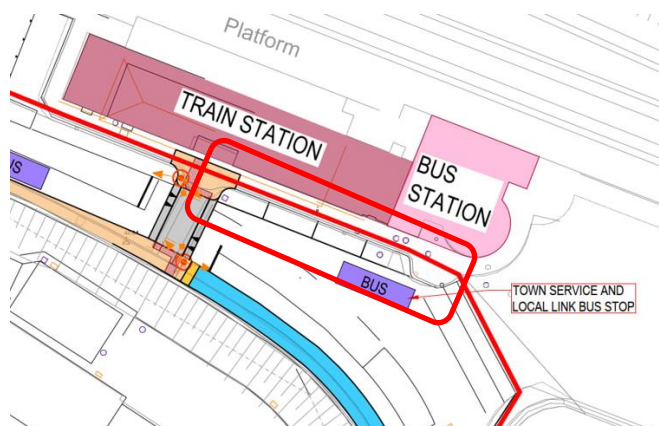
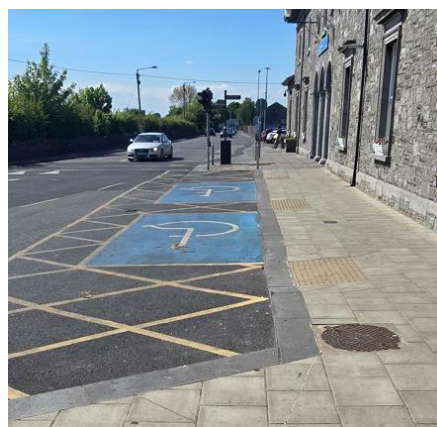
3.2.5 PROBLEM

Location: Existing disabled parking bays adjacent to train station.

Summary: Removal of disabled parking bays reduces accessibility for mobility-impaired users.

Detail: The proposed scheme removes existing designated disabled parking bays without providing suitable replacement spaces of equivalent proximity or accessibility. This reduction in accessible parking provision may disproportionately affect mobility-impaired users, particularly for access to the train station. The absence of conveniently located and clearly marked accessible bays may result in mobility-impaired drivers being forced to park further away or in unsuitable locations, increasing their exposure to vehicular traffic and potentially leading to unsafe crossing or movement through the car park or carriageway.

RECOMMENDATION

The design should be reviewed to ensure that an adequate number of accessible parking bays are retained or provided in accordance with relevant standards (e.g. Building Regulations Part M, Inclusive Mobility guidance). Bays should be located close to key destinations with level access, sufficient space for side and rear transfer, and clear signage.

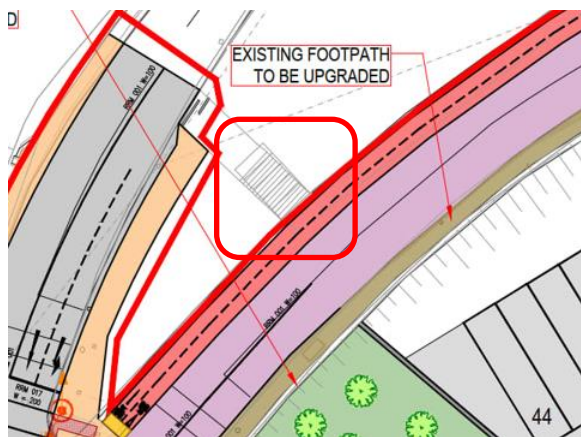
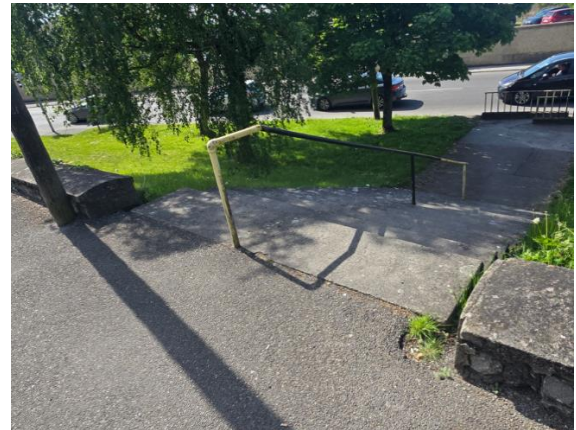
3.2.6 PROBLEM

Location: Pedestrian access steps leading onto proposed cycleway at Southern Station Road.

Summary: Risk of collision or trip due to steps emerging directly onto a live cycle route.

Detail: A set of pedestrian steps leads directly onto the cycleway from Coosan Point Road without any form of buffer space, warning signage, or visibility measures. Pedestrians may emerge suddenly onto the cycle track, often at reduced visibility or speed due to the descent. Cyclists travelling along the route may be unaware of the pedestrian access and unable to react in time to avoid conflict, particularly if speeds are moderate or higher. The interface creates a risk of collision and may also pose a trip hazard if the cycleway surface is flush with or obscures the step edge. This arrangement does not align with recommended separation or transition design between pedestrian and cycling facilities.

RECOMMENDATION

Remove steps as there appeared to be no formal pedestrian route from Coosan Point Road to the existing steps.

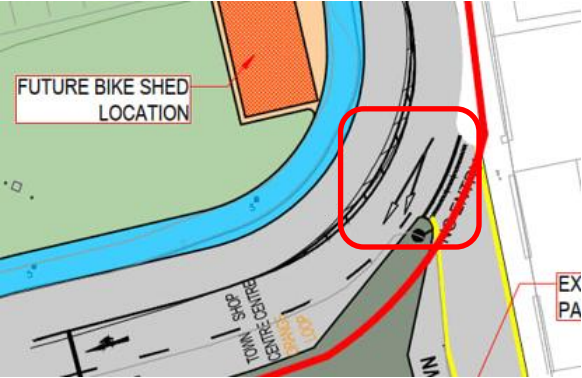
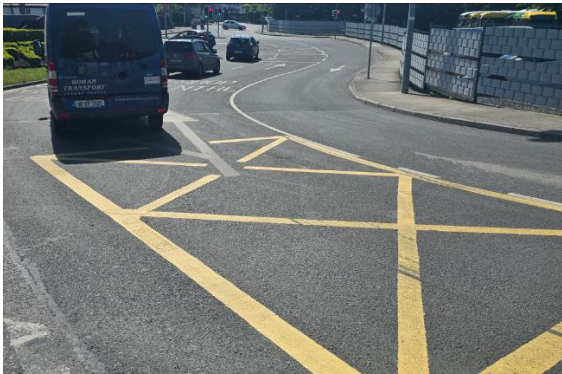
3.2.7 PROBLEM

Location: Southern Station Road junction with link to Ballymahon Road.

Summary: Removal of yellow box may lead to blocking of junction and increased risk of collisions.

Detail: The proposed design removes an existing yellow box road marking at the junction of Southern Station Road and the link road to Ballymahon Road. The yellow box previously served to prevent vehicles from queuing across the junction and obstructing turning movements or cross-traffic flows. Its removal may result in vehicles entering and stopping within the junction during congestion, leading to blocked side-road access, driver frustration, and unsafe manoeuvres such as vehicles forcing gaps or entering opposing traffic lanes. This could also reduce visibility between

opposing drivers and increase the risk of side-impact collisions or pedestrian conflicts, particularly at busy intersections or during peak hours.

RECOMMENDATION

It is recommended that the need for yellow box markings be reviewed and retained where they are necessary to maintain junction clearance and safe turning movements. If removal is intended, justification should be provided through junction modelling and capacity analysis. Where junction blocking is still a risk, reinstatement of the yellow box or implementation of alternative junction control measures (e.g. keep-clear markings, traffic signal staging adjustments) should be considered.

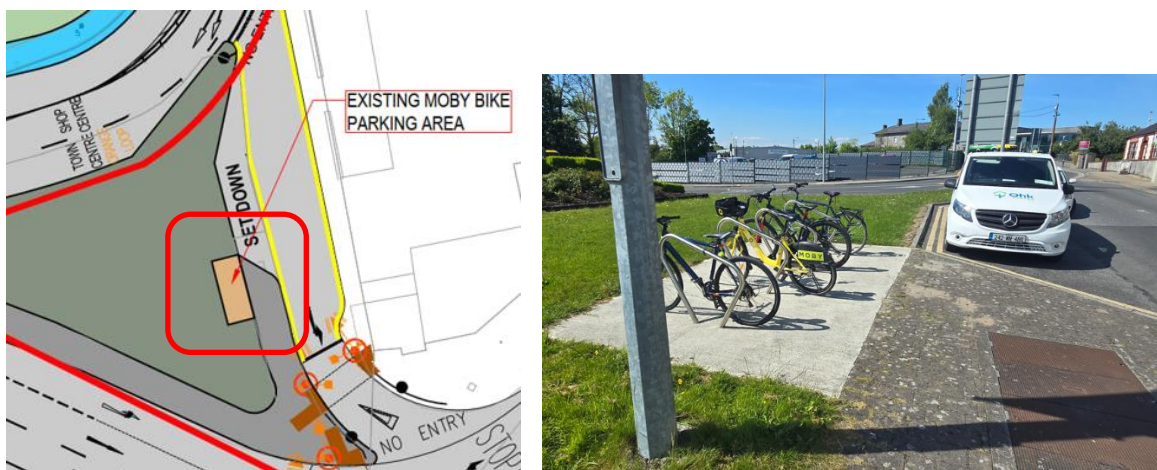
3.2.8 PROBLEM

Location: Moby bike parking area on link road to Ballymahon Road from Southern Station Road.

Summary: No cycle lane or safe access route provided to serve bicycle parking area.

Detail: The existing Moby bike parking area is located adjacent to the carriageway; however, there is no dedicated cycle lane or marked access route connecting the facility to the wider cycling network. Cyclists are required to either dismount and wheel their bicycles across pedestrian areas or merge with general traffic, which may be unsuitable or intimidating for less confident cyclists. This may result in unpredictable cyclist movements, including riding on footways, conflicting with pedestrians, or errant movements through vehicle lanes. The lack of defined connectivity undermines the utility and safety of the facility and may deter use.

RECOMMENDATION

A clearly marked, continuous, and safe cycle access route should be provided between the bicycle parking area and the nearest cycle lane. This route should be designed to minimise conflicts with pedestrians and vehicles. Wayfinding signage and surface markings should be used to assist user understanding of the route and encourage proper use. Alternatively, relocate the Moby bike parking area to be adjacent to the proposed shared cycleway.

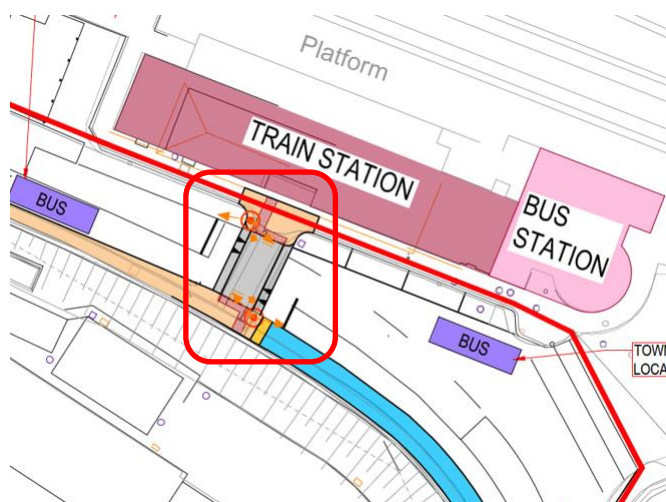
3.2.9 PROBLEM

Location: Controlled crossing at train station on Southern Station Road.

Summary: Shared facility terminates without clear provision for onward cyclist movement at controlled crossing.

Detail: The shared footway/cycleway terminates abruptly at the existing controlled crossing with no defined onward route or crossing facility for cyclists. There is no dedicated cycle crossing, cyclist signal head, or guidance on whether cyclists should dismount and use the pedestrian crossing. This lack of clarity may result in inconsistent or unsafe behaviours, such as cyclists remaining mounted and weaving through pedestrian traffic or attempting to cross within the live carriageway outside of signal control. The arrangement increases the risk of conflict with pedestrians or vehicles and fails to provide a legible and continuous route for cyclists in accordance with good design practice.

RECOMMENDATION

The design should be revised to provide a formal and continuous crossing facility for cyclists. Options may include a parallel crossing with appropriate markings and cyclist signal heads (e.g. Toucan crossing), or clear signage and layout to indicate dismounting where appropriate.

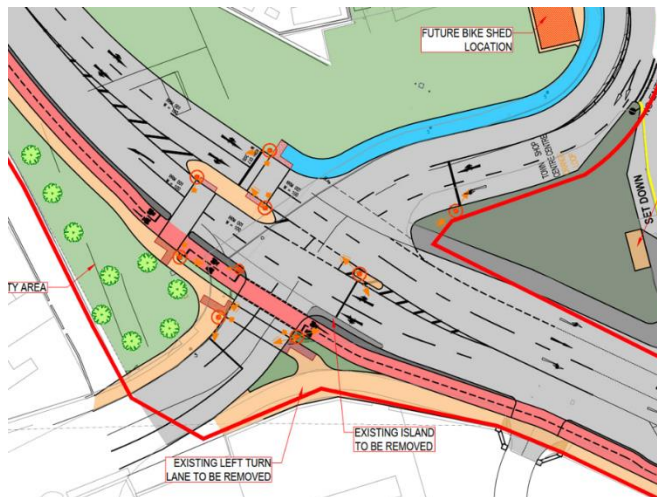
3.3.1 PROBLEM

Location: Signalised junction at The Crescent / proposed link road junction with Southern Station Road.

Summary: Potential insufficient capacity at signalised junction may lead to congestion and driver frustration.

Detail: Observed queue lengths indicate that the signalised junction may not have sufficient capacity to accommodate peak hour traffic demand. This may result in extended delays, vehicles queuing beyond designated storage areas, and blocking of adjacent junctions or access points. Prolonged queuing and driver frustration can increase the likelihood of risky manoeuvres, such as vehicles entering the junction on a red signal, sudden lane changes, or mounting footways to bypass queues. Congestion at the junction may also impact pedestrian and cyclist safety, particularly where crossings are located near conflict points or blocked by stationary vehicles.

RECOMMENDATION

It is recommended that the junction capacity be assessed using updated traffic flow data, and signal timings or staging be optimised to improve throughput. Consideration should also be given to junction layout adjustments (e.g. additional turning lanes, extended storage lengths). If capacity constraints cannot be resolved through layout changes, measures to manage traffic demand or encourage modal shift should be explored.

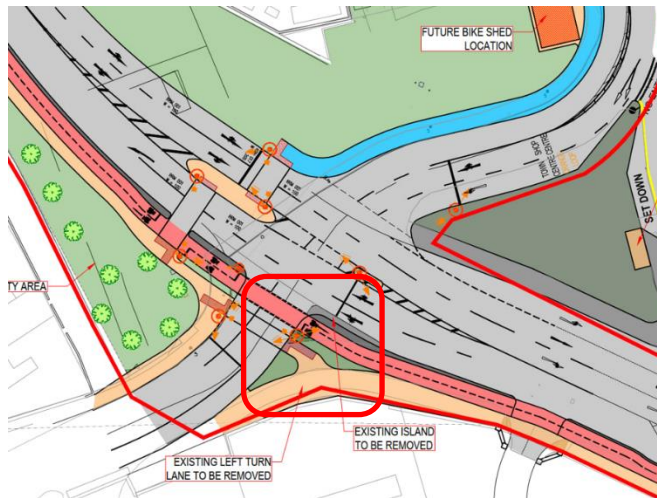
3.3.2 PROBLEM

Location: The Crescent junction.

Summary: Insufficient junction corner radius may restrict HGV manoeuvres, leading to safety risks.

Detail: The junction design incorporates a tight corner radius that appears insufficient to accommodate the swept path of large vehicles, such as HGVs or refuse vehicles, turning into or out of the side road. As a result, HGVs may be required to encroach into opposing traffic lanes or mount footways to complete turning movements, creating a risk of side-swipe collisions, conflicts with oncoming traffic, or danger to pedestrians. The current layout may also result in kerb overruns, structural damage to footways, and increased maintenance needs.

RECOMMENDATION

A swept path analysis should be carried out for the largest design vehicle expected to use the junction. The corner radii should be adjusted as necessary to ensure safe and efficient HGV movements without encroaching onto pedestrian areas or into opposing lanes. If widening is constrained, alternative mitigation such as overrun strips or HGV-friendly kerb arrangements may be considered.

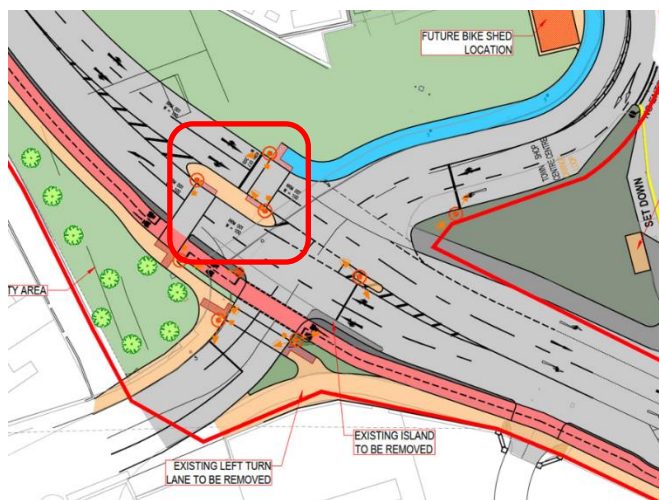
3.3.3 PROBLEM

Location: Splitter island at the Crescent junction.

Summary: Potential insufficient width of central refuge creates safety and usability issues for cyclists.

Detail: The central refuge area forming part of a staggered signal-controlled crossing may be of insufficient width to safely accommodate cyclists waiting to complete the crossing manoeuvre. The refuge appears to be designed primarily for pedestrians and does not allow adequate space for a

bicycle to remain fully within the island without encroaching into the adjacent traffic lanes or obstructing pedestrian flows. This presents a safety risk to cyclists who may feel pressured to complete the crossing in a single stage or may encroach onto live traffic lanes while waiting, particularly in groups or when accompanied by cargo bikes or adapted cycles. The lack of sufficient standing space also undermines compliance with staged signal timings and increases the risk of conflict between pedestrians and cyclists.

RECOMMENDATION

It is recommended that the central refuge island be widened to provide adequate waiting space for cyclists in accordance with relevant standards, including the accommodation of larger or non-standard cycles. The design should ensure cyclists can wait safely without obstructing pedestrian movement or entering live traffic lanes. Alternatively, if widening is not feasible, the crossing should be redesigned to allow single-stage crossing for cyclists, or a separate parallel crossing provided to improve flow and safety for all users.

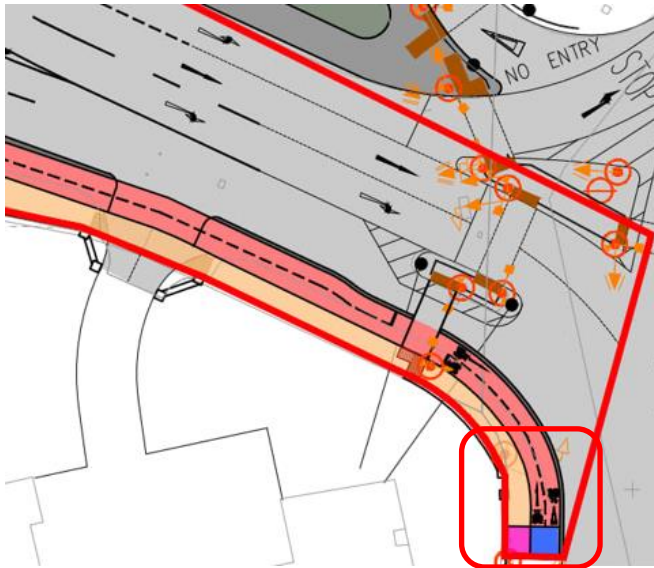
3.3.4 PROBLEM

Location: Start / end of proposed cycleway at Gleeson Street junction with The Crescent.

Summary: Unclear start and end of cycle lane in footway area creates confusion and risk of conflict.

Detail: The cycle lane begins and terminates within a pedestrian footway area without clear delineation, signage, or transition markings to guide cyclist and pedestrian movements. The absence of defined start and end points results in a lack of clarity regarding cyclist priority, direction of travel, or expected behaviour at the interface. This may lead to conflicts between pedestrians and cyclists and increases the risk of collisions or near misses. The arrangement may also cause uncertainty for visually impaired users, as tactile guidance is not continuous or clearly aligned with cycle movements.

RECOMMENDATION

Clear and continuous delineation should be provided at the start and end of the cycle lane within the footway area. This should include surface markings, contrasting surfacing, and vertical or tactile separation as appropriate. Wayfinding signage and on-surface symbols should be used to reinforce user expectations. Where shared space is unavoidable, adequate width and sightlines should be maintained, and conflict minimisation measures introduced to promote safe coexistence of pedestrians and cyclists.

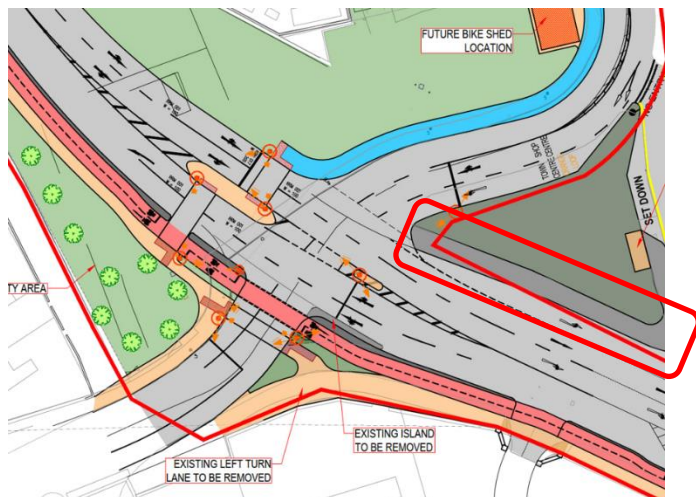
3.3.5 PROBLEM

Location: Footway on northern side of The Crescent junction.

Summary: The footway leads directly to a junction without any formal pedestrian crossing facility, creating a safety risk due to informal and potentially hazardous crossing movements.

Detail: Pedestrians approaching the junction with Southern Station Road along The Crescent (travelling west) via the footway are not provided with any designated crossing facility. As a result, pedestrians – including vulnerable users such as children, older people, and mobility-impaired individuals – may be required to cross multiple traffic lanes informally, often between moving or waiting vehicles. This can lead to unsafe crossing behaviour, increased exposure time on the carriageway, and a heightened risk of pedestrian-vehicle conflict, particularly during peak traffic periods or low visibility conditions.

RECOMMENDATION

A controlled crossing facility should be provided at the junction on Southern Station Road. The facility should align with pedestrian desire lines. Alternatively, the footway should be removed.

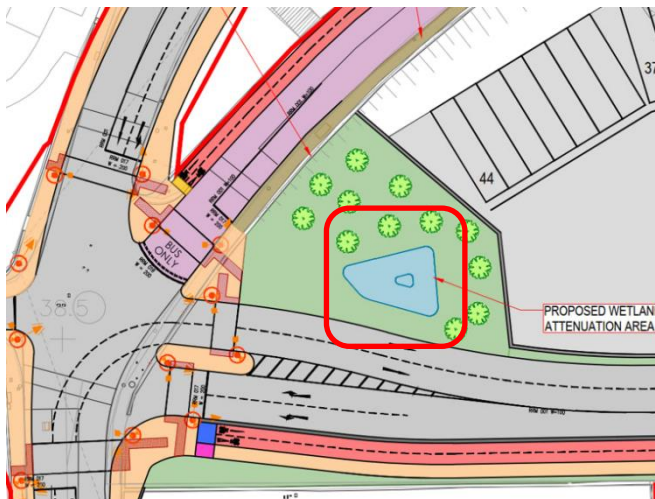
3.4.1 PROBLEM

Location: Proposed wetlands area at western end of proposed link road.

Summary: Proximity of proposed wetlands to road may increase risk of vehicle incursion and water-related hazards.

Detail: The proposed scheme includes the creation of a wetlands area located immediately adjacent to the carriageway, separated only by a verge or shallow embankment with no physical restraint or containment feature indicated. In the event of vehicle loss of control, particularly in poor weather or during evasive manoeuvres, there is a risk that a vehicle may leave the carriageway and enter the wetlands, potentially resulting in occupant injury or vehicle submersion. The presence of standing or slow-moving water also increases the risk of hydroplaning due to water splash or runoff onto the carriageway. Additionally, there may be safety concerns related to maintenance access and unauthorised pedestrian entry into the wetlands from the road edge.

RECOMMENDATION

It is recommended that a suitable containment system (e.g. vehicle restraint barrier) be provided between the carriageway and the wetlands area, particularly where the verge width or embankment gradient is insufficient to prevent vehicle overrun. Drainage design should ensure runoff from the wetlands does not compromise road surface conditions. Consideration should also be given to fencing or low-profile barriers to deter pedestrian access from the carriageway and to maintain road user safety.

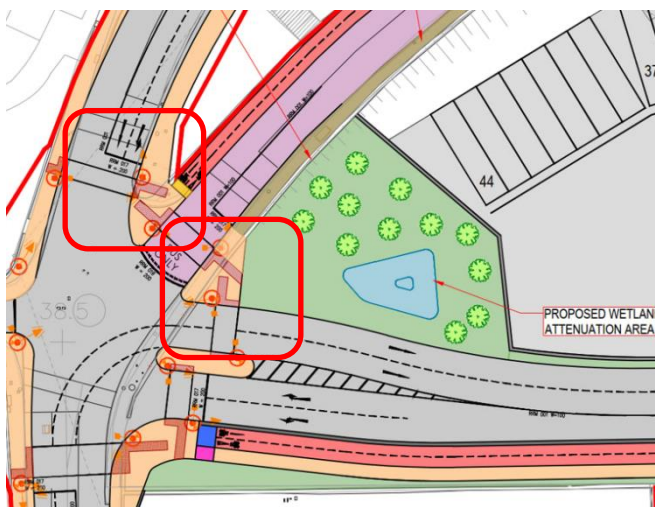
3.4.2 PROBLEM

Location: Right-turning movement for bus at junction with Southern Station Road and Coosan Point Road and left turn for bus to proposed link road from Southern Station Road.

Summary: Inadequate swept path provision for bus may result in vehicle conflict and overrun.

Detail: The junction layout does not appear to adequately accommodate the swept path of a standard or articulated bus making a right or left turn manoeuvre. A bus may encroach into adjacent lanes, opposing traffic lanes, or mount kerbs and footways while completing the turn. This creates a risk of conflict with oncoming vehicles, stationary traffic, or pedestrians at the kerb edge. Repeated overrunning of the kerb may also damage footway surfaces and increase maintenance requirements.

3.4.1	YES	YES		
3.4.2	YES	NO	Coosan Point Road north of this junction has a low bridge which restricts the size of vehicles making these manoeuvres. The proposed junction layout does not alter the swept path from existing for these movements.	YES

RECOMMENDATION

It is recommended that swept path analysis be carried out using appropriate design vehicles (e.g. 12m rigid or 18m articulated bus) to verify the adequacy of the junction geometry. If the current layout does not accommodate bus movements safely, revisions should be made to widen the turning radius, adjust kerb lines, or provide additional lane width. The revised design should ensure that buses can turn without entering opposing lanes or over-running pedestrian areas.

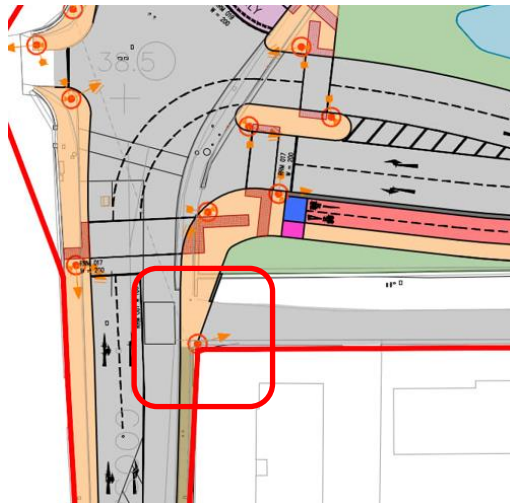
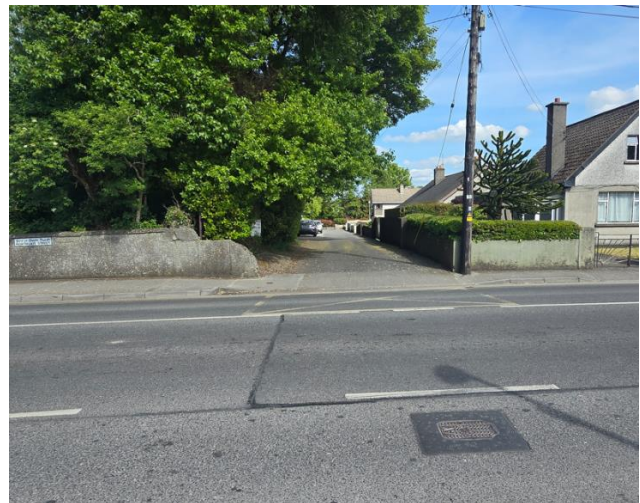
3.4.3 PROBLEM

Location: Private access lane opposite St Vincent's Care Centre on Northgate Street.

Summary: Restricted visibility for vehicles emerging from private access located at or near the junction stop line.

Detail: A private access/egress is located immediately adjacent to the signalised junction stop line (on the opposite side of the carriageway), with limited visibility of approaching traffic from Coosan

Point Road. Due to the presence of signal poles, street furniture, boundary fencing, or queuing vehicles, drivers emerging from the private access may have insufficient sight distance to safely assess traffic conditions or signal phases. This could lead to vehicles exiting the access unsafely into live traffic or conflicting with vehicles approaching the stop line. The problem is exacerbated during peak periods or where access demand is high, creating an increased risk of side-impact collisions or blocking of the junction's operational area.

3.4.3	YES	YES	The existing layout of the entrance and its location, will not change in the proposed scheme, other than it will become signal controlled with an enhanced sightline to the right. This is considered to be an improvement on the existing situation, and relocation is not considered possible. Other mitigation measures will be considered as recommended by the auditor.

RECOMMENDATION

The location and operation of the private access should be reviewed in the context of the signalised junction layout. Where feasible, the access should be relocated or restricted to avoid direct interaction with the stop line. If relocation is not possible, mitigation measures such as improved visibility splays, controlled access (e.g. entry-only or timed operation), mirror installations, or advanced warning signage should be considered.

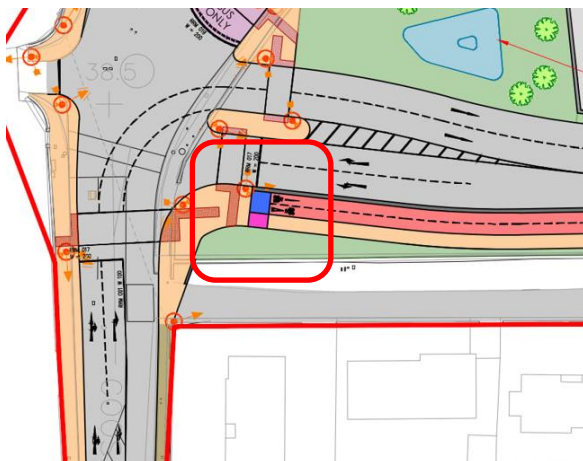
3.4.4 PROBLEM

Location: Start / end of proposed cycleway at western side of proposed link road.

Summary: Unclear start and end of cycle lane in footway area creates confusion and risk of conflict.

Detail: The cycle lane begins and terminates within a pedestrian footway area without clear delineation, signage, or transition markings to guide cyclist and pedestrian movements. The absence of defined start and end points results in a lack of clarity regarding cyclist priority, direction of travel, or expected behaviour at the interface. This may lead to conflicts between pedestrians and cyclists and increases the risk of collisions or near misses. The arrangement may also cause uncertainty for visually impaired users, as tactile guidance is not continuous or clearly aligned with cycle movements.

RECOMMENDATION

Clear and continuous delineation should be provided at the start and end of the cycle lane within the footway area. This should include surface markings, contrasting surfacing, and vertical or tactile separation as appropriate. Wayfinding signage and on-surface symbols should be used to reinforce user expectations. Where shared space is unavoidable, adequate width and sightlines should be maintained, and conflict minimisation measures introduced to promote safe coexistence of pedestrians and cyclists.
