## **Stage 1 Road Safety Audit**

**Gort Town Centre Public Realm Scheme**

On behalf of **Galway County Council**

**October 2024**

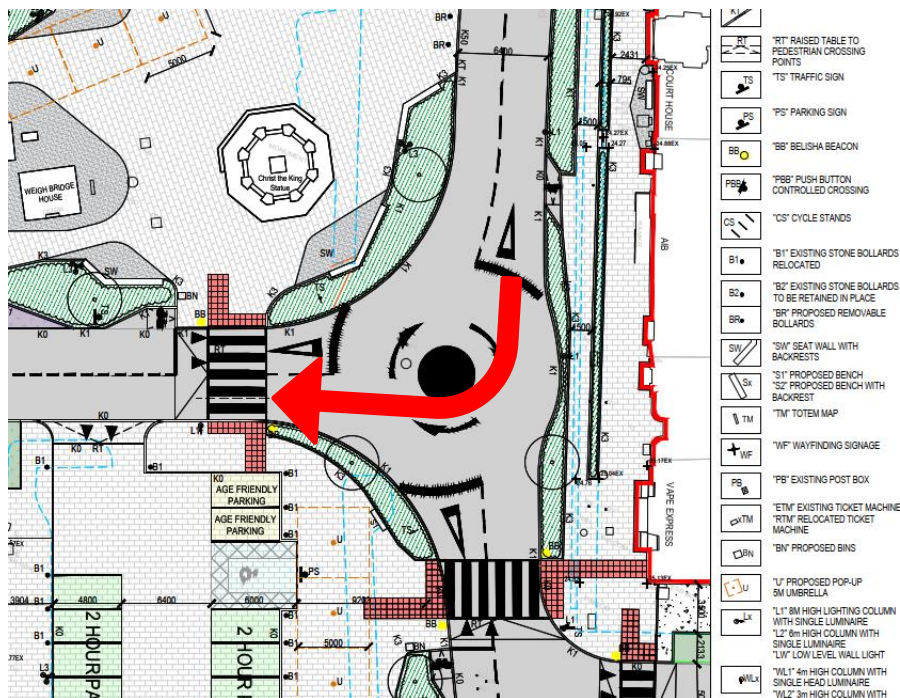
##### 3.2.1 Zebra Crossings at Roundabout .

**Problem:** The proposals show a new zebra crossing to two arms of the 3-arm roundabout. Motorists arriving at the roundabout from the north and turning right may not expect to encounter crossing pedestrians when exiting the roundabout.

**Hazard:** Pedestrians may be struck by exiting vehicles.

**Recommendation:** Provide an additional zebra crossing to the northern arm of the roundabout, in order to condition motorists that zebra crossings are located at this roundabout.

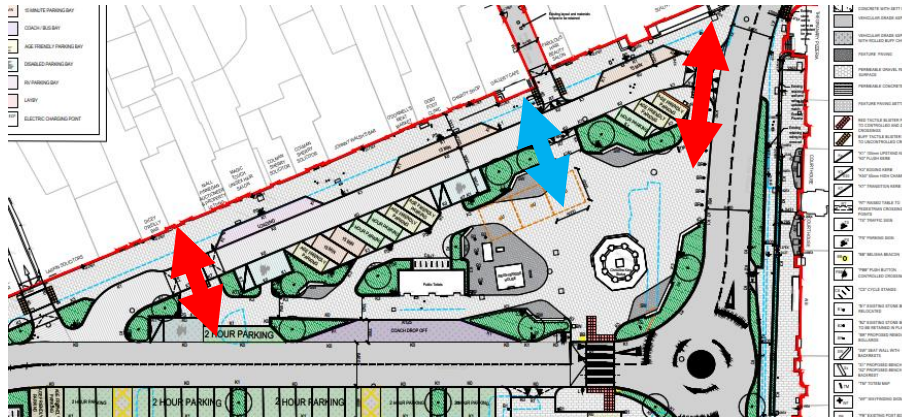
### 3.2.2 Pedestrian Connectivity Lowry's Lane to Town Core

**Problem:** There is a large car park proposed for Lowry's Lane. The likely desire line for pedestrians from this car park is to walk along Lowry's Lane into Market Street and across to the town core. The pedestrian crossings of Market Street are to both ends, which requires a diversion off the likely desire line. Pedestrians are likely to cross Market Street as a continuation of, or close to, Lowry's Lane.

**Hazard:** No assistance for sight impaired pedestrians attempting to cross the road in this location is given. The sight impaired pedestrian may errantly enter the carriageway, into the path of oncoming traffic.

**Recommendation:** The Design Team should provide an uncontrolled crossing closer to the likely pedestrian desire line.

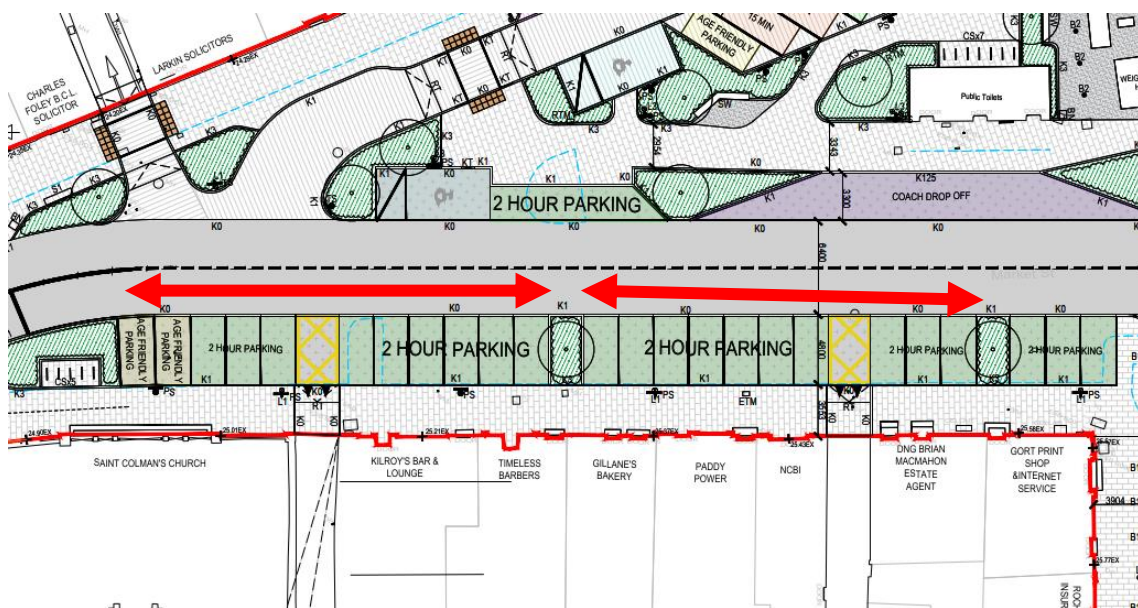
### 3.2.3 Car Parking Market Street Main Square

**Problem:** There is a long run of perpendicular car parking proposed on the Market Street main square. When these spaces are unoccupied the street will appear very wide. Wide and straight streets have a poor record of high vehicle speeds.

**Hazard:** Motorists may impact with other road users, possibly cyclists, at high-speed resulting in serious injuries.

**Recommendation:** Provide additional breaks in the parking that contain vertical features, in an attempt to control vehicle speeds.

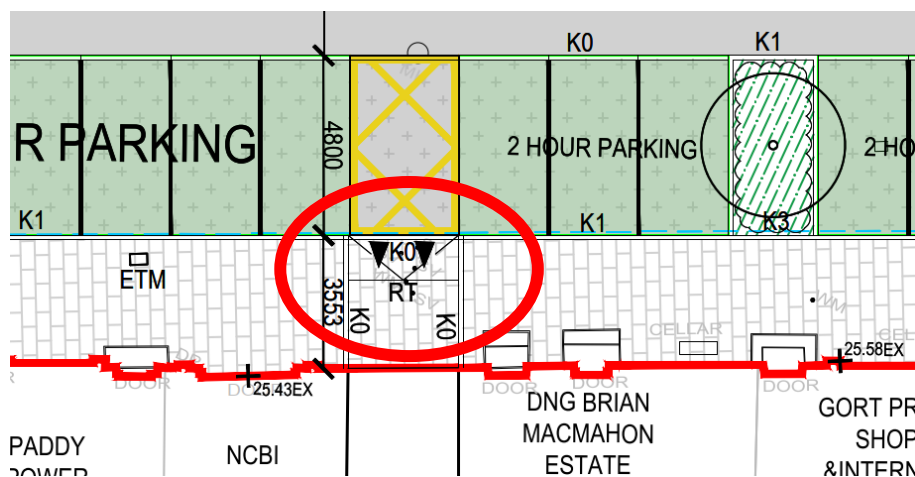
### 3.2.4 Vehicular Footpath Crossovers

**Problem:** There are a number of locations where vehicles are permitted to cross the footpath in order to access driveways and back lands. At these locations a flush kerb is indicated to the rear of the car parking bay adjacent to a 100mm face kerb. It appears there is a ramp up from the car park level to the footpath level incorporated into the footpath. There are two problems with this arrangement.

**Hazard:**

1. Pedestrians walking along the line of the footpath may trip on the side of the ramp.
2. Sight impaired users may errantly depart the footpath where there is zero kerb face and walk within the car parking bays / carriageway.

**Recommendation:** Omit any trip hazards within the footpath and also retain a minimum 60mm kerb face between the footpath and the car parking bay / carriageway.

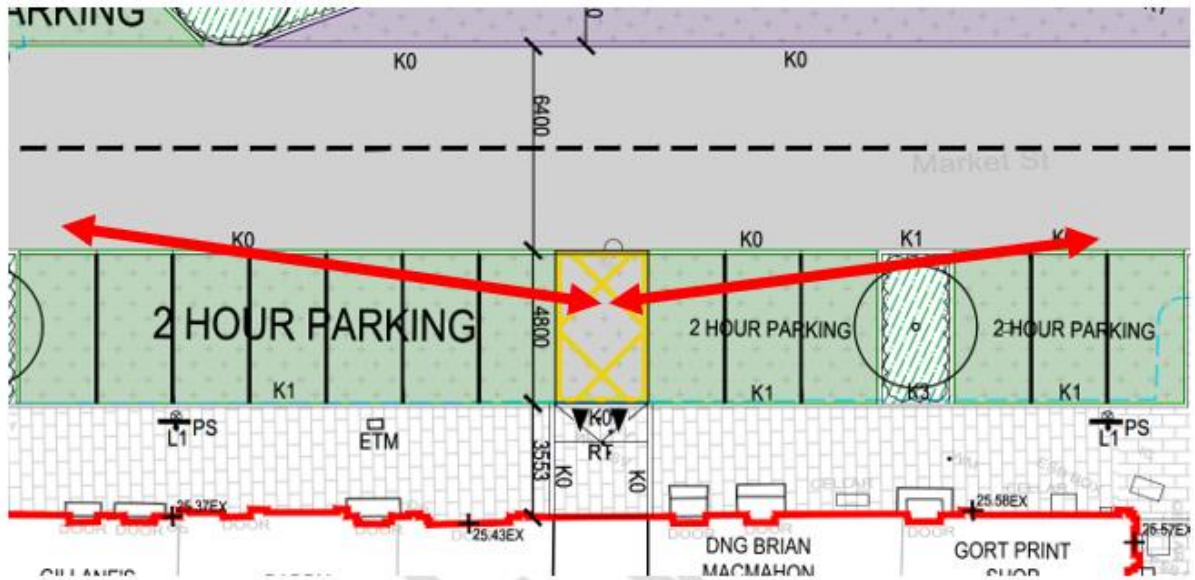
### 3.2.5 Driveway Visibility

**Problem:** There are a number of locations where vehicles are permitted to cross the footpath in order to access driveways and back lands in between roadside parking bays. Visibility may be restricted by high sided vehicles in the parking bay.

**Hazard:** Motorists may proceed into the path of oncoming traffic.

**Recommendation:** Ensure adequate visibility is provided for all users entering the public carriageway.

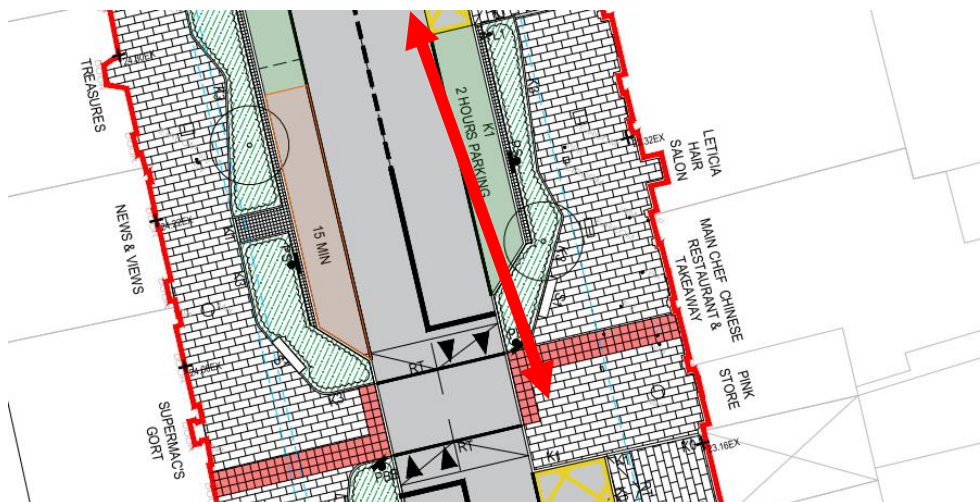
### 3.2.6 Pedestrian Crossings – Visibility

**Problem:** Visibility to pedestrians waiting to cross the road may be restricted by high sided vehicles parked in adjacent parking bays and/or high vegetation. This problem includes signal-controlled crossing locations, as pedestrians often cross the carriageway even when shown a red man at the light.

**Hazard:** Pedestrian may step out into the path of oncoming traffic.

**Recommendation:** the Design Team should ensure adequate visibility is provided. This should include pedestrians waiting to the rear of push chairs at the carriageway edge.

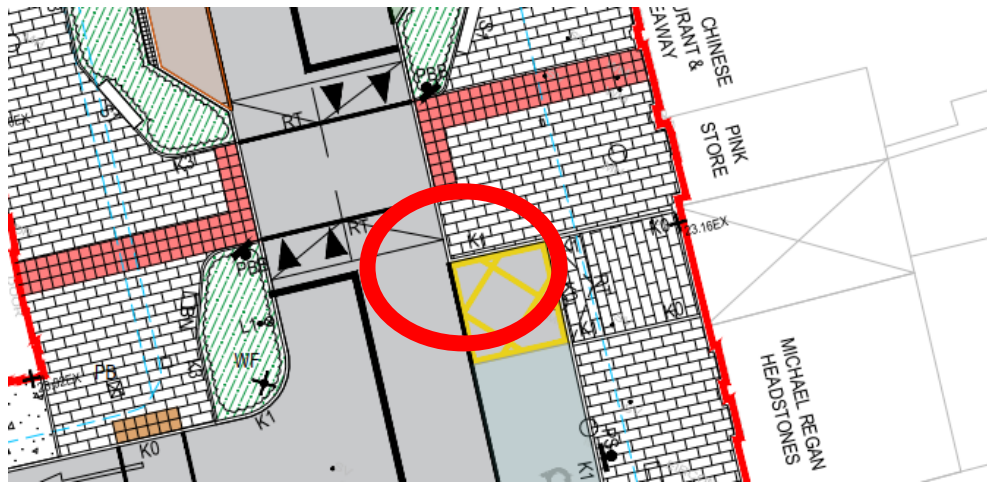
### 3.2.7 Sharp Kerb Edges

**Problem:** There are areas within the design that indicate a 100mm high kerb meeting at a 90 degree corner. Vehicles that attempt to turn at these locations are at risk of tyre damage on the kerb.

**Hazard:** Tyre damage caused at these locations may result in tyre failure elsewhere on high-speed roads.

**Recommendation:** The Design Team should design out areas of potential vehicle tyre damage.

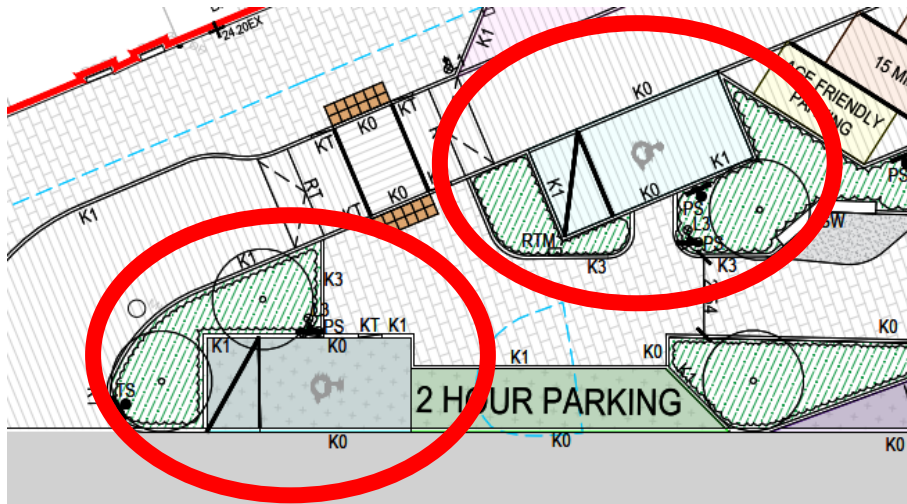
### 3.2.8 Disabled User Parking Bays – Church Street and Market Street

**Problem:** There are a number of disabled user parking bays located throughout the scheme. Some of these bays have landscaping located between the bay and the footpath. Users with differing disabilities use different methods of accessing / egressing their vehicles. This can include rear door access, rear side doors or front doors.

**Hazard:** Disabled users without direct access to the footpath may be required to travel on the carriageway prior to accessing the footpath. Impact from passing vehicles may result.

**Recommendation:** The Design Team should ensure direct access to the footpath can be achieved from all the vehicle passenger doors.

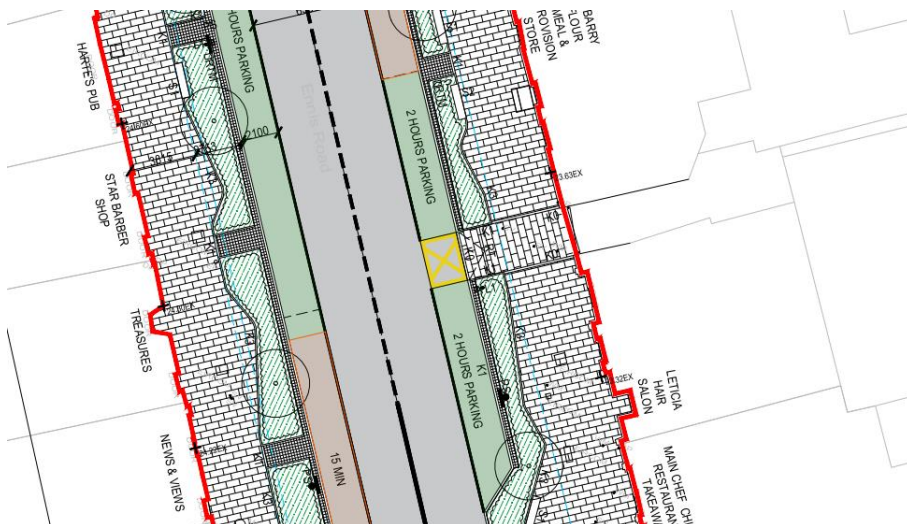
### 3.2.9 Landscaping Adjacent to Parking Bays

**Problem:** There are lengths of linear landscaping strips located adjacent to on-line parking bays. Although there are a number of paved links from the footpath at the rear of the landscaping through to the parking bay, these links will only be of use if the parked vehicle directly aligns with the paved link and even then, they will only be of use for the passenger adjacent to this link.

**Hazard:** Vehicle drivers and passengers are likely to walk within the carriageway until they can find a paved link through to the footpath. This may involve walking the full length of the parking bay on the carriageway. Impact from passing traffic may result.

**Recommendation:** The Design Team should omit the landscaping and provide direct connectivity to the footpath for all vehicle passengers.

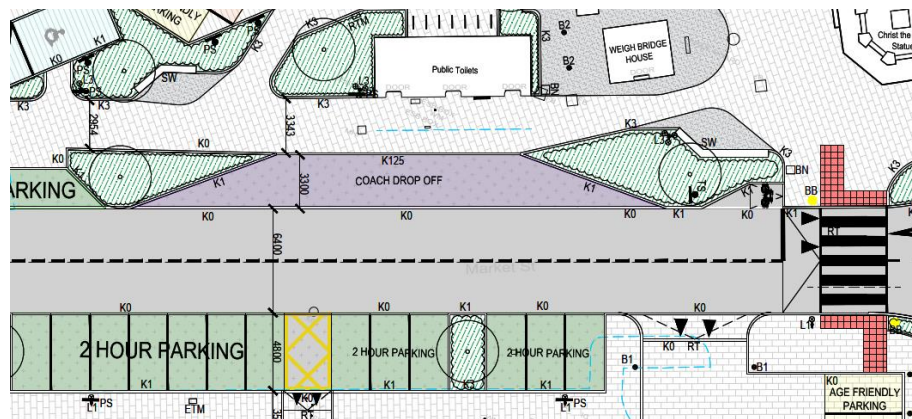
### 3.2.10 Coach Drop-off Bay

**Problem:** The coach drop-off bay is located on the northern side of Church Street. No information has been provided by the Design Team to the route of the coach. There is concern the coach may arrive from the M18/R458. If this is the case the coach will need to turn on or near to Church Street in order for the passenger door to be adjacent to the footpath, or passengers will alight into the carriageway. There is no obvious location for the coach to undertake a 'U' turn along Church Street.

**Hazard:** The coach may attempt to reverse into one of the side streets off Church Street. Impact with other road users may result. If passengers alight into the carriageway, impact from passing traffic may result.

**Recommendation:** The Design Team should ensure the coach arrives from Church Street west and does not need to undertake a 'U' turn in order to achieve a drop off or collection.

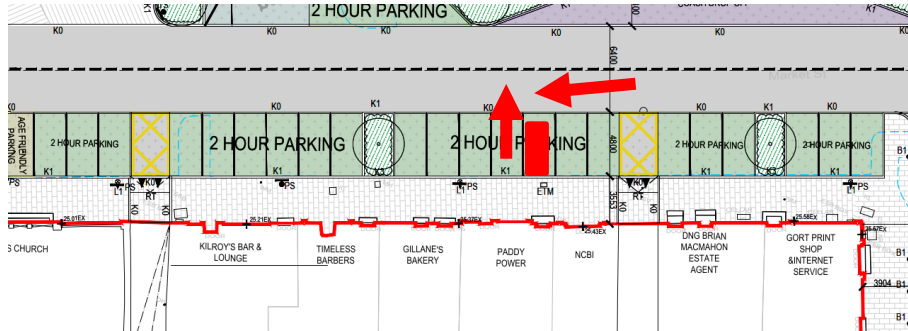
### 3.2.11 Church Street – Perpendicular Parking Bays

**Problem:** There is a long run of perpendicular parking bays on Church Street. Users attempting to exit these bays may have visibility to oncoming traffic restricted by adjacent parked high-sided vehicles.

**Hazard:** Exiting motorists may be struck by passing mainline traffic.

**Recommendation:** The Design Team should provide a buffer strip between the carriageway and parking bay, such that mainline traffic can observe a moving vehicle and slow/stop to permit this vehicle safe egress.

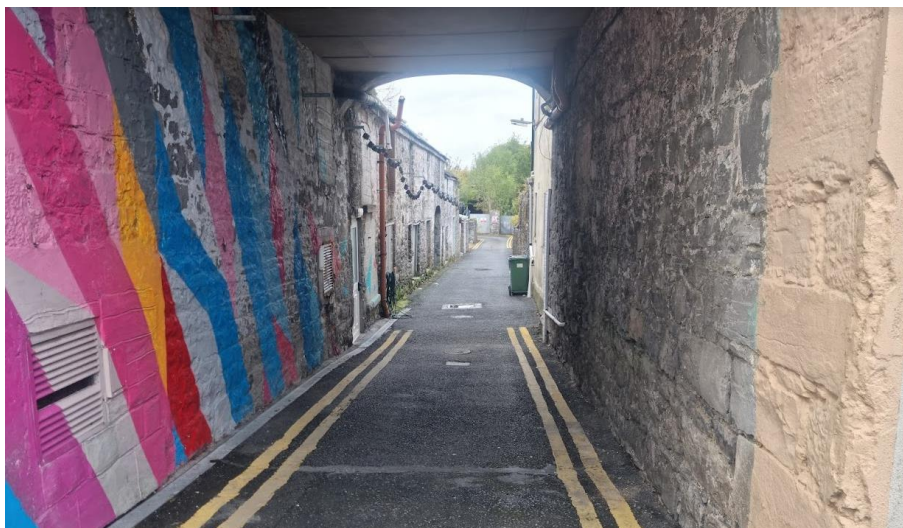
#### 3.3.1 Crowe Street Car Park – Pedestrian Access

**Problem:** It appears from the drawings that pedestrian access to/from the car park is intended to be achieved via Lowry's Lane. This lane is very narrow and currently used by vehicles to access the rear of premises.

**Hazard:** Motor vehicles are unlikely to have sufficient room to pass wheelchair users. The motorist may decide to reverse back onto Market Street. Impact with pedestrians on Market Street may result.

**Recommendation:** Prohibit vehicular use of the lane.

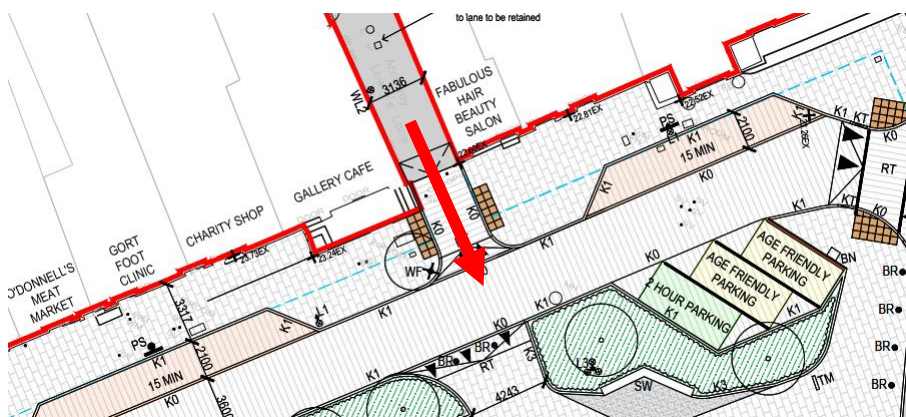
#### 3.3.2 Lowry's Lane – Pedestrian Access

**Problem:** Pedestrians walking from Crowe Street car park to the town core are likely to walk along Lowry's Lane. Upon arrival at Market Street the pedestrian, possibly sight-impaired, is offered no warning they may be entering the Market Street carriageway.

**Hazard:** Motor vehicle impact with pedestrians on Market Street may result.

**Recommendation:** The Design Team should provide a pedestrian deterrent / hazard warning surface at the junction of Lowry's Lane / Market Street.

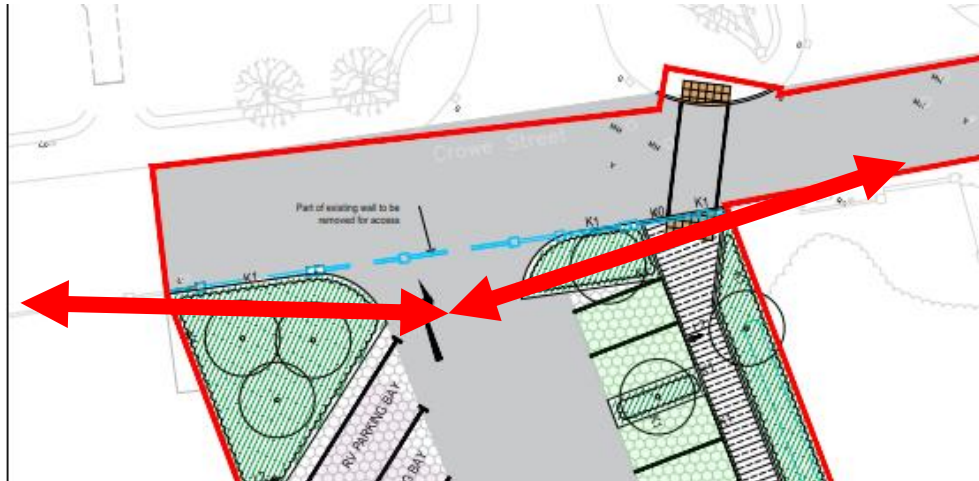
### 3.3.3 Crowe Street Car Park – Visibility

**Problem:** Visibility on exit from the car park may be restricted in either direction by boundary walls / vegetation.

**Hazard:** Car park users may exit into the path of oncoming traffic.

**Recommendation:** The Design Team should ensure suitable visibility is provided in both directions.

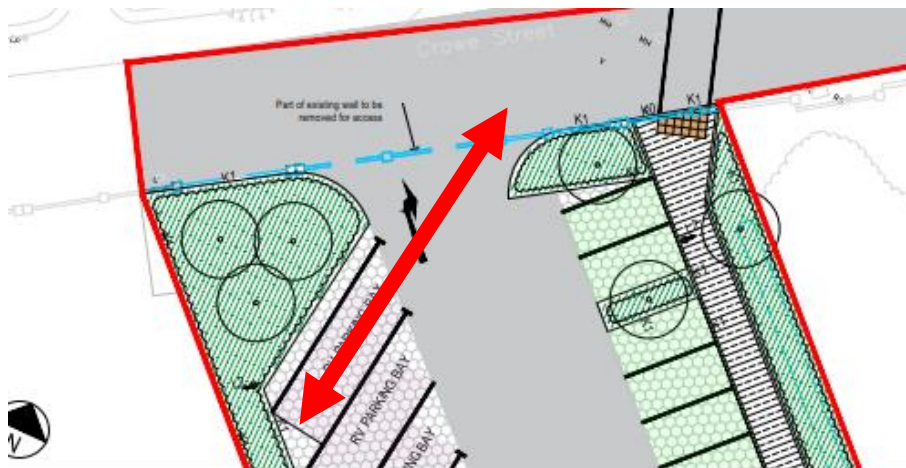
### 3.3.4 Crowe Street Car Park – RV Parking

**Problem:** RV parking is indicated near the entrance to the car park. It is not clear how long vehicles are meant to enter / exit these spaces. It is likely the users will drive forward into the space and reverse back out of the car park junction in order to exit.

**Hazard:** Impact with vehicles entering the car park may result.

**Recommendation:** The RV spaces should be relocated where entry and exit to the car park can be achieved without need to reverse towards entering vehicles.

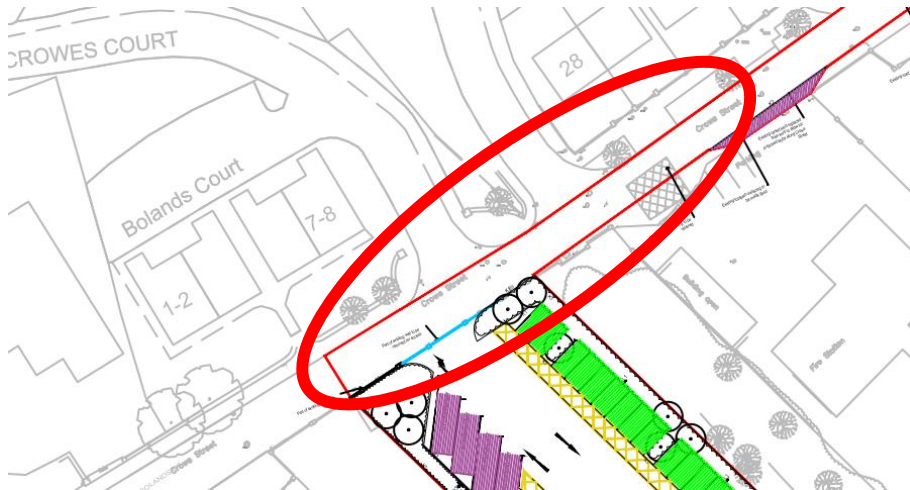
### 3.3.5 Crowe Street – Widening (1)

**Problem:** Sections of Crowe Street are intended to be widened, but this widening does not include the full length of the street. Sections remain narrow, where passage of two-way traffic may be difficult. Narrow sections include the carriageway at the housing development junctions opposite the proposed car park. Users existing the housing development and other junctions may be concentrating on vehicles approaching from their right only. The provision of the car park is likely to generate a substantial increase in traffic movements on Crowe Street.

**Hazard:** Head-on impact between users may result.

**Recommendation:** The Design Team should ensure adequate carriageway width is provided in areas where left turning movements onto Crowe Street may occur.

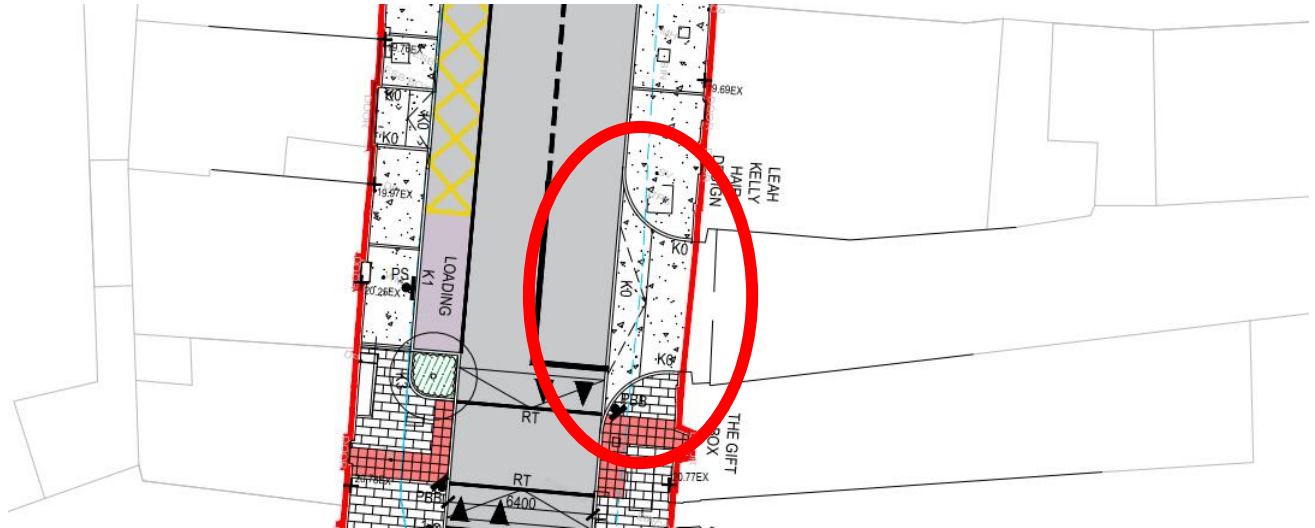
### 3.3.7 Ennis Road – HGV Access adjacent to An Post

**Problem:** The paving plan indicates the kerb returning into the HGV access. Motorists may believe vehicles have priority at this junction, yet pedestrians are not advised to take care for vehicles here.

**Hazard:** Pedestrians, in particular sight-impaired pedestrians, may cross the mouth of the junction into the path of turning vehicles.

**Recommendation:** Due to the proximity of the tactile paving for the adjacent controlled crossing, tactile paving could be confusing if located for this entrance. The Design Team should remove the radius kerbs leading to the access lane and treat this area as a footpath crossover, where pedestrians have priority.

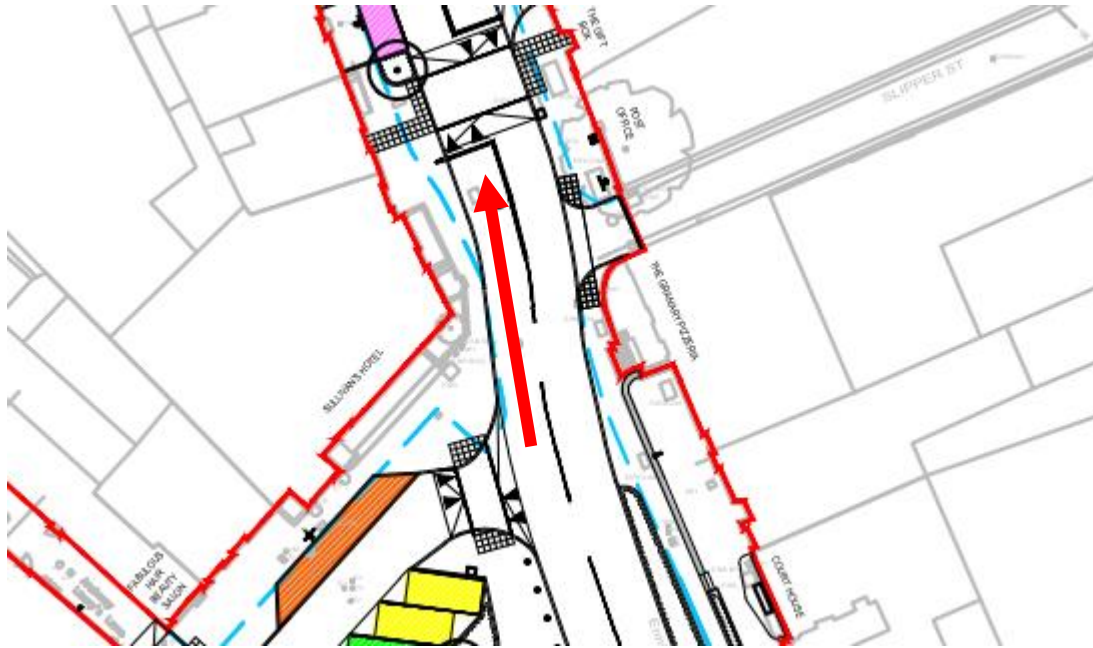
### 3.3.8 Crowe Street (Ennis Road R380) Controlled Crossing

**Problem:** The controlled crossing located to the front of “The Gift Box / An Post” is located on a steep downhill section of carriageway. Vehicles approaching from the south may have their ability to stop compromised by the steep carriageway, particularly in wet or frosty conditions.

**Hazard:** Vehicles may overshoot the crossing, impacting with pedestrians.

**Recommendation:** The Design Team should provide enhanced friction material on the carriageway surface.

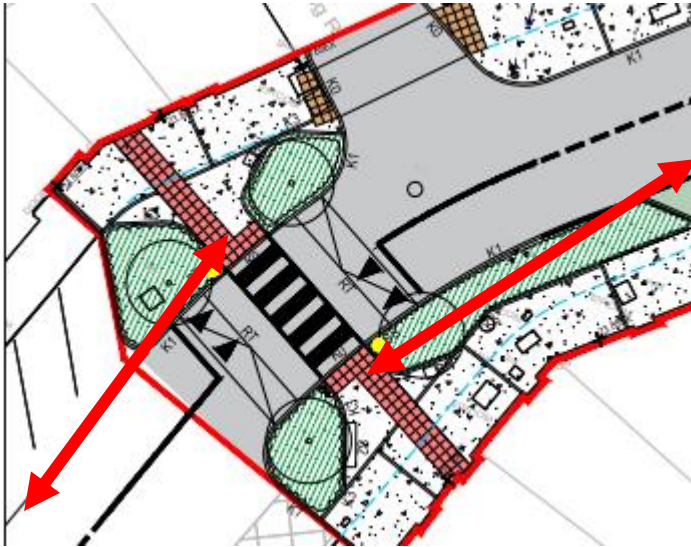
### 3.3.9 Church Street – Zebra Crossing near Garraghbeg Road

**Problem:** There is a zebra crossing proposed to the south of Garraghbeg Road junction. This zebra crossing is located on a bend with both landscaping and vehicles parking to both sides. Pedestrians waiting to cross the road may be shielded from view by either/or the landscaping or parked high sided vehicles.

**Hazard:** Pedestrians may commence their crossing into the path of unsighted vehicles.

**Recommendation:** The Design Team should ensure all visibility splays are clear of obstruction.

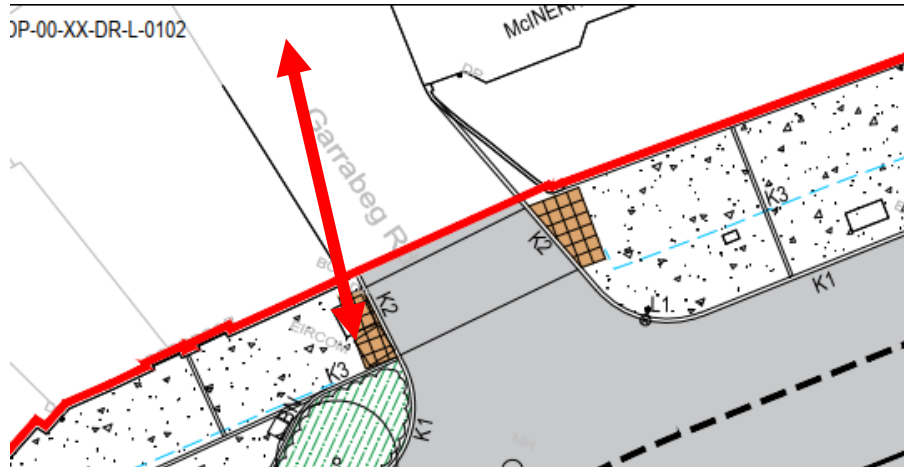
### 3.3.10 Gararghbeg Road – Pedestrian Crossing

**Problem:** The tactile paving / pedestrian crossing on Gararghbeg Road is located such that pedestrians crossing from west to east will have very limited sight of vehicles approaching on Gararghbeg Road.

**Hazard:** Pedestrians may step into the carriageway into the path of oncoming vehicles.

**Recommendation:** Relocate the crossing closer to Church Street, where improved inter-visibility can be achieved.

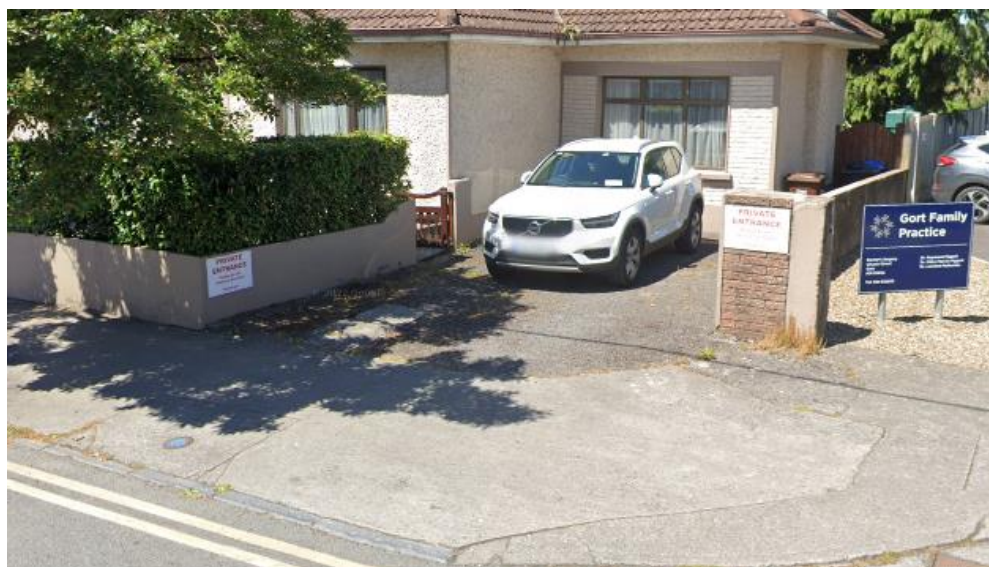
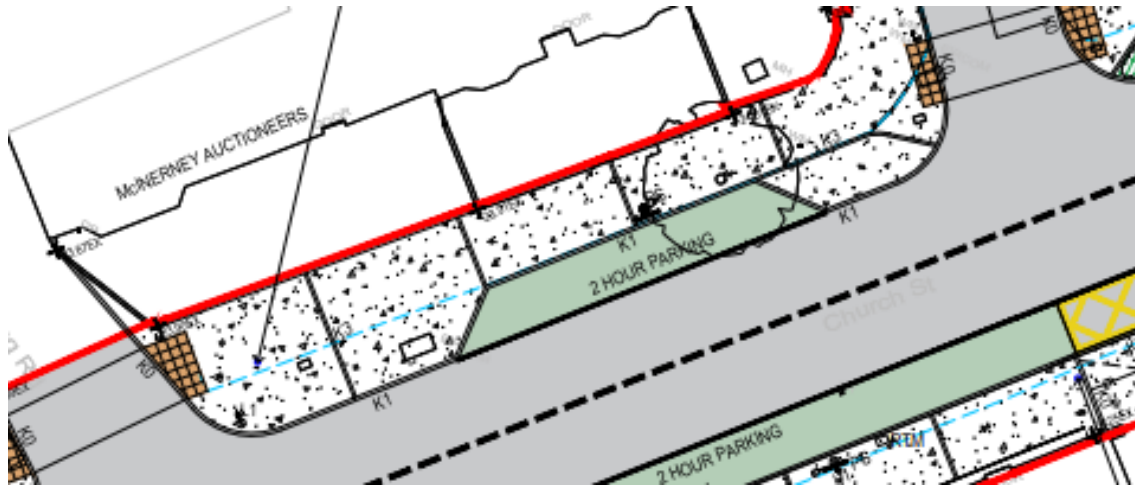
### 3.3.11 Church Street – McNerney Auctioneers and Dwelling House

**Problem:** There is existing off-street parking located at McNerney Auctioneers and a dwelling house at the corner of the Gort Family Practice. The proposals include for the provision of a 100mm high kerb across both entrances and also a parking bay.

**Hazard:** Riders of powered two-wheeled vehicles may lose vehicle control when attempting to cross the kerb. Additionally high sided vehicles in the parking bay may restrict visibility on exit from the driveways.

**Recommendation:** The Design Team should provide suitable entrance to the parking areas, with suitable visibility splays.

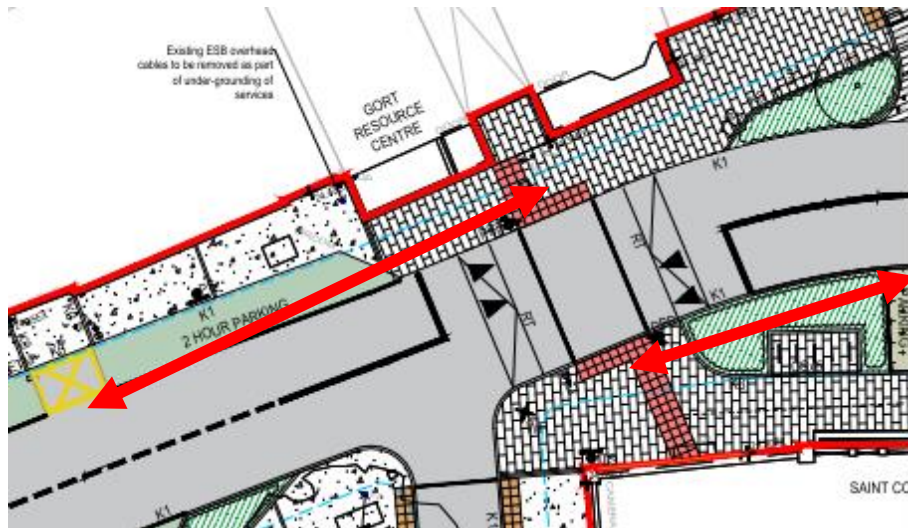
### 3.3.12 Church Street – Controlled Crossing and Queens Street Junction visibility.

**Problem:** There is a parking bay located to both sides of the controlled crossing, also with landscaping to the east the crossing. High-sided vehicles within the parking bays or high vegetation may restrict driver visibility to the crossing signal heads and also visibility for motorists exiting Queens Street. Furthermore, pedestrians have a poor record at signal-controlled crossings of crossing when the red man is illuminated.

**Hazard:** Motorists may exit Queens Street into the path of oncoming traffic, Pedestrians may commence their crossing unsighted to oncoming motorists, or motorists may fail to stop when shown a red light.

**Recommendation:** The Design Team should ensure adequate visibility is provided.

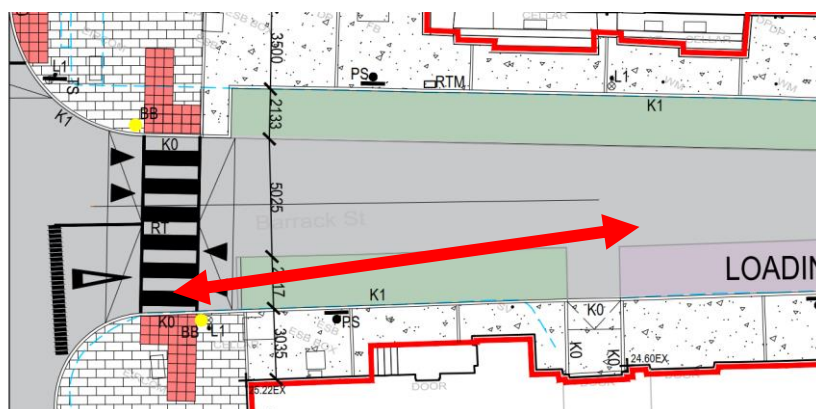
### 3.3.13 Barrack Street – Controlled Crossing at R458 Junction.

**Problem:** There is a parking bay located to the east of the controlled crossing. High sided vehicles within the parking bay may restrict driver visibility to the waiting or northbound crossing pedestrian.

**Hazard:** Pedestrians may commence their crossing unsighted to oncoming motorists.

**Recommendation:** The Design Team should reduce the carriageway width at the mouth of the junction such that the southern side of the crossing is visible to approaching motorists.

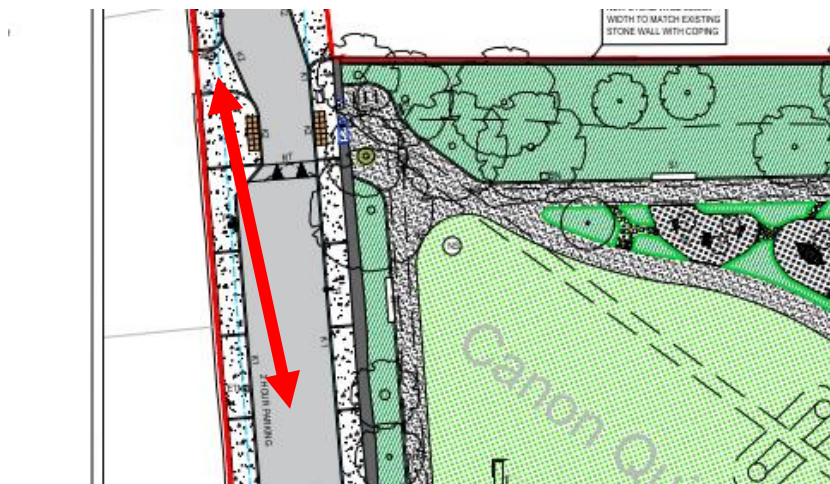
### 3.3.15 Queens Street - Chicane

**Problem:** The proposed vehicle parking on Queens Street is to the west of the carriageway near the park. There is a dwelling house on the western side of the street. High-sided vehicles parked in the bay may restrict visibility for users exiting the dwelling driveway.

**Hazard:** Users may exit the driveway into the path of oncoming traffic.

**Recommendation:** The Design Team should ensure adequate driveway visibility is provided.

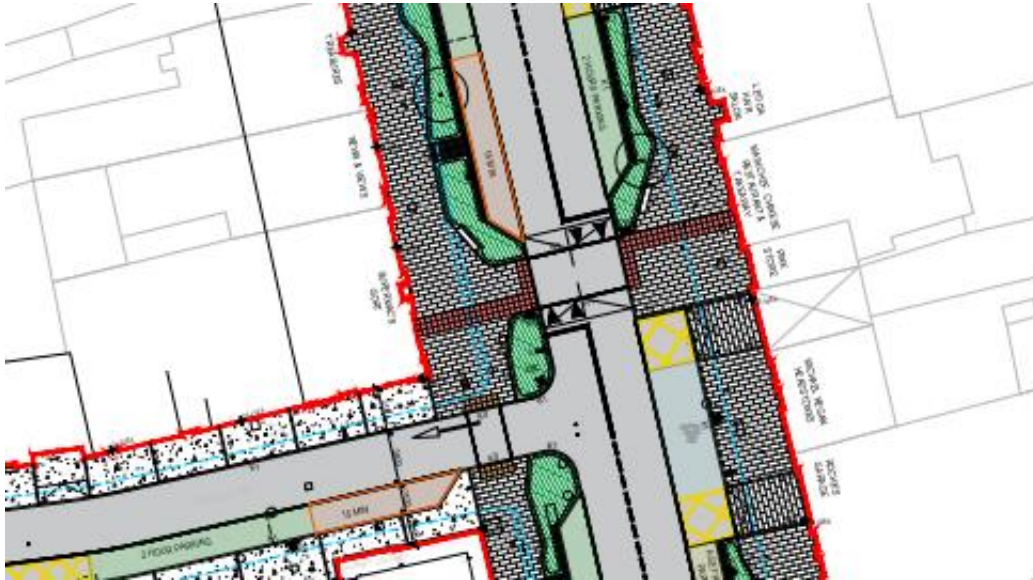
**Hazard:** Mobility-impaired users may fall due to the gradient.

**Recommendation:** The Design Team should ensure all footpath gradients comply with current best practice.

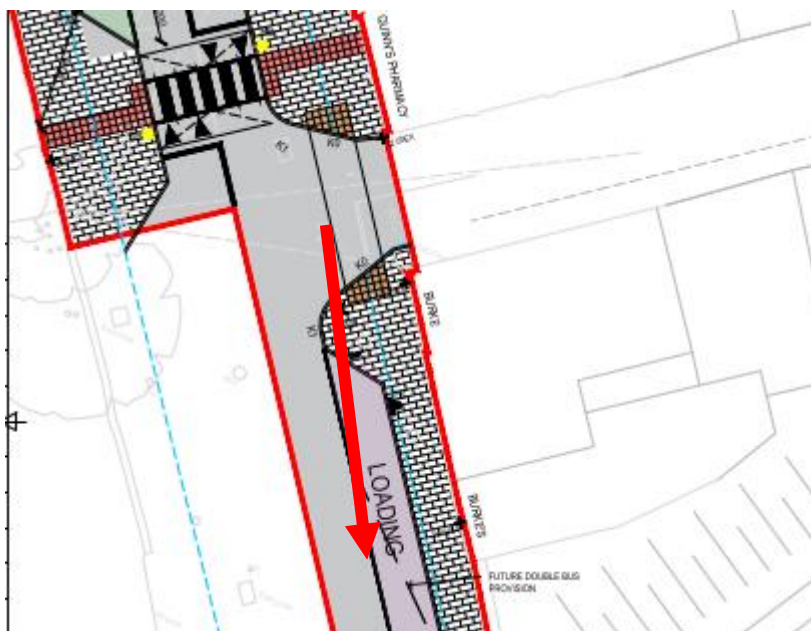
### 3.3.18 Station Road – Visibility

**Problem:** There is a loading bay located to the south of Station Road. Large vehicles parked in the bay may block visibility for exiting traffic.

**Hazard:** Users may exit Station Road into the path of oncoming traffic.

**Recommendation:** The Design Team should ensure suitable junction visibility is achieved.

**Note:** If all parking is needed in this area, swapping the bus bay with the loading bay may result in shorter occupancy of the problem bay.

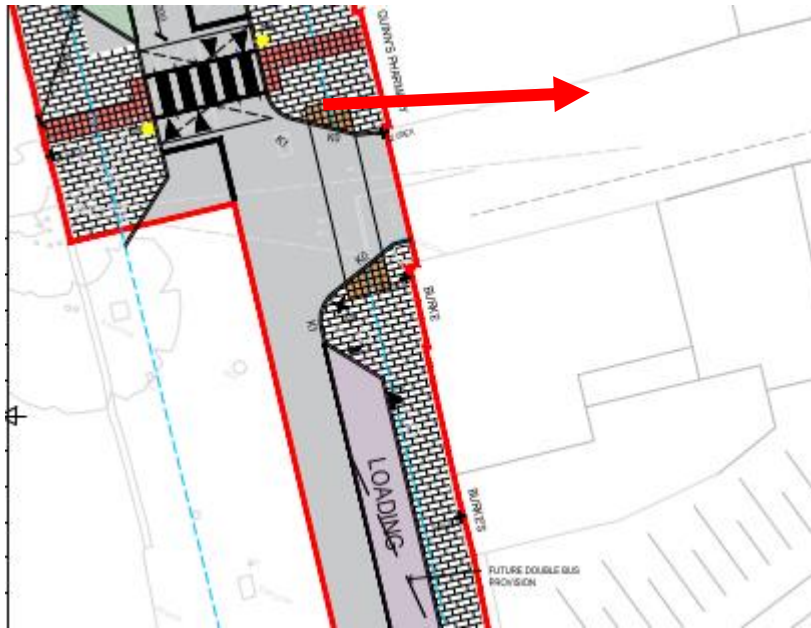
### 3.3.19 Station Road – Pedestrian Crossing Visibility

**Problem:** Pedestrians crossing north south of Station Road have their visibility to traffic exiting Station Road restricted by the building.

**Hazard:** Pedestrians may commence their road crossing and be subject to vehicle strikes.

**Recommendation:** The Design Team should relocate the tactile paving and dropped kerb closer to the Ennis Rd carriageway edge.

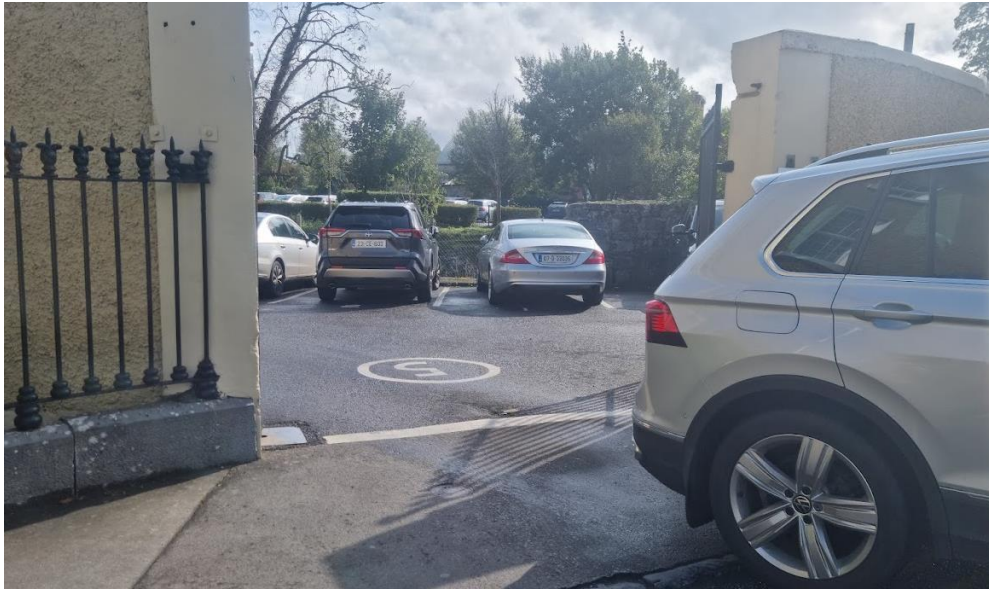
### 3.3.20 Gort Medical Centre – Car Park

**Problem:** Motorists' visibility to pedestrians crossing the entrance to Gort Medical Centre is very restricted, both by boundary walls and the angle of the entrance. It was noted during the site visit this car park is very busy and has a high turnover rate.

**Hazard:** Pedestrian / vehicle collisions may result.

**Recommendation:** The team, in consultation with the medical centre, should undertake works to improve the existing car park access.

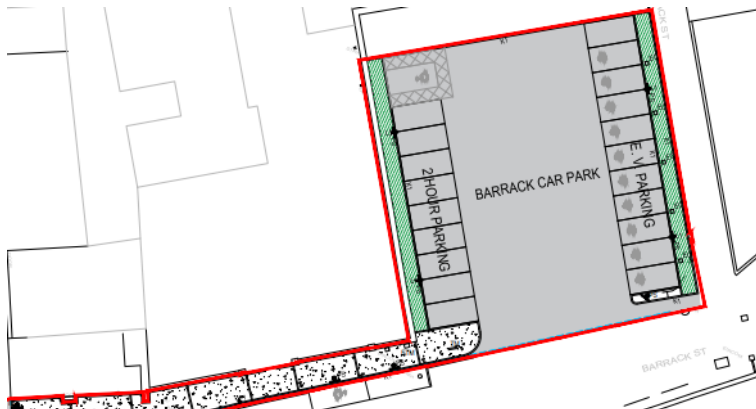
### 3.3.21 Barrack Street – Car Park

**Problem:** The car park has a large vacant space to the middle. We have been informed by the design team that this space is required for turning of HGVs. There is concern that overspill car parking will occur in this central space and this will prevent the HGV from turning here. The HGV may reverse back onto the regional Road.

**Hazard:** Impact with Regional Road traffic may occur.

**Recommendation:** The Design Team should provide suitable road markings and advisory signage in order to prevent vehicle parking within the turning area.

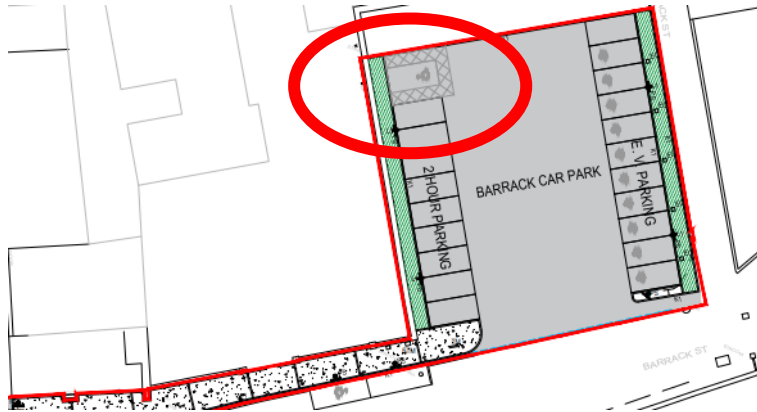
### 3.3.22 Barrack Street – Car Park Disabled users Parking

**Problem:** The disabled user parking space within the car park is not located adject to a segregated footpath. Disabled users will be required to walk through the trafficked area of the car park in order to access the footpath.

**Hazard:** Impact from passing or reversing vehicles may occur.

**Recommendation:** The Design Team should relocate the disabled user parking spaces, such that direct access to a segregated footpath can be achieved.
