Stage 1 Road Safety Audit

Gort Town Centre Public Realm Scheme

On behalf of **Galway County Council**

October 2024

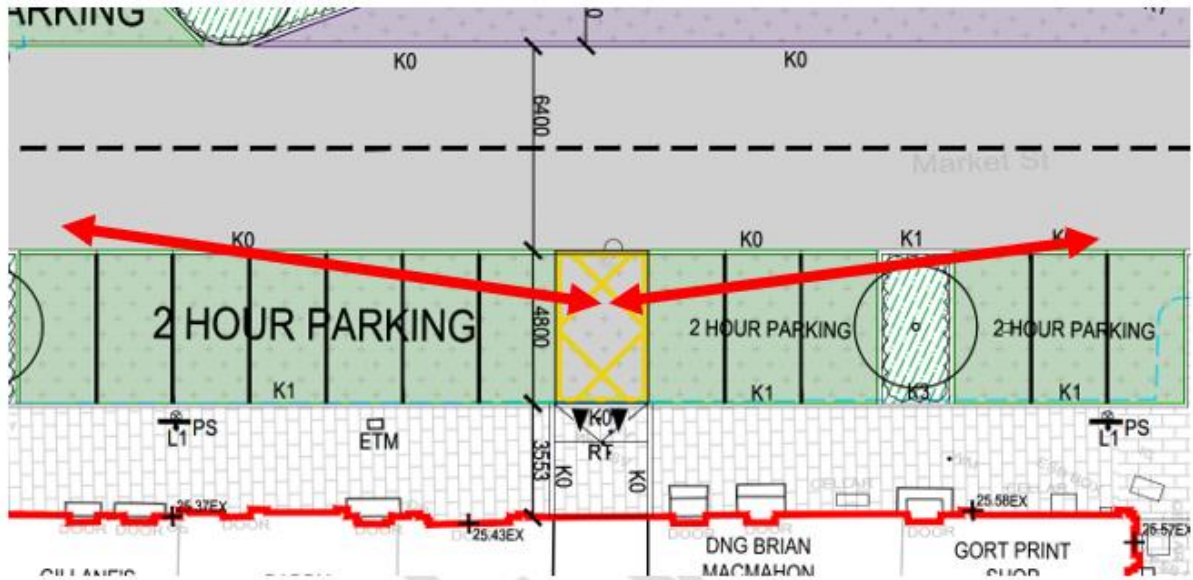
3.2.5 Driveway Visibility

Problem: There are a number of locations where vehicles are permitted to cross the footpath in order to access driveways and back lands in between roadside parking bays. Visibility may be restricted by high sided vehicles in the parking bay.

Hazard: Motorists may proceed into the path of oncoming traffic.

Recommendation: Ensure adequate visibility is provided for all users entering the public carriageway.

3.2.5	Yes	No	This is typical and an existing scenario within the town where there is on street parking and entrances to driveways / alleyways. Its not feasible to take out all of the parking on the streets, instead the yellow markings provide a clear space for vehicles to enter an exit. There is very low number of vehicles doing this movement.	Yes. However, it is suggested the landscaping within the bay is located to the approaching traffic side of the entrance, to provide some visibility.

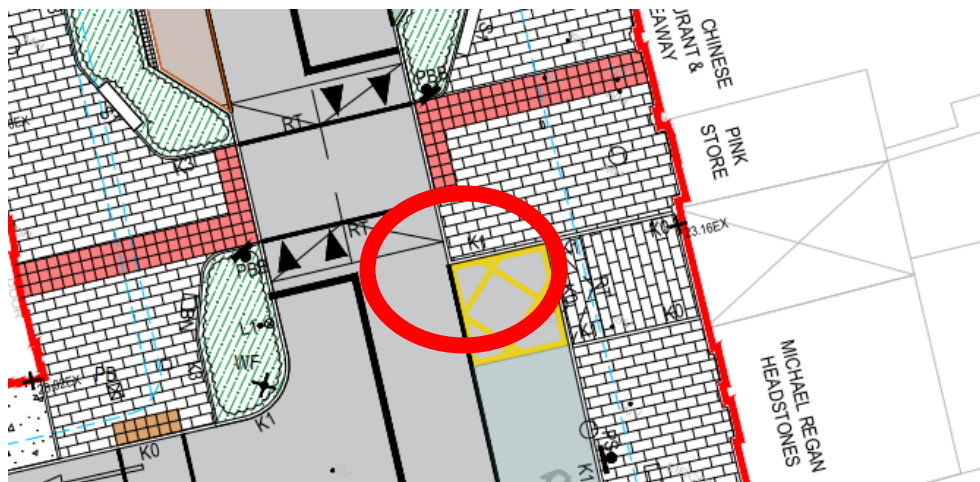
3.2.7 Sharp Kerb Edges

Problem: There are areas within the design that indicate a 100mm high kerb meeting at a 90 degree corner. Vehicles that attempt to turn at these locations are at risk of tyre damage on the kerb.

Hazard: Tyre damage caused at these locations may result in tyre failure elsewhere on high-speed roads.

Recommendation: The Design Team should design out areas of potential vehicle tyre damage.

3.2.7	No	Yes	All 90 degree kerbs will be a smooth radius quadrant kerb with a bull nose top	
3.2.8	Yes	Yes		
3.2.9	Yes	No	A paved margin will be provided adjacent to the kerb to assist connectivity for all vehicle passengers	Yes

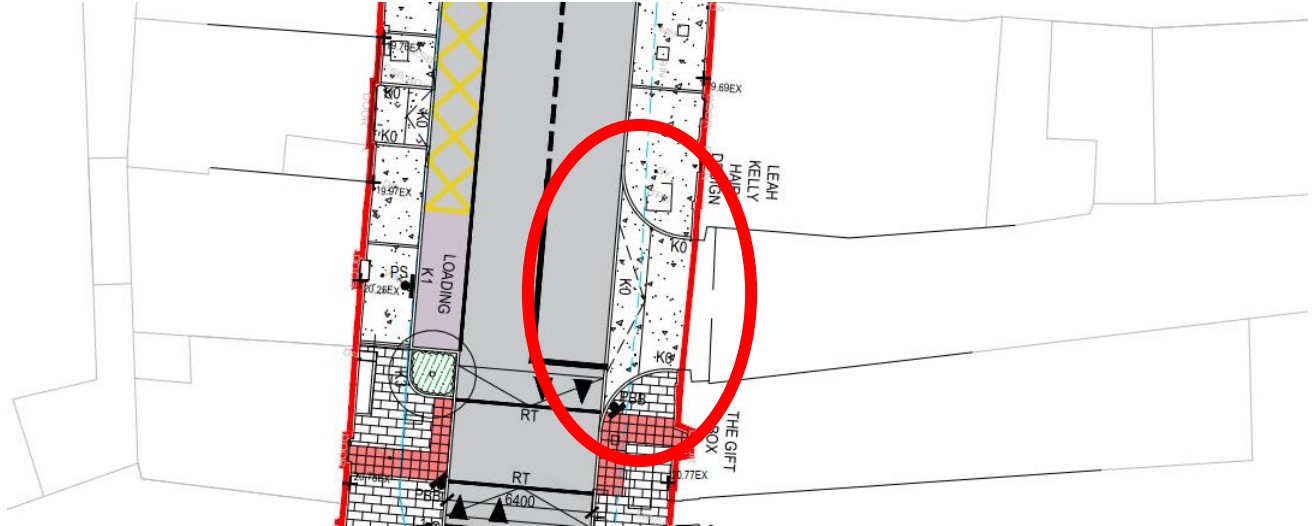
3.3.7 Ennis Road – HGV Access adjacent to An Post

Problem: The paving plan indicates the kerb returning into the HGV access. Motorists may believe vehicles have priority at this junction, yet pedestrians are not advised to take care for vehicles here.

Hazard: Pedestrians, in particular sight-impaired pedestrians, may cross the mouth of the junction into the path of turning vehicles.

Recommendation: Due to the proximity of the tactile paving for the adjacent controlled crossing, tactile paving could be confusing if located for this entrance. The Design Team should remove the radius kerbs leading to the access lane and treat this area as a footpath crossover, where pedestrians have priority.

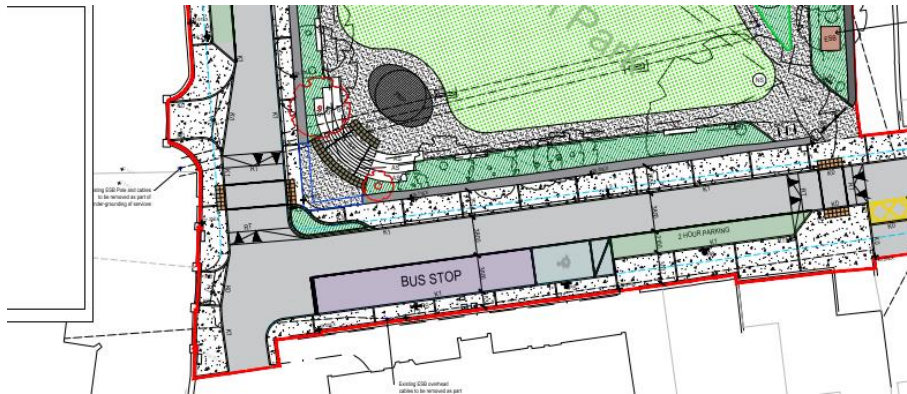
3.3.16 Queens Street – Bus Parking

Problem: It appears the design is reducing the carriageway width on elements of Queens Street. There is a bus stop located on Queens Street. There is concern that the general reduction of carriageway width will result in difficulties for the bus to navigate along and around the tight bend in Queens Street. The bus may be required to reverse or over-run the footpath.

Hazard: The bus may impact with other vehicles or pedestrians.

Recommendation: The Design Team should ensure adequate carriageway space is provide for the bus to travel without the need to reverse or overhang the footpath.

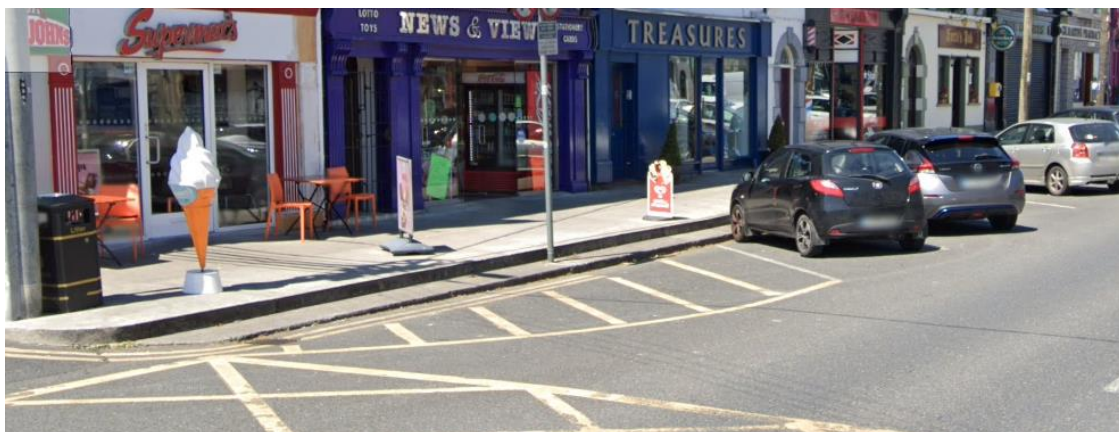
3.3.17 Georges Street – Pedestrian Cross Outside Supermac's

Problem: There is a pedestrian crossing proposed on Georges Street, outside of the Supermac's premises. Currently there is a double kerb in this location as the carriageway is substantially lower than the footpath. There is concern that the footpath to the crossing will be excessively steep.

Hazard: Mobility-impaired users may fall due to the gradient.

Recommendation: The Design Team should ensure all footpath gradients comply with current best practice.
