Stage 1 Road Safety Audit Report

N58 STRADE RIVER BRIDGE REHABILITATION WORKS

Strade River Bridge

Stage 1 Road Safety Audit

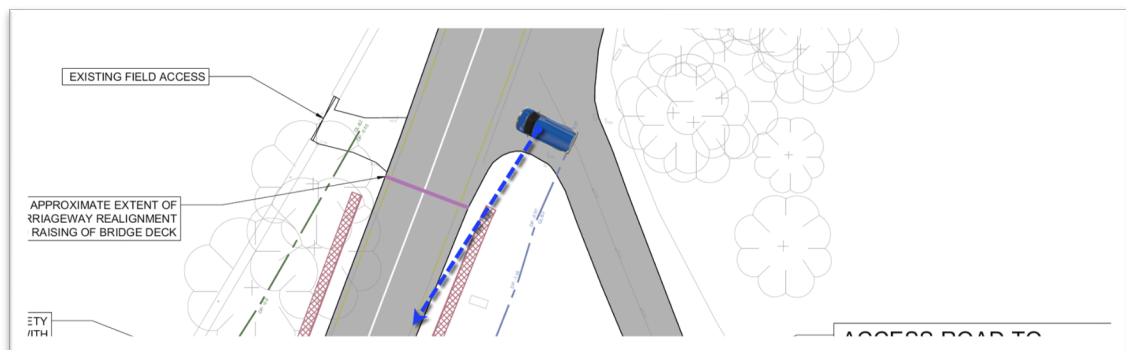
Figure 2.1 – Safety Barrier Partially Obscuring Sight Lines at The Davitt Museum Access

2.1 Problem: Safety Barrier Partially Obscuring Sight Lines

Location: Accesses on Either Side of Strade River Bridge

The proposed safety barrier may partially obscure drivers' sight lines at the Davitt Museum access, potentially increasing collision risks on the N58.

| Problem Reference (Section 2) | Designer Response Section | | | Audit Team Response Section |
|---|---|--|---|---|
| 2.1 | Yes | Yes | Sightlines have been assessed with the ends of the safety barriers on the northwest departure and northeast approach to be flared to avoid impact on sightlines from the field access and the junction to the museum. | Noted. |

Assess sight lines at the access and adjust the safety barrier (if required) to optimize visibility.

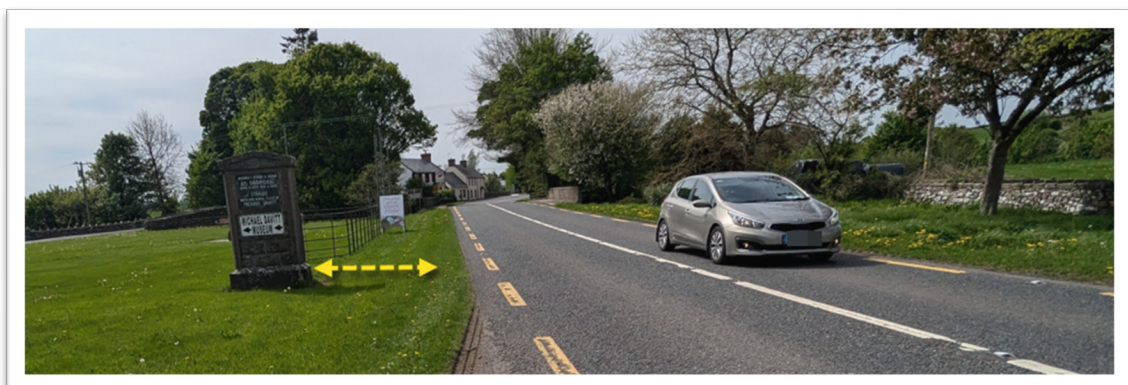
Figure 2.2 – Davitt Museum Sign May Prevent Barrier from Deforming Following Vehicle Impact

2.2 Problem: Road Side Feature Impacting on Barrier Operation

Location: Existing Masonry Sign for Davitt Museum

The Davitt Museum sign could be positioned within the barrier's working width, which may compromise the barrier's ability to deform correctly in the event of a vehicle impact. This could potentially increase the severity of a collision.

| Problem Reference (Section 2) | Designer Response Section | | | Audit Team Response Section |
|---|---|--|---|---|
| 2.2 | No | No | The Davitt Museum sign is confirmed to be outside the working width of the proposed barrier. | Yes. |

The position of the sign as it relates to the barrier should be checked, with appropriate adjustments made to ensure that the performance of the barrier is not compromised.
