# Stage 2 Structural Assessment Report

Mayo County Council

Document title: MO-N58-001.00 Strade River Bridge Stage 2 Assessment

Client	Mayo County Council
Project	TASK ORDER NO.315 MAYO BRIDGE ASSESSMENTS & STRENGTHENING 2023
Job number	0088572
Client

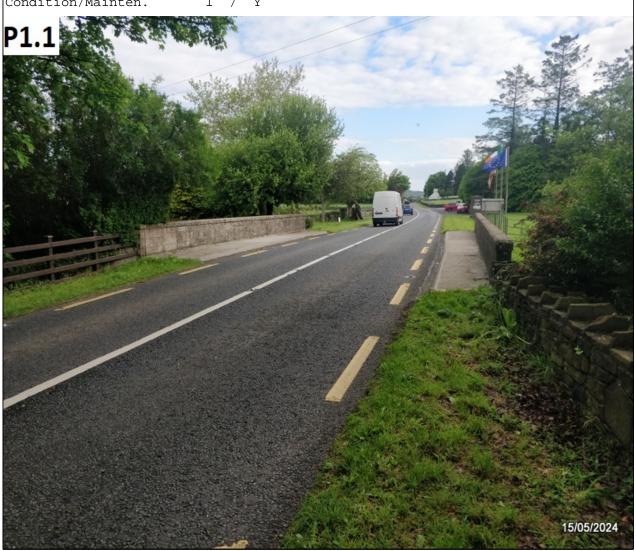
The bridge surface is in good condition overall, see P1.1 for a view north. There is cracking evident to the carriageway at the northwest corner to be sealed during routine maintenance, see P1.2.

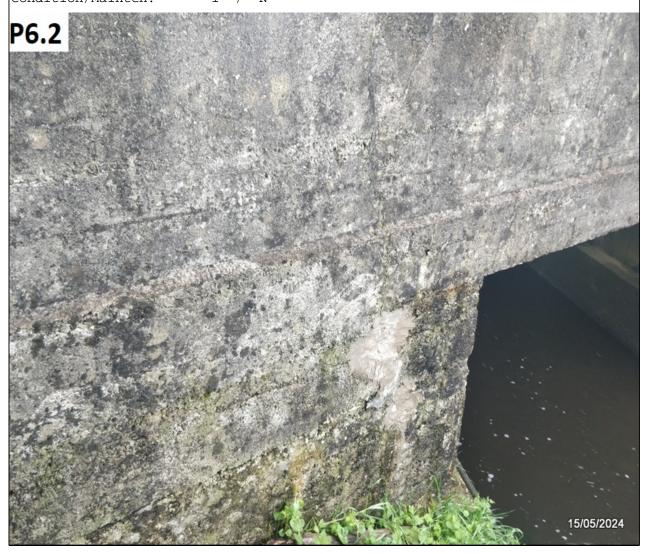
The wing walls are in good condition, see P6.1 for a view of the northeast wing wall. There is a previous repair evident to the northwest wing wall, see P6.2.

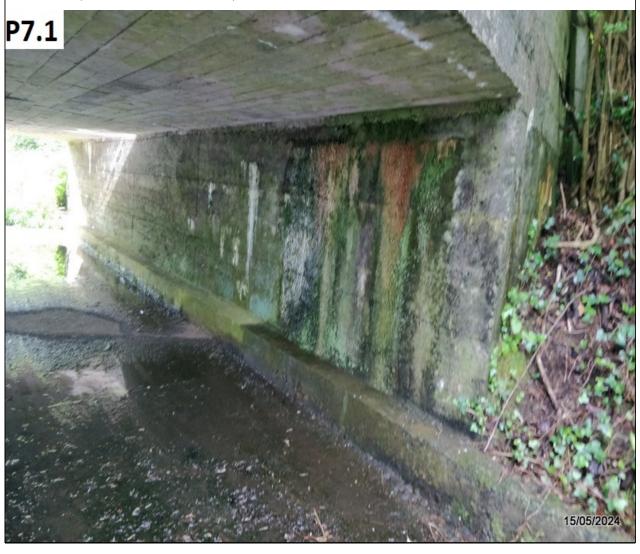
Both abutments are in a fair condition, see P7.1 for view of the southern abutment. The previously reported crack to the west side of the northern abutment remains 0.6mm wide, see P7.2. The previously installed crack pips have a measurement of 25.91mm (The previous base reading 23.1mm is confirmed to be incorrect with 25.91mm the new base reading). The crack should be injection repaired.

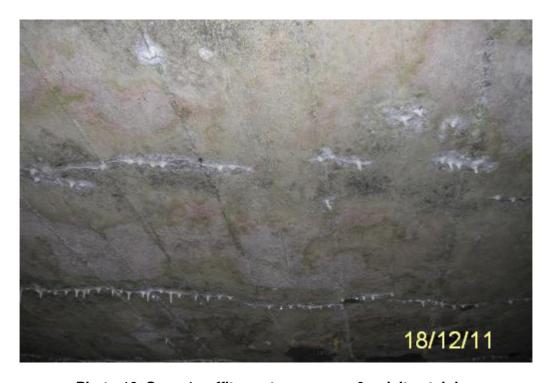
Photo 10. Span 1 soffit – water seepage & calcite staining

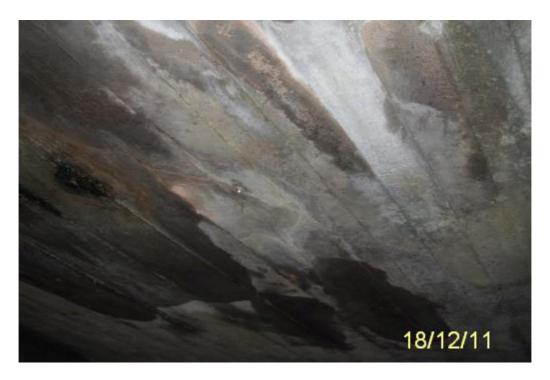
Photo 11. Span 2 soffit – water seepage

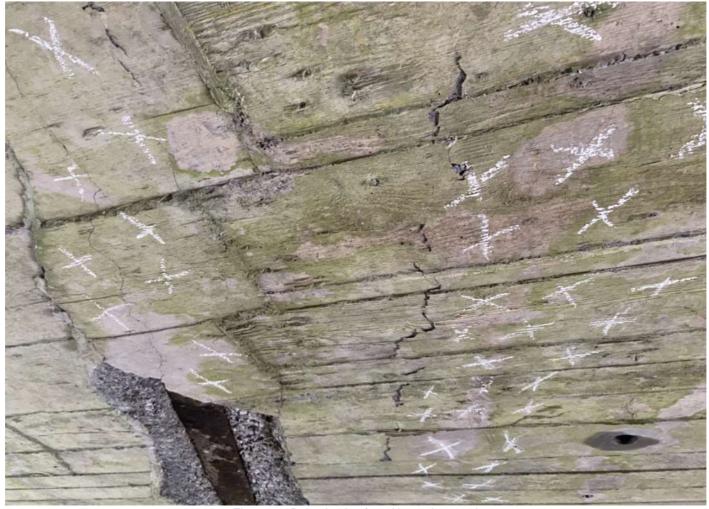
Figure 37: Delamination found in northern arch

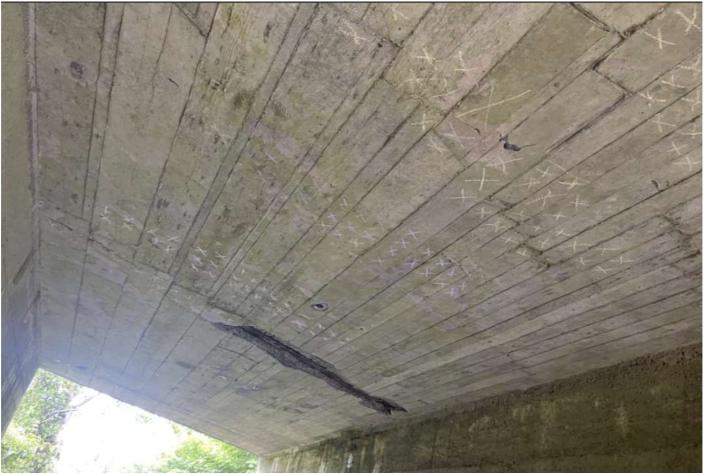
Figure 38: Delamination survey in Northern arch wide angle view

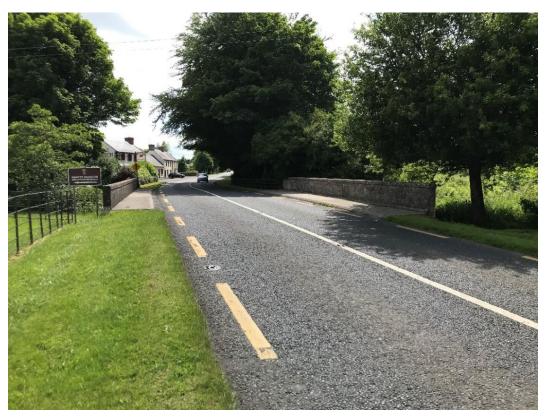
The bridge surface is in good condition apart cracking evident to the carriageway on the northwest approach. See Photograph H-1 to view the surface looking south and see Photograph H-2 to view the cracking to the northwest approach.

Figure H-1 - View of the carriageway looking south

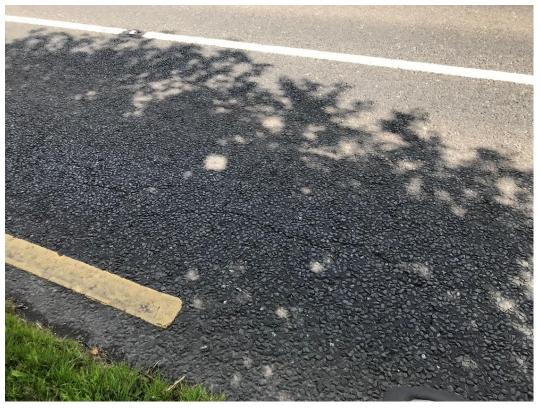
Figure H-2 - View of the cracking to the northwest corner of the carriageway

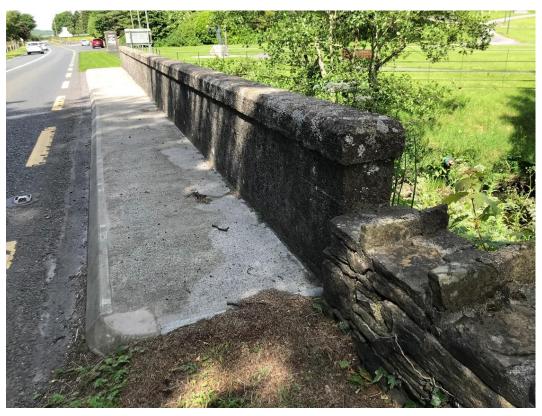
The footways are in good condition apart from vegetation debris. See Photograph H-3 for the east footway and see Photograph H-4 for the west footway.

Figure H-3 - View of the eastern footway

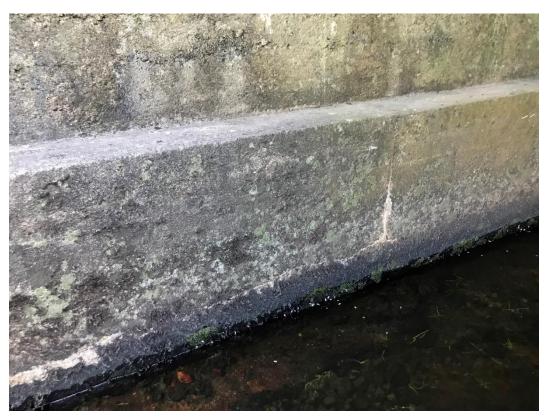
The pier is in good condition apart from algae and calcite staining evident. Minor honeycombing evident to the east side upstream of the pier. Cracking sealed with calcite is evident to the north face of the pier. See Photograph H-12 and H-13 for a view of the northeast and south faces. See Photograph H-14 to view the cracking to the north face of the pier sealed with calcite.

Figure H-14 – View of the cracking to the north face of the pier

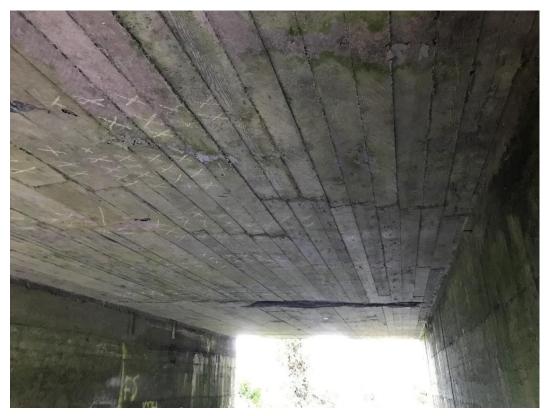
The deck is in poor condition with multiple areas of spalling noted with exposed filler beams evident. Extensive delamination is noted throughout both spans which is concentrated below each beam location, with water seepage and calcite staining evident. Refer to the defect plan in Appendix C.

Previously installed crack pips (2023 PI) are located on a 0.5mm wide longitudinal crack in the north span, approximately 5m from the west elevation and measured 25.56mm at the time of inspection. The widespread cracking is attributed to the low bond capacity between the concrete and steel girders found by the assessment, resulting in the cracking and delamination of the concrete at each girder bottom flange.

Figure H-15 – View of the north span deck slab

The deck slab is therefore recommended to be removed and a new deck installed across the structure, in either a single or two span structural arrangement.

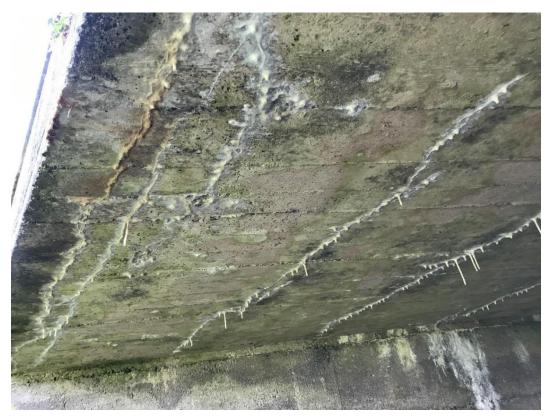
Figure H-17 - South span - Cracking sealed with calcite

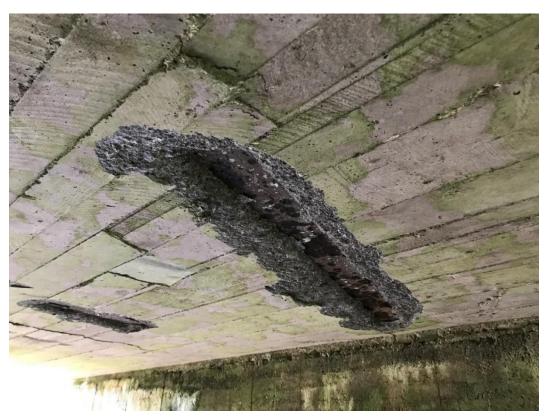
Based on the findings of the assessment the structure is determined to have a reduced load capacity due to bond failure between the concrete and steel beams with the significant delamination and spalling visible to the deck slab soffit providing evidence of the issue. As a result no further assessment measures are deemed required for the structure as they are not likely to increase the bond capacity to 40t loading due to the low compressive strength values found for the concrete in the soffit of the structure.

Figure H-18 - South span - spalling with exposed filler beam

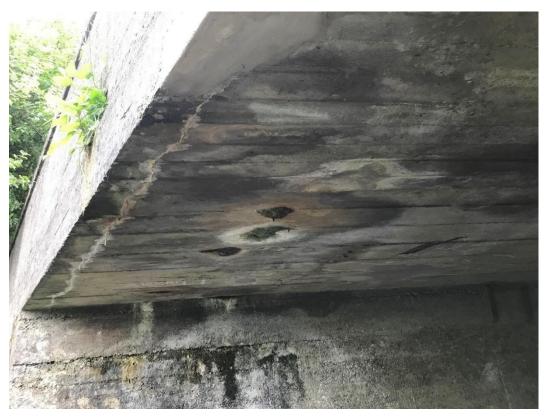
Figure H-19 - North span - cracking sealed with calcite, water staining and spalling

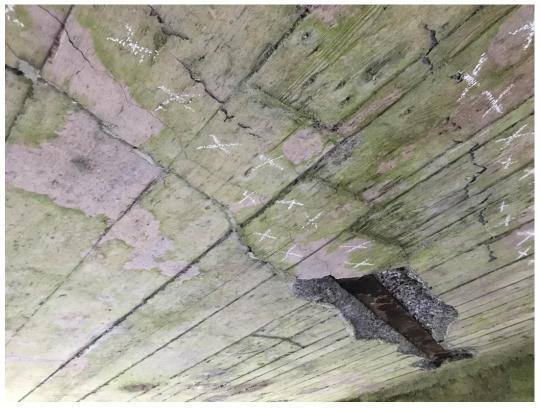
Figure H-20 - North span - exposed filler beam with delamination evident
