Structure Options Report

Mayo County Council

N58 STRADE RIVER BRIDGE REHABILITATION WORKS

Name and nature of the Structure(s) Strade River Bridge

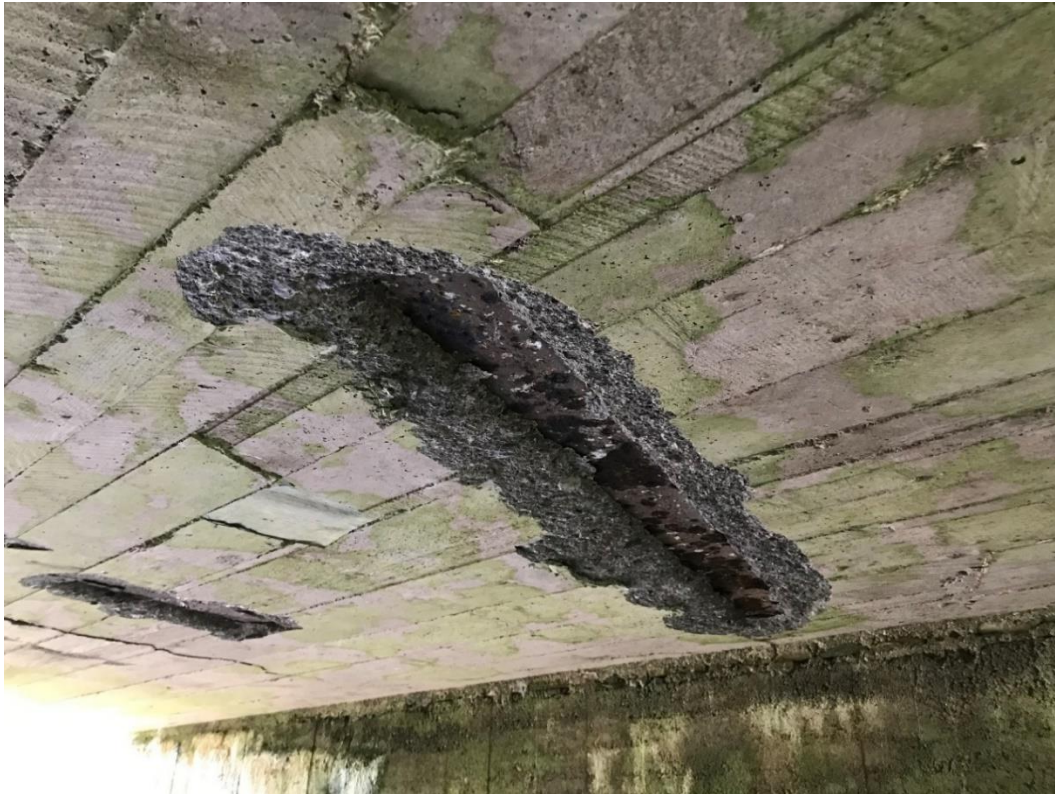
The Stage 2 Assessment report for Strade River Bridge determined the structure has a reduced load capacity of 7.5t due to bond failure between the concrete and steel beams with significant cracking, delamination and spalling visible to the deck slab soffit providing evidence of the issue, see Figure 3-1 and 3-2 overleaf.

Figure 3-1 - South span with spalling and exposed filler beams evident

Due to the extensive defects to the soffit of the structure and the use of railway girders as primary structural members which have debonded from the concrete, the strengthening of the structure is not recommended. A deck replacement is recommended with the existing deck slab removed and a new deck installed across the structure, in a single span arrangement. This option would partially retain the existing abutments and has sustainability and environmental advantages over the full structure replacement option. The alteration of the existing abutments would remove the deck loading from the abutments with the existing abutments considered to have adequate capacity and durability to retain a reduced height of fill material.

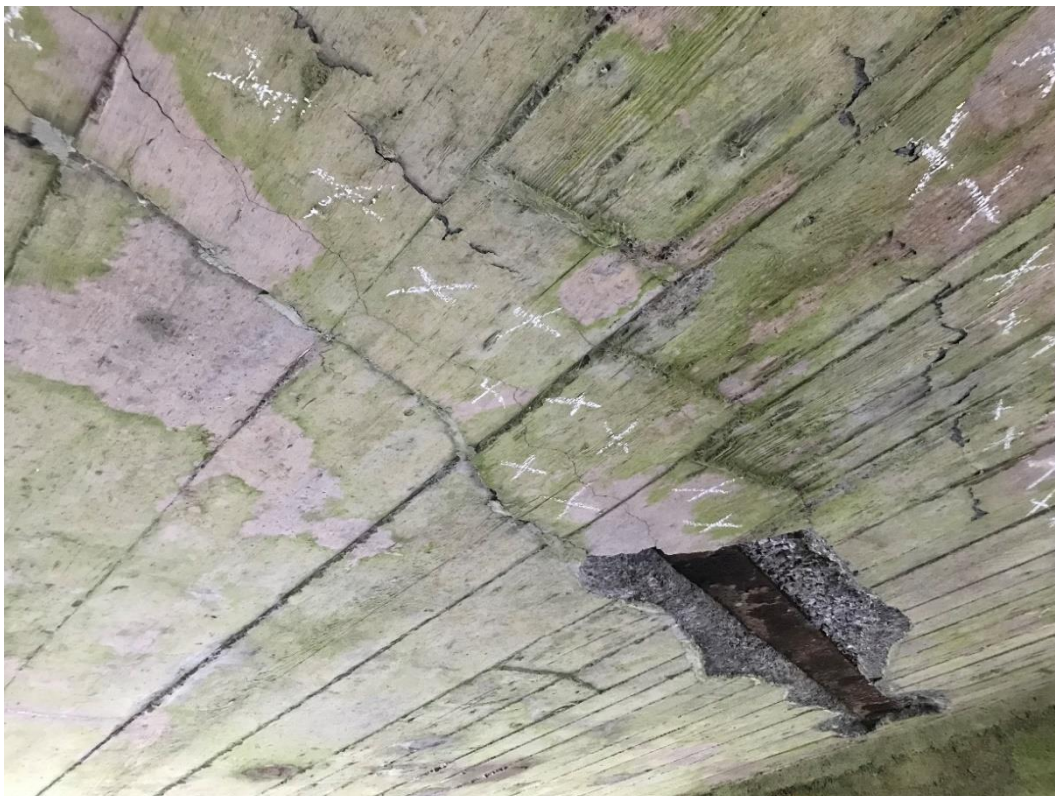
Figure 3-2 - North span with spalling, delamination and exposed filler beams evident

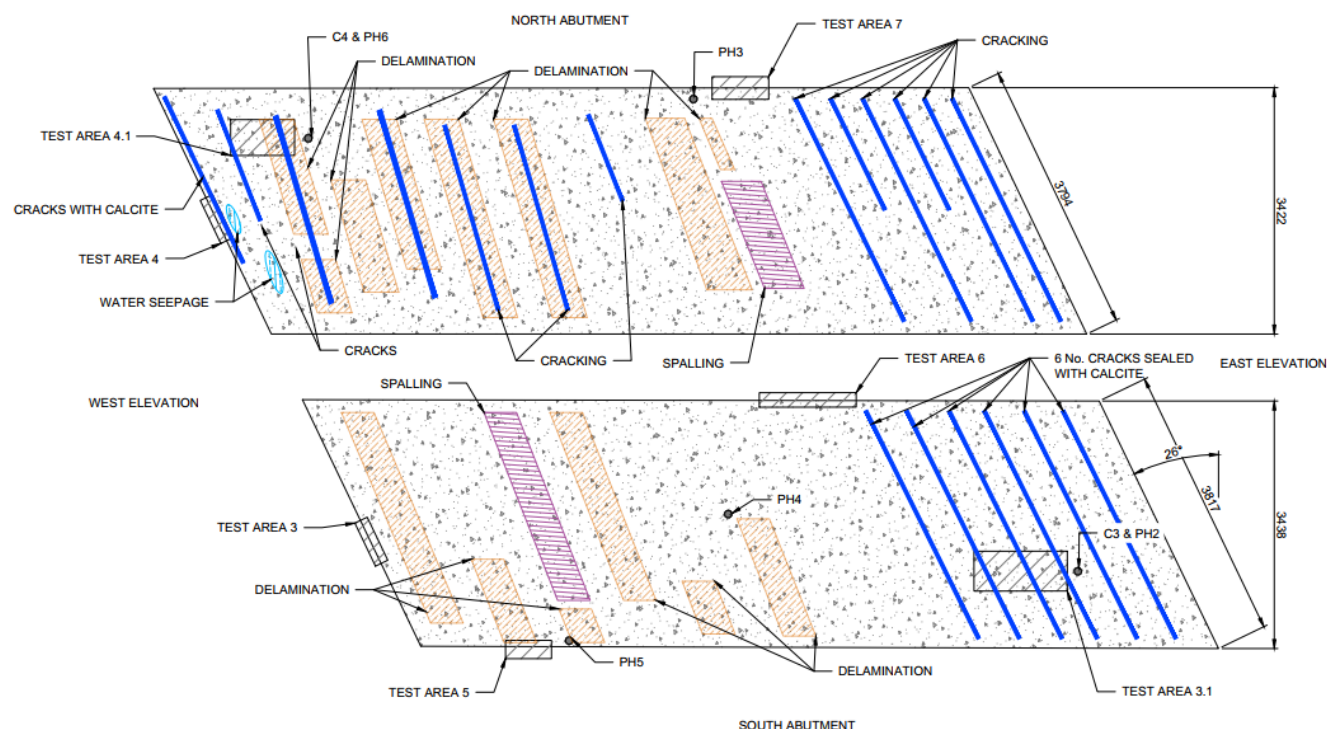
Figure 3-4 – Defect Plan & Test Area Locations

The visual inspection of the structure found the deck to be in poor overall condition with extensive cracking, delamination and spalling evident. The abutments and piers were in good overall condition.

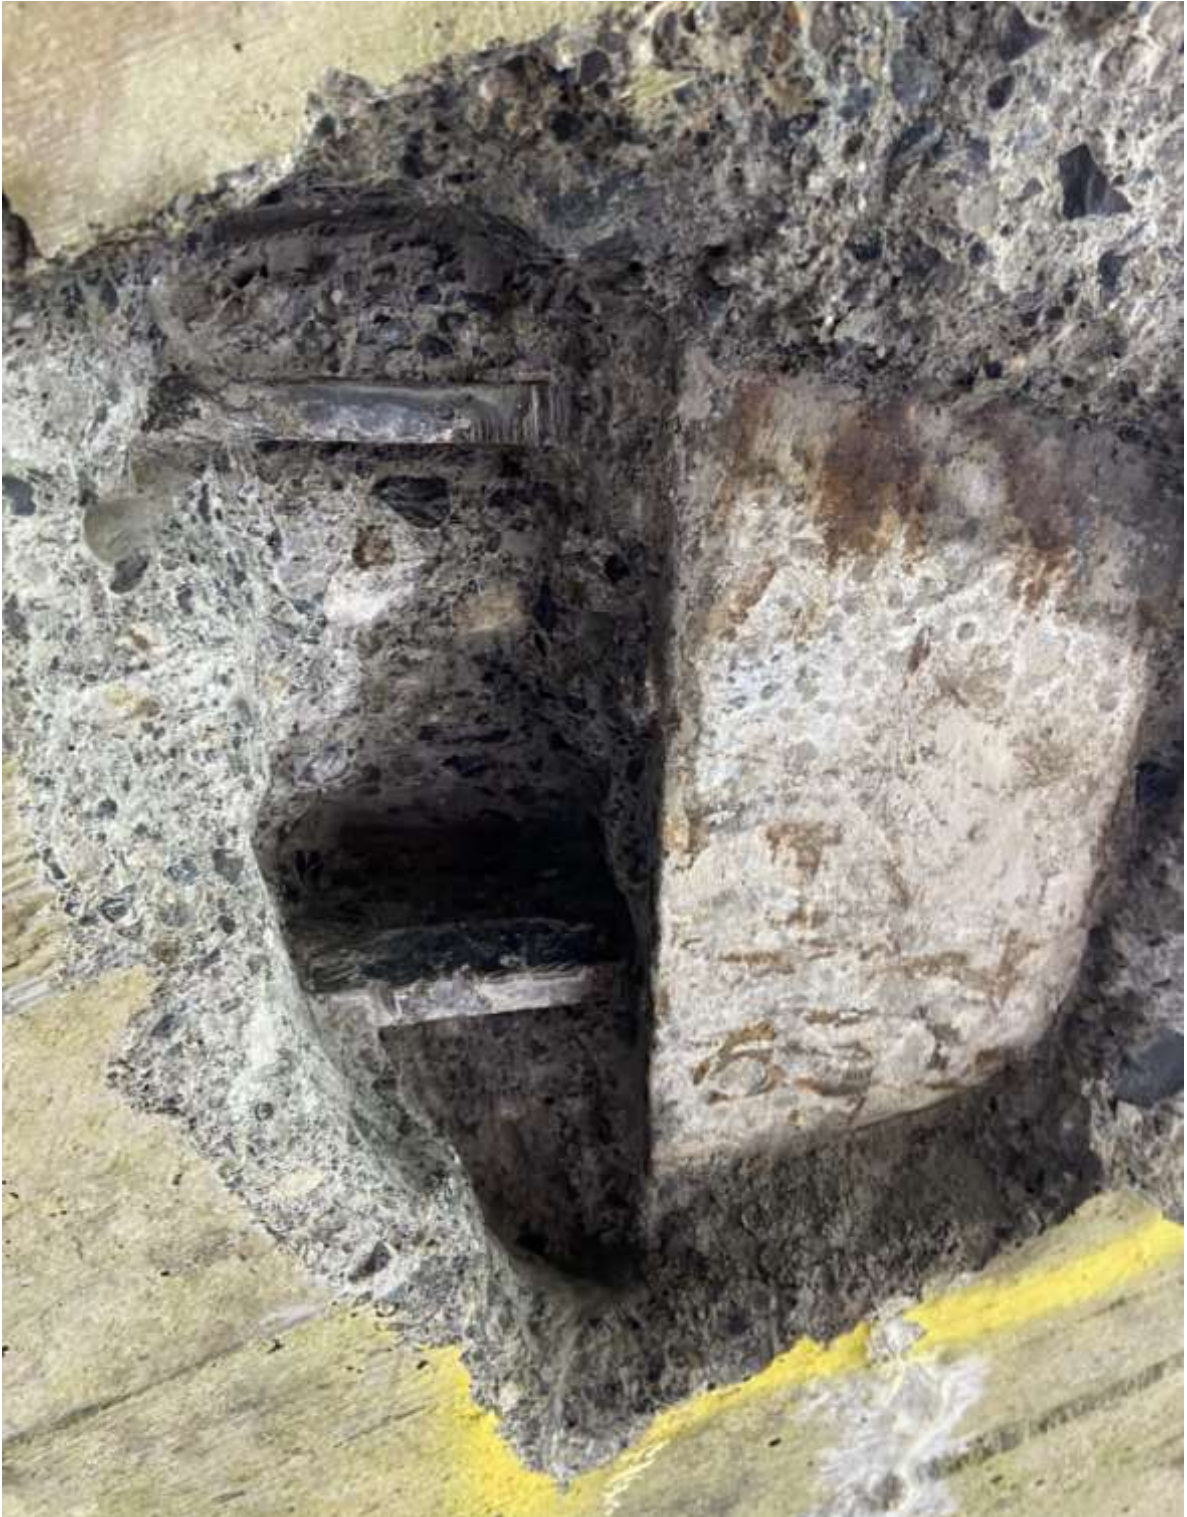
Figure 27: Longitudinal cover was 39mm, Transverse cover was 54mm

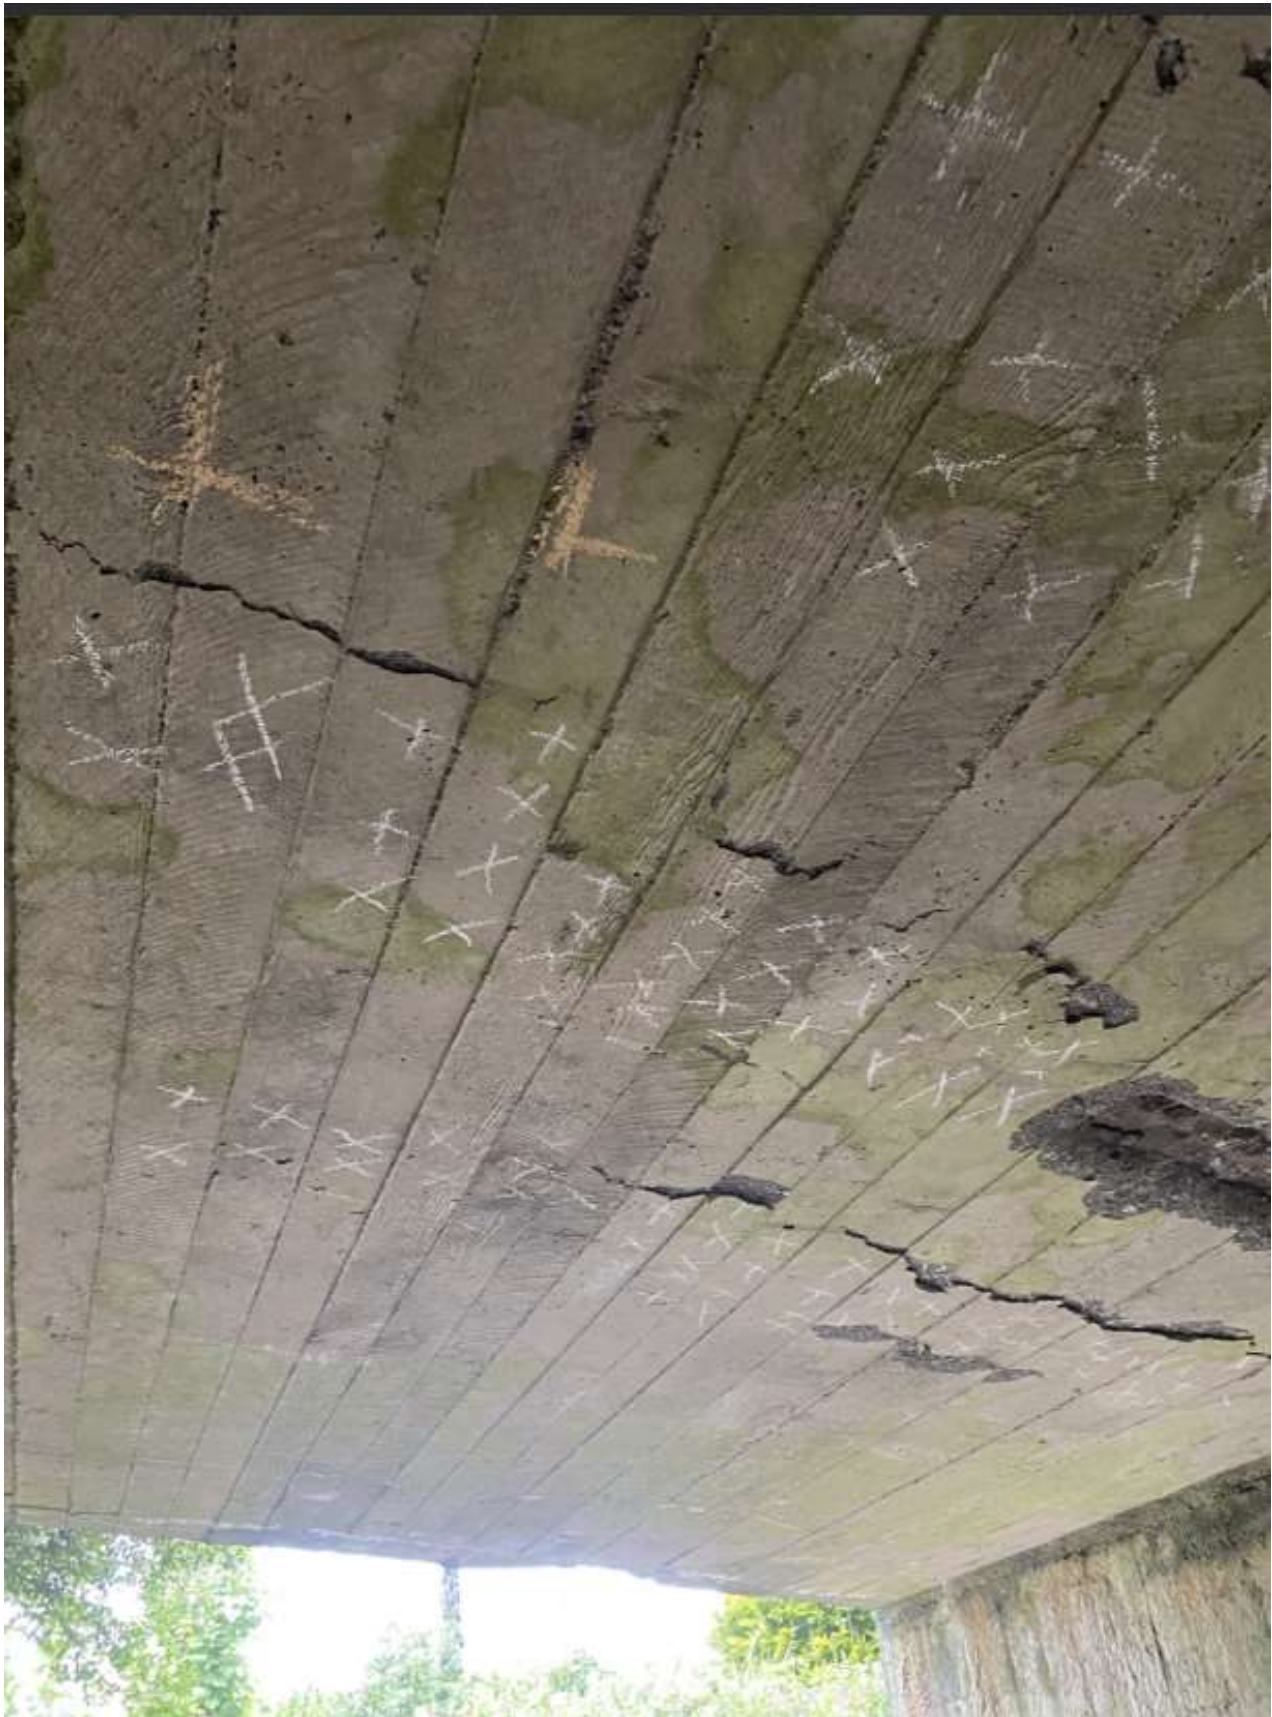
Figure 28: Delamination survey showed significant delamination underneath longitudinal sections on south arch

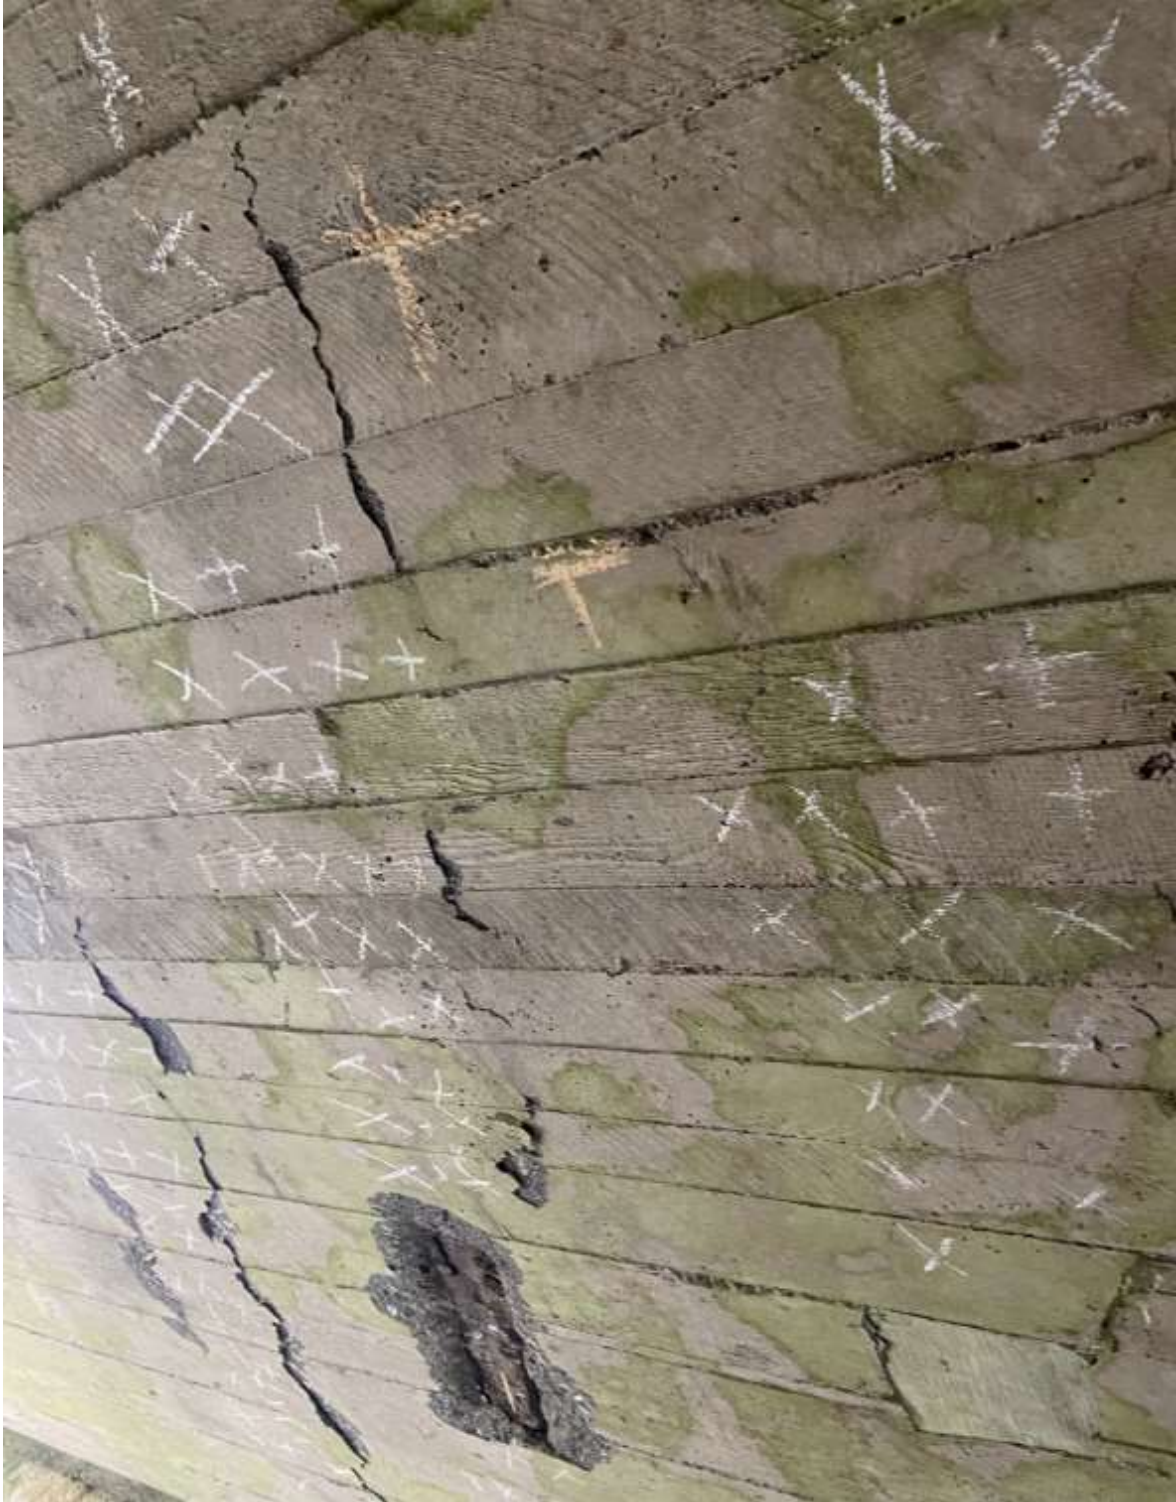
Figure 29: Further delamination on south arch

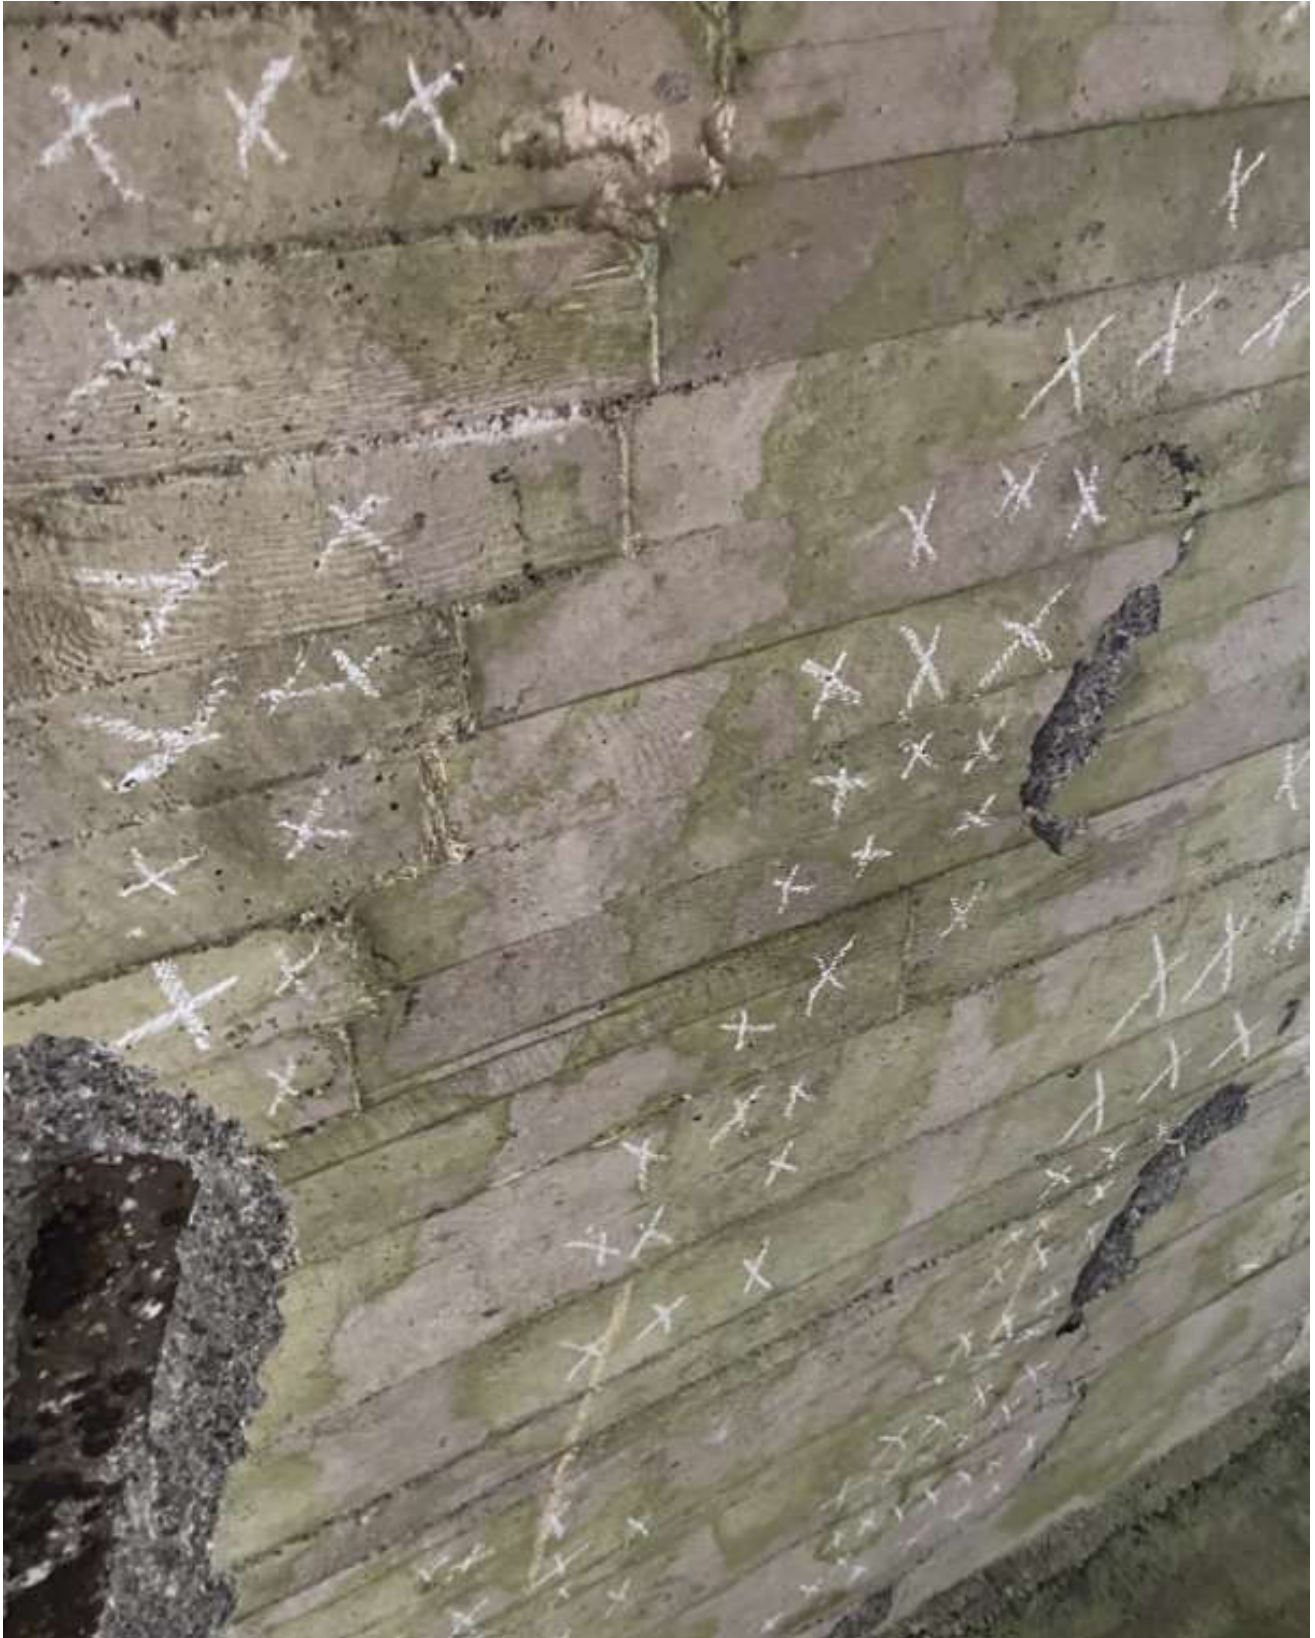
Figure 30: Exposed beams due to delamination of concrete cover

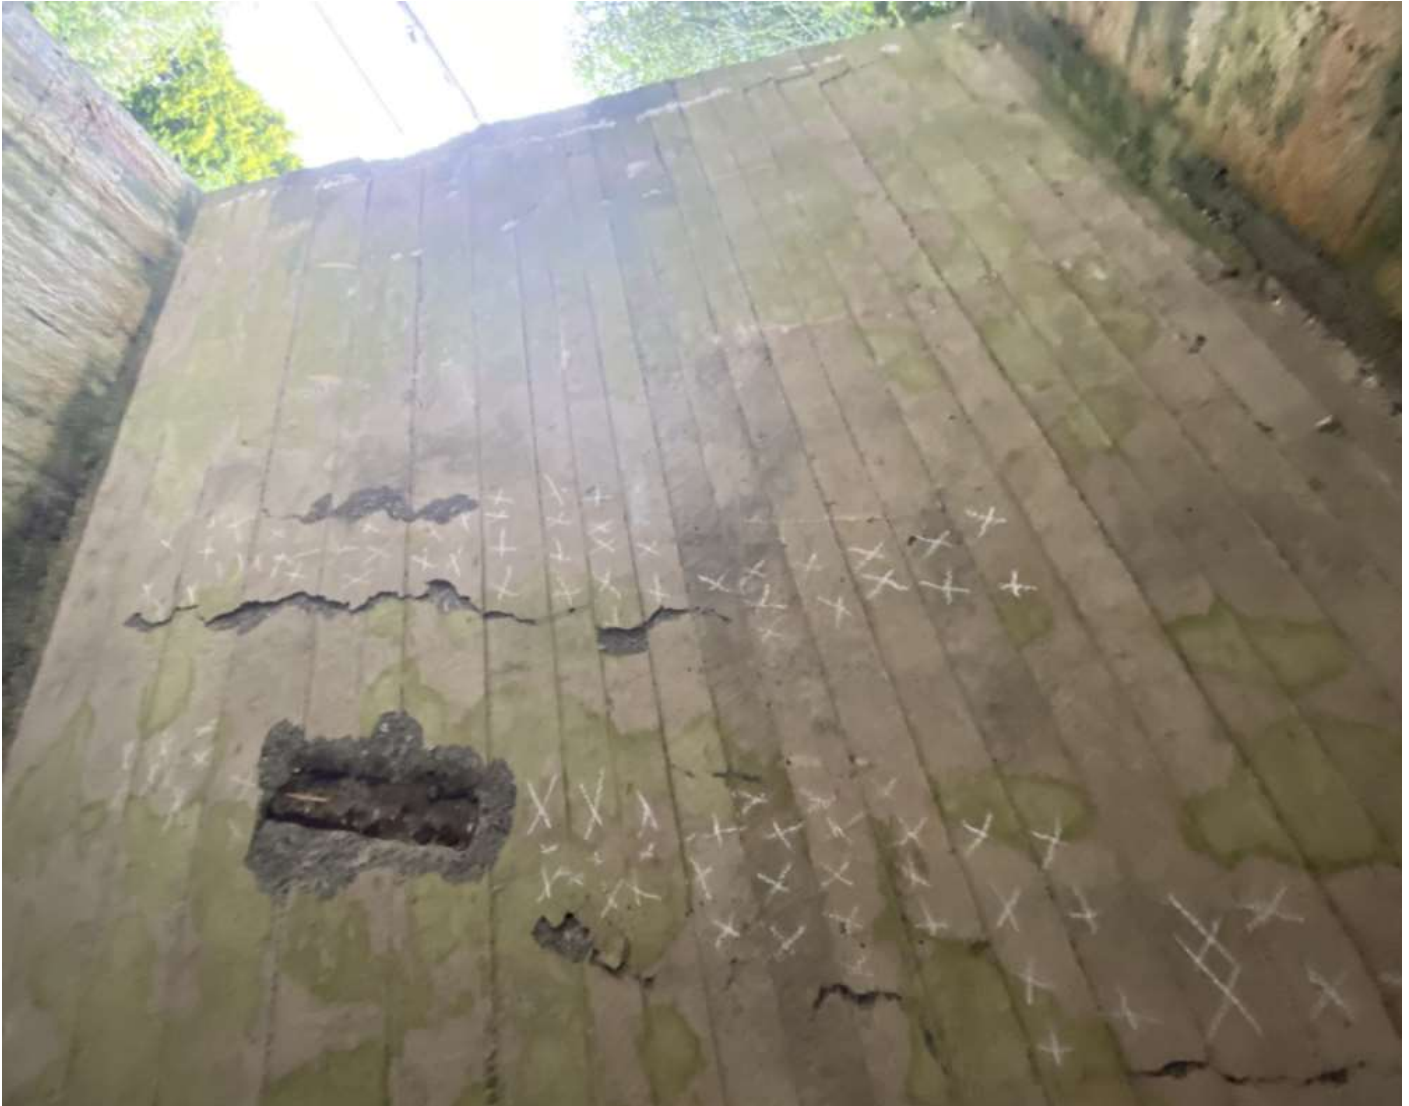
Figure 31: Delamination denoted by white x chalk marks

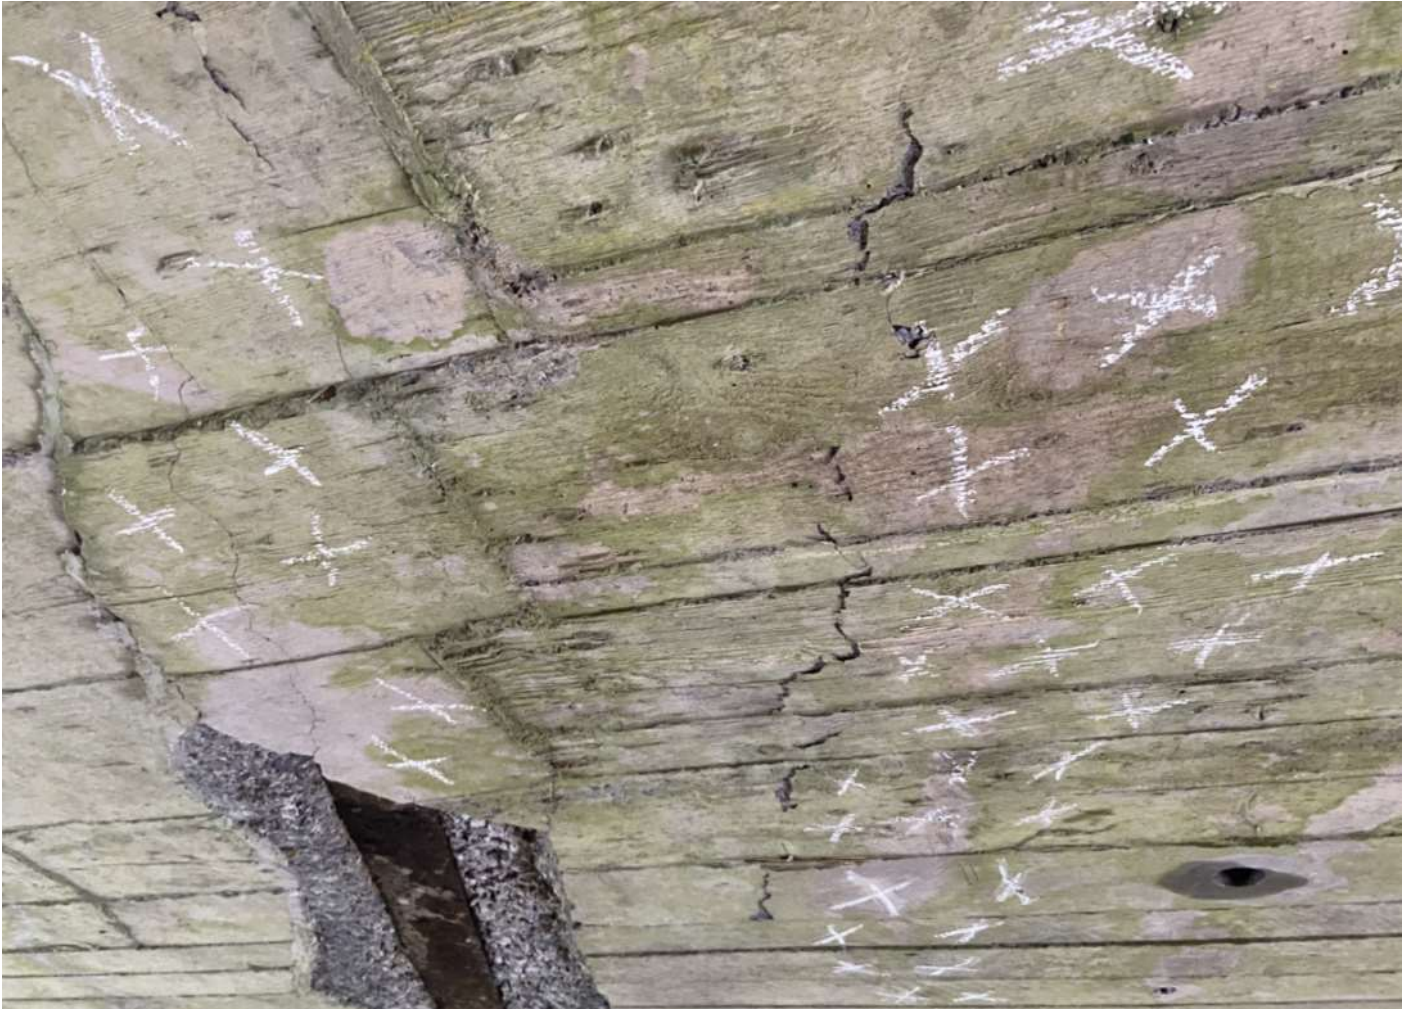
Figure 37: Delamination found in northern arch

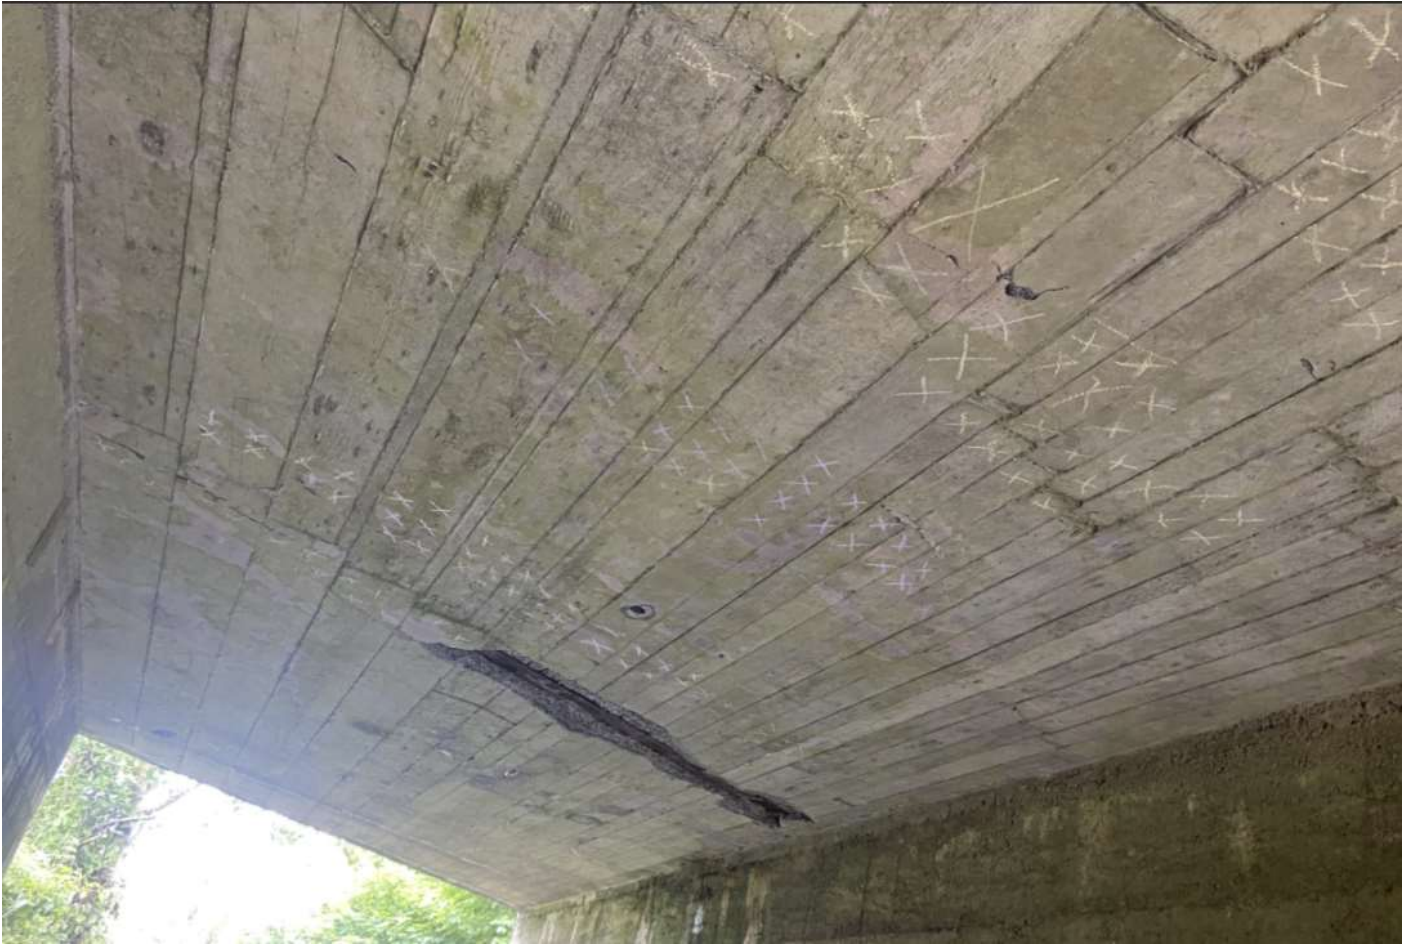
Figure 38: Delamination survey in Northern arch wide angle view

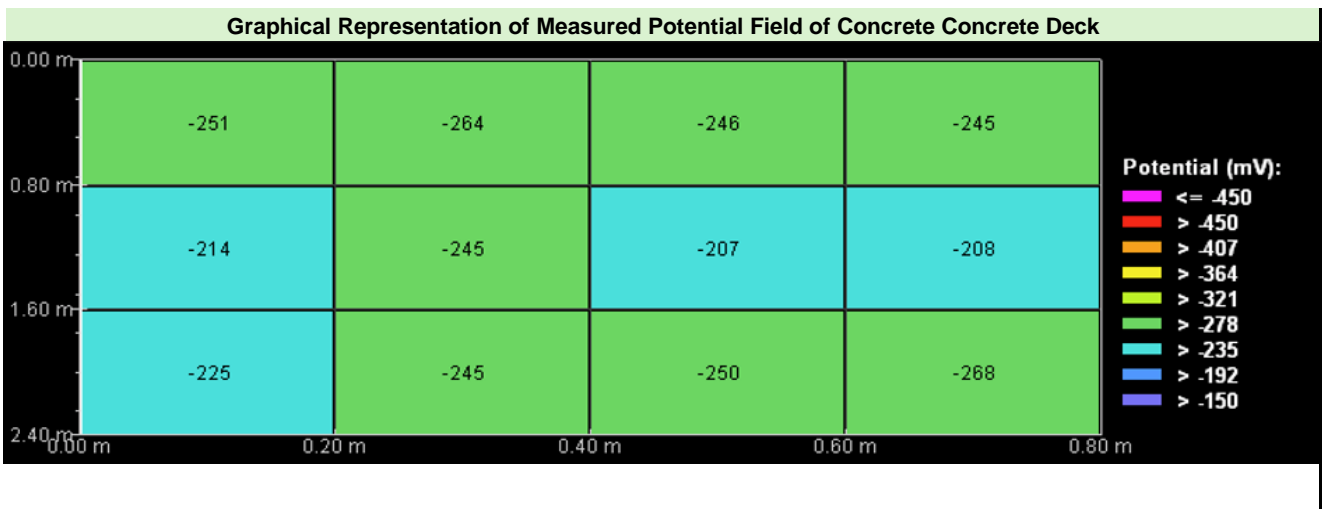
Project: Mayo Bridges - Strade River Bridge
Location Reference: Area 1 C1 Deck
Test Standard: ASTM C876

Test No.	1
No. of Readings	12
Median (mV)	-245
Mean (mV)	-239
Standard Deviation	19.8
Lowest (mV)	-268
Highest (mV)	-207
Reinforcement Condition	Intermediate Risk of Corrosion

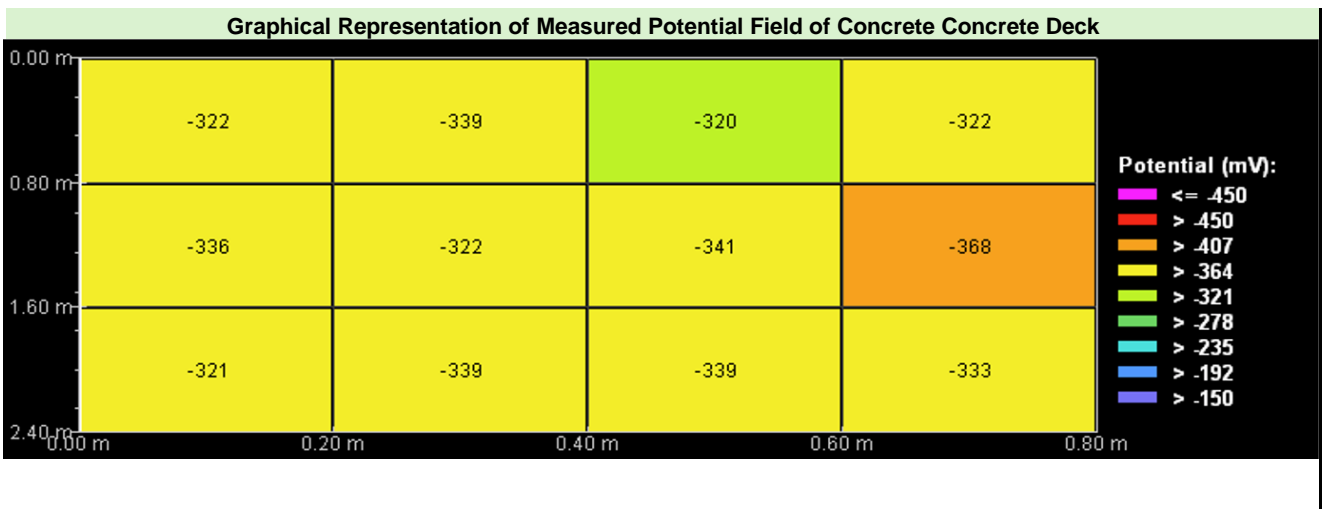
Project: Mayo Bridges - Strade River Bridge
Location Reference: Area 3.1 Soffit
Test Standard: ASTM C876

Test No.	3
No. of Readings	12
Median (mV)	-335
Mean (mV)	-333.5
Standard Deviation	13.2
Lowest (mV)	-368
Highest (mV)	-320
Reinforcement Condition	Intermediate Risk of Corrosion

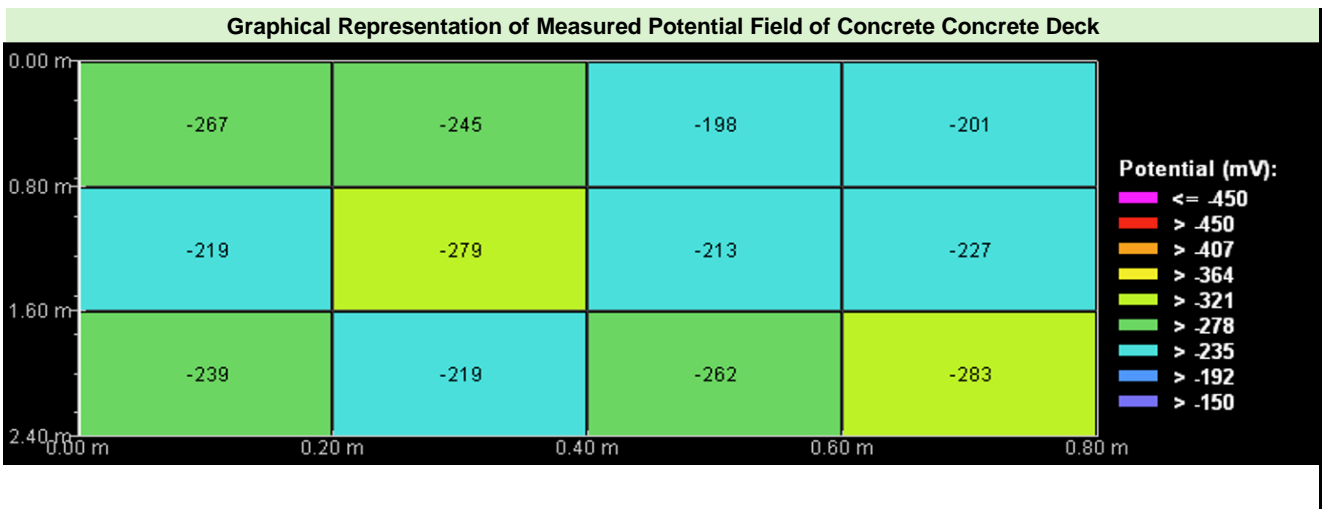
Project: Mayo Bridges - Strade River Bridge
Location Reference: Area 4 Face Deck
Test Standard: ASTM C876

Test No.	4
No. of Readings	12
Median (mV)	-233
Mean (mV)	-237.7
Standard Deviation	28.3
Lowest (mV)	-283
Highest (mV)	-198
Reinforcement Condition	Intermediate Risk of Corrosion
