**ARCHITECTURAL HERITAGE IMPACT ASSESSMENT**  
**PROPOSED STRUCTURAL ENHANCEMENT OF**  
**MARKIEVICZ BRIDGE / 'NEW BRIDGE', SLIGO**

September 2024

**MOLLOY & ASSOCIATES**  
CONSERVATION ARCHITECTS

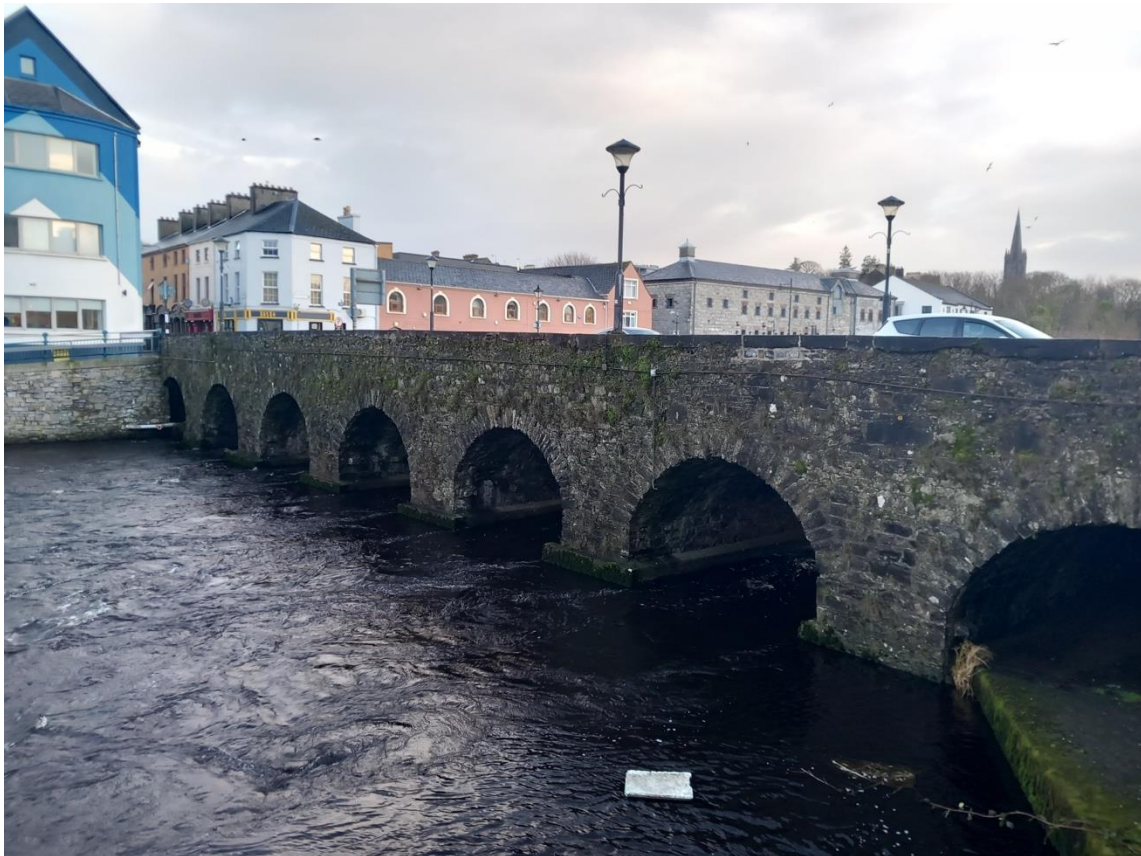
The scour damage identified at the base of the masonry piers leaves the bridge vulnerable to increased damaging scour in the future and if not addressed, will lead to loss of the historic fabric and ultimately threaten the stability of the bridge.

*Figure 13 – Western elevation of Markievicz Bridge. The southernmost arch have been partially infilled, and the concrete base is exposed at low tide*

The present concrete skirts at the base of each of the piers were added during the 20<sup>th</sup> century to address scour damage. These concrete footings have weathered over time and now require replacement to prevent erosion of the 17<sup>th</sup> century fabric. It is proposed to carefully remove the existing concrete footings and to subsequently reinstate new concrete footings thus safeguarding the earlier fabric.

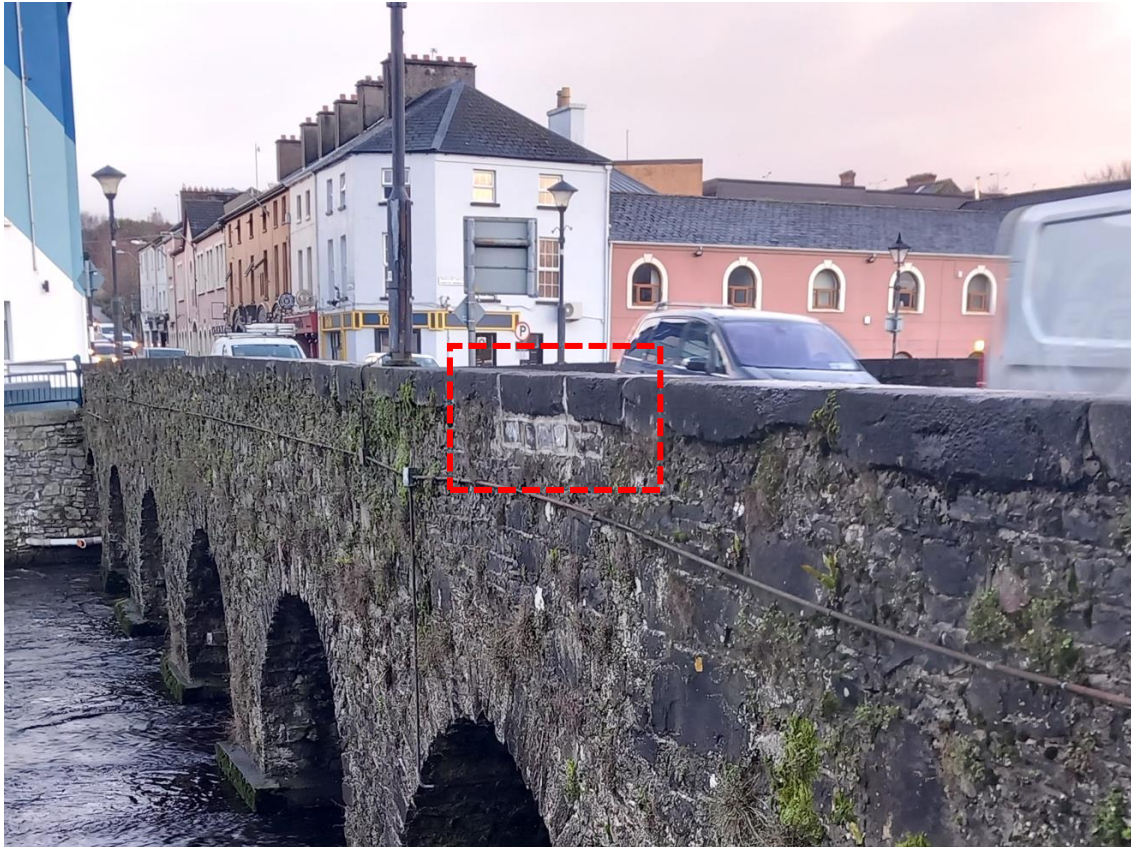
Patch repointing has been previously undertaken using cementitious mortars which visually disfigure the appearance of the bridge and likely to result in damage to the adjacent limestone.

*Figure 14 –Inappropriate mortar and repointing style, as evidenced in the highlighted area can injure the appearance of the bridge and where cementitious mortars are used, they can cause physical damage to the adjacent limestone*

Inappropriate pointing has been previously undertaken which has had a visually disfiguring impact on the structure. It is recommended that detailed historic mortar analysis should be undertaken in advance of repairs to inform reconstruction. Repointing will be carried out using lime mortar informed by this analysis matching existing constructional techniques. New work will have continuity with the original structure and maintain the original pointing style and maintain the integrity of the original structure. At the discretion of the supervising conservation consultant, the contractor may be required to prepare repointing samples for approval.

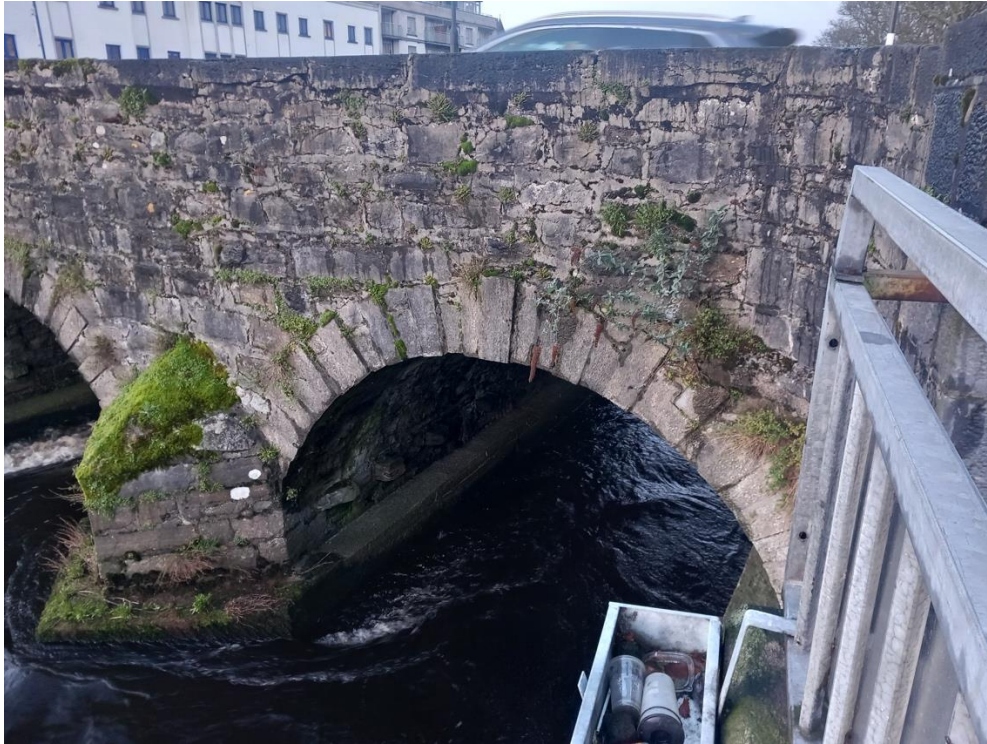
*Plate 3 – Detail of dressed limestone voussoirs with keystone. Vegetation is apparent on the spandrel walls and cutwaters*

Any biological growth embedded within walls will be removed, and the joints raked out to a sufficient depth to remove developed root systems. Where aggressive roots are found, they will be removed insofar as possible and breaches infilled to discourage regrowth.

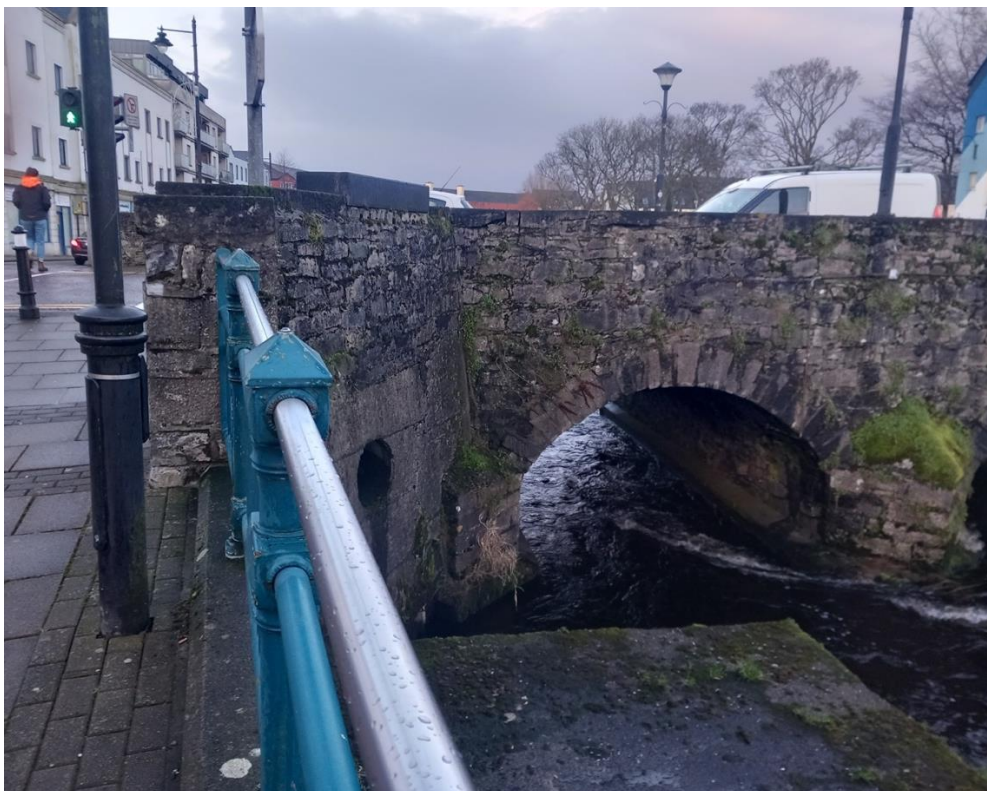
*Plate 4 –The southernmost arch has been partially infilled and the parapet walls modified adjacent the southern bank*

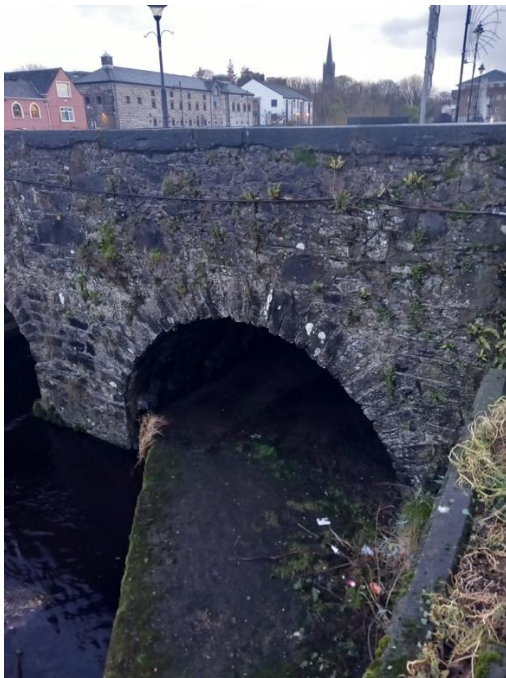
*Plate 6 –Downstream view of the partially infilled southern arch*

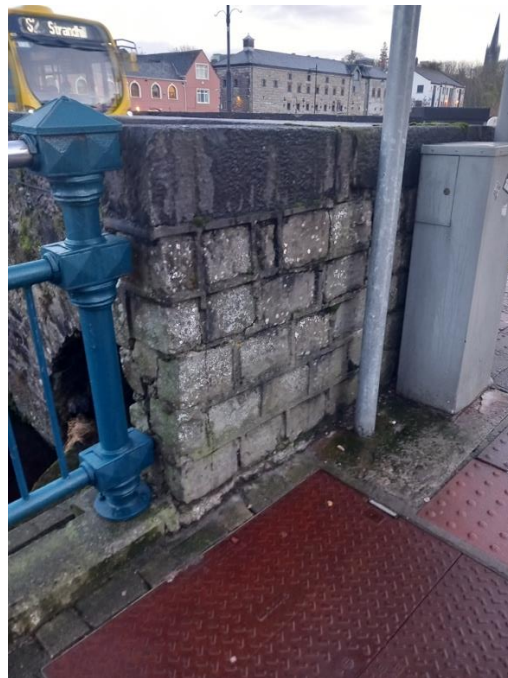
*Plate 7 –The modified wing walls (southern side) are comprised of coursed limestone blocks, with heavy strap pointing*

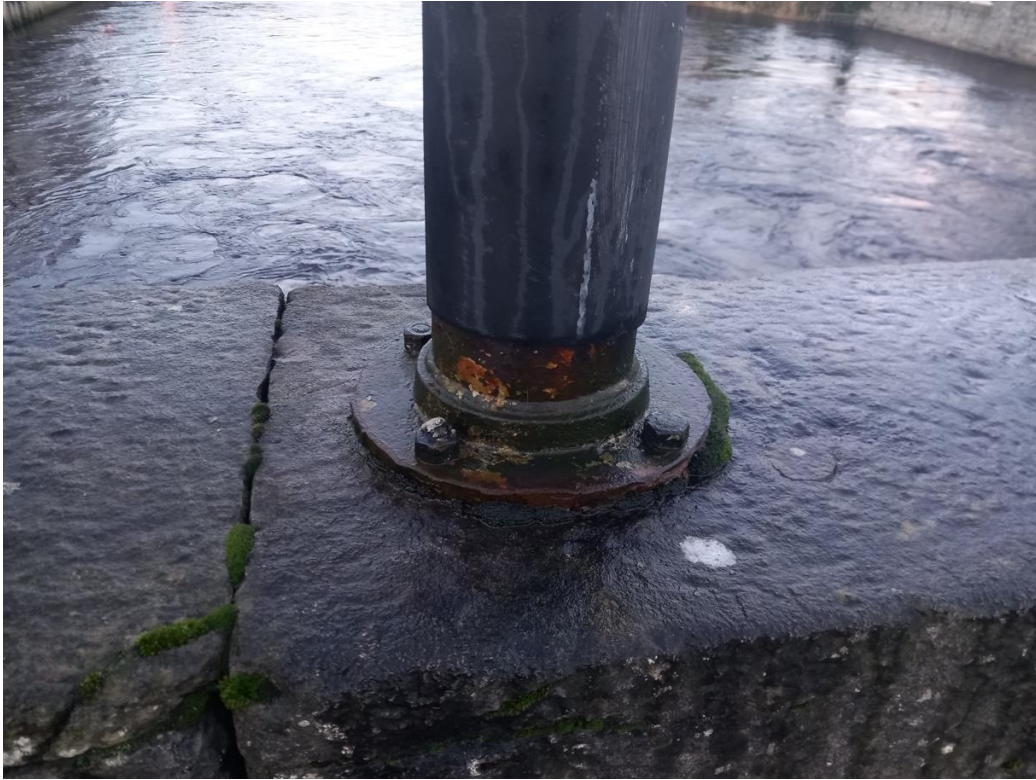
A pair of lamp standards are bolted to the top of the parapet cappings at either end of the bridge. Being 20<sup>th</sup> century fixtures they are not of architectural heritage significance.

*Plate 8 –Detail of base of lamp standards bolt fixed to limestone parapet walls*
