# Stage 2 Structural Assessment Report

Mayo County Council

# N5 KNOCKAVRONY BRIDGE REHABILITATION WORKS

Document title: MO-N05-013.00 Knockavrony Bridge Stage 2 Assessment

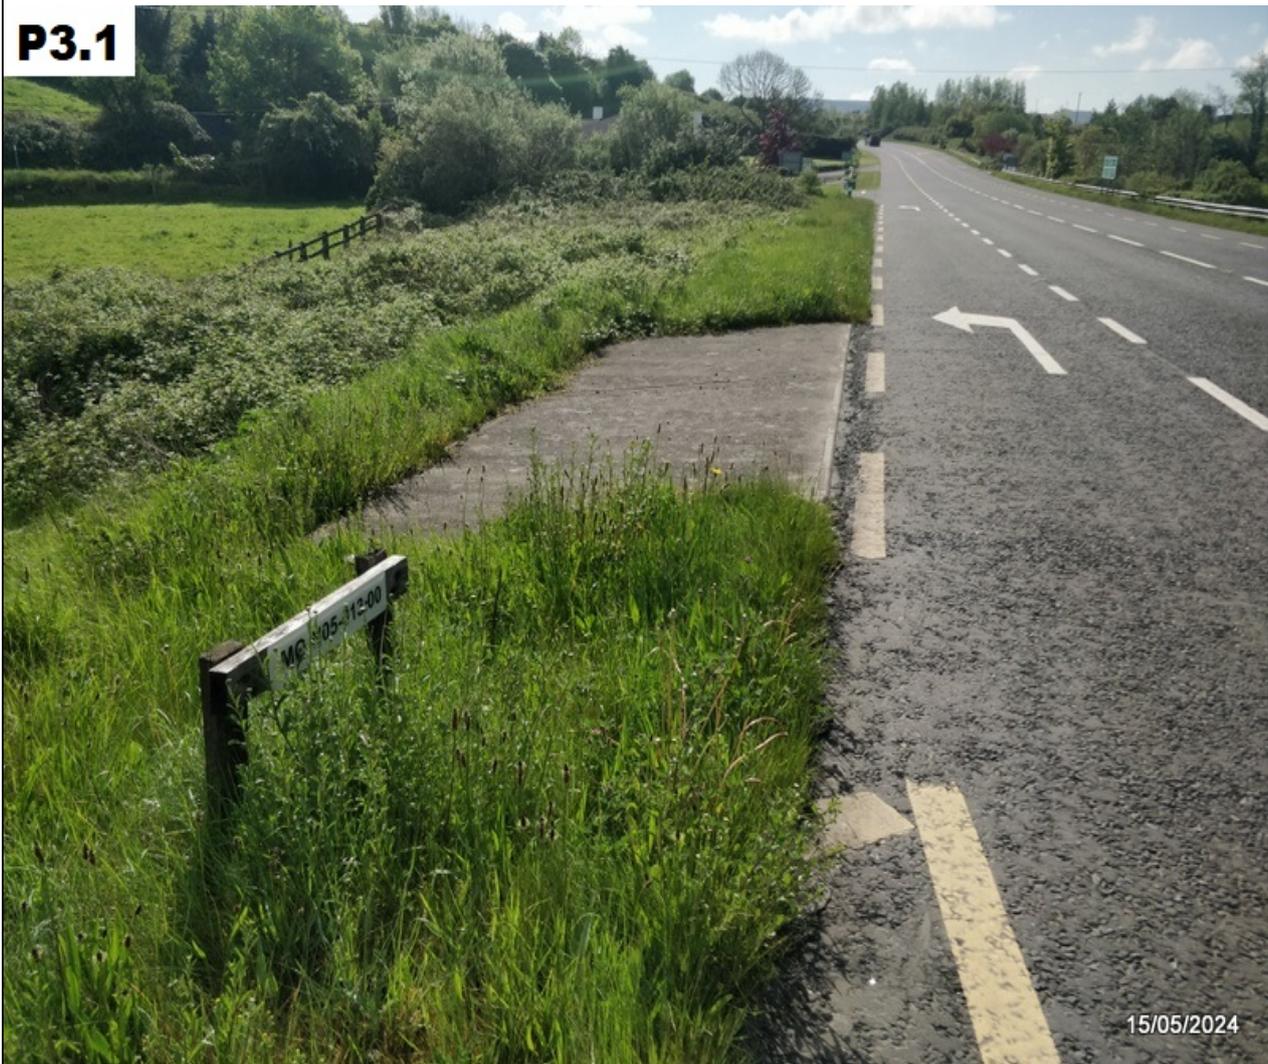
**P3.1**

Both rubbing strips are in good condition, see P3.1 for a view of the north rubbing strip looking east. There is vegetation growth at the base of the south rubbing strip which should be removed during RM, see P3.2.

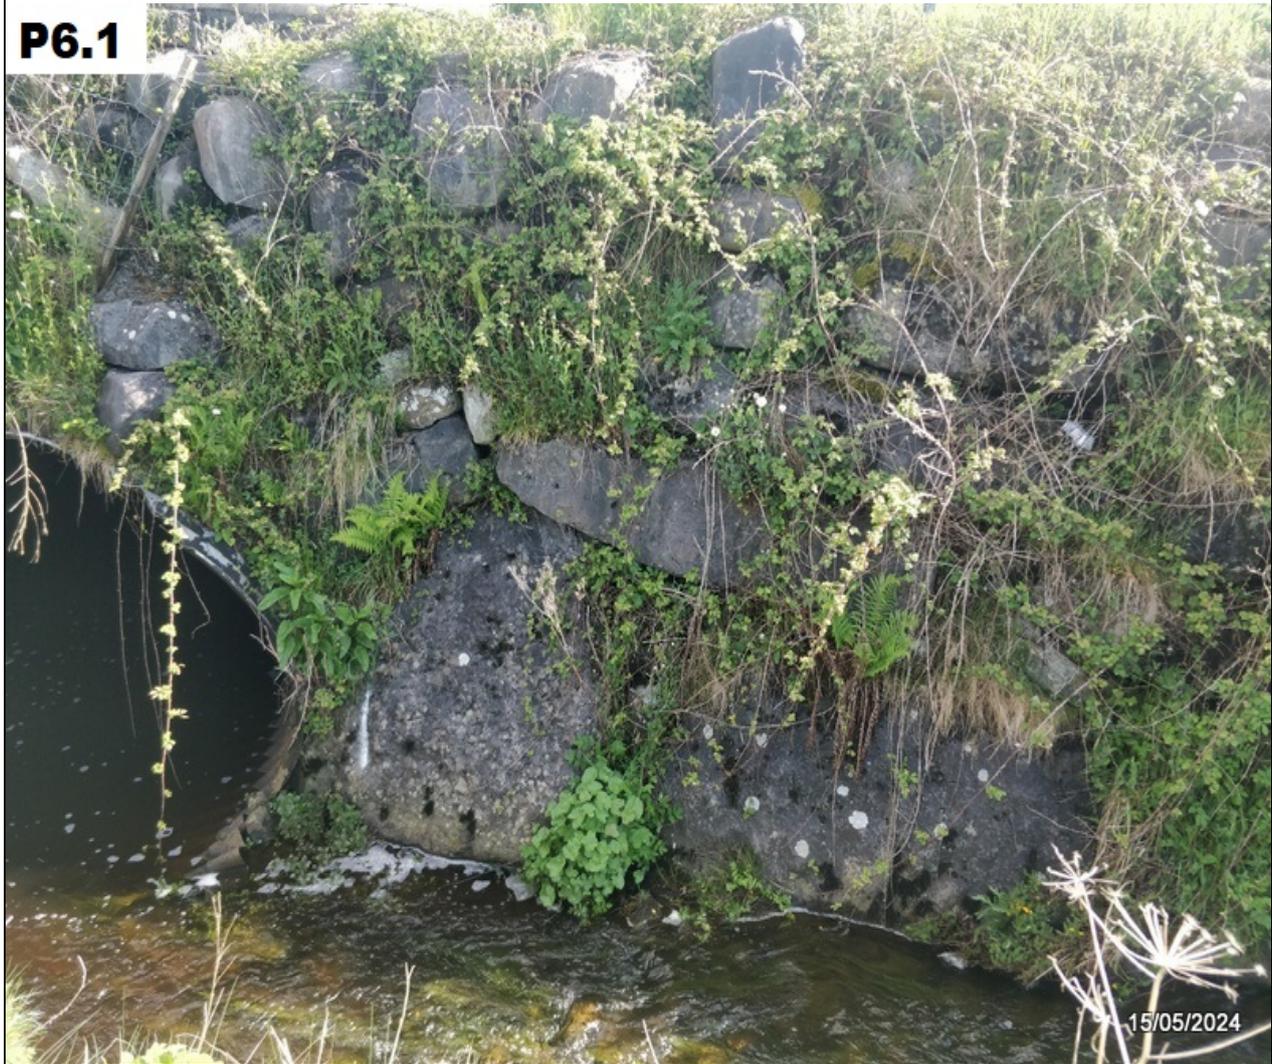
**P6.1**

Component No.	6	Wing/Spandrel/Retaining Walls
All wing walls are in good condition apart from vegetation growth which should be removed during RM. See P6.1 for a view of the southeast wing wall. There is a crack and undermining of 400mm at the southwest wing wall that should be repaired during RM, see P6.2 and P6.3 respectively.		
Condition/Mainten.	2	/ Y

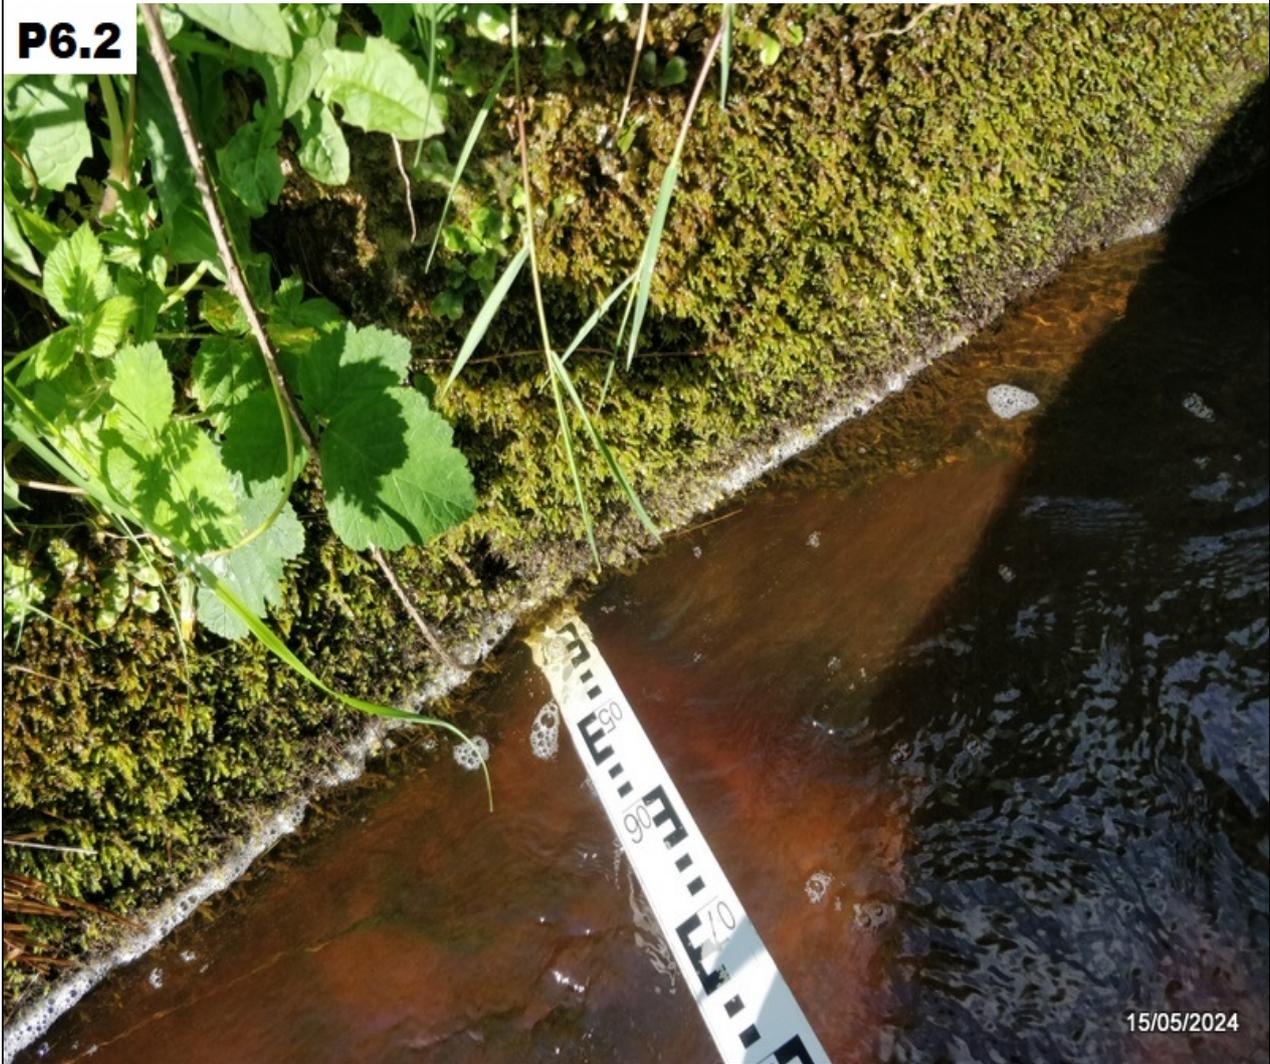
**P6.2**

Component No.	6	Wing/Spandrel/Retaining Walls
All wing walls are in good condition apart from vegetation growth which should be removed during RM. See P6.1 for a view of the southeast wing wall. There is a crack and undermining of 400mm at the southwest wing wall that should be repaired during RM, see P6.2 and P6.3 respectively.		
Condition/Mainten.	2	/ Y

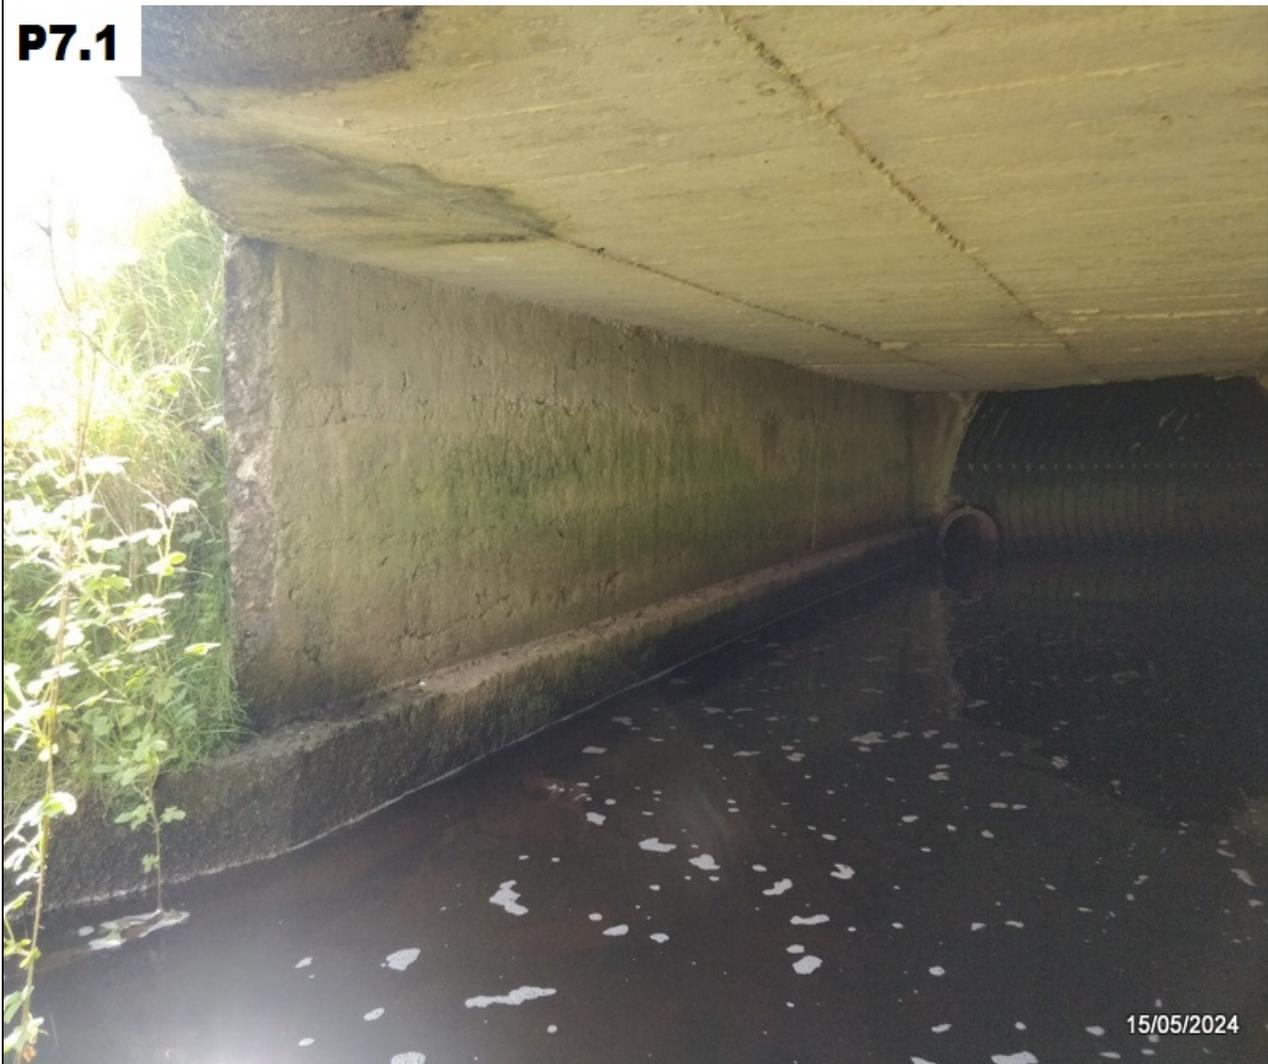
**P7.1**

Component No.	7	Abutments
Both concrete abutments are in good condition apart from minor honeycombing and algae stationing which requires no action. See P7.1 and P7.2 for views of the east and west abutments looking south.		
Condition/Mainten.	0	/ N

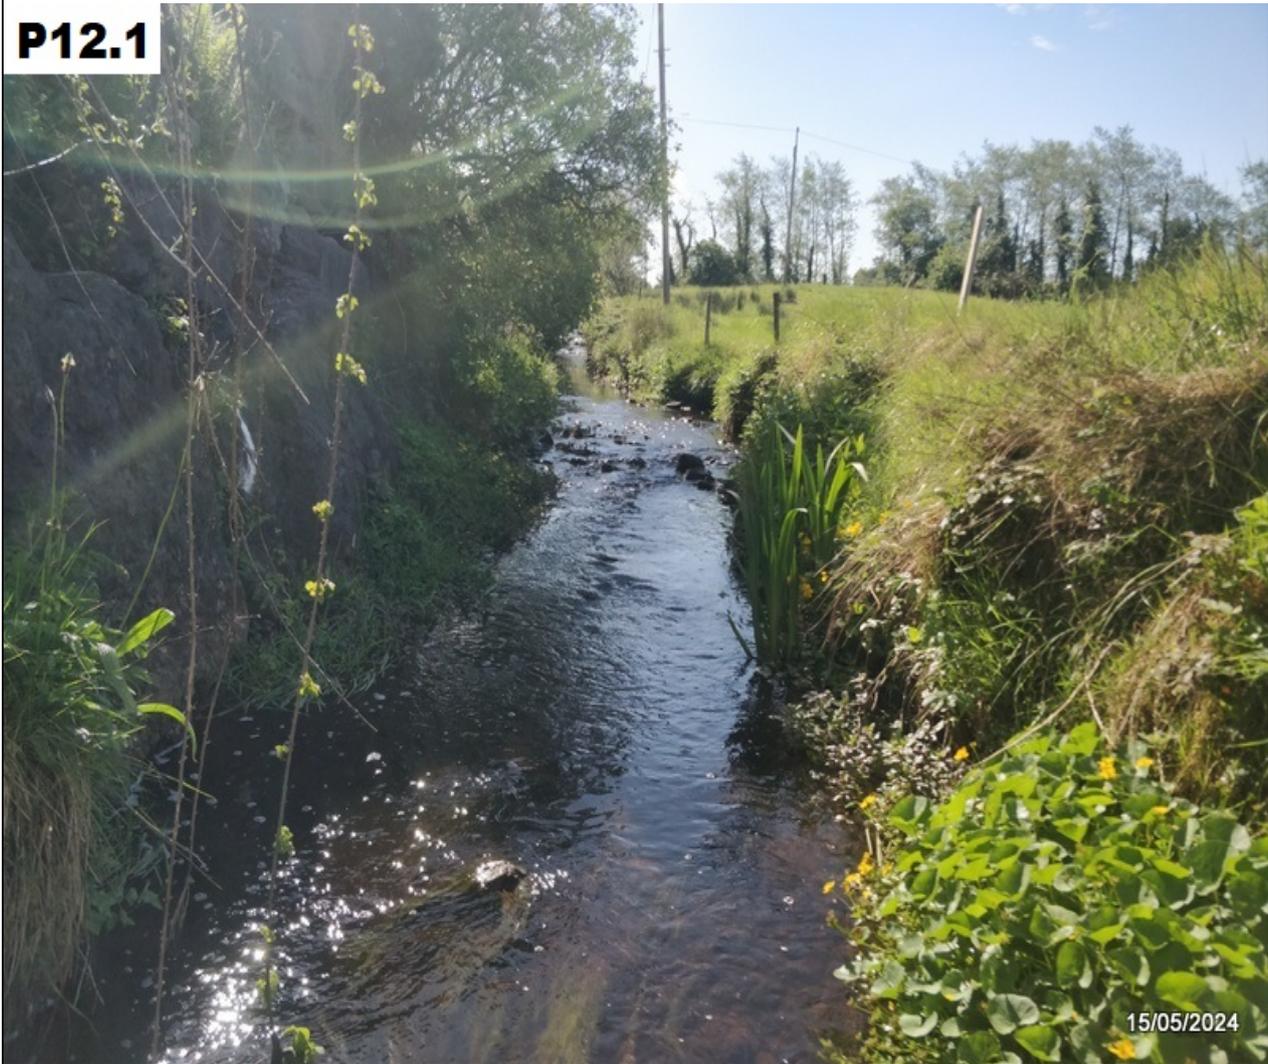
**P12.1**

Component No.	12	Riverbed
The riverbed is in good condition. See P12.1 and P12.2 for views of the upstream(south) and downstream(north) respectively. There is minor honeycombing to the scour protection in the northwest abutment which requires no action, see P7.2.		
Condition/Mainten.	1	/ N

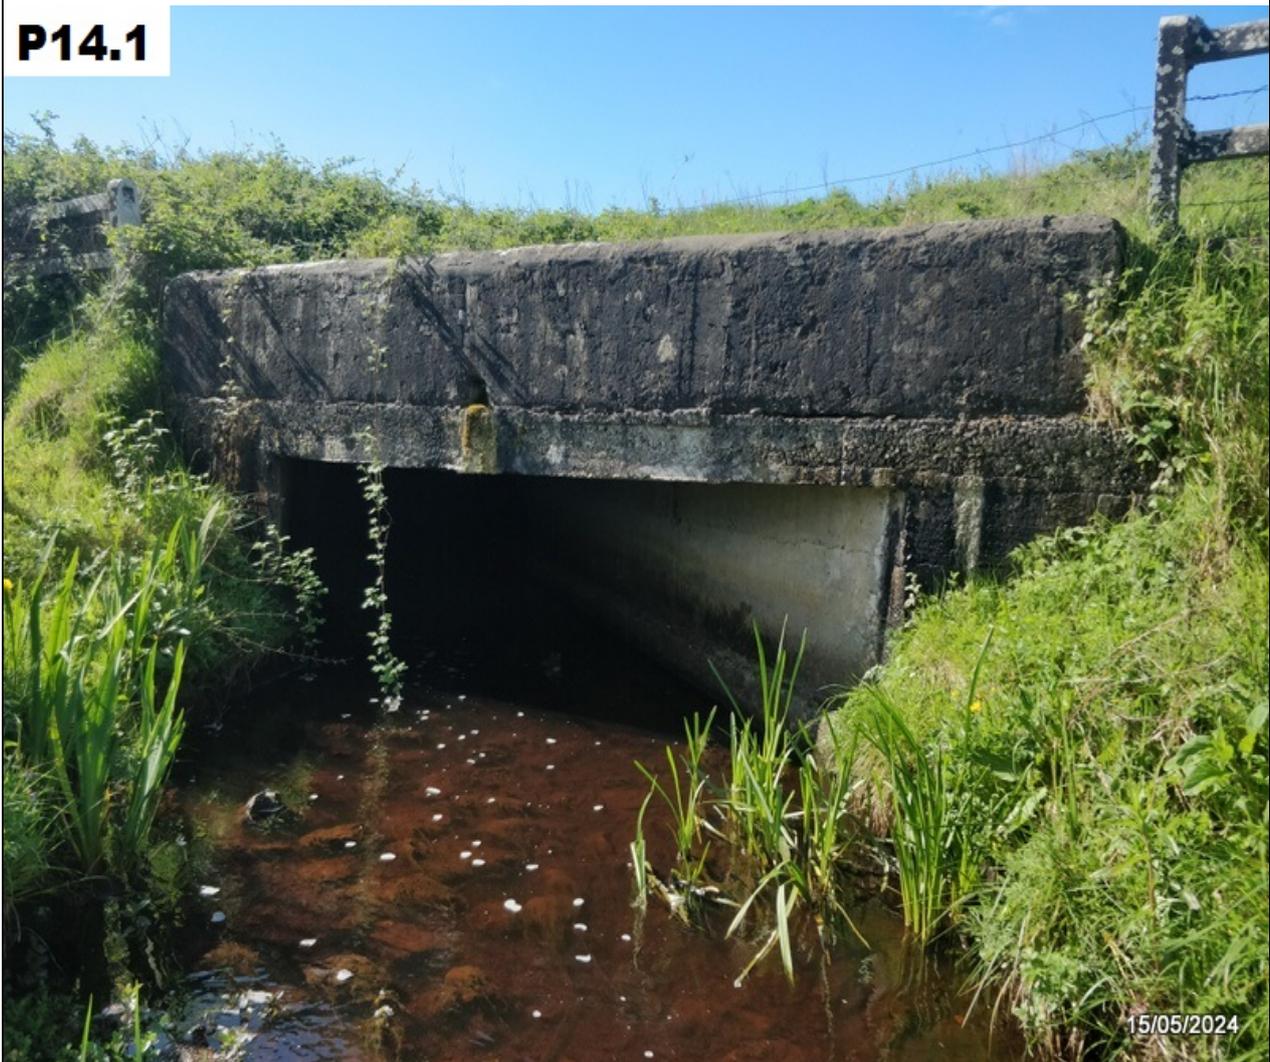
**P14.1**

Component No.	14	Structure in general
<p>The structure is in good condition overall. Minor routine maintenance is required. See P14.1 and P14.2 for views of the north and south elevations of the structure respectively.</p> <p>The inspection of the structure has been undertaken in accordance with the requirements of TII AM-STR-06039 (BD 79) outside of the normal PI schedule due to the 2005 Stage 1 Assessment Report finding that the RC slab structure was substandard with live load capacity of 0 tonnes (structure was assessed as being incapable of sustaining dead load from the embankment above). The expected mode of failure of the RC slab structure would be by yielding of steel at midspan due to bending. No evidence of failure was recorded during this PI inspection. When viewed in elevation there is an obvious permanent deflection of the slab (15-20mm) however this deflection is also visible in the elevation photos in the 2005 SI report and it does not appear that additional deflection has taken place indicating that the deflection is historic and likely to have occurred during construction.</p> <p>Condition/Mainten.            1 / Y</p>

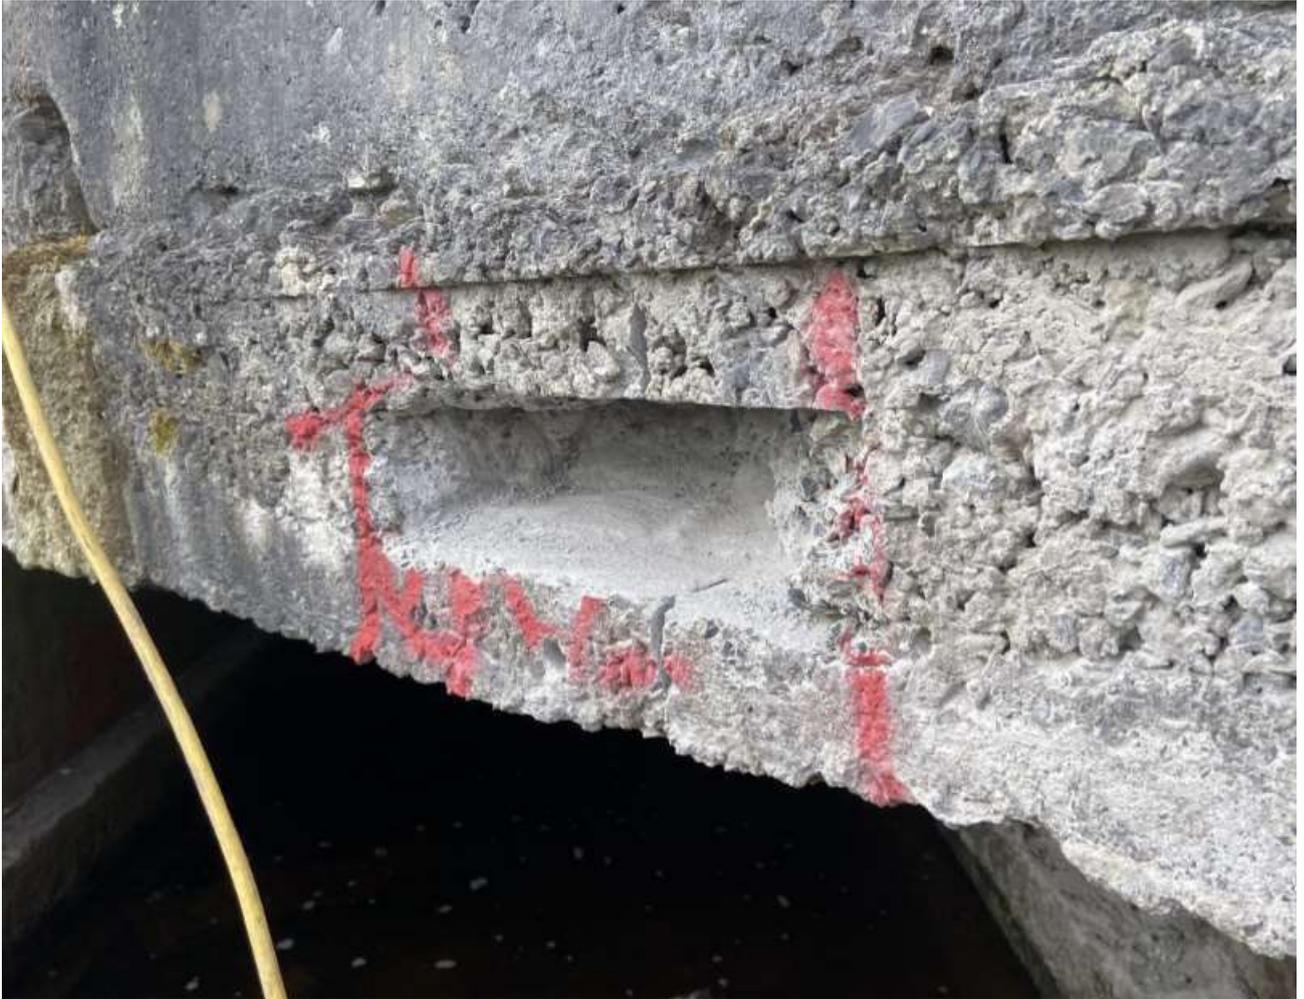
*Figure 14: Breakout of the Northern Facia revealing no reinforcement at a depth of 200mm approx.*

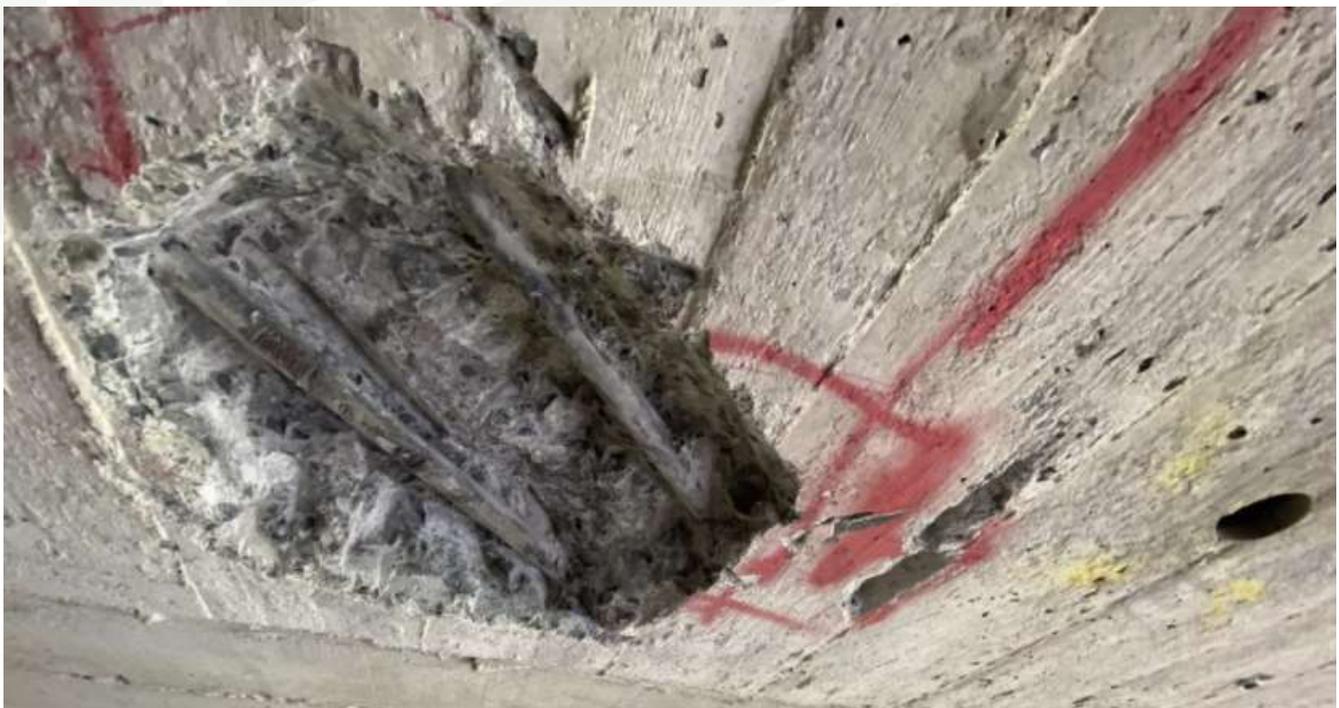
Figure 17 : Test Area 4 showing breakout with 22mm bars at 160mm spacing, Core to the right

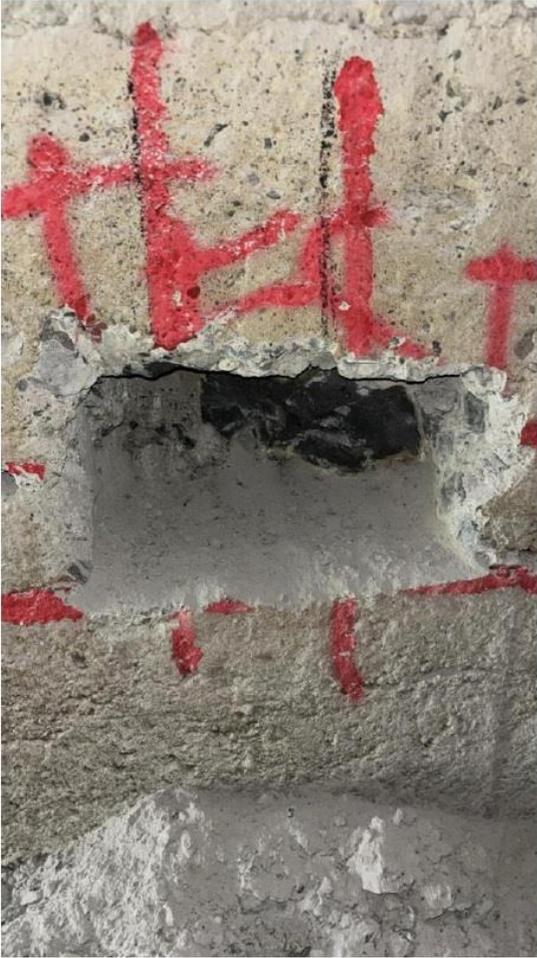
East abutment area 6 no reinforcement found

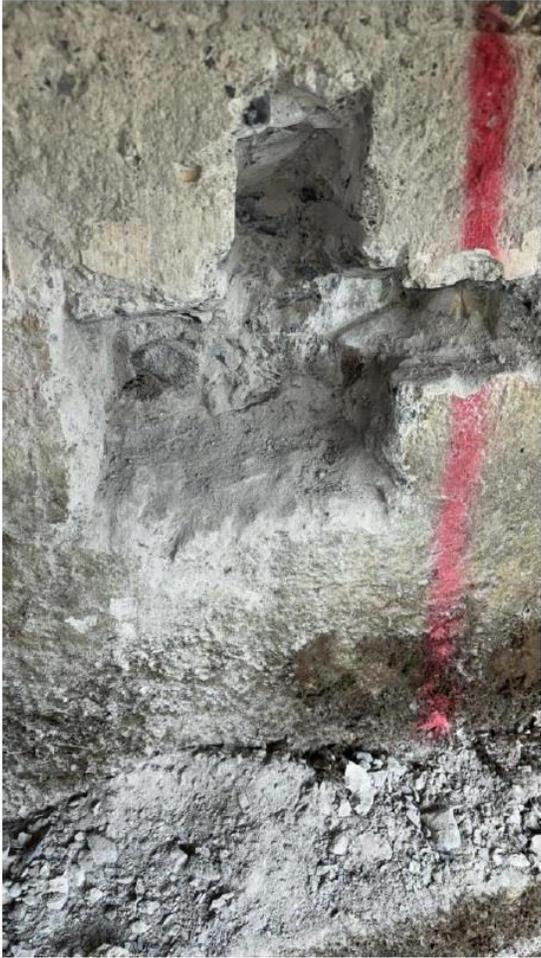
Area 3 no reinforcement found

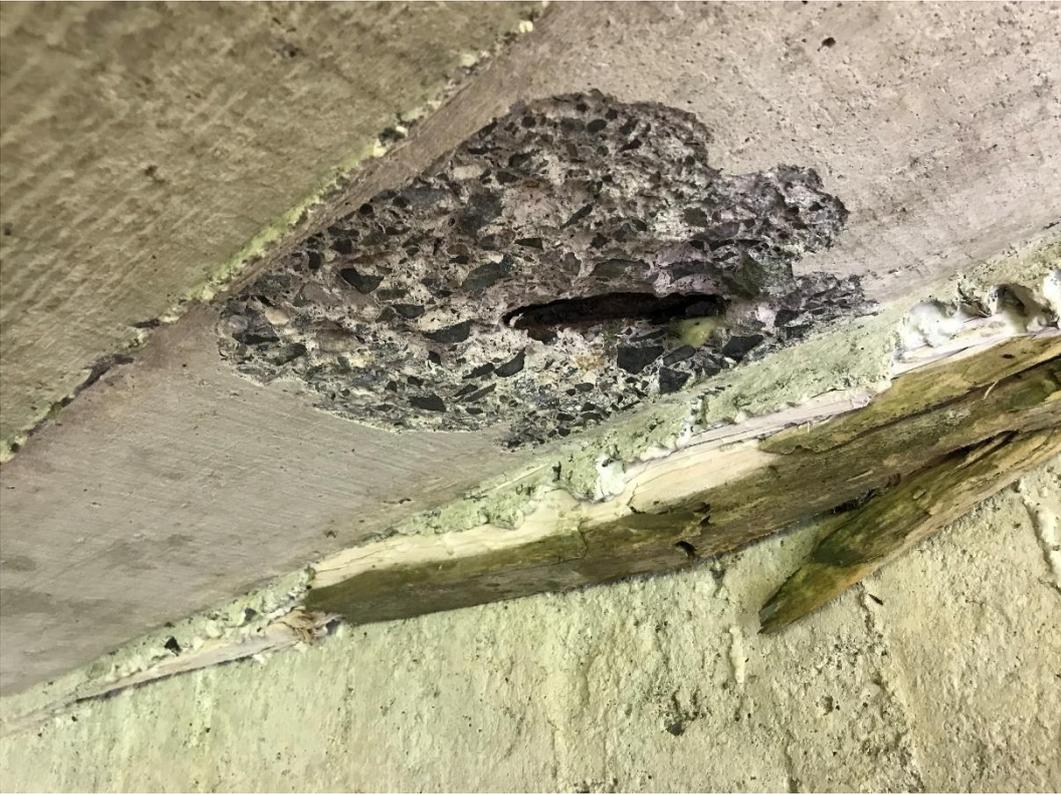
**Photograph H-12 – View of the deck soffit looking south**

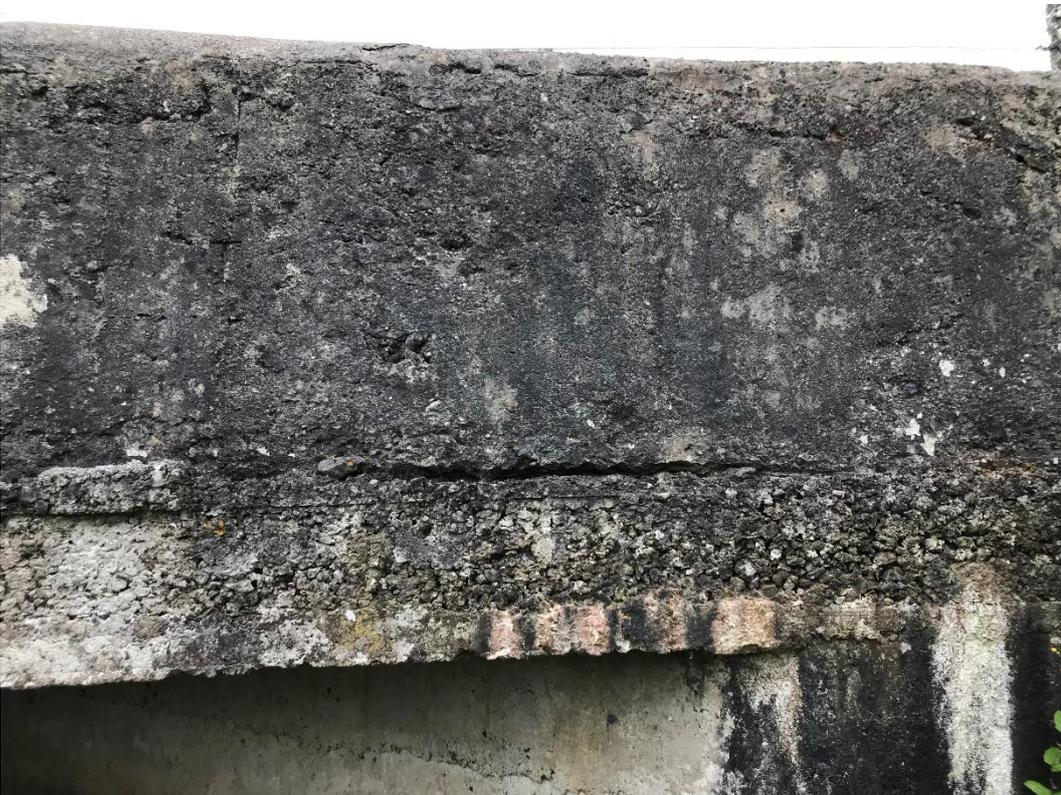
The concrete deck extension to the north end of the structure is in good condition with recent repairs evident. Spalling is evident to the west end of the deck measuring 0.2m x 0.17m with exposed reinforcement also present. A void is also present at the base of the headwall of the north elevation with a length of 0.75m. 500mm long concrete spalling is also evident to the slab soffit at the interface with the pipe section. As noted in previous inspections a 15-20mm deflection is evident to the north elevation of the slab but appears to be a defect from the construction stage with no distress noted in the slab soffit.

**Photograph H-13 – View of the spalling to the deck with exposed reinforcement**

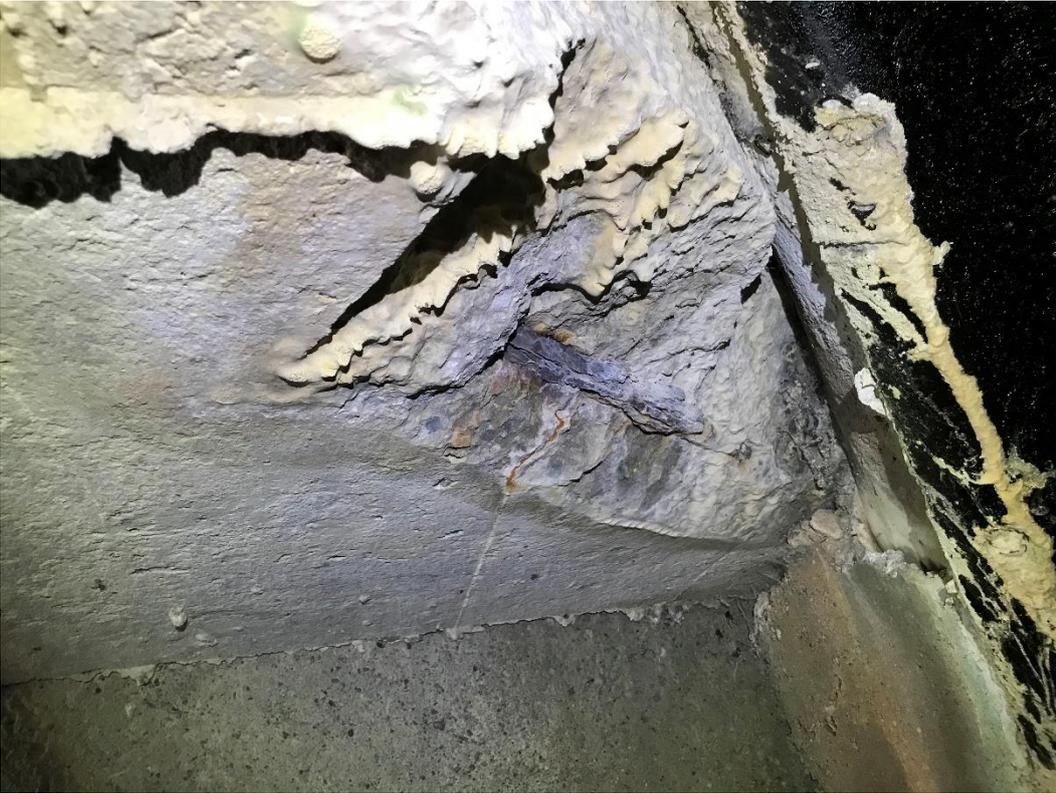
**Photograph H-14 – View of the void to the headwall of the north elevation**
