**CORK COUNTY COUNCIL – SOUTH CORK DISTRICT
(AREA OPERATIONS SOUTH)**

DERELICT SITES ACT 1990

Engineering report from the Carrigaline Area Office

Site Address: Elm Lawn, Loughbeg, Ringaskiddy

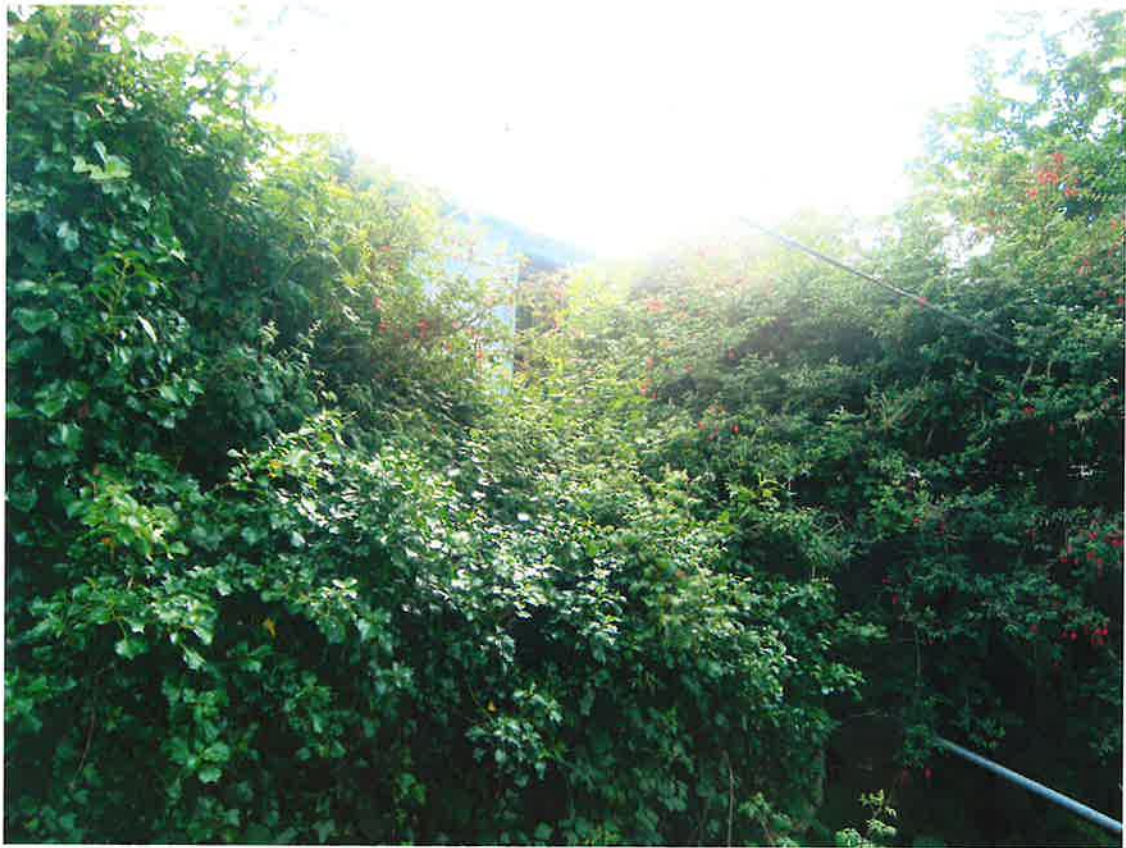
Photograph No. 1.1

Elm Lawn is a large old two-story dwelling house, which is overgrown with vegetation. Access to the site was restricted by the vegetation. Some of the Windows in the property are broken and the roof slates and guttering may need some attention.

Cut Back Vegetation on all sides. Board up windows and doors and paint in a matching colour. Remove any litter, debris and waste to an approved site.
Secure site.

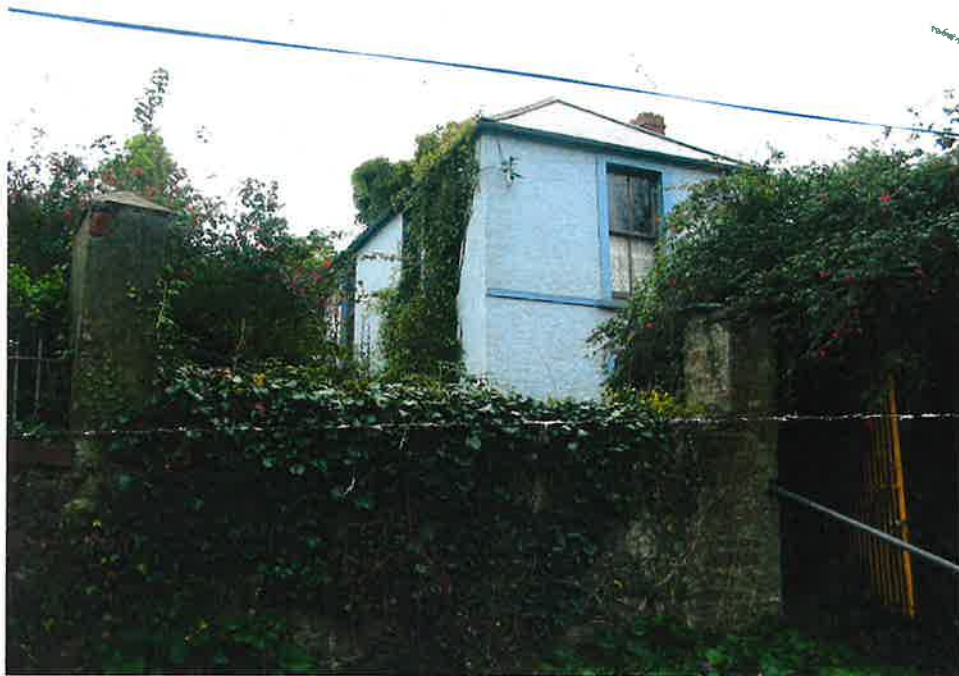
Photograph No. 1.4

Picture from Area Planner's Report on Adjoining Site dated 18/10/2007
