**CORK COUNTY COUNCIL – SOUTH CORK DISTRICT
(AREA OPERATIONS SOUTH)**

DERELICT SITES ACT 1990

Site Address: Elm Lawn, Loughbeg, Ringaskiddy, Co. Cork.

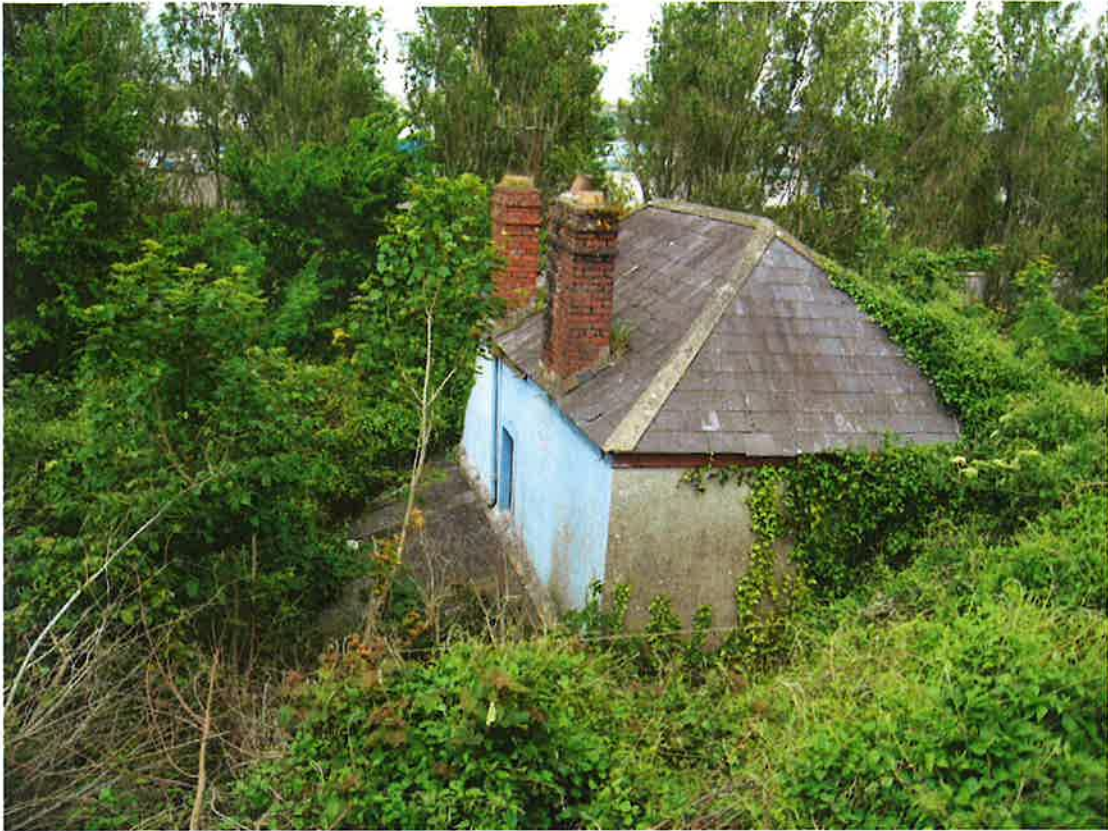
Photograph 1.0 –Date Taken: 31.5.11 - View of rear of house

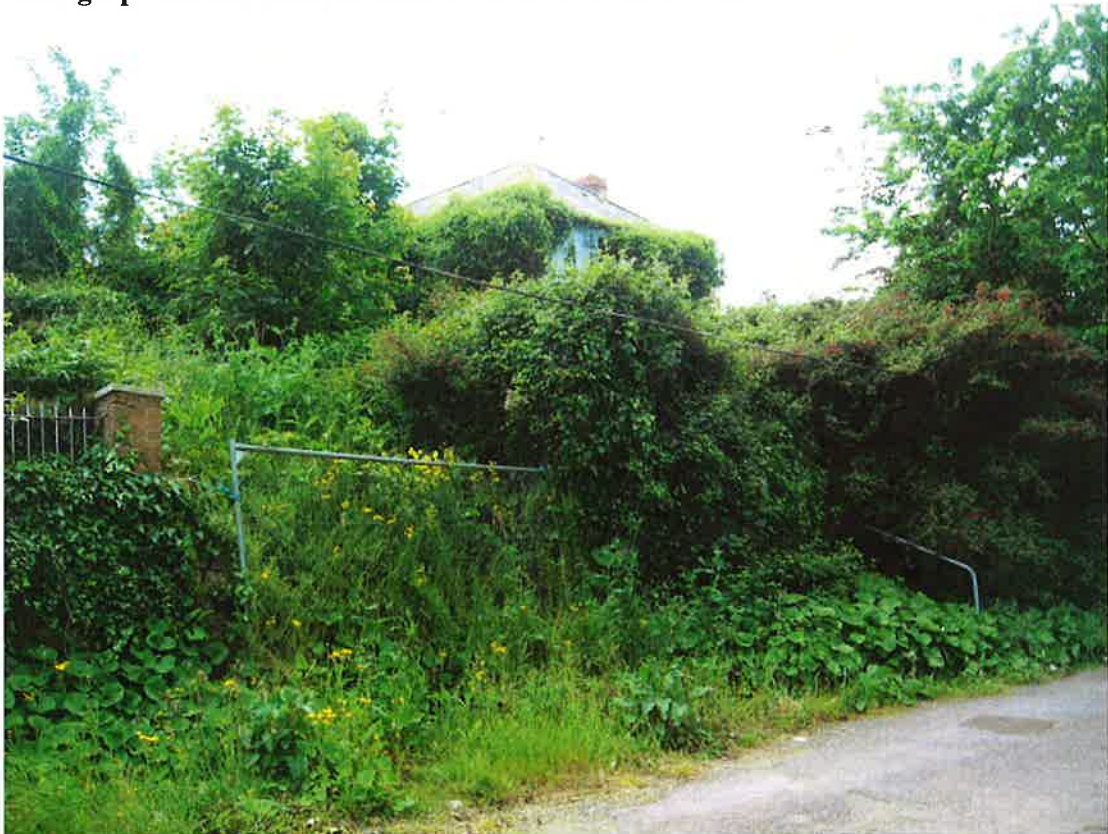
Photograph 1.1 –Date Taken: 31.5.11 - View of front of house from public road

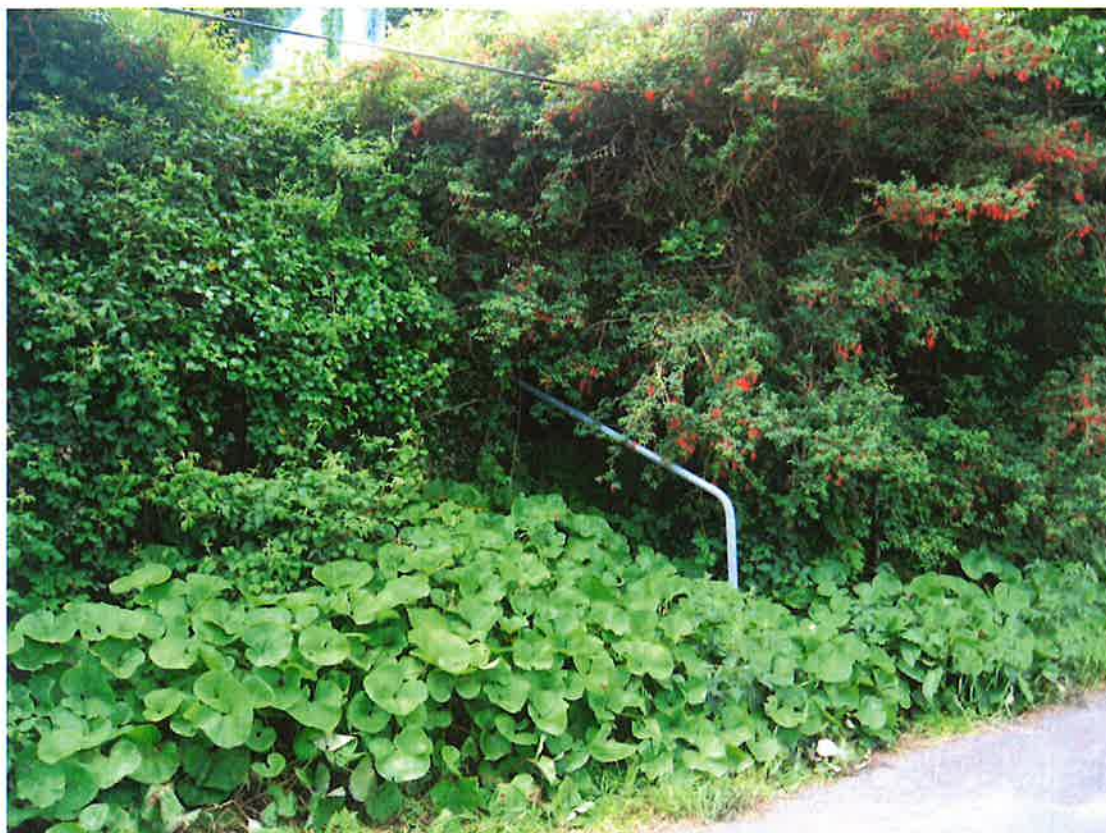
Photograph 1.3 –Date Taken: 31.5.11 - View of house entrance from public road

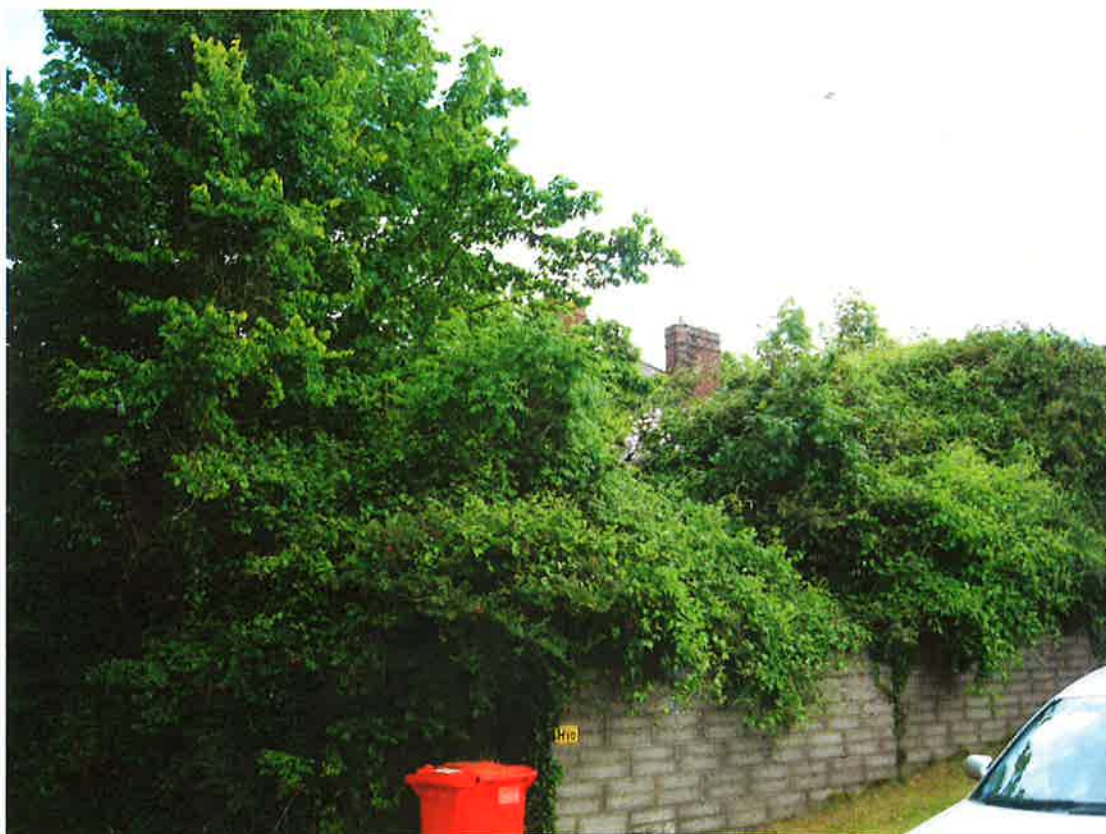
Photograph 1.4 –Date Taken: 31.5.11 - View of side of house from public road

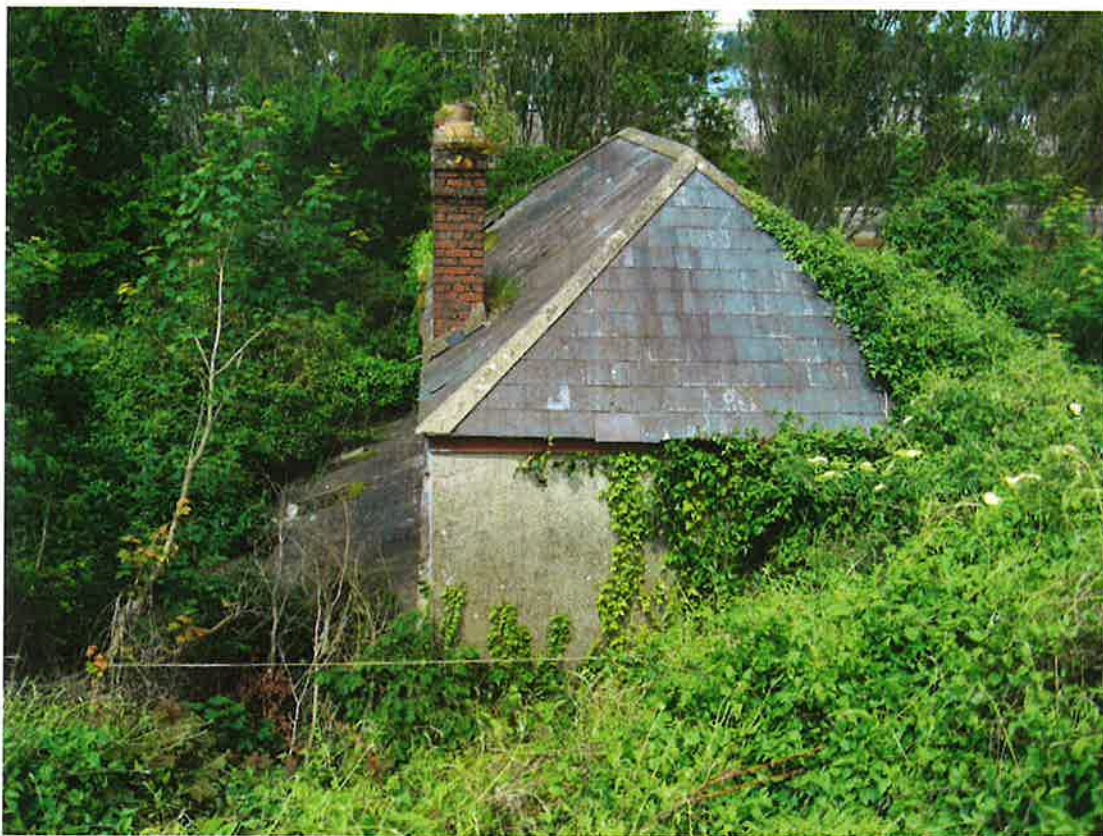
Photograph 1.5 –Date Taken: 31.5.11 - View of rear of house
