**Stage 1/2 Road Safety Audit
Proposed Residential Development,
Stradbally Road, Portlaoise, Co. Laois**

Client:	Hayes Higgins Partnership
Document No:	240130-ORS-XX-XX-RP-TR-13g-001

Job: 240130 – Proposed Residential Development, Stradbally Road, Portlaoise, Co. Laois

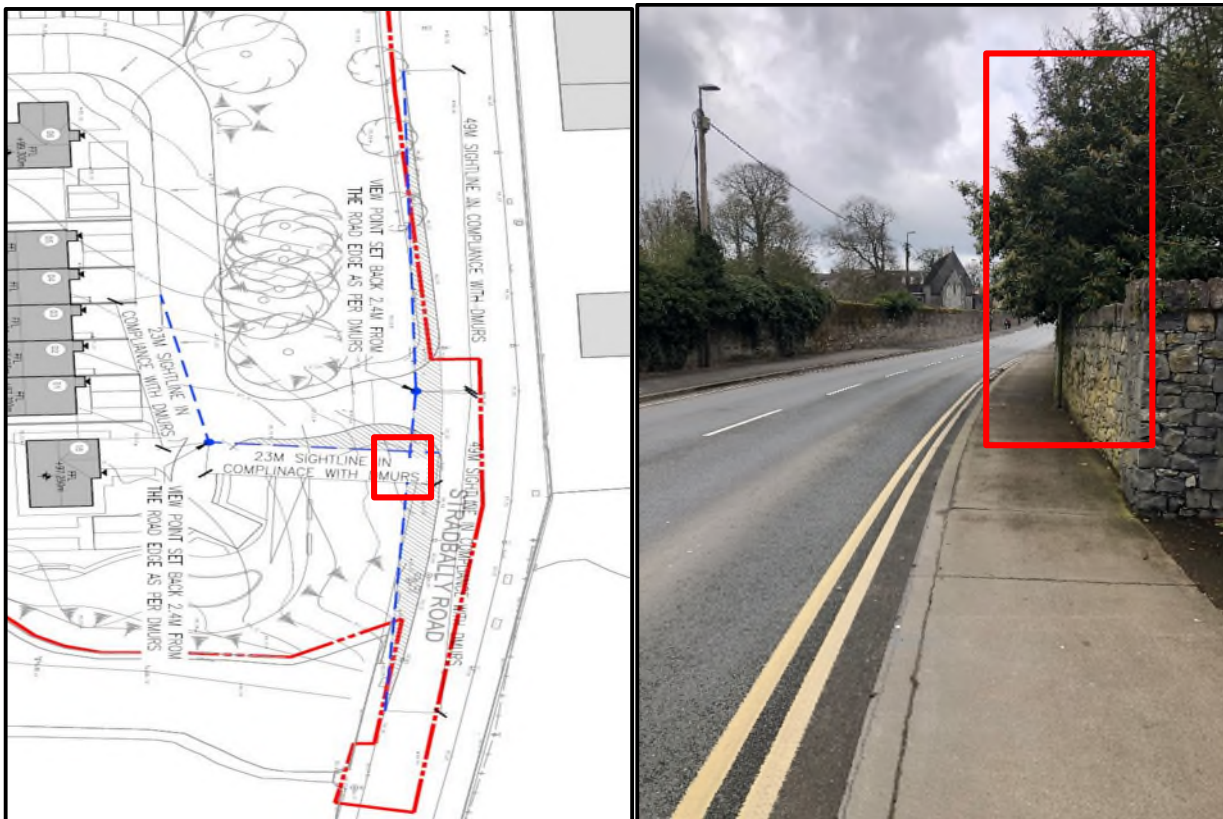
Location: Main Entrance to the Development.

Problem No.01: Sightlines East and West

The audit team note that there are sightlines detailed on the proposed drawings for the development. However, on the day of the site visit it was noted that utility poles and boundary walls are within the line of sight of vehicles exiting the development reducing visibility to the east and west. The audit team is concerned that inadequate sightlines and stopping distances could lead to sideswipe, side impact, or rear end shunt type collisions.

The design team should ensure that clear visibility is provided in both directions and that visibility envelopes are clear of any obstacles such as street furniture and boundary walls.

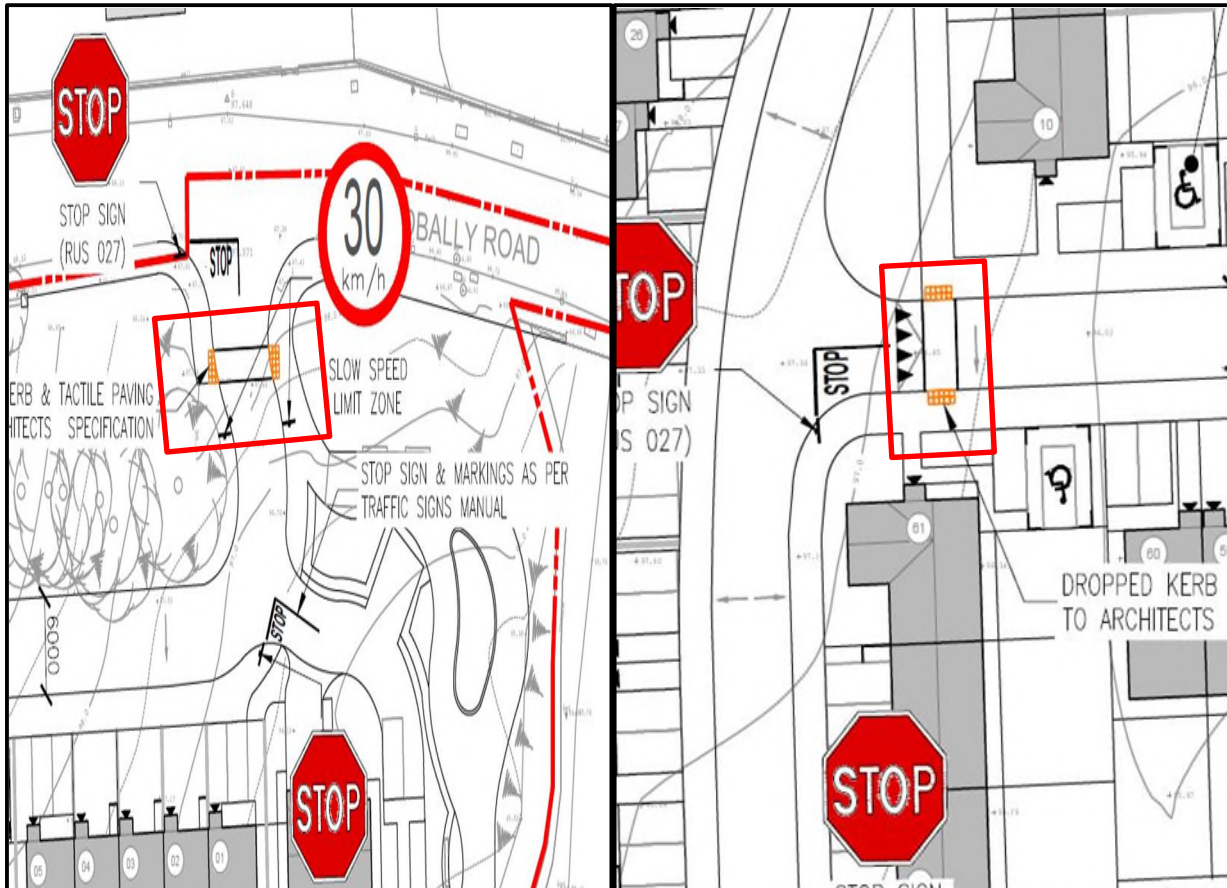
Location: Various Locations Throughout Development

Problem No.2: No Crossing Point on Desire Line

The audit team note from the provided drawings that the proposed crossing points at multiple areas of the scheme are not positioned along pedestrian desire lines. This could result in users crossing the carriageway in undesigned locations which could result in potential vehicle collisions with vulnerable users or potential trip and falls.

The design team should ensure that the dedicated crossing points are positioned on desire lines to mitigate the safety risk identified.

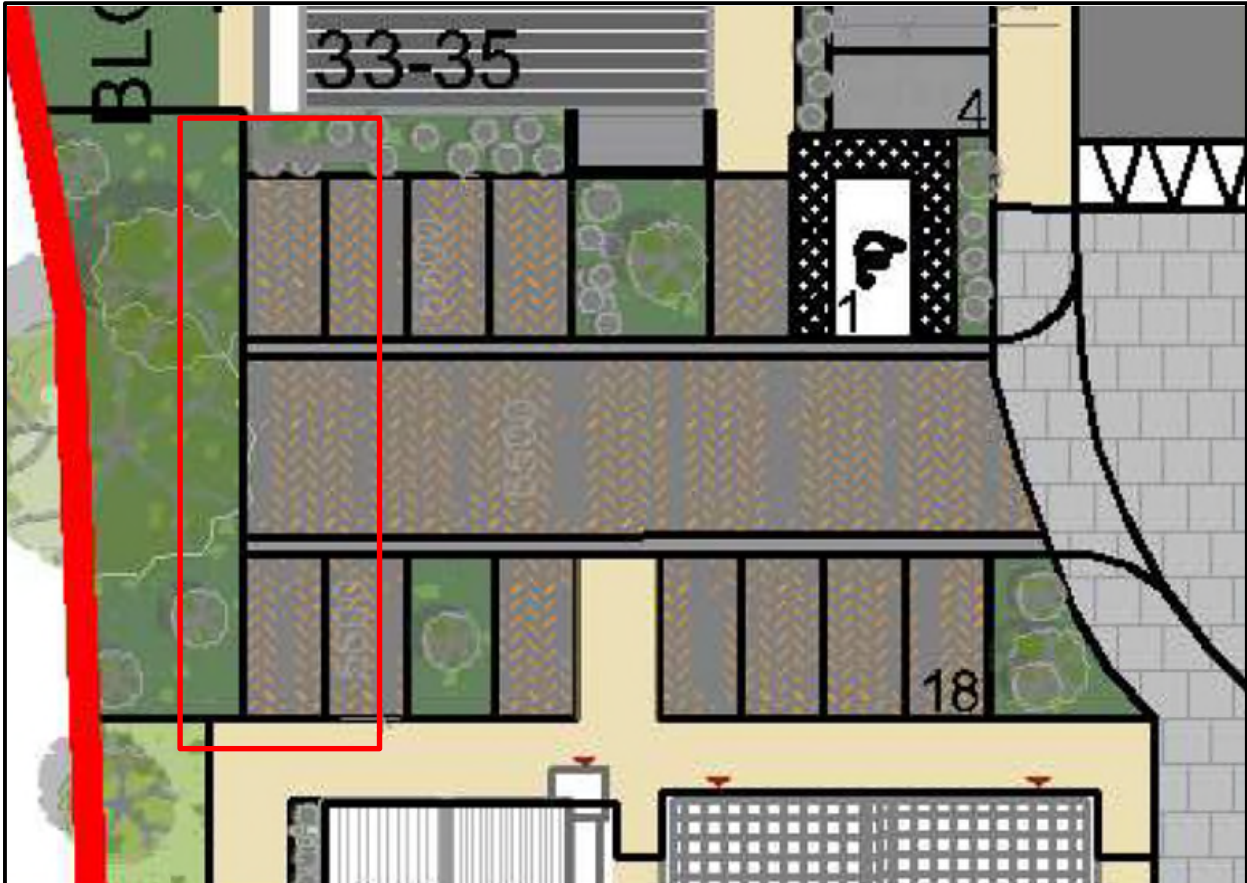
Location: Adjacent to Property No. 33 & 36

Problem No.3: Restricted Car Parking Spaces

The audit team note from the drawings that parking space to adjacent to the identified properties appear to be limited in space and could be difficult for users to access given their restricted nature. This could increase the risk of potential conflicts among vehicles or vehicles conflicts with pedestrians as users may have to reverse excessive distances to exit the spaces.

The design team should review the geometry of these parking spaces to ensure that vehicles can safely enter and exit.

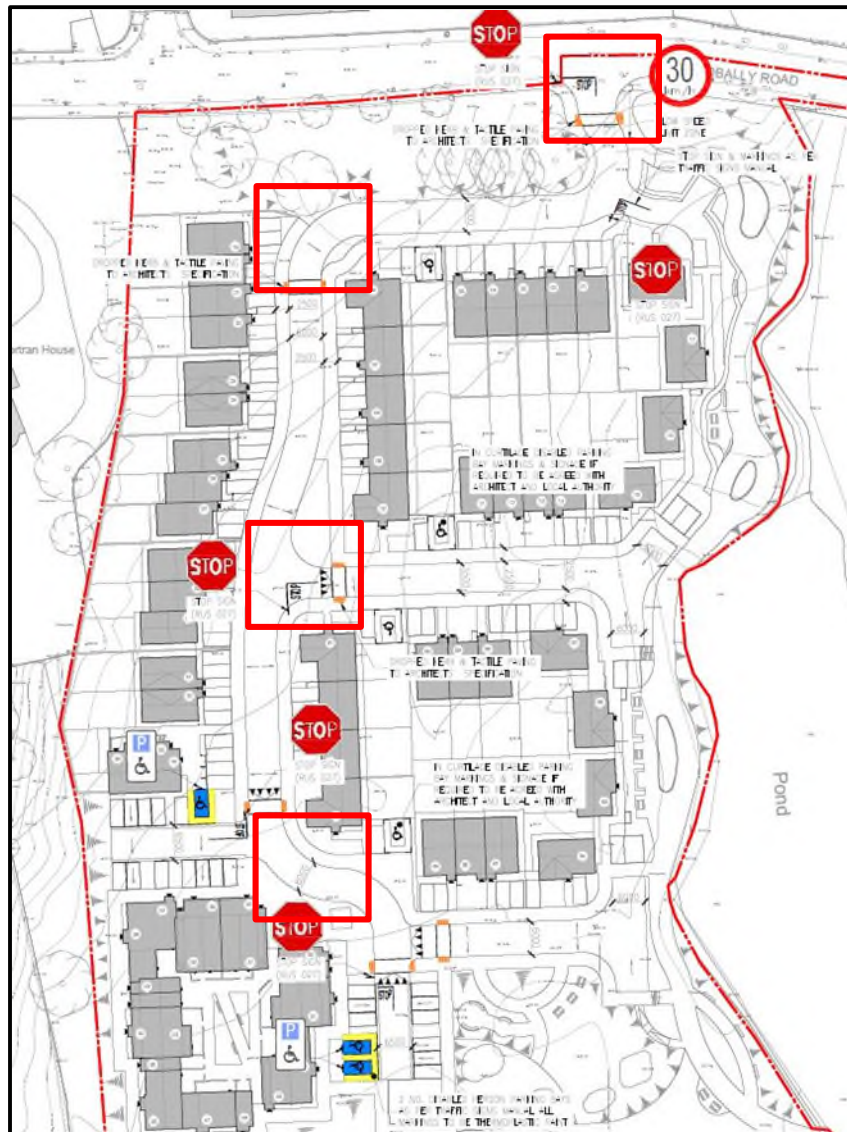
Location: Within Scheme

Problem No.4: Corner Radii within the Scheme

The audit team note from the drawings provided that the corner radii appear to be excessive which could increase the potential for higher vehicle speeds within the development. The audit team has concerns, that vehicles would not be encouraged to slow down and could result in collisions with vulnerable road users at the uncontrolled crossing.

The design team should ensure that the corner radii is appropriate for the design speed to slow vehicles down.

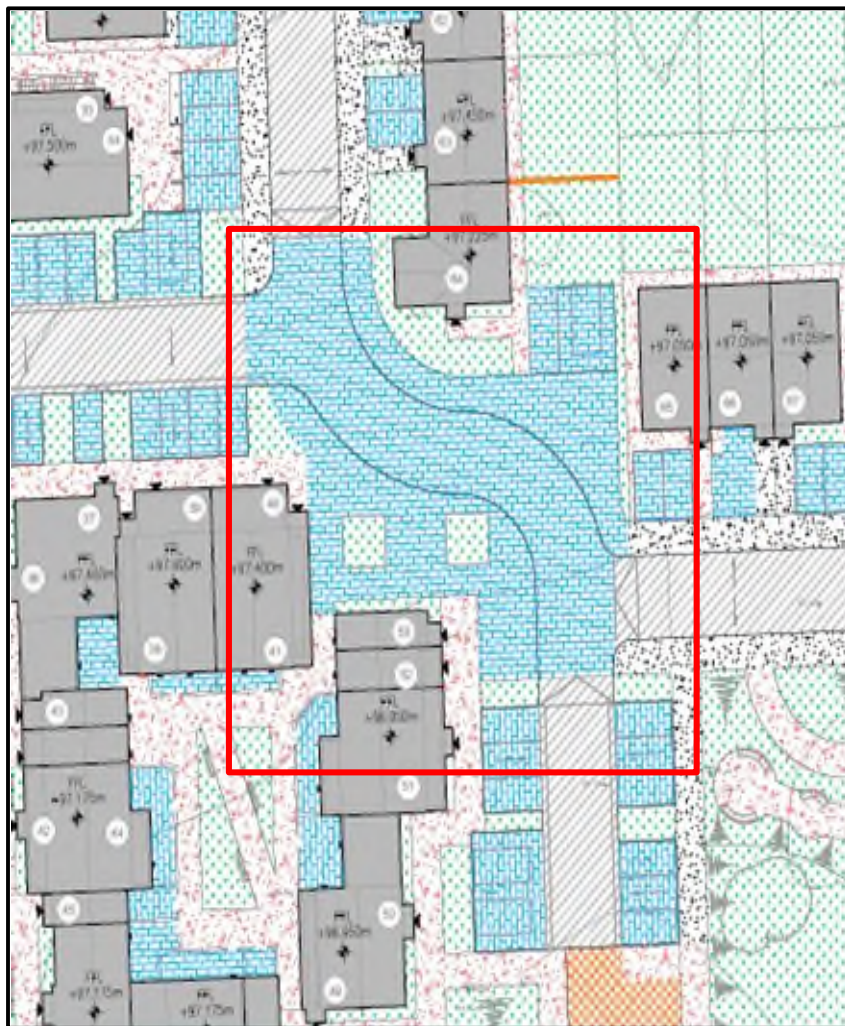
Location: Location Identified

Problem No.5: Delineation/Visual Contrast of Driving Area

The audit team note from the drawings provided that the area identified is fully paved with access to a disabled car parking space to the north. It is not clear if a kerb line will be provided and if it is how, it visually contrasts with the paving installed. The audit team has concerns that motorists may be given the impression that the carriageway is wider which could lead to vehicles driving in areas meant for vulnerable road users and could result in collisions with vulnerable road users. There is also a risk of illegal parking in this open area which increases the safety risk for vulnerable users.

The design team should ensure that the area provided with appropriate road marking/signage and that the colour contrast of materials between any footpath/ kerbing such that clear distinction can be made between the carriageway and footpath area. The design team should also provide hard measures in the open space to mitigate the risk if illegal parking.

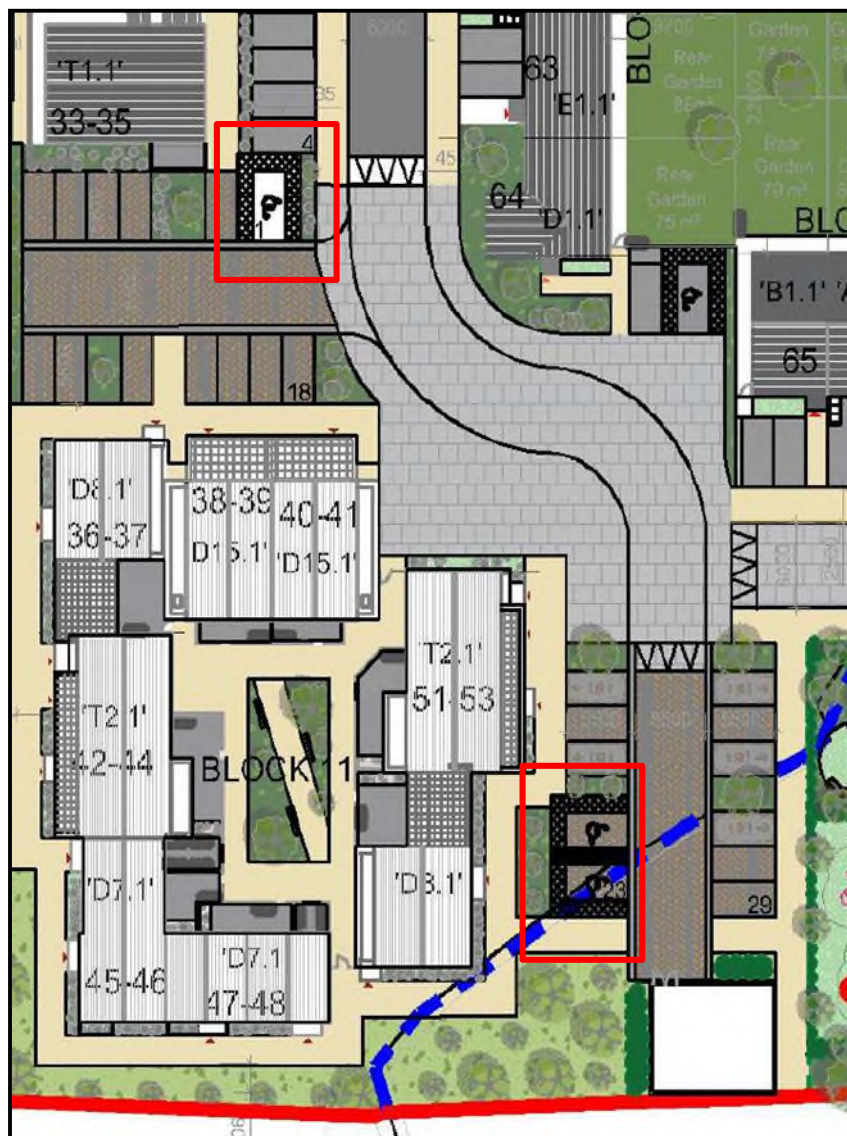
Location: Disabled Parking Spaces at Properties 34 and 50

Problem No.6: Accessibility of Disabled Parking Spaces

The audit team note from the drawings provided, that there are disabled parking spaces provided throughout the development. It is not clear from the drawings provided if appropriate dropped kerbing is provided for these spaces at the locations identified below. The audit team are concerned that users of the spaces may not have access to the footpath and may use the closest road to access the footpath resulting in potential collisions between vehicles and vulnerable road users.

The design team should provide adequate provision for users of the spaces to access the footpath safely.

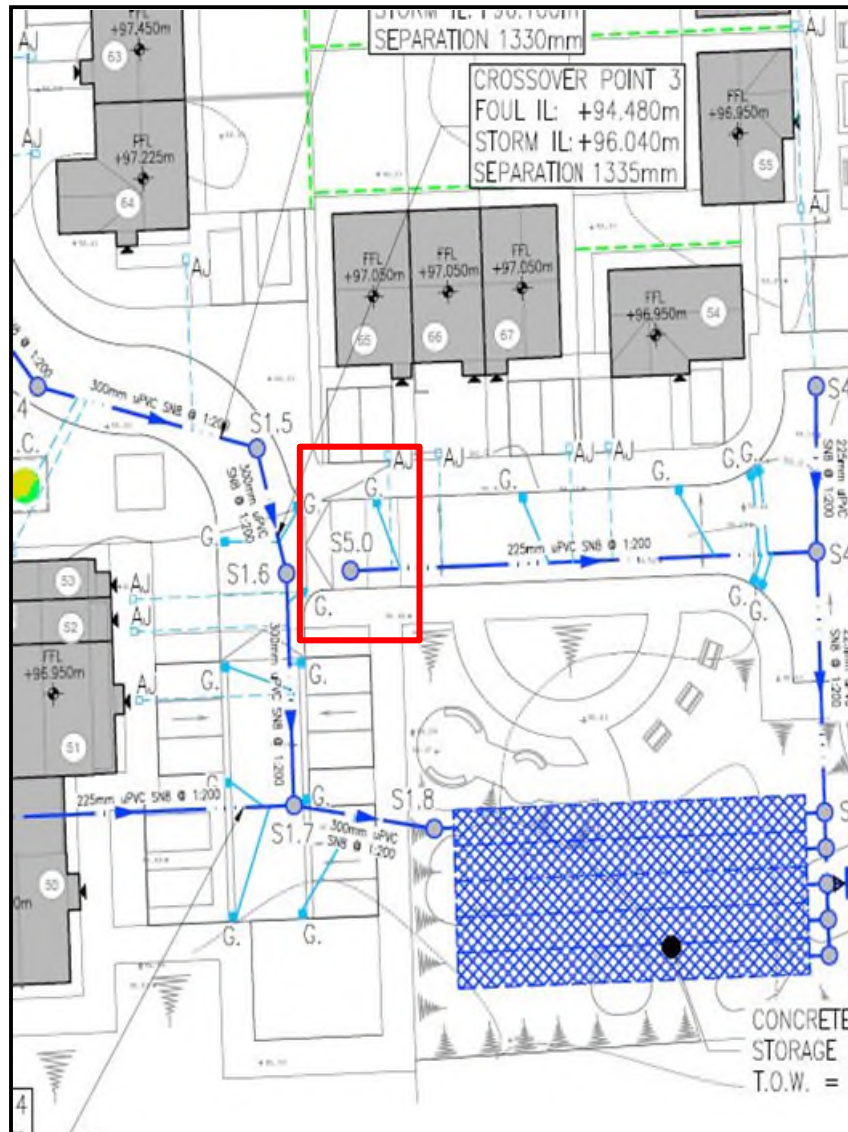
Location: Uncontrolled Crossing to the front of No. 65

Problem No.7: Gully Location

The audit team note from the storm drainage drawings provided, that there appears to be a gully positioned in the line of the uncontrolled crossing. The audit team are concerned that the gullies positioned in the uncontrolled crossing line would cause slips, trips and falls to vulnerable road users.

The design team should position gullies out of the line of crossings.

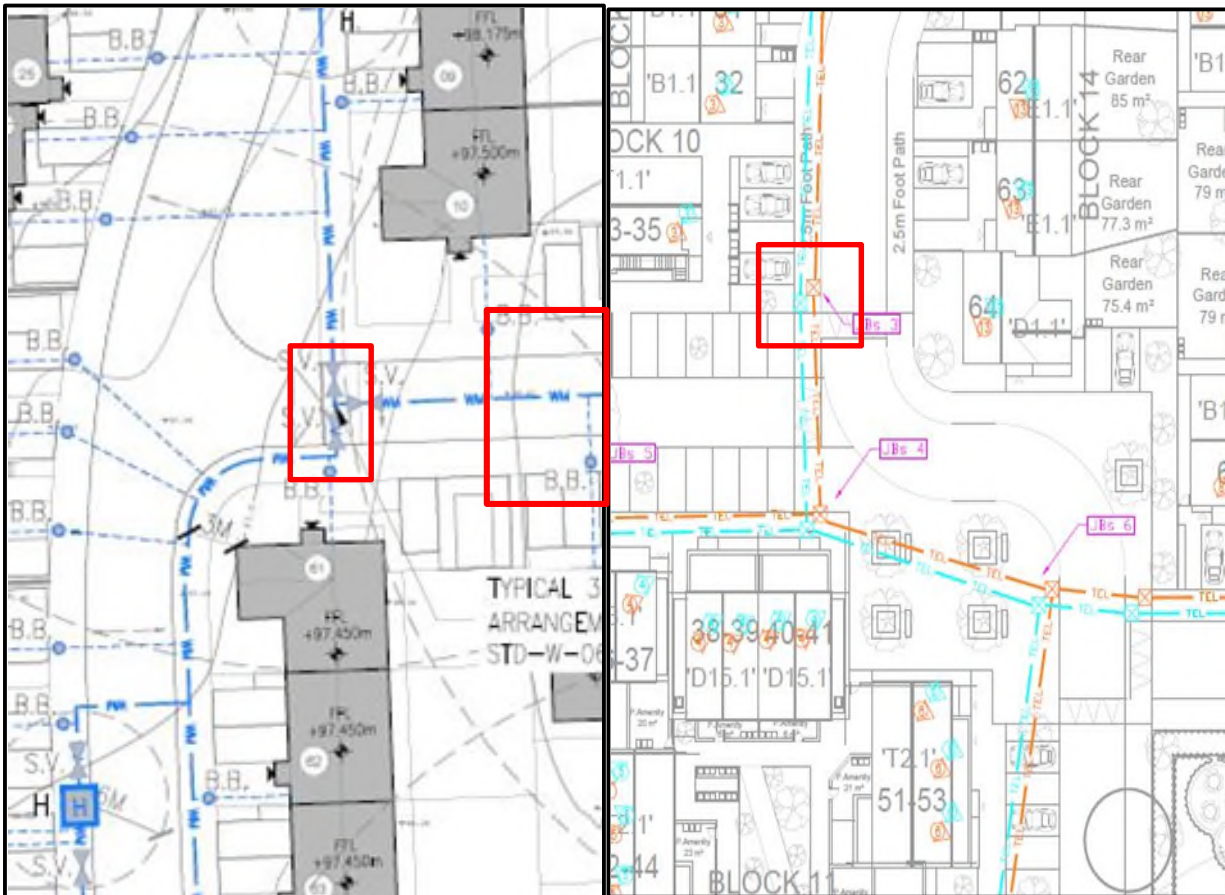
Location: Uncontrolled Crossing Identified

Problem No.8: Utility Manholes

The audit team note from the services drawings provided, that there are utility manholes in the uncontrolled crossing areas. The audit team are concerned that the manholes positioned along pedestrian crossing lines would cause slips, trips and falls to vulnerable road users.

The design team should position utility manholes out of the line of crossings.

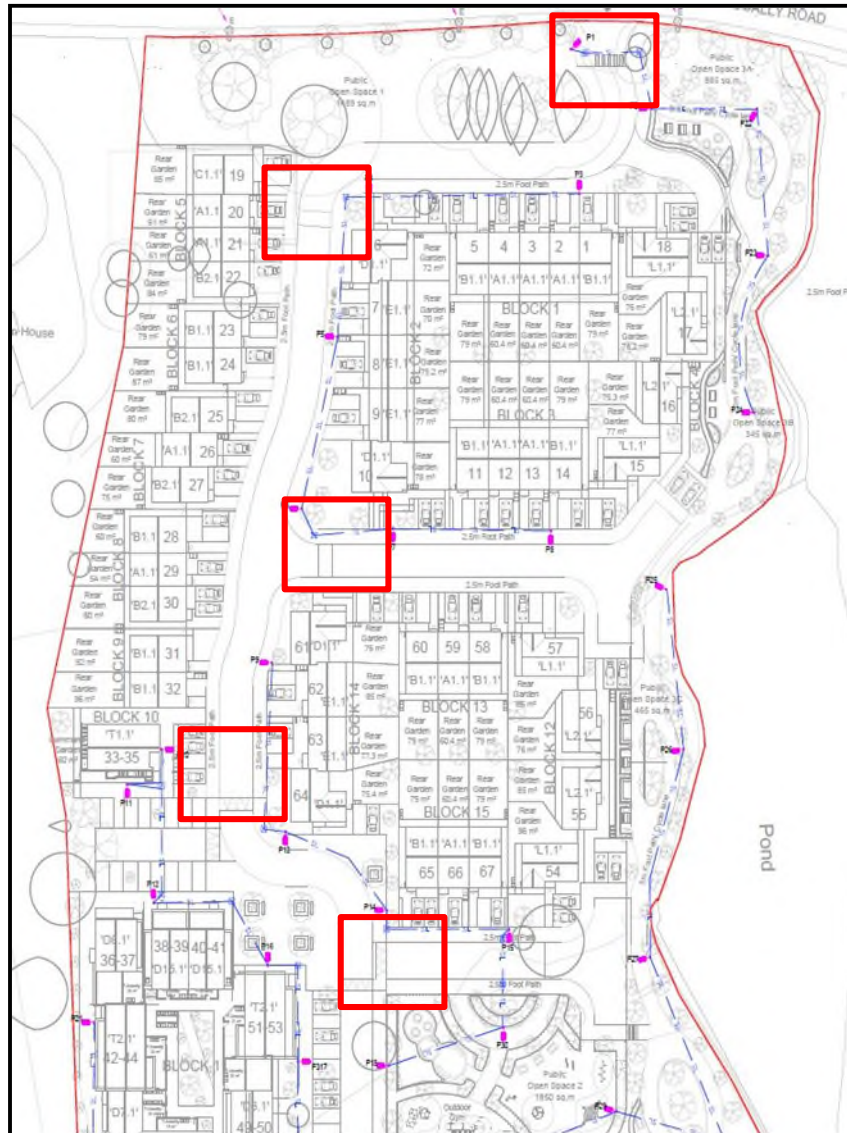
Location: Main Entrance and Internally within Site

Problem No.9: Public Lighting at Uncontrolled Crossings

The audit team note from the public lighting drawing's provided that although there is public lighting provided it is not clear if this will adequately illuminate the uncontrolled crossings. This creates an issue in low light conditions where drivers may be unable to see pedestrians on the crossings. This has potential to lead to pedestrian-vehicle collisions which poses a risk of serious injury to pedestrians.

The designers should ensure that appropriate public lighting is provided to illuminate the crossings.

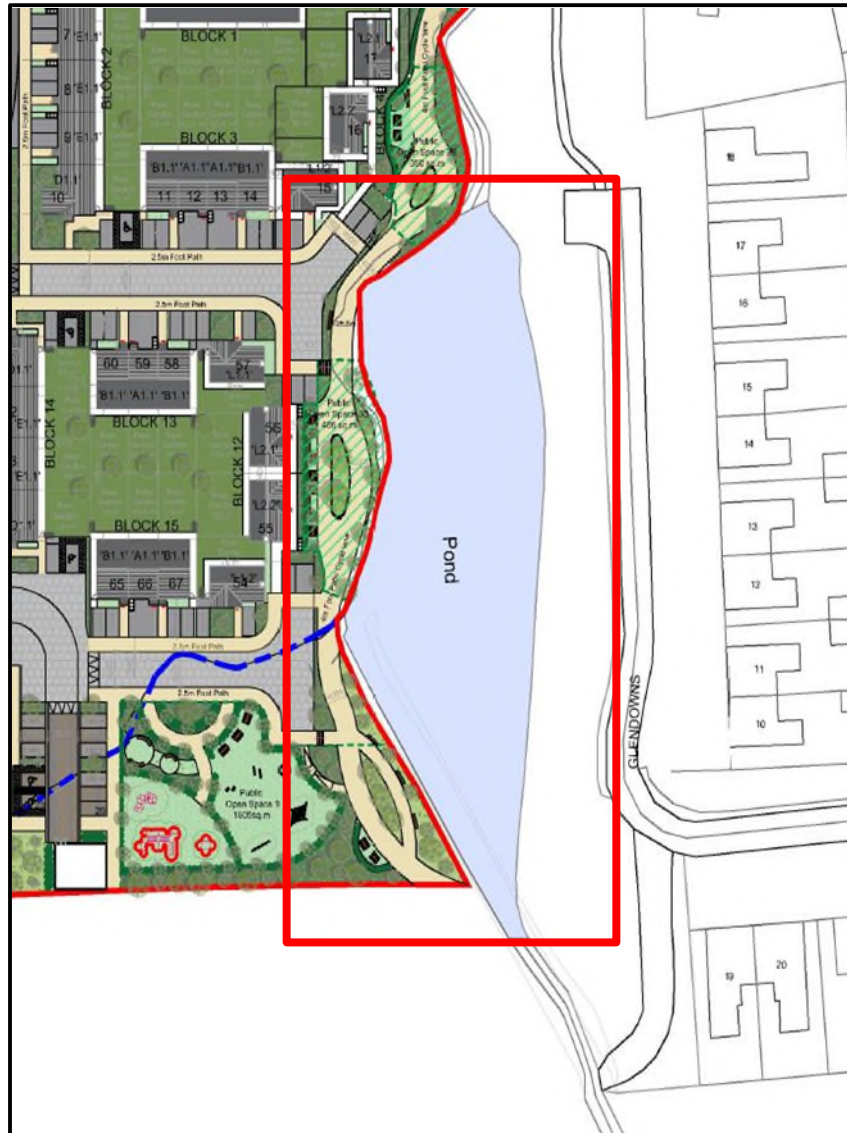
Location: Pond to the East

Problem No.10: Protection to Pond to the East

The audit team note that there is a pond that runs parallel to pedestrianised surface which could be a high footfall area for children in particular. As no protection is provided for vulnerable users, the audit team has concerns that a vulnerable road user could inadvertently enter the pond area which could result in potential drowning incidents.

The design team should provide adequate protection to the pond and any protruding pipework is provided to prevent vulnerable users from entering the pond area.

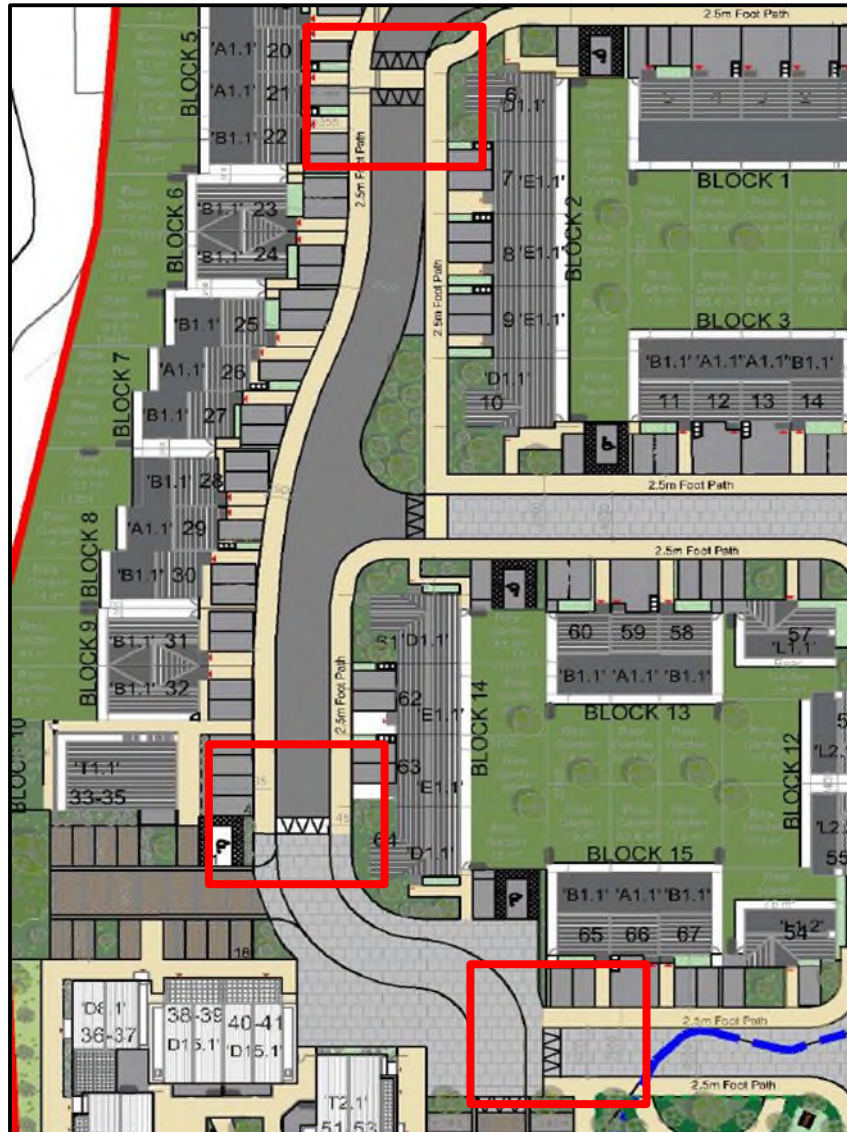
Location: Throughout Development at Raise Table Locations

Problem No.11: Raised Table Ramps Positioned Over Parking Spaces

The audit team note that the ramps for the raised tables appear to straddle or cross over the entrances to parking bays throughout the scheme. This could result in potential trips and falls for users when walking to the rear of their vehicles. There is a particular risk at night when the ramps may be harder to notice.

The design team should ensure that the proposed ramps for the raised tables do not interact with the proposed parking bays throughout the scheme.
