**Garrane Wind Farm,  
Garrane, Charleville, Co. Limerick**

## Bridge Inspection Report

**May 2024**

<b>PROJECT</b>	Carrane Wind Farm	
<b>CLIENT / JOB NO</b>	Garrane Green Energy Limited	6839
<b>DOCUMENT TITLE/No.</b>	Bridge Inspection Report	6839-JOD-00-XX-RP-S-001-P1

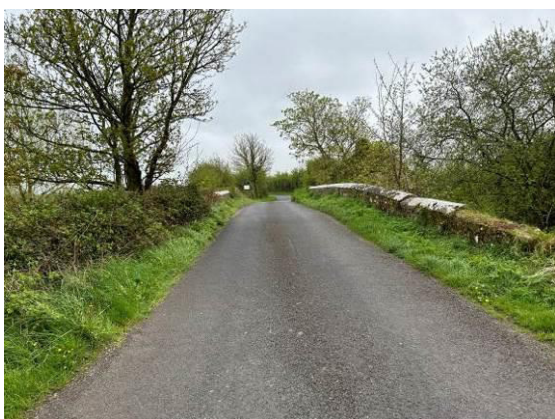
**Photo No. 4.1**

General view of bridge facing south.

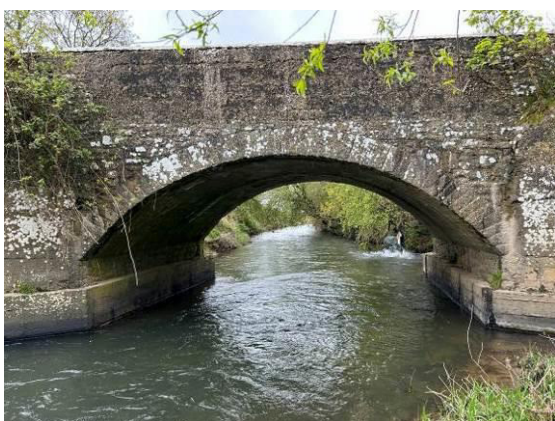
**Photo No. 4.2**

General view of main arch from upstream side.

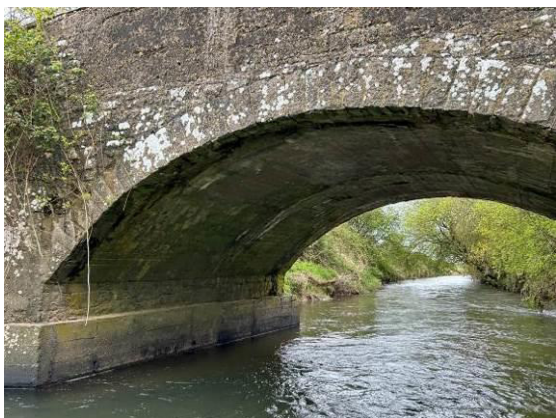
**Photo No. 4.3**

Main arch from upstream side.

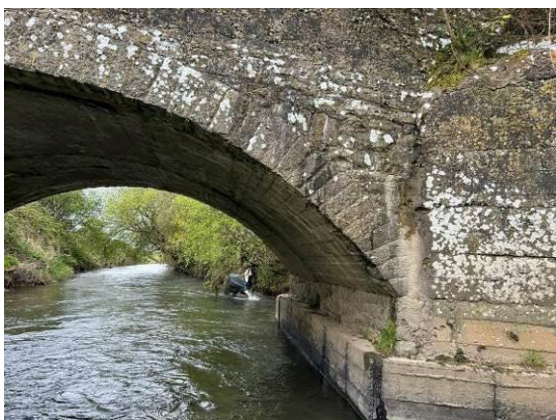
**Photo No. 4.4**

Main arch from upstream side

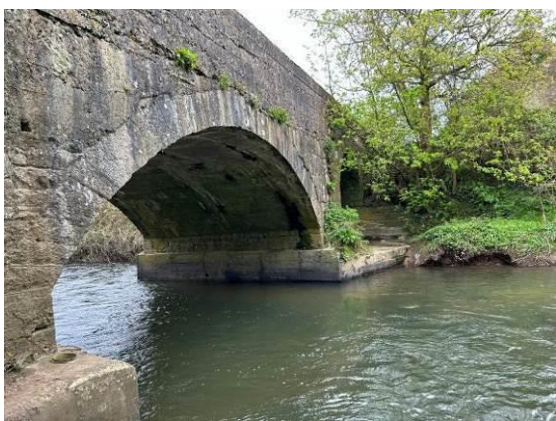
**Photo No. 4.5**

General view of main arch from downstream side.

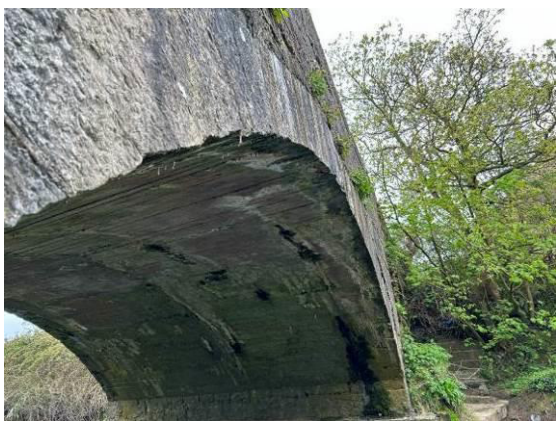
**Photo No. 4.6**

Main arch soffit.

Note concrete surface to arch soffit.

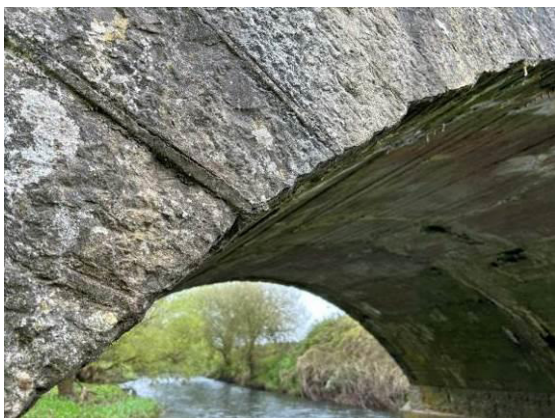
**Photo No. 4.7**

Main arch soffit and voussoirs.

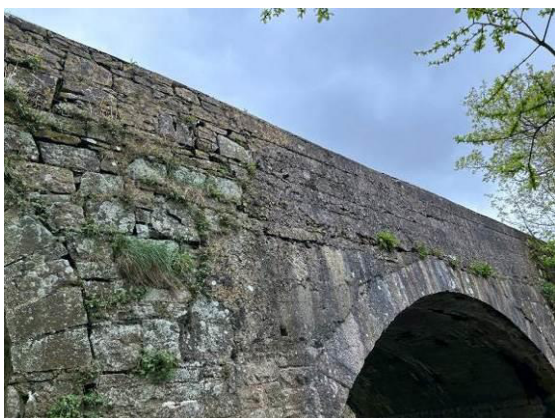
**Photo No. 4.8**

Downstream spandrel wall.

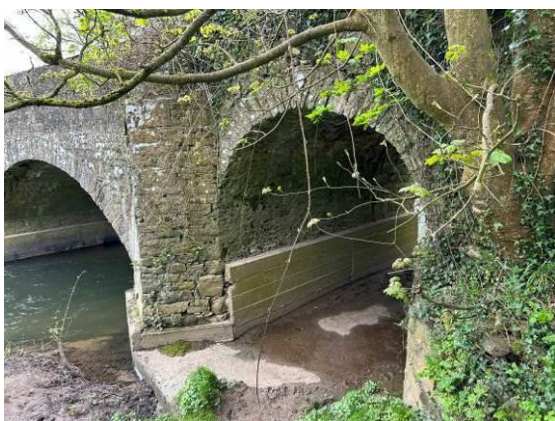
**Photo No. 4.9**

General view of upstream side of right hand side arch.

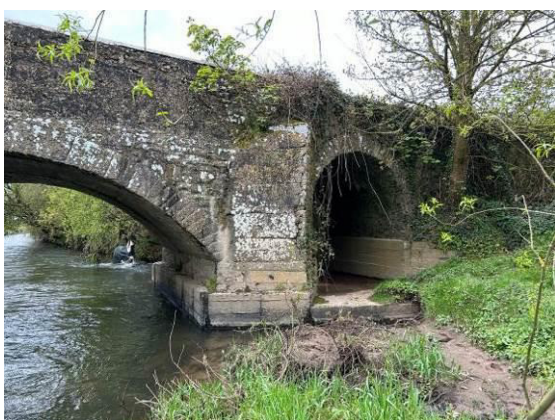
**Photo No. 4.10**

Upstream side of right hand side arch.

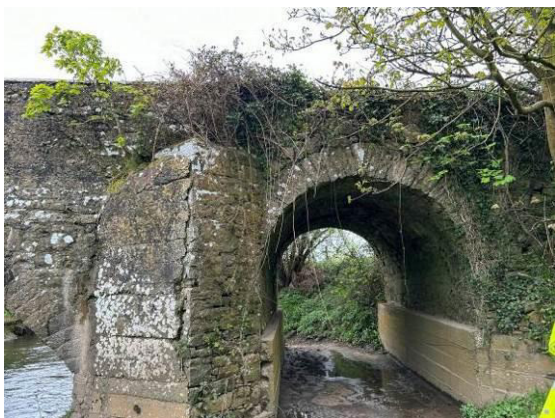
**Photo No. 4.11**

Upstream side of right hand side arch.

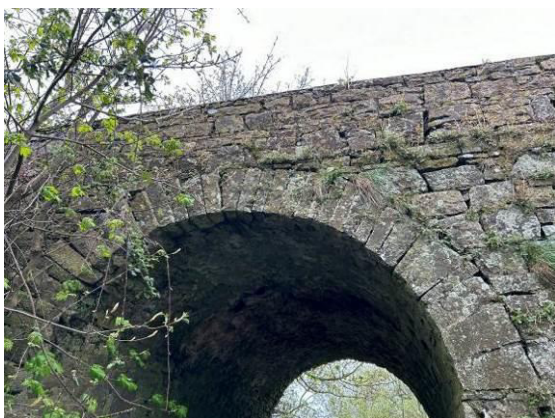
**Photo No. 4.12**

Downstream side of right hand side arch.

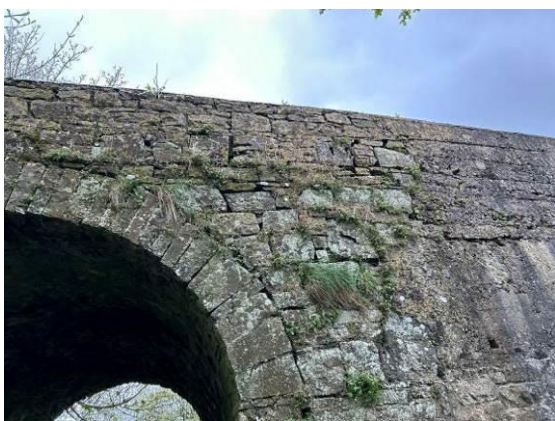
**Photo No. 4.13**

Downstream spandrel wall.

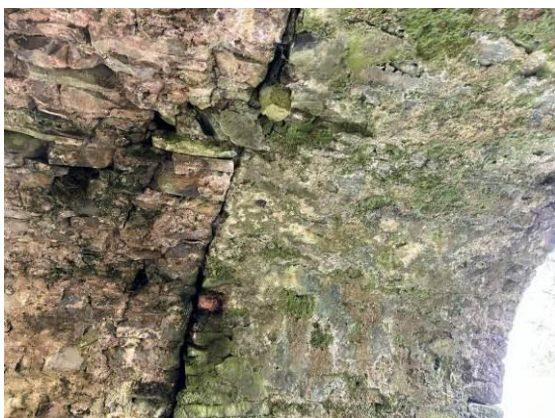
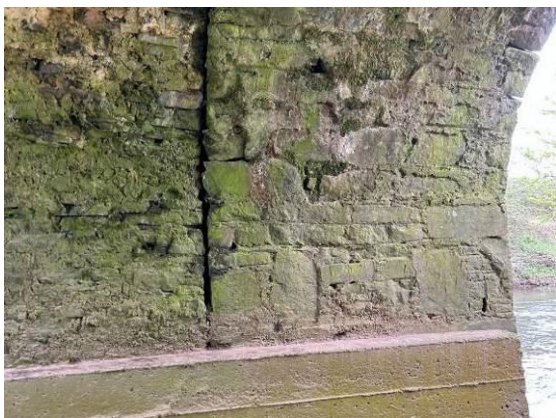
Engineering Inspection Notes		
1	Right Hand Side Arch	Circumferential joint at approx. 3 m from downstream end. This may be a result of an historic widening of the bridge. Recommend that the joint is repointed when appropriate.
2	Right Hand Side Arch	Some open joints and cracking observed. Recommend that these are repointed when appropriate. It is expected that the left hand side arch has similar issues.
3	Left Hand Side Arch Parapet	The upstream parapet is fully obscured by vegetation and could not be inspected.
4	Spandrel Walls	Some open joints and minor vegetation were observed.
5	Low Level Concrete Wall	Damage to lower level concrete wall was observed.

Joint in right hand side arch.

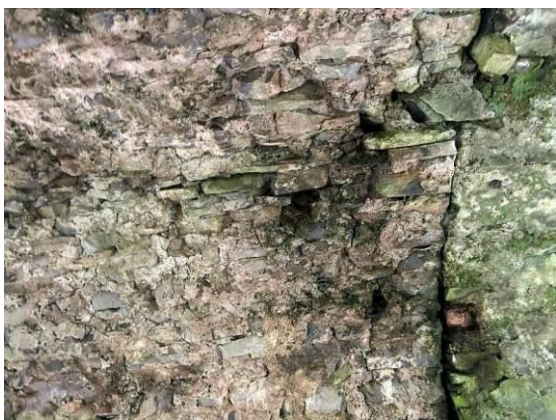
**Photo No. 4.16**

Open joints in right hand side arch.

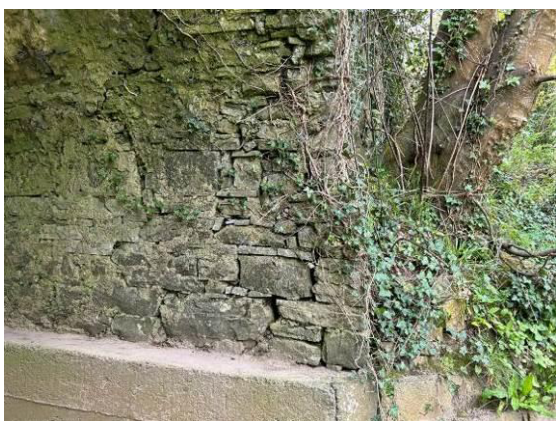
**Photo No. 4.17**

Open joints in right hand side arch.

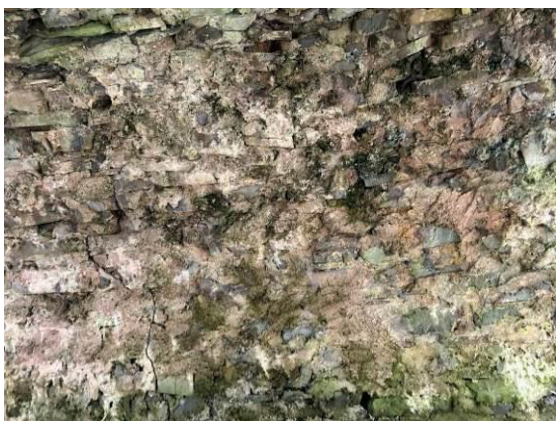
**Photo No. 4.18**

Pointed joints in right hand side arch.

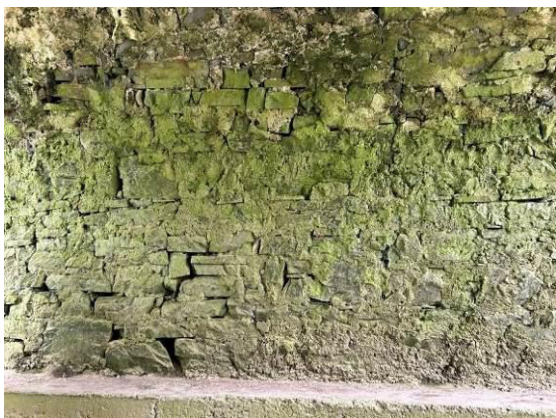
**Photo No. 4.19**

Open joints in right hand side arch.

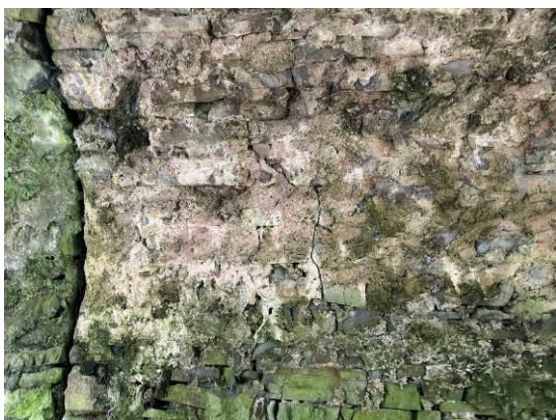
**Photo No. 4.20**

Crack in right hand side arch.

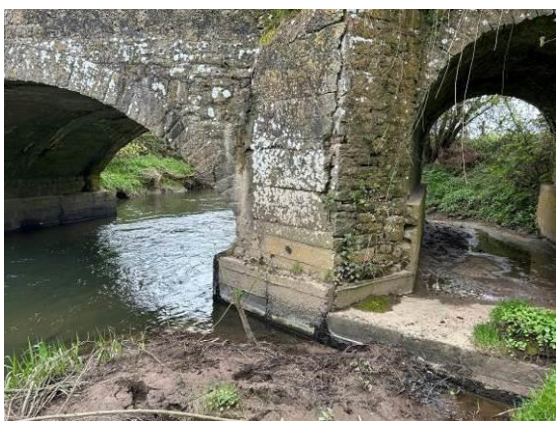
**Photo No. 4.21**

Abutment between main arch and right hand side arch.

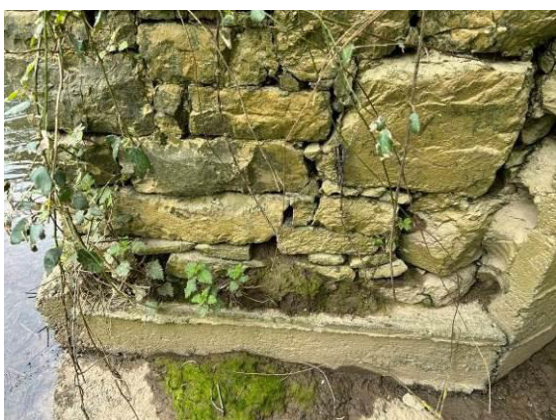
**Photo No. 4.22**

Open joints in abutment.

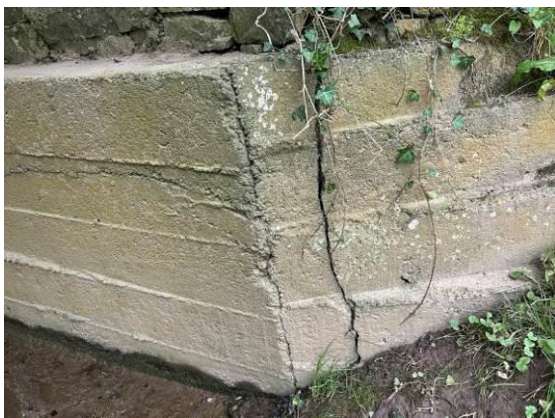
**Photo No. 4.23**

Crack in concrete low level wall.

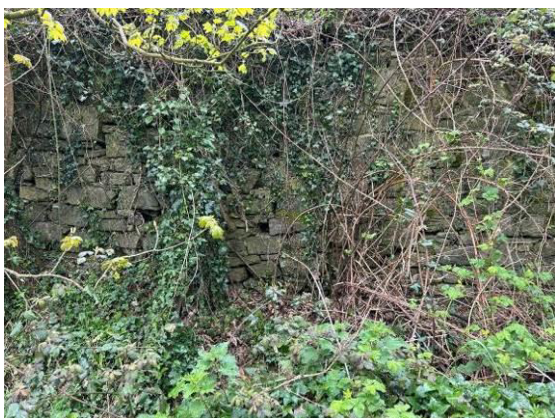
**Photo No. 4.24**

Vegetation on upstream side wall.

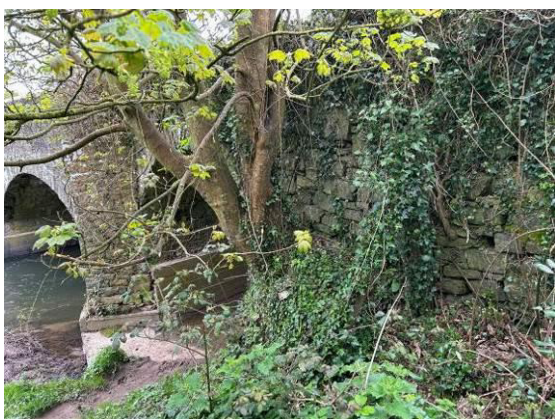
**Photo No. 4.25**

Vegetation on upstream side wall.

Note tree in close proximity to side wall.

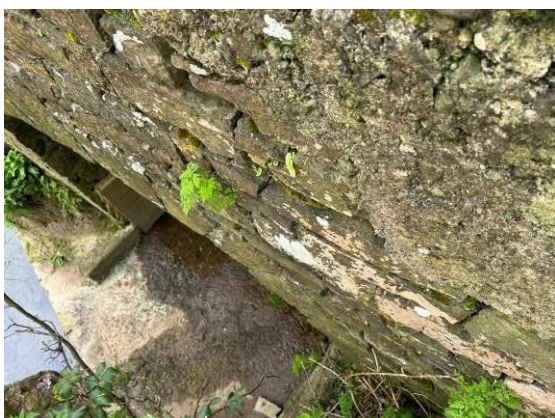
**Photo No. 4.26**

View of left hand side arch from above.

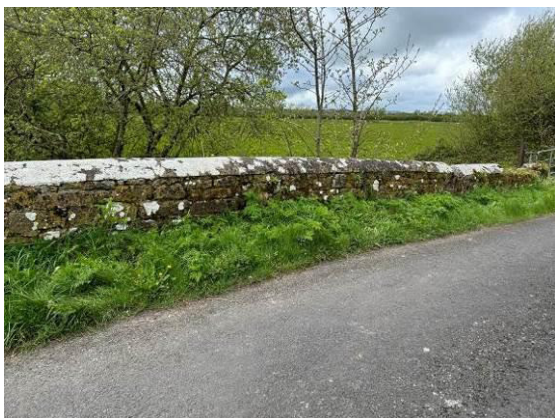
**Photo No. 4.27**

General view of downstream parapet wall.

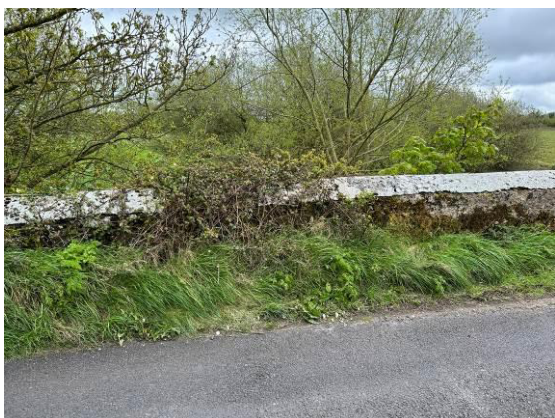
**Photo No. 4.28**

General view of downstream parapet wall

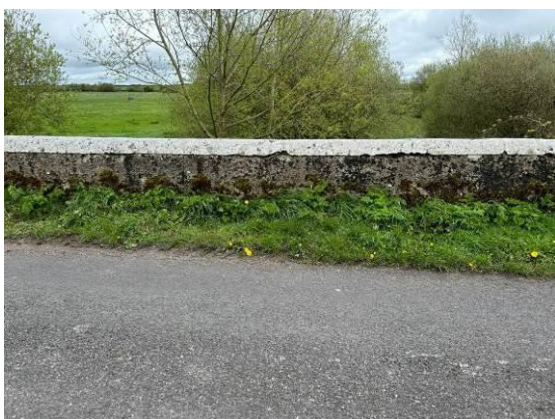
**Photo No. 4.29**

General view of downstream parapet wall.

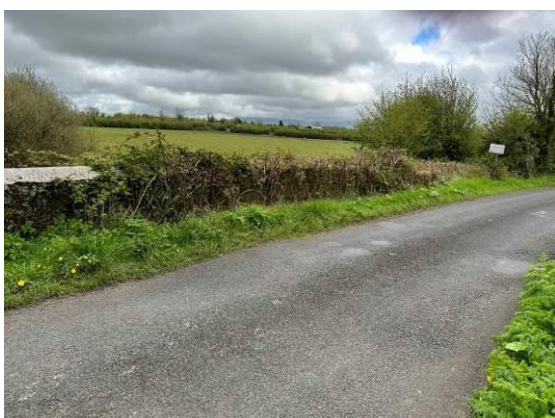
**Photo No. 4.30**

General view of upstream parapet wall.

Note heavy vegetation.
