Bridge inspection report

# ENVIRONMENTAL IMPACT ASSESSMENT REPORT (EIAR) FOR THE PROPOSED SHANCLOON WIND FARM, CO.GALWAY

## Bridge crossing number 1 Visual Structural Inspection

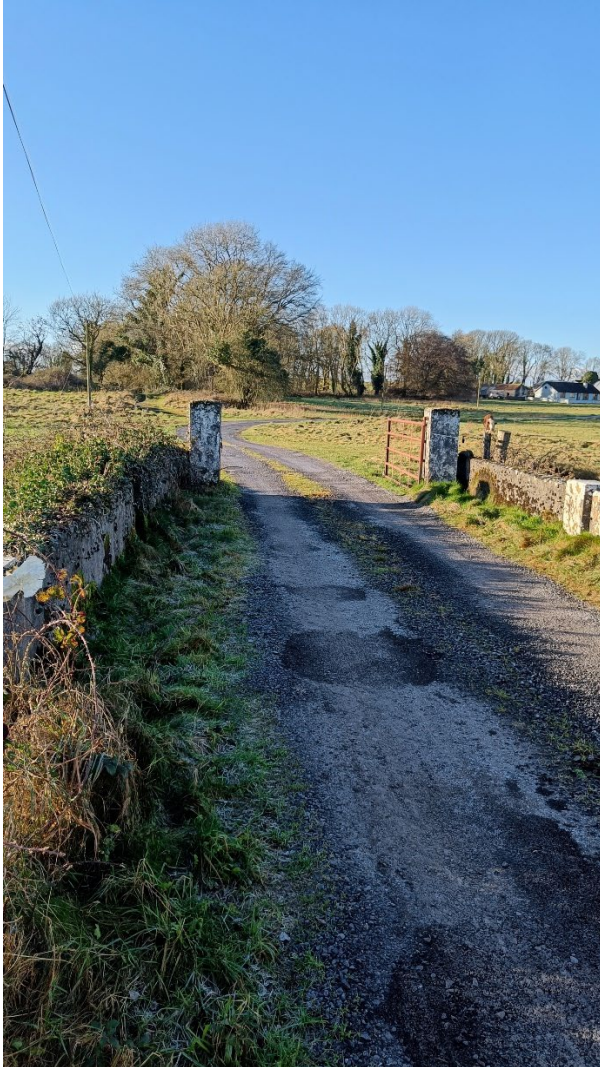
Inspection Notes	Good condition overall few minor areas east of the bridge are raveling (center of the carriageway east of the bridge in Appendix 1)	
Condition Rating	1	
Repair Needed	No

Appendix 1: Road surface: View facing west from the east side of the structure showing minor raveling along the side of the carriageway.

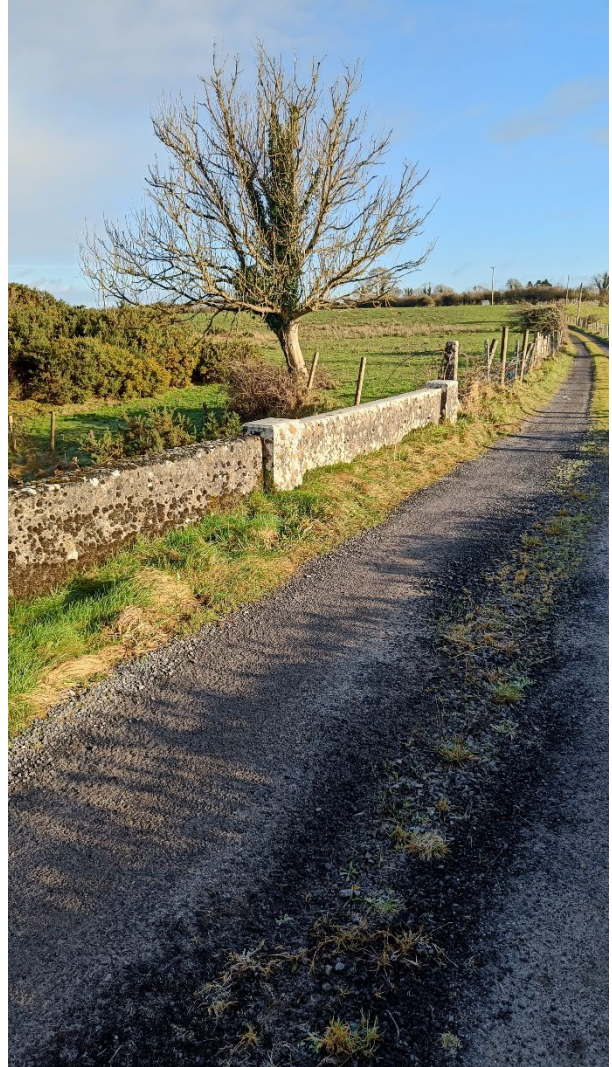
Appendix 2: Road surface/Parapet: View facing east from the west side of the structure.

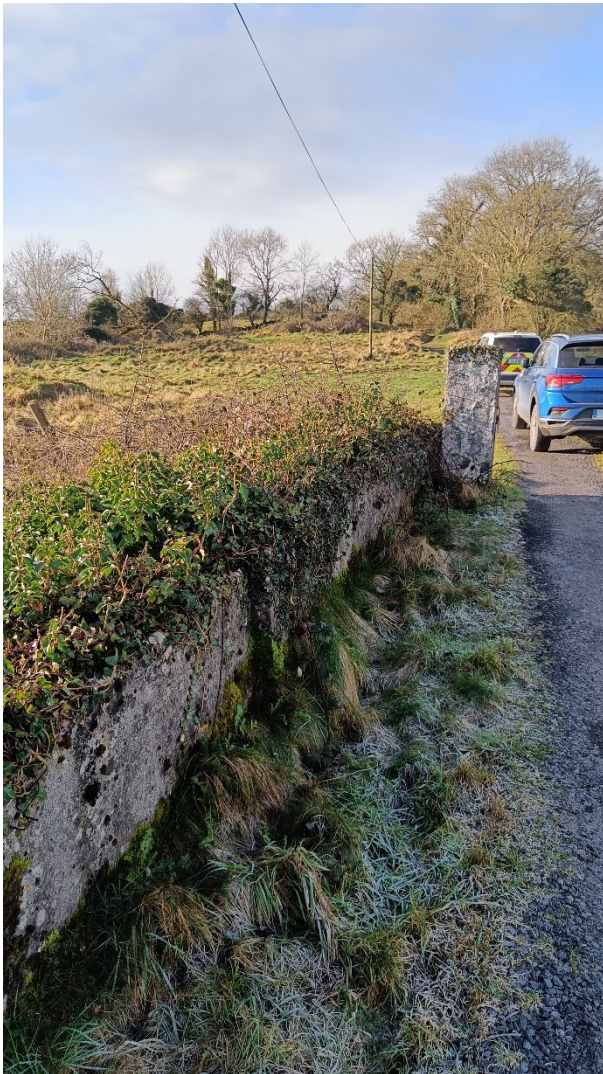
Inspection Notes	<p>The visible sections of the parapet are reinforced concrete and overall, in good condition with few areas fully/partially covered by vegetation (see appendix 3 and 6).</p> <p>On both sides, vegetation needs to be cleared to fully assess the structural condition of the parapets. On both sides parapets are 800mm high approximately. Which is lower than the minimum (1250mm) required by DN-STR-03011. Parapets should be rebuilt to achieve minimum height to be in accordance with current standards.</p>	
Condition Rating	2	
Repair Needed	Yes	Vegetation is to be removed to determine if any additional work is needed.

Appendix 3: Southern parapet/Retaining wall showing overgrown vegetation.

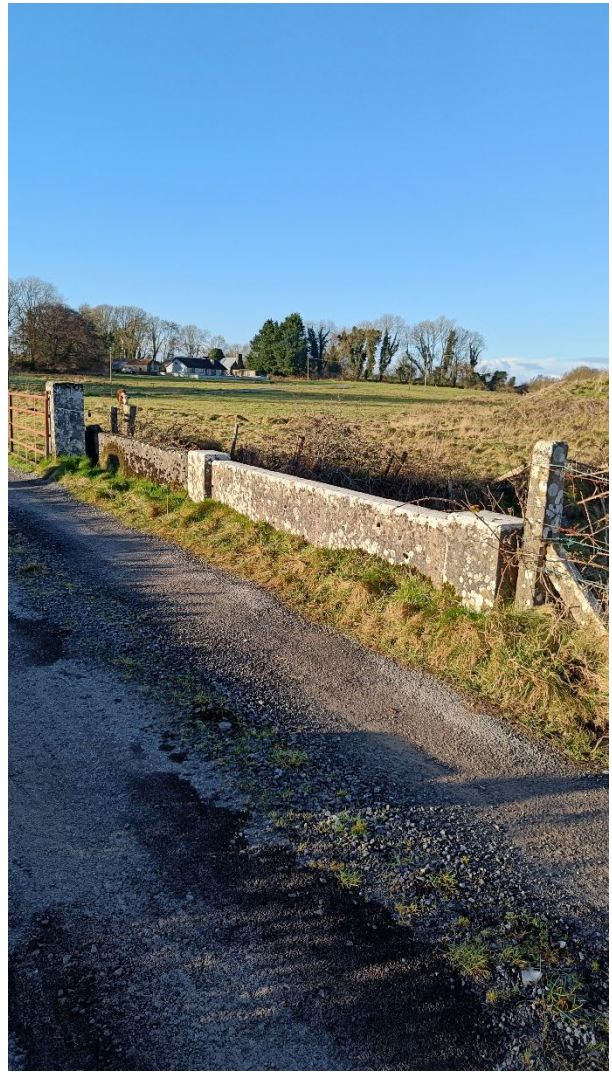
Appendix 4: Northern parapet view.

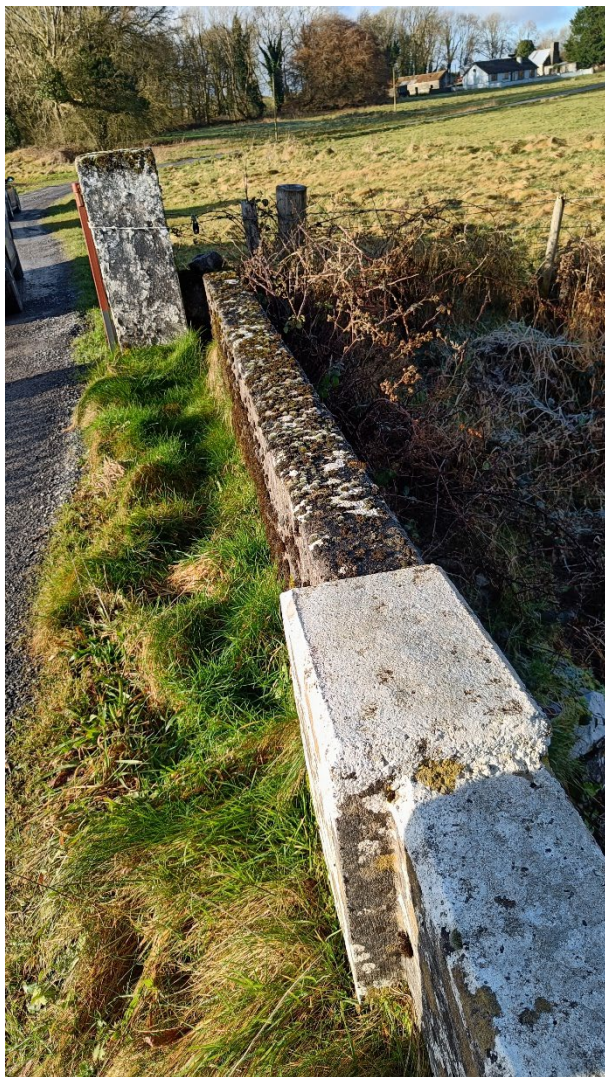
Appendix 5: Northern parapet view facing entrance of property – showing parapet covered in moss.

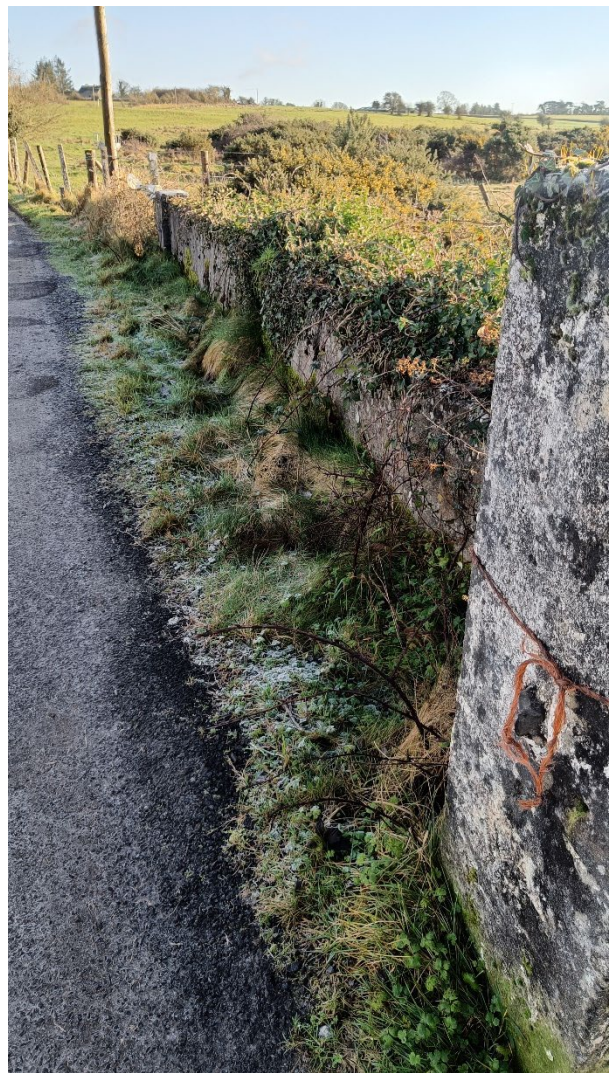
Appendix 6: Southern parapet/Retaining wall view from the entrance of property– showing overgrown vegetation.

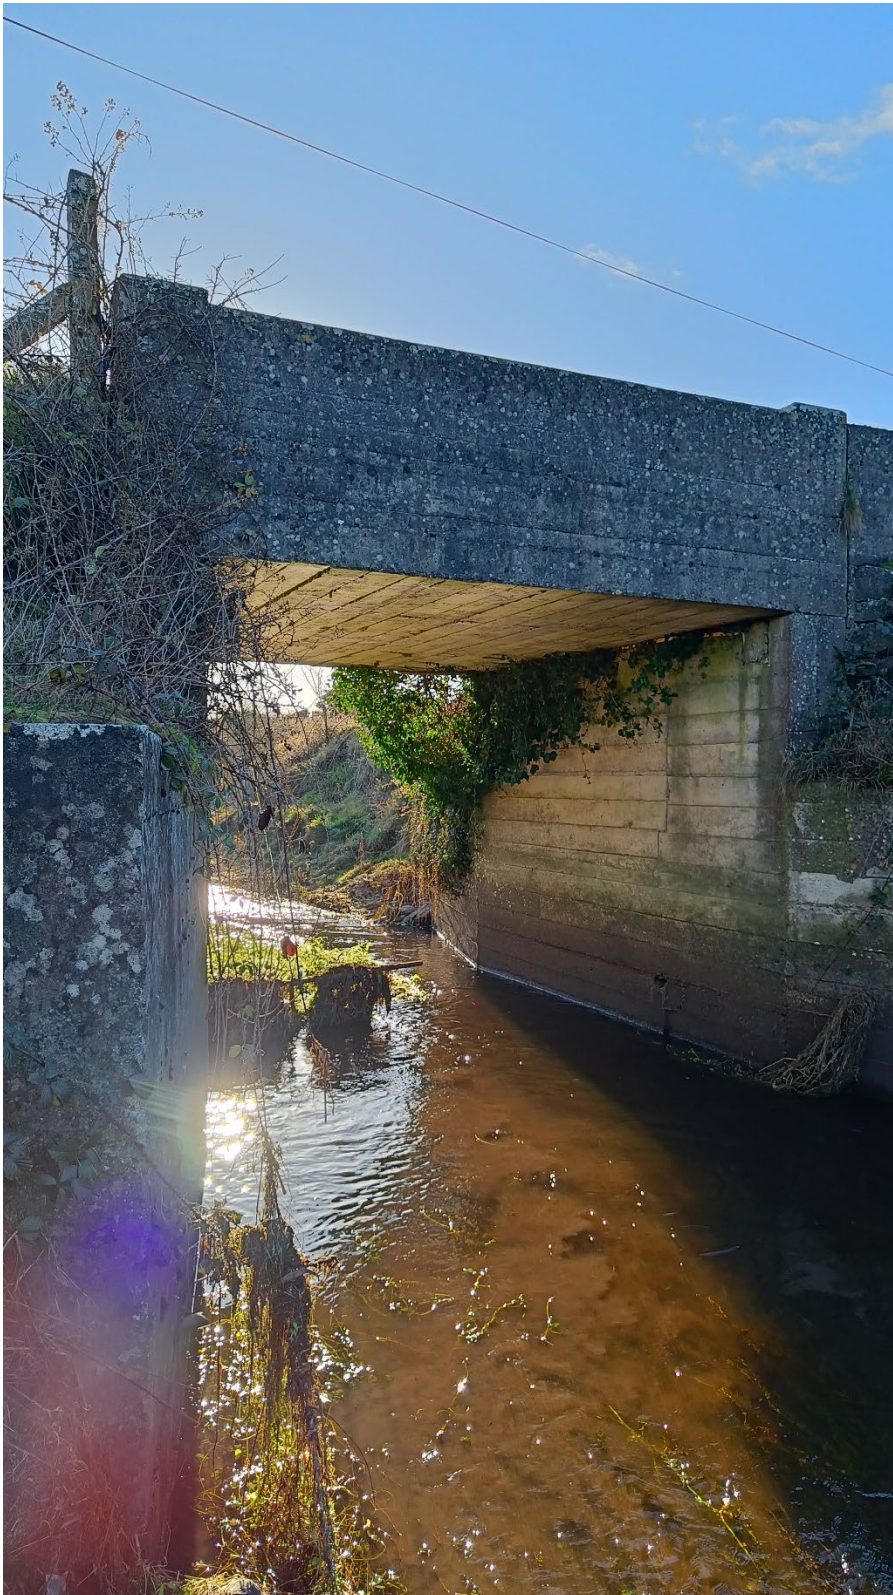
Inspection Notes	<p>No scour was observed on the abutments. Both abutments are reinforced concrete and generally in good condition, vegetation is partially covering the upper part of the western abutment (see appendices 7,9,10,14,15).</p> <p>A few crevices are visible on both abutments located approximately from 0.5m to 1m above the water level. Note that these openings do not seem to impact the structural integrity of the bridge (see appendices 9,11,12,13,17). The northern side wall on the eastern and western abutments displays cracks at the bottom in the order of 15 to 30 mm in width and 150 mm in length (see appendix 8 and 20). Upon clearance of vegetation, the rest of the abutment shall be inspected to determine if any further repair works are required.</p>	
Condition Rating	2	
Repair Needed	Yes	Vegetation to be cleared.

Appendix 7: View of the bridge from riverbed north side – showing heavily vegetated soffit of the bridge deck.

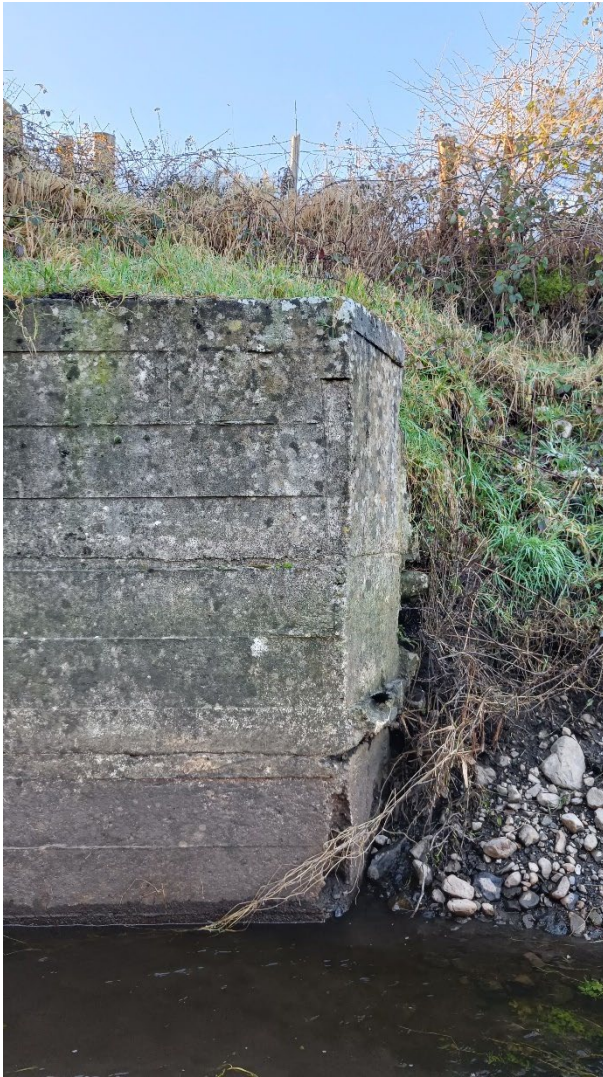
Appendix 8: West abutment view along the northern side – cracks shown at the bottom of the abutments needing repairs.

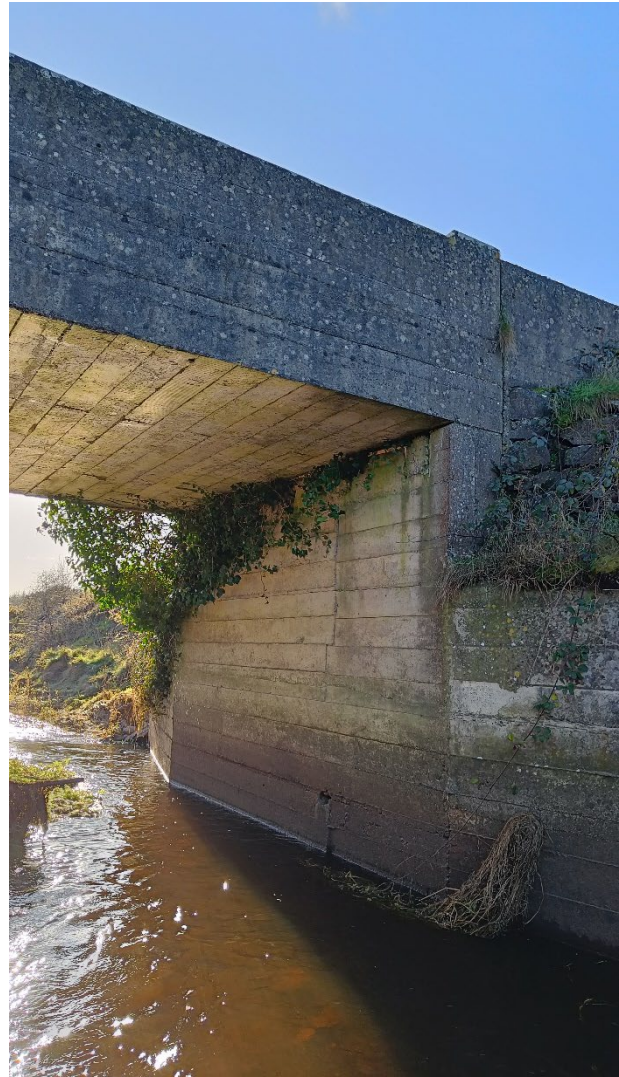
Appendix 9: West abutment view along the northern side – showing heavily vegetated soffit of the bridge deck and minor crevices approximately 0.5m above the water level at the center of the abutment.

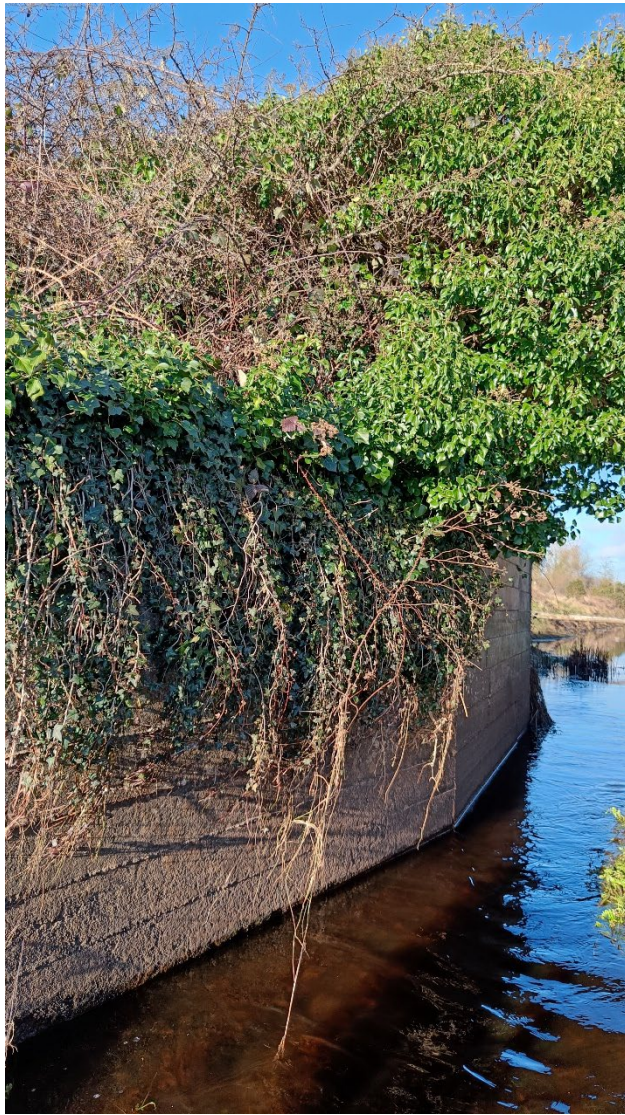
Appendix 10: West abutment view along the southern side – showing heavily vegetated abutment/ soffit of the bridge deck.

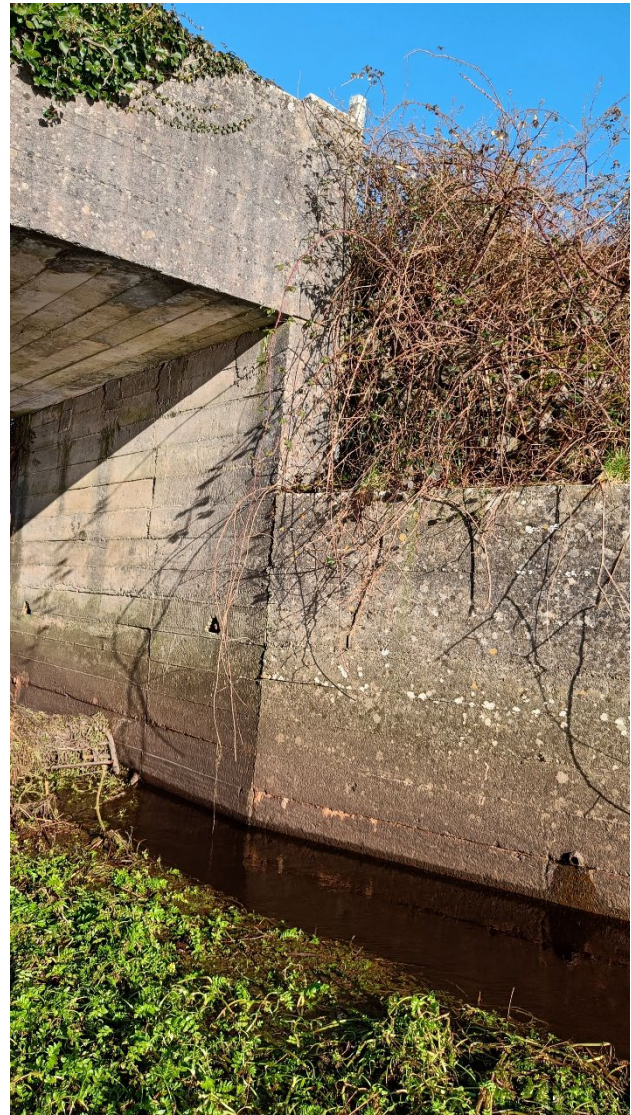
Appendix 11: East abutment view along the southern side – showing 2 no. minor crevices located 1m above the water level and 0.4m from the face of the bridge approximately.

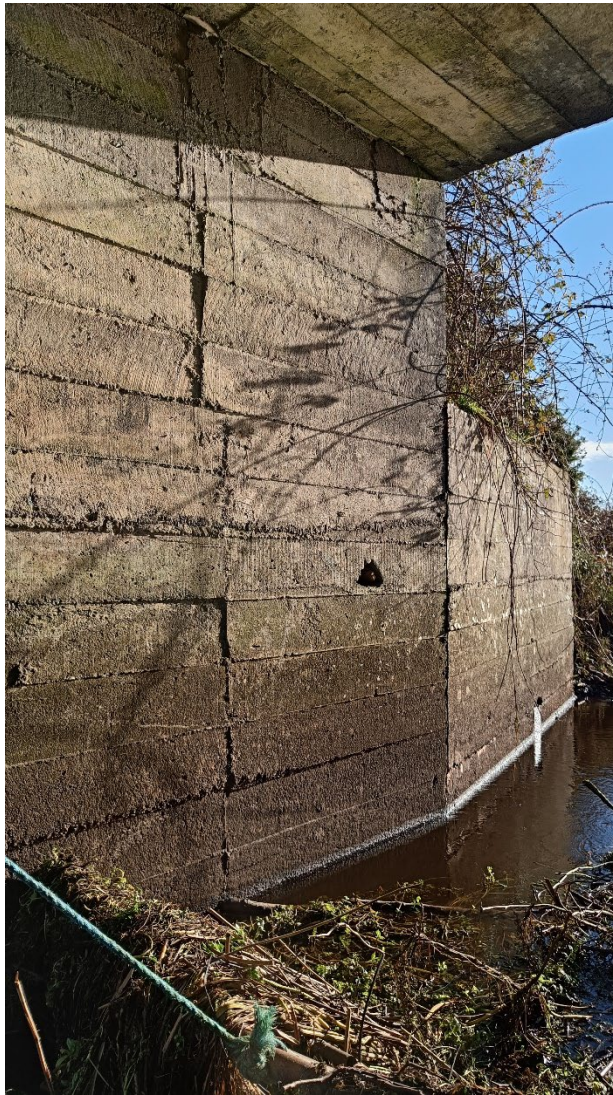
Appendix 12: East abutment view along the northern side – showing 1 no. minor crevices located 1m above the water level and 0.4m from the face of the bridge approximately.

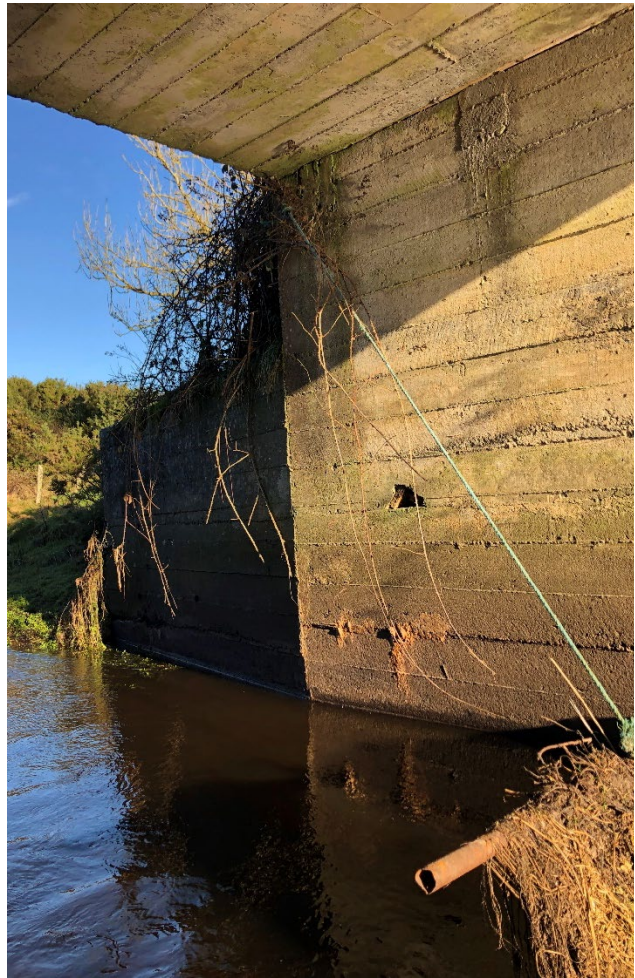
Appendix 13: East abutment view along the northern side – showing 1 no. minor crevices located 1m above the water level and 0.4m from the face of the bridge approximately.

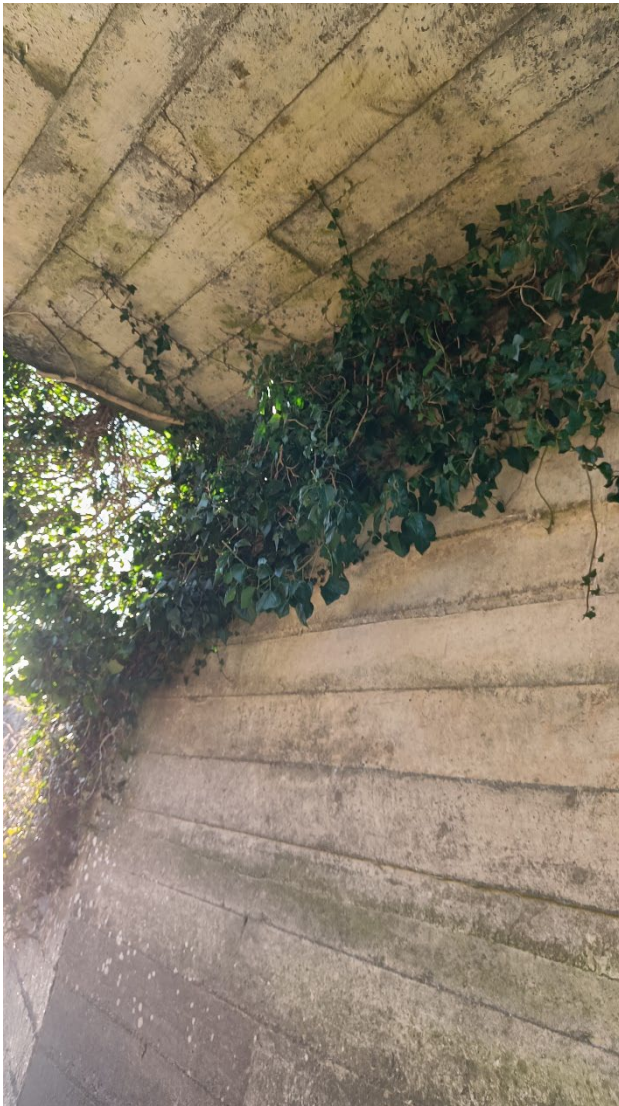
Appendix 14: West abutment and deck soffit front view – showing overgrown vegetation.

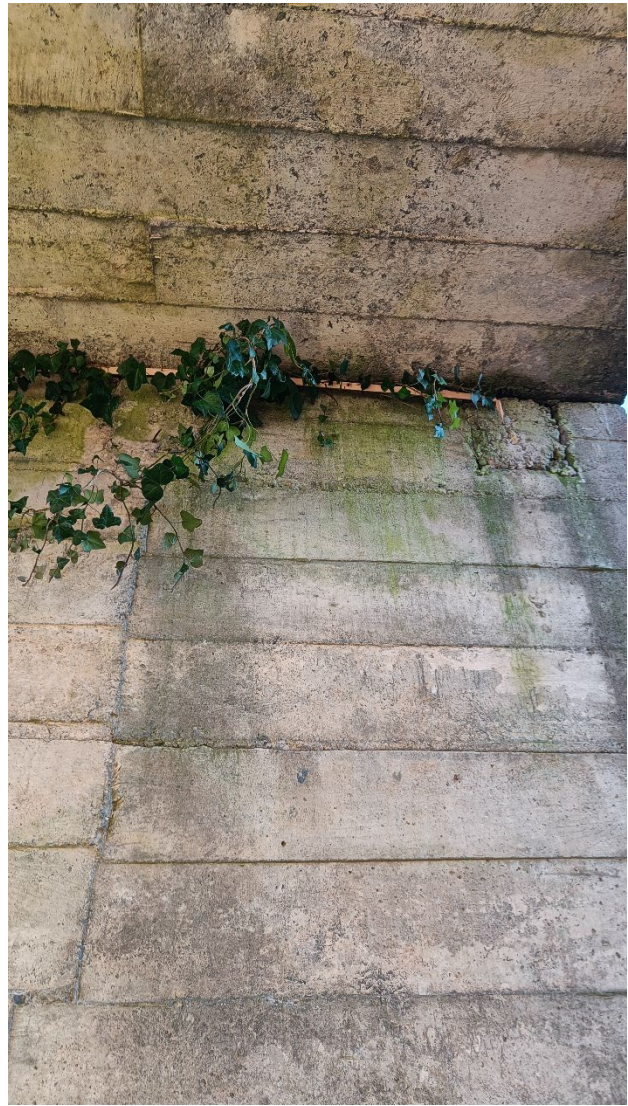
Inspection Notes	<p>The reinforced concrete slab is in good condition overall. No cracks are visible along the deck, however mild honeycombs in concrete are visible towards the western abutment (see Appendix 15).</p> <p>Vegetation is partially covering the deck area located towards the western abutment (see Appendices 14,15). An additional assessment will be carried out after vegetation clearance.</p>	
Condition Rating	1	
Repair Needed	No	However, additional assessment to be carried out once vegetation clearance is carried out.

Appendix 15: West abutment and deck soffit front view – showing concrete honeycombs area and overgrown vegetation.

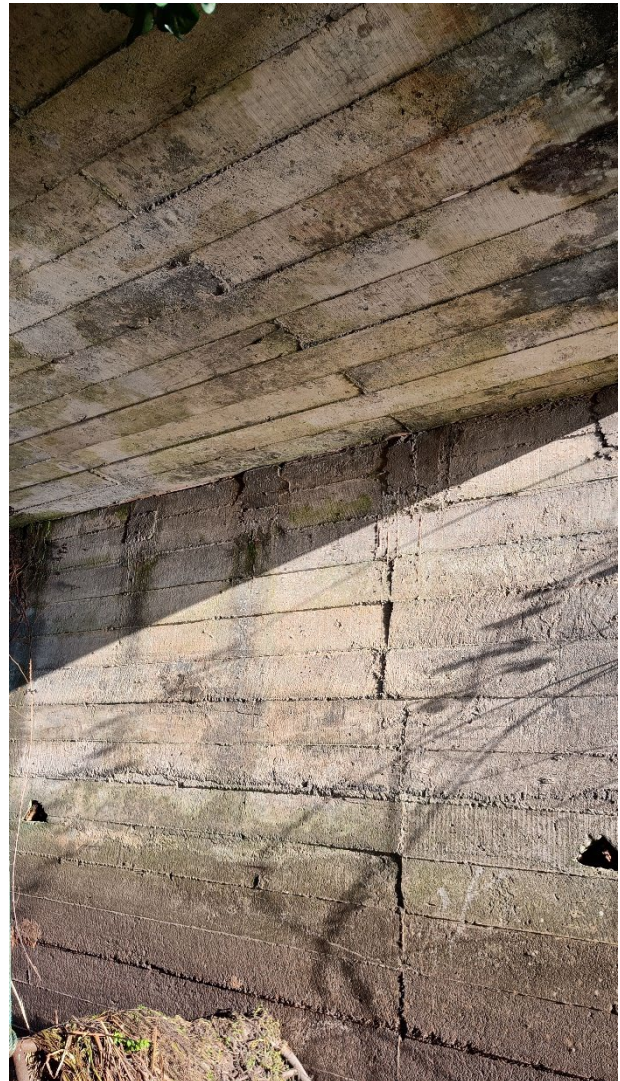
Appendix 17: East abutment and deck soffit front view – showing 2 no. minor crevices located 1m above the water level and 0.4m from the face of the bridge approximately.

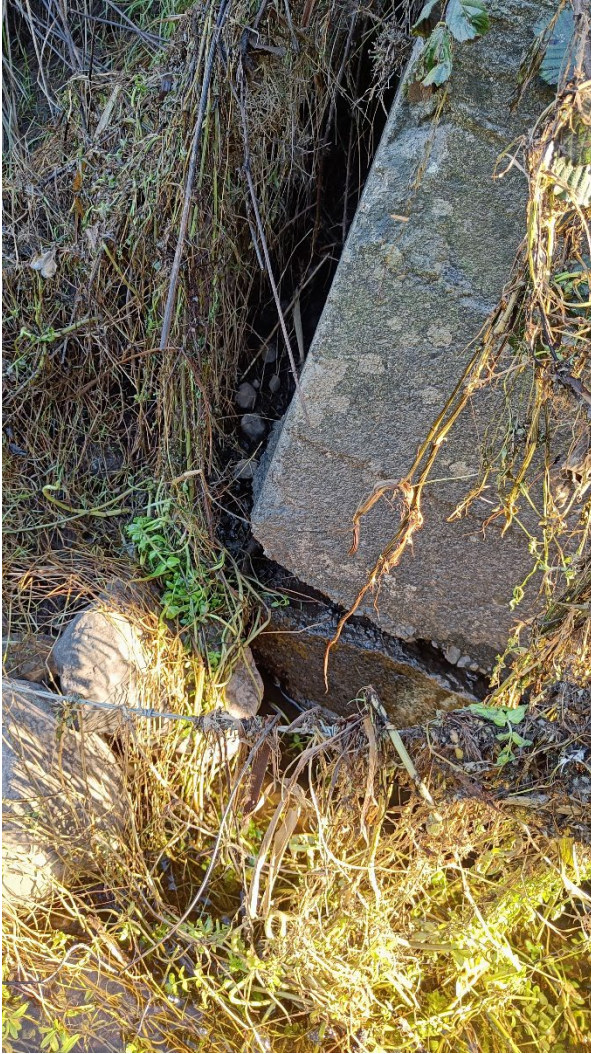
Appendix 20: Crack shown at the East Abutment side wall along the northern side of the bridge.
