## Tirawley Wind Farm

### Palmerstown Bridge Structural Assessment Report

**25<sup>th</sup> January 2023**

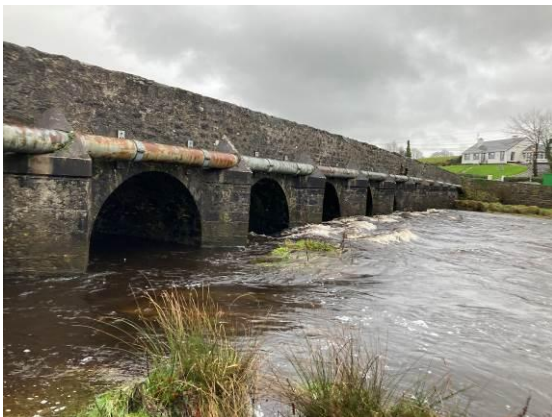
**Photo No. 2.4.1**

Upstream side of bridge from the left riverbank.

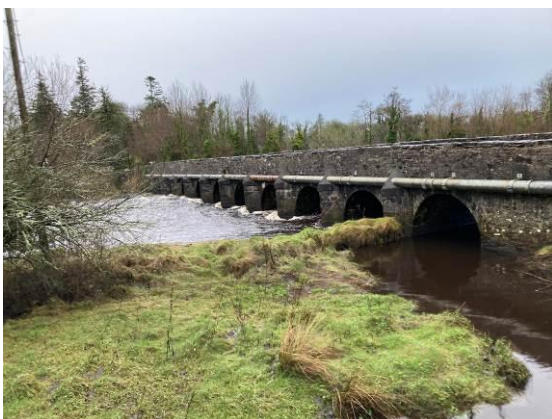
**Photo No. 2.4.2**

Upstream side of bridge from the right riverbank.

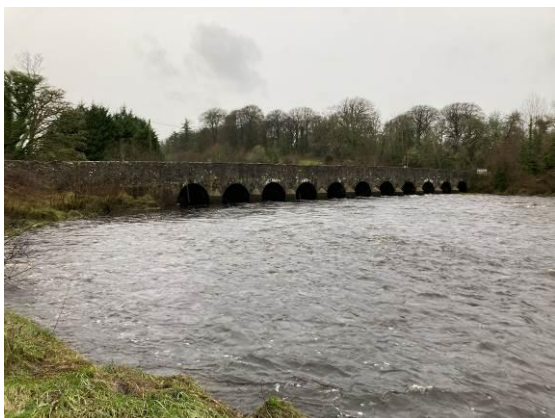
**Photo No. 2.4.3**

Downstream side of bridge from the right riverbank.

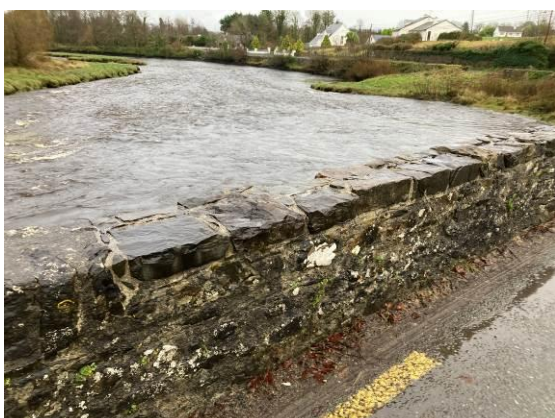
**Photo No. 2.4.6**

Typical example of repairs carried out on parapet walls.

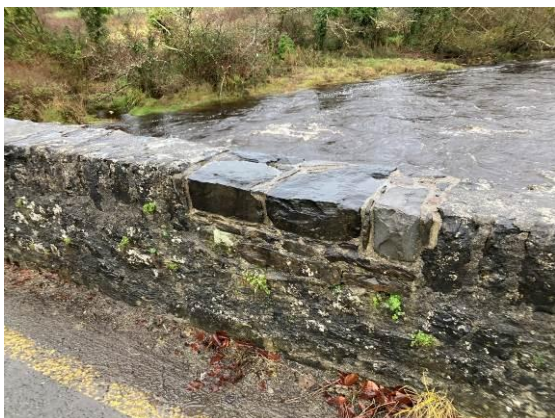
**Photo No. 2.4.7**

Typical example of repairs carried out on parapet walls.

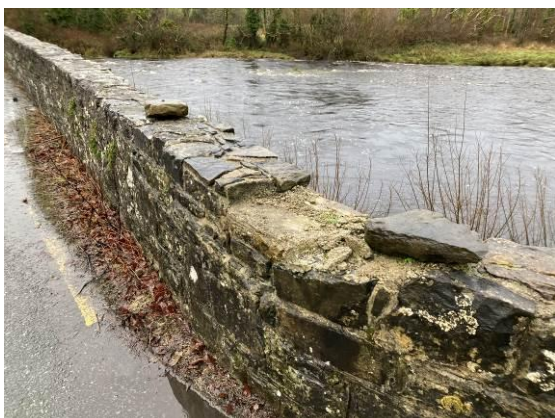
**Photo No. 2.4.8**

| Engineering Inspection Notes | | |
|---|---|---|
| 3 | Parapets | Some minor damage and missing stones were observed. |

Damage observed on downstream parapet wall.

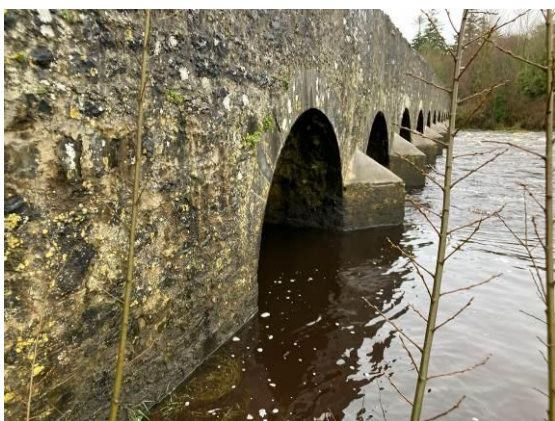
**Photo No. 2.4.9**

Arch on downstream side of bridge.

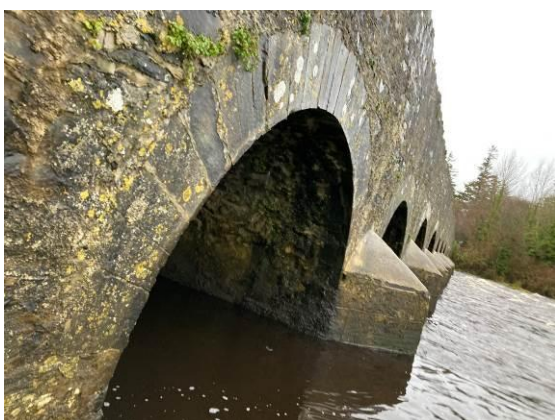
**Photo No. 2.4.10**

Arch on downstream side of bridge. Note arch appears to be in good condition.

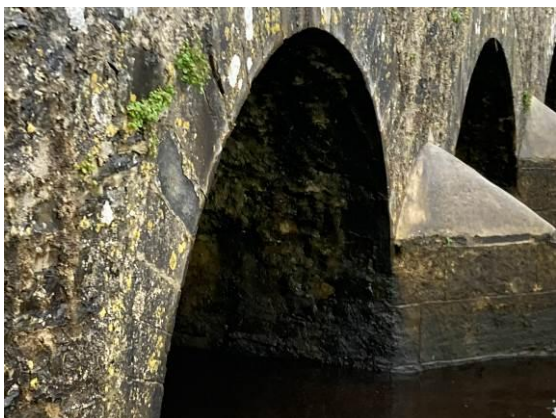
**Photo No. 2.4.11**

Arch on downstream side of bridge. Note arch appears to be in good condition.

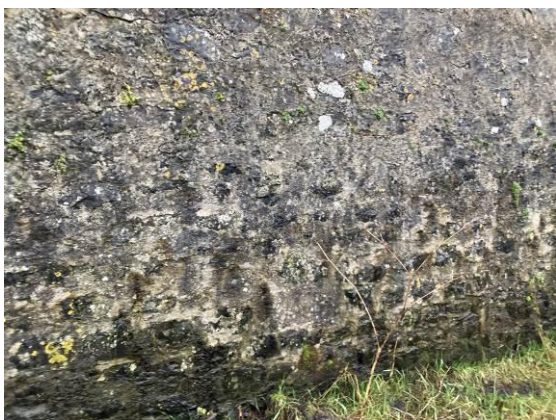
**Photo No. 2.4.12**

Side wall on downstream side in good condition.

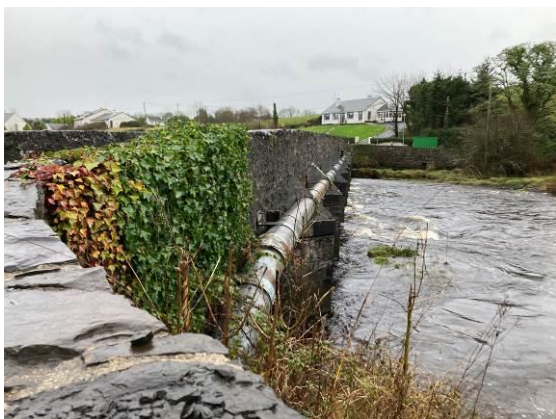
**Photo No. 2.4.13**

Watermain attached to upstream side of bridge. Note vegetation.

| Engineering Inspection Notes | | |
|---|---|---|
| 2 | Parapets and Spandrel Walls | Parapets and spandrels walls partly overgrown with vegetation. We recommend that this is removed when convenient. |

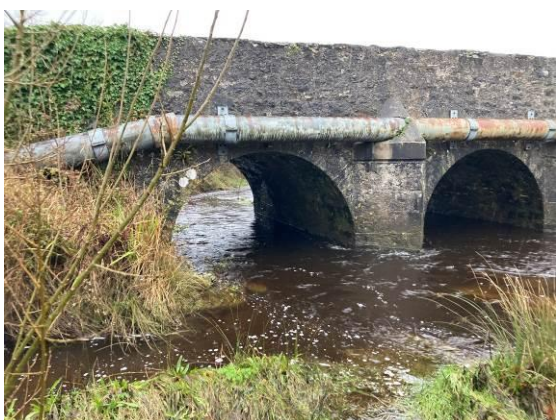
**Photo No. 2.4.14**

Watermain attached to upstream side of bridge. Note vegetation.

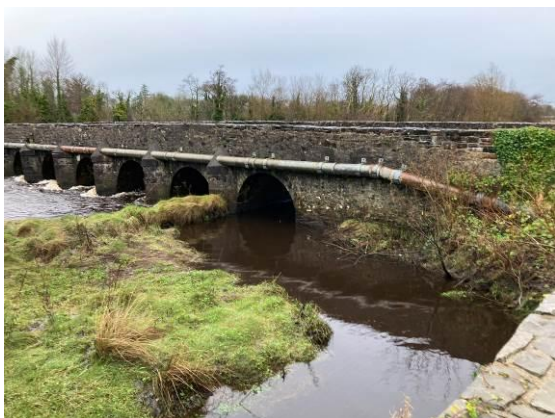
**Photo No. 2.4.15**

Watermain attached to upstream side of bridge.  
Note vegetation.

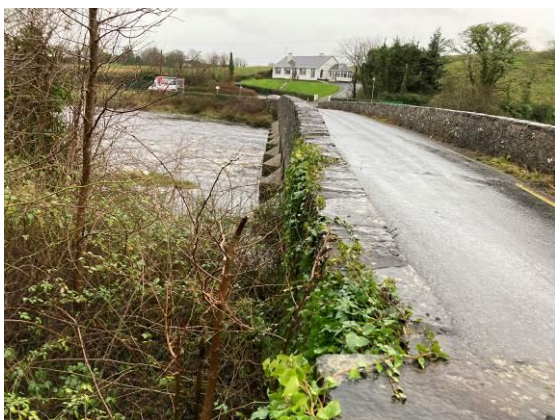
**Photo No. 2.4.16**

Downstream side wall. Note vegetation.
