Building Record Reports

Cleeves Former Condensed Milk Factory Cleeves Riverside Quarter

Client: Limerick 2030

Date: 15th of October 2025

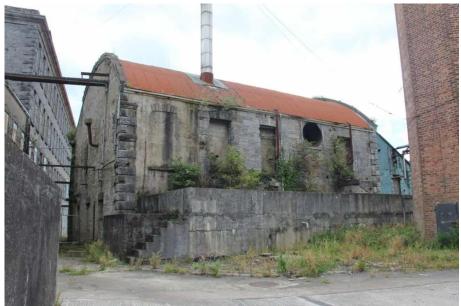
The original building, the Engine House has a curved corrugated iron roof covering, with concrete barges. There is a modern stainless steel chimney stack protruding from the roof.

Photograph 2 External view of the Engine House. Note curved corrugated sheeting and chimney stack protruding from the roof.

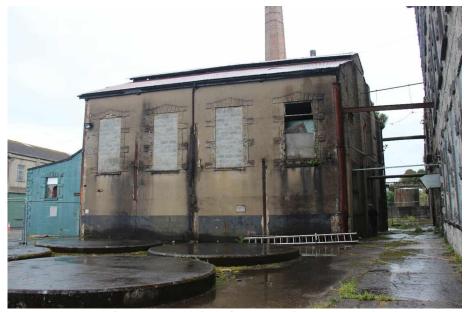
Some sections of the external walls are rendered, most notably the eastern elevation, which is finished with a ruled Ashlar Stucco and rusticated stone imitation window surrounds, an attempt to match the Engine House and Mill itself.

Photograph 6 Eastern elevation of the extension to the Engine House.

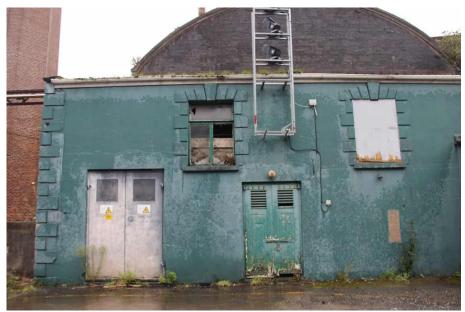
The external elevations are painted, with an Ashlar Stucco render and raised replica masonry quoins and window surrounds, to match the original buildings, all be without the rustication effect on the quoins and window surrounds.

Photograph 7 Southern elevation of the building 3 extension.

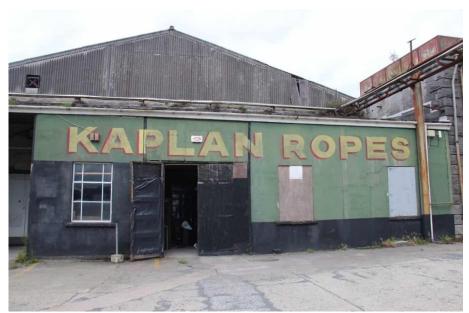
As noted above, there is suspected remnants of the façade of the dye house building located within the front section of the current warehouse building, covered in by the lean to building.

Photograph 2 Front elevation of subject building.

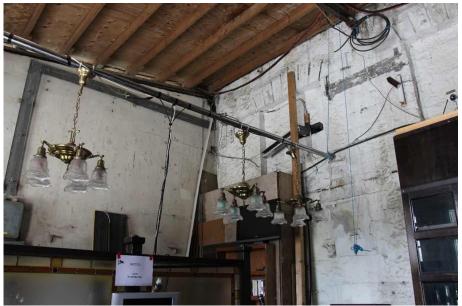
Photograph 3 - Example of the suspected original façade of the dye house, surviving within the current warehouse complex.

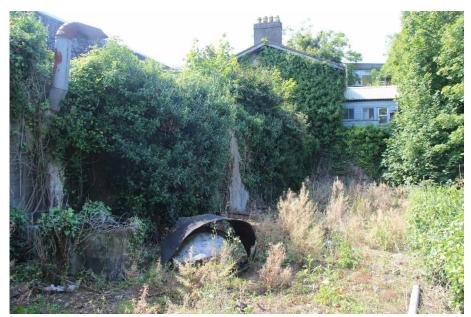
Photograph 4 General view of the rear of the Cheese Plant complex. Note overgrowth to rear walls.

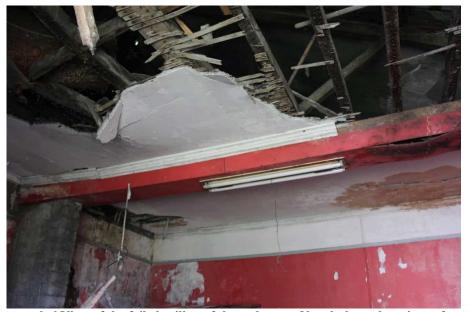
The ceilings to the end room have failed locally, with the roof structure exposed internally.

Photograph 6 View of the failed ceiling of the end room. Note laths and sections of coving.

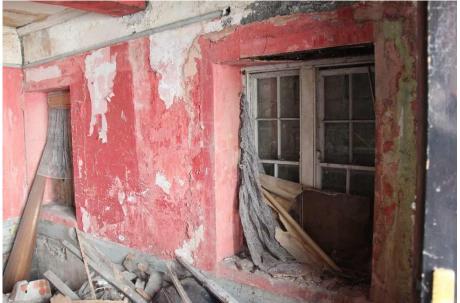
The end room walls appear to have been drylined (evident from the failed window soffit).

Photograph 8 View of the internal elevation of the external wall to the end room.

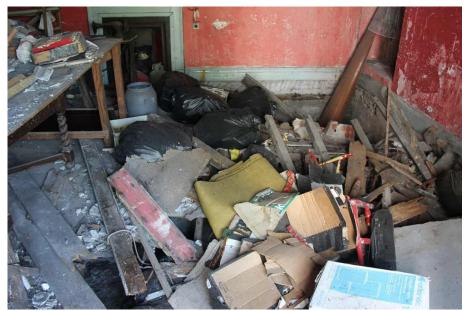
The main section of the building is finished with a concrete floor, the end room is finished with a suspended timber floor, now long since failed.

Photograph 9 View of the floor of the end room. Sprung timber floor. Failed.

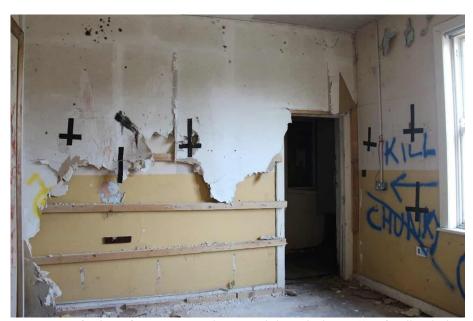
Photograph 8 View of the damaged internal lining within the "welfare" building.

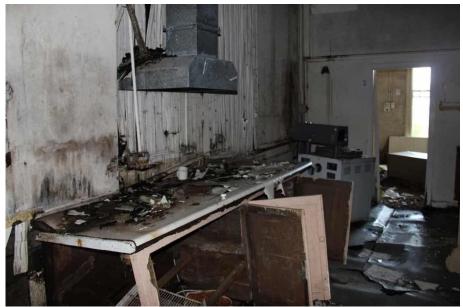
Photograph 15 Laboratory with an example of the timber sprung floors, all decimated with rot now.

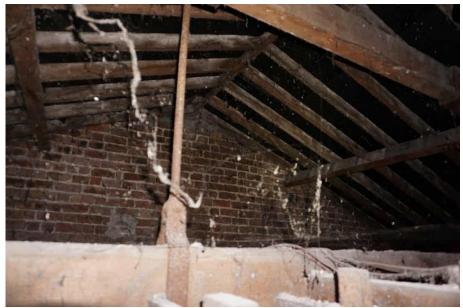
Attic has a cut timber roof consisting of cementitious replacement slates on bitumen underlay on original timber rafters on purlins with truss supports. Cast iron hangers are used to tie the truss members. The original lime parging is evident between the joists.

Photograph 26 - Roof Space indicating cast iron hanger.

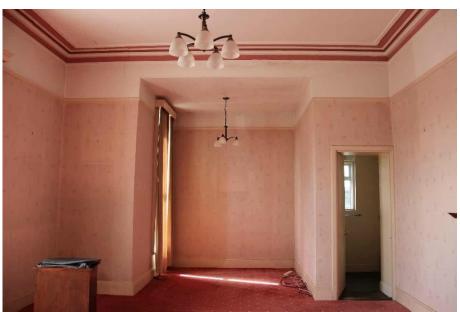
Photograph 19 - Original gable wall broken through to provide for modern extension.

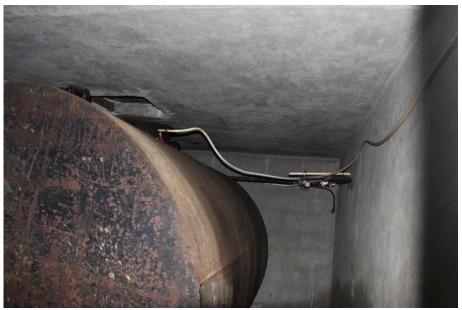
The services installations are noted to be mostly modern, with fluorescent tubed fittings throughout the building, modern electrical sockets and light switches mounted to the walls etc. As these have been dormant a fully electrical audit and assessment is advised. Radiators are used throughout.

Photograph 36 - Small basement rooms house the oil tanks and burner. Electrical distribution boards may also be located here.
