# Pre-Demolition Waste Audit Report

Limerick 2030

October 2025

# CLEEVES RIVERSIDE QUARTER

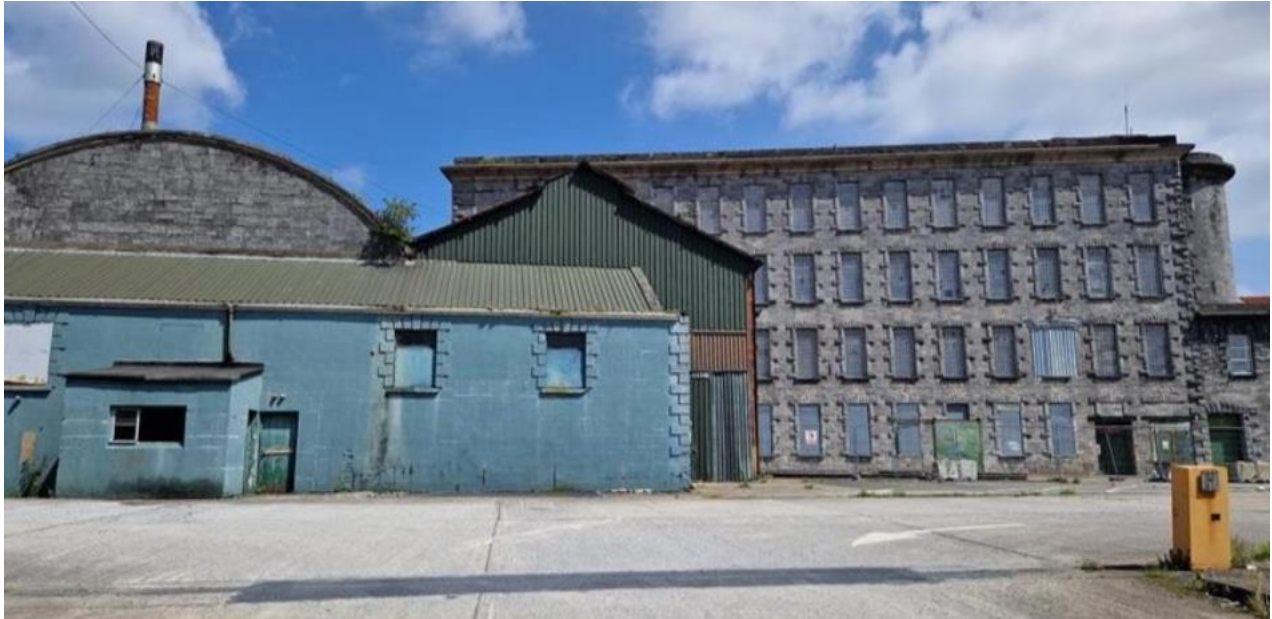
**Figure 3-3 - View of Flaxmill area from North Circular Road**

The Flaxmill building is a four-storey stone masonry building with a two-storey lean-to extension located at the eastern elevation of the original building. The outer façade of the original building comprises of cut course limestone walls and rock-faced quoins. Some corrosion was noted to the steel lintels over the doors and windows to the façade.

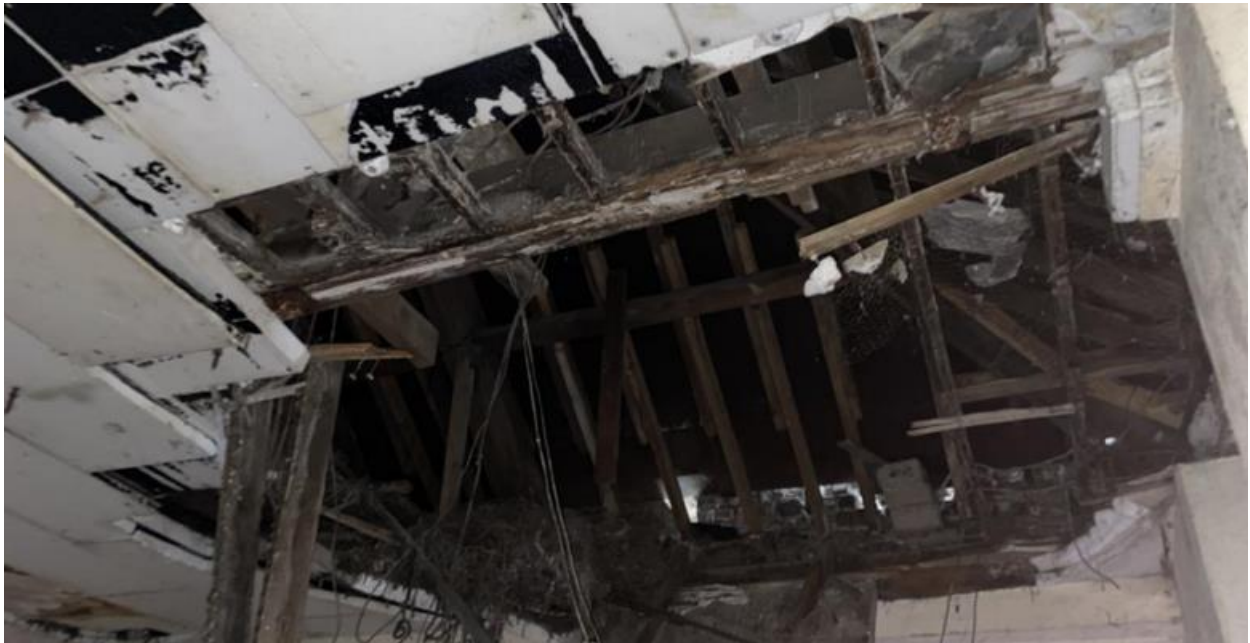
**Figure 3-4 – Collapsing roof showing exposed timber structure within the Flaxmill building (photo taken from Phoenix ACM Survey report)**

The roof of the Flaxmill comprises a timber hipped roof which appears to be in a very poor state of repair. The timber structure is supported on cast iron columns internally and walls externally. There is significant water ingress at hipped ends of the roof, which has led to extensive ceiling and timber joist damage with the ceiling collapsing in various locations on this floor. There is evidence of horizontal cracking internally to the walls at the top floor and there is propping evident to the window heads close to the northern elevation.

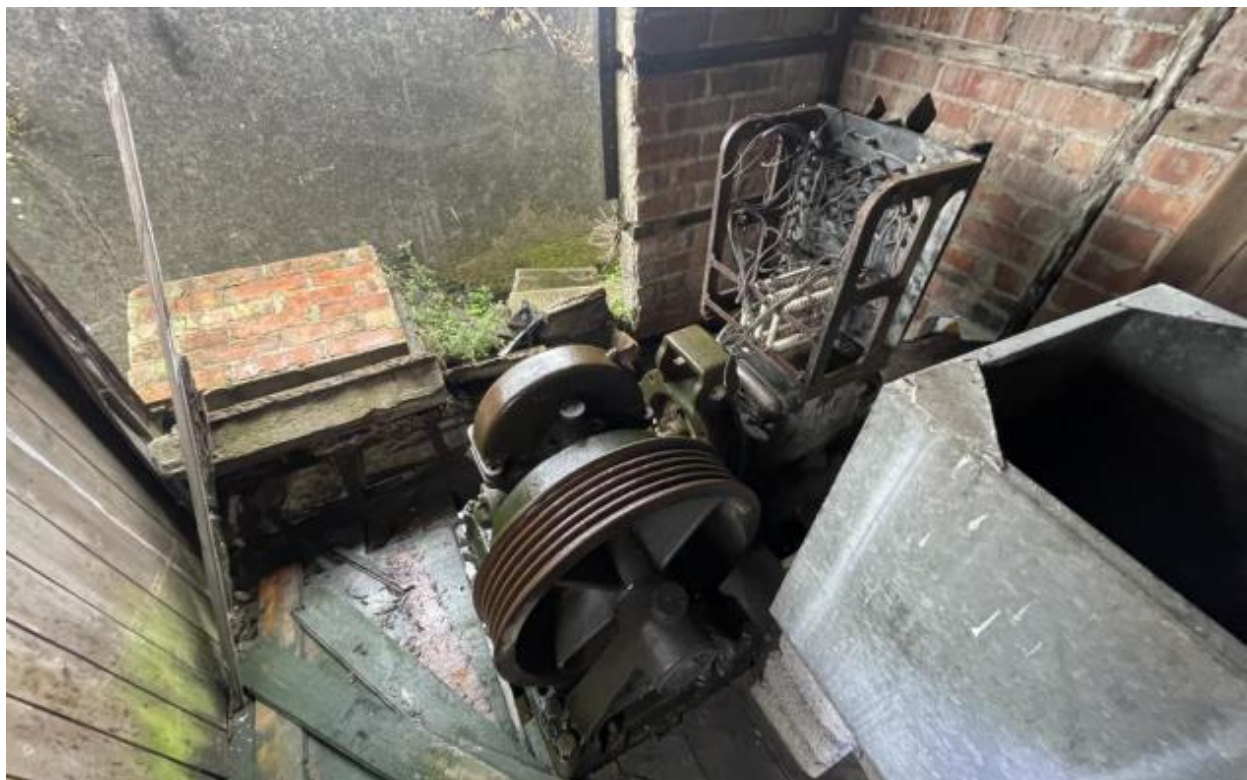
Figure 3-6 – Lift motor unit in the Flaxmill building (photo taken from Phoenix ACM Survey report)

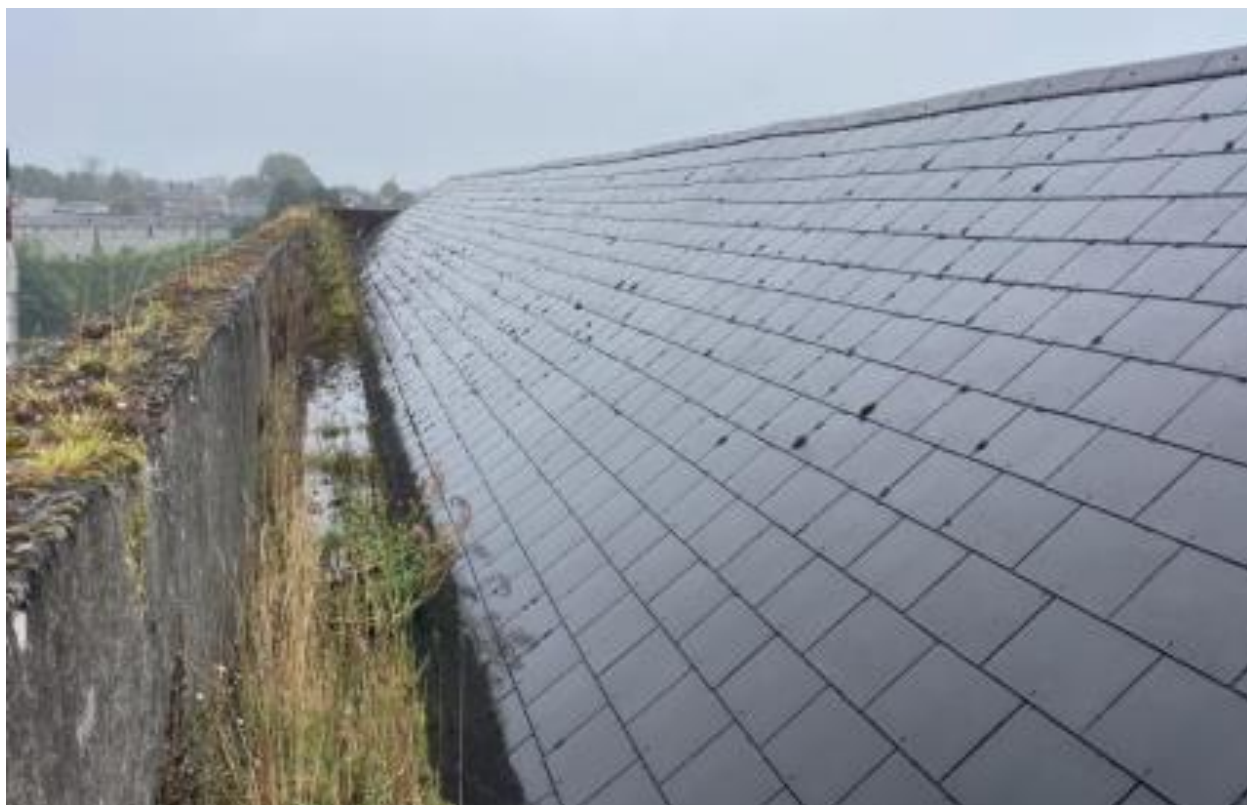
**Figure 3-7 Concrete parapet and cement tile roof on the Flaxmill building (photo taken from Phoenix ACM Survey report)**

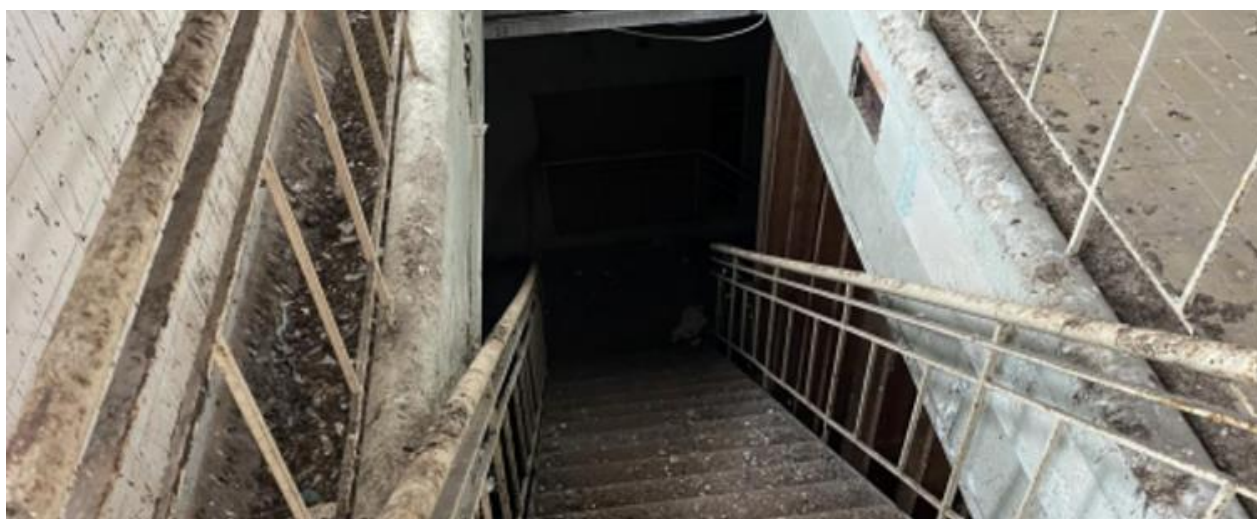
**Figure 3-18 – Stairway (steel handrails) and ACM board within the Packaging Store and Offices (photo taken from Phoenix ACM Survey report)**

It may be possible to dismantle the metal structures on site such as metal stairs, handrails, propping, metal sheeting found on site.

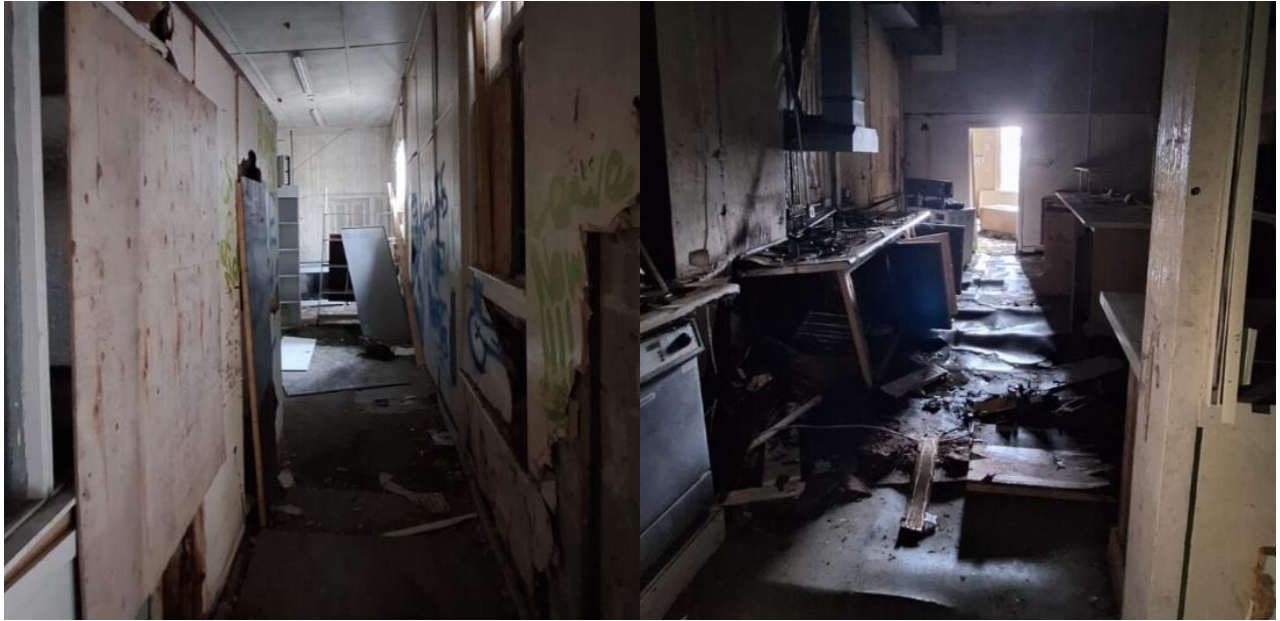
**Figure 3-27 – Offices and Laboratory – Delict insides**

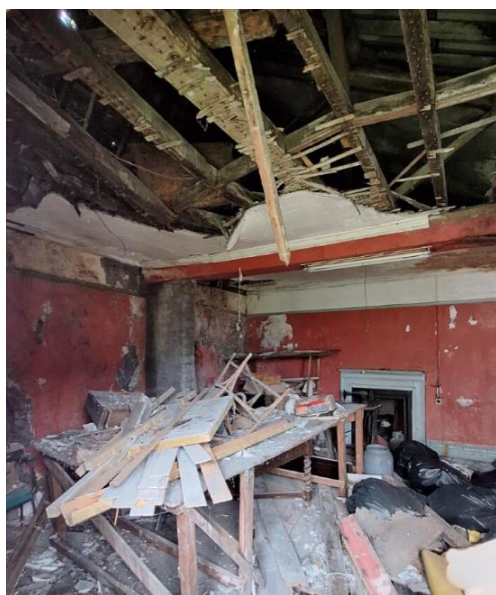
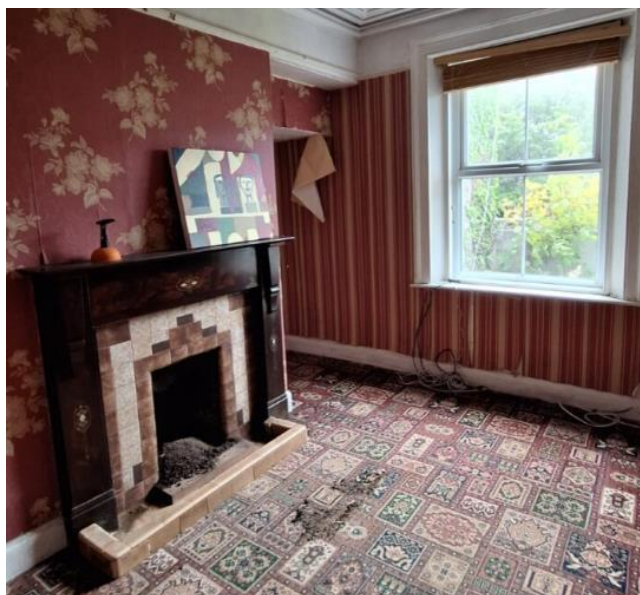
Figure 3-32– Victorian houses – Internals (Different conditions)
