# **ENVIRONMENTAL IMPACT ASSESSMENT REPORT**

### Appendix 19-1 Asbestos Survey Report

## ASBESTOS SURVEY REPORT

**Location:** The Cleeves Site,  
North Circular Road, Limerick

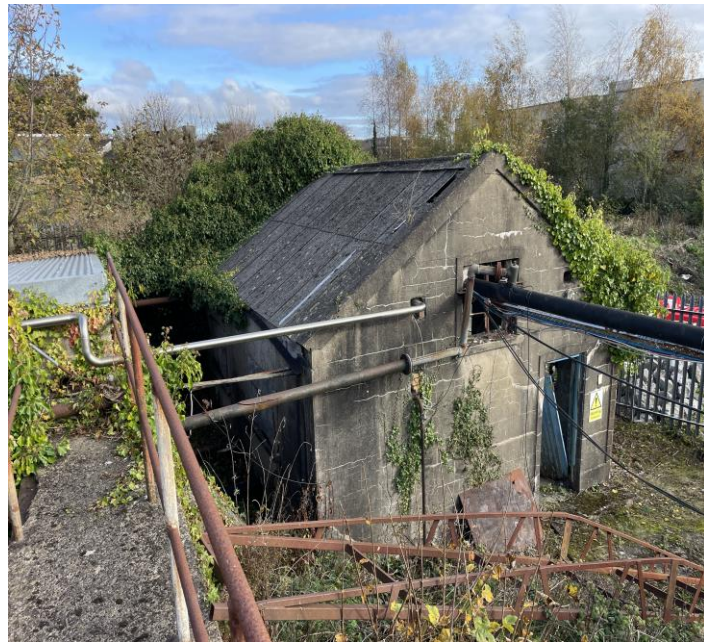
| Location | Roof areas |
| Extent/<br>Amount | 90 m <sup>2</sup> total approx. |

| | MATERIAL ASSESSMENT | | PRIORITY ASSESSMENT |
|---|---|---|---|
| Extent of damage | Damaged | Likelihood of disturbance | N/A |

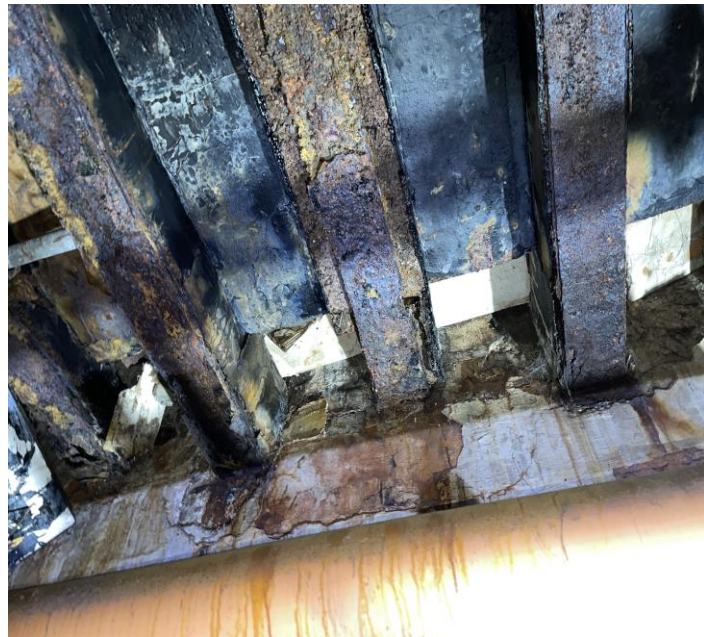
| Location | Ceiling |
| Extent/<br>Amount | Not quantified |

| | MATERIAL ASSESSMENT | | PRIORITY ASSESSMENT |
|---|---|---|---|
| Extent of damage | High | Likelihood of disturbance | N/A |

The asbestos insulation board (AIB) should be removed under controlled conditions by a specialist asbestos removal contractor and disposed of as asbestos waste before the demolition works commence. The upper floors in Building 2 were inaccessible to assess the quantity of the material

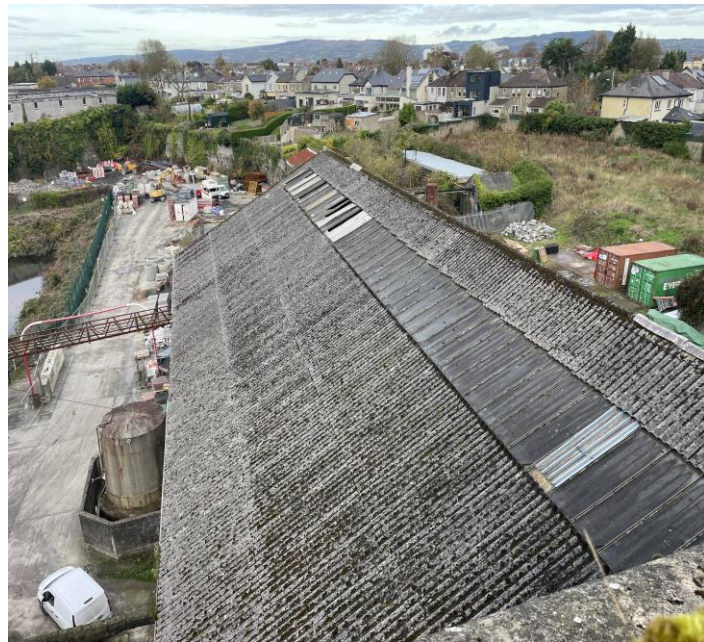
| Location | Roof & sides of building |
| Extent/<br>Amount | 720 m <sup>2</sup> approx. |

| | MATERIAL ASSESSMENT | | PRIORITY ASSESSMENT |
|---|---|---|---|
| Extent of damage | High | Likelihood of disturbance | N/A |

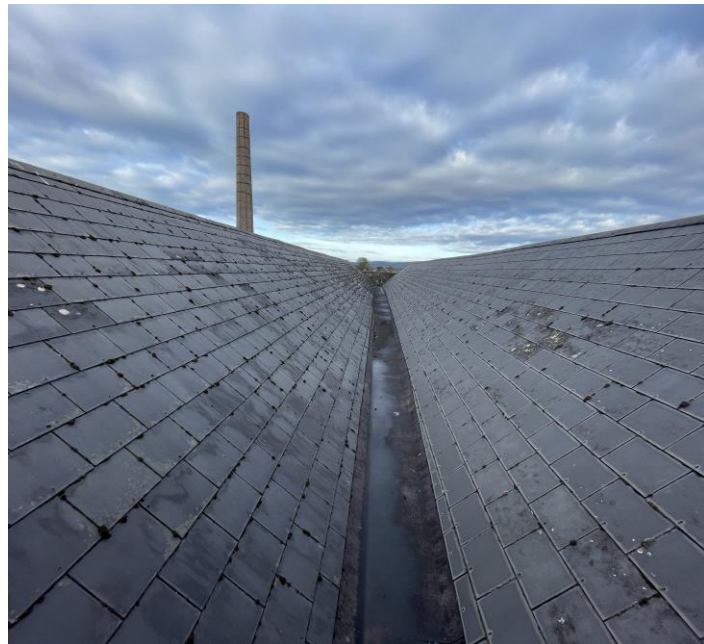
| Location | Roof |
| Extent/<br>Amount | 600 m <sup>2</sup> approx. |

| | MATERIAL ASSESSMENT | | PRIORITY ASSESSMENT |
|---|---|---|---|
| Extent of damage | Low | Likelihood of disturbance | N/A |

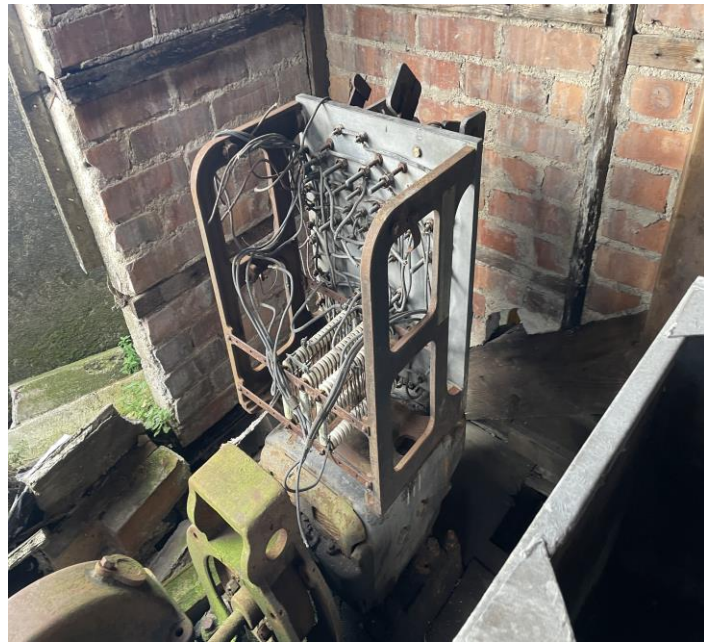
| Location | Lift motor room |
| Extent/<br>Amount | Electrics |

| | MATERIAL ASSESSMENT | | PRIORITY ASSESSMENT |
|---|---|---|---|
| Extent of damage | Low | Likelihood of disturbance | N/A |

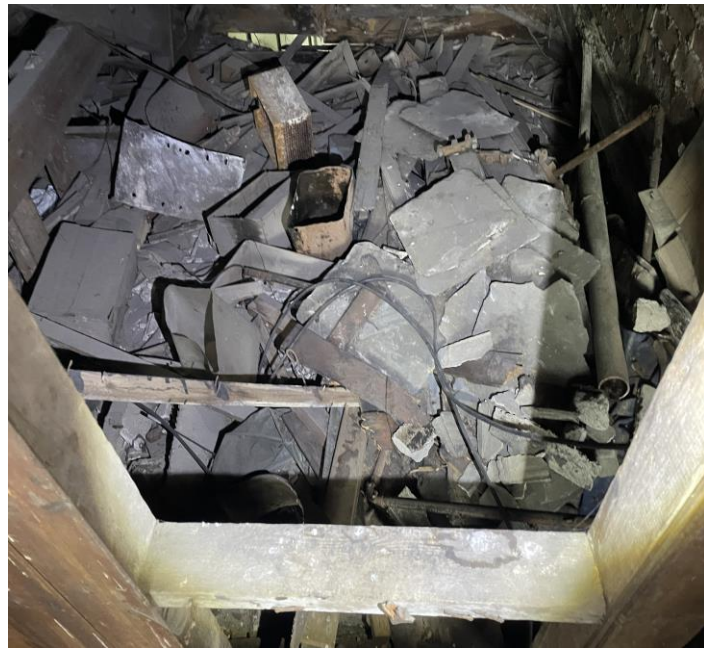
| Location | Attic |
| Extent/<br>Amount | Beside lift motor room |

| | MATERIAL ASSESSMENT | | PRIORITY ASSESSMENT |
|---|---|---|---|
| Extent of damage | Medium | Likelihood of disturbance | N/A |

The cement and insulation board debris should be removed under controlled conditions by a specialist asbestos removal contractor and disposed of as asbestos waste before the demolition works commence.

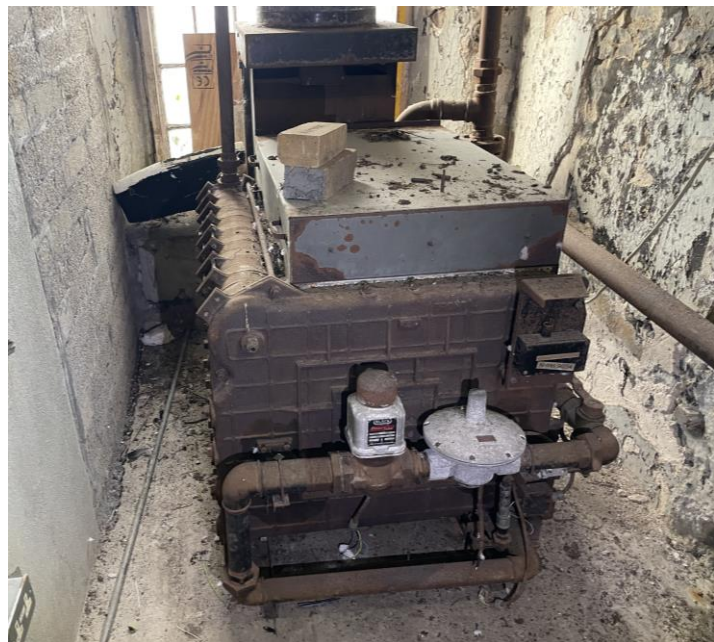
| Location | 3 <sup>rd</sup> floor |
| Extent/<br>Amount | Boiler unit |

| | MATERIAL ASSESSMENT | | PRIORITY ASSESSMENT |
|---|---|---|---|
| Extent of damage | Low | Likelihood of disturbance | N/A |

The thermal insulation should be removed under controlled conditions by a specialist asbestos removal contractor and disposed of as asbestos waste before the demolition works commence.

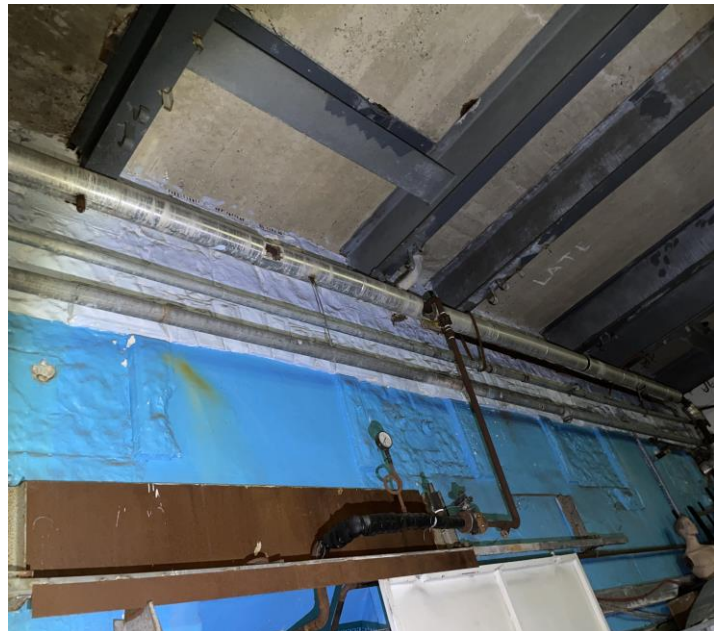
| Location | Ground floor |
| Extent/<br>Amount | 23 linear meters approx. |

| | MATERIAL ASSESSMENT | | PRIORITY ASSESSMENT |
|---|---|---|---|
| Extent of damage | Medium | Likelihood of disturbance | N/A |

The thermal insulation should be removed under controlled conditions by a specialist asbestos removal contractor and disposed of as asbestos waste before the demolition works commence.

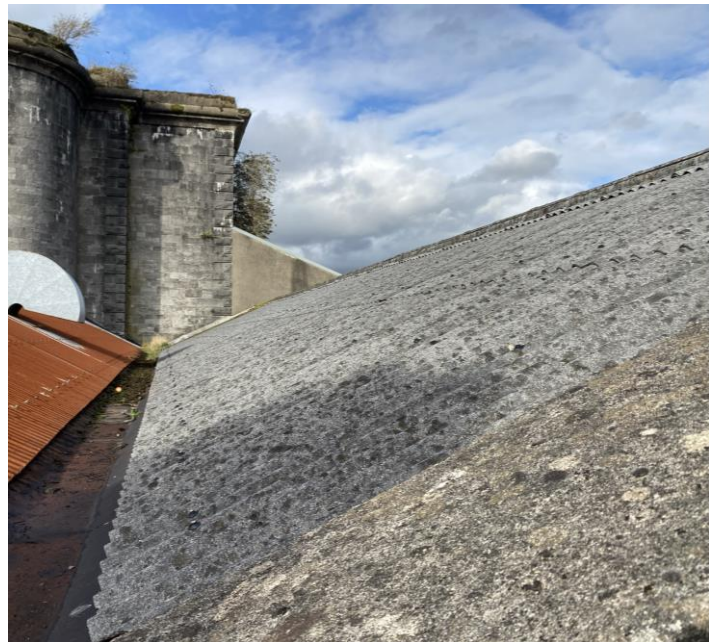
| Location | Roof |
| Extent/<br>Amount | 270 m <sup>2</sup> approx. floor area |

| | MATERIAL ASSESSMENT | | PRIORITY ASSESSMENT |
|---|---|---|---|
| Extent of damage | Weathered | Likelihood of disturbance | N/A |

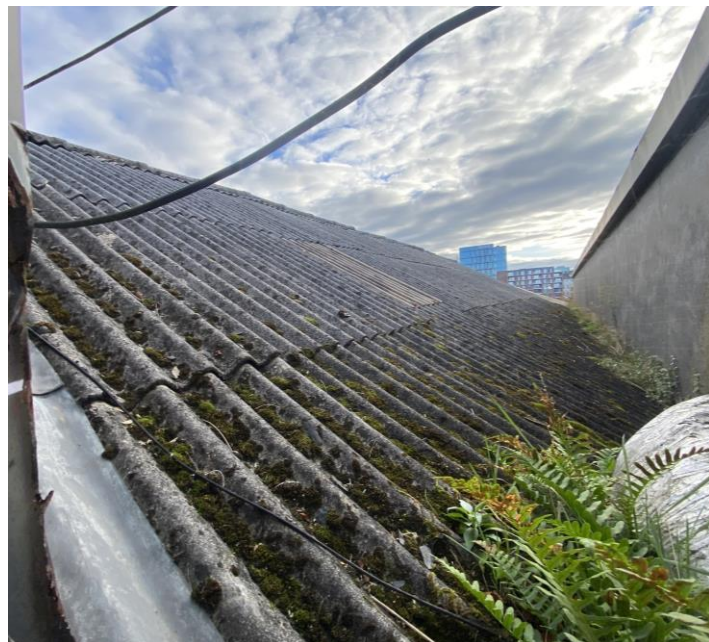
| Location | Roof |
| Extent/<br>Amount | 160 m <sup>2</sup> approx. floor area |

| | MATERIAL ASSESSMENT | | PRIORITY ASSESSMENT |
|---|---|---|---|
| Extent of damage | Weathered | Likelihood of disturbance | N/A |

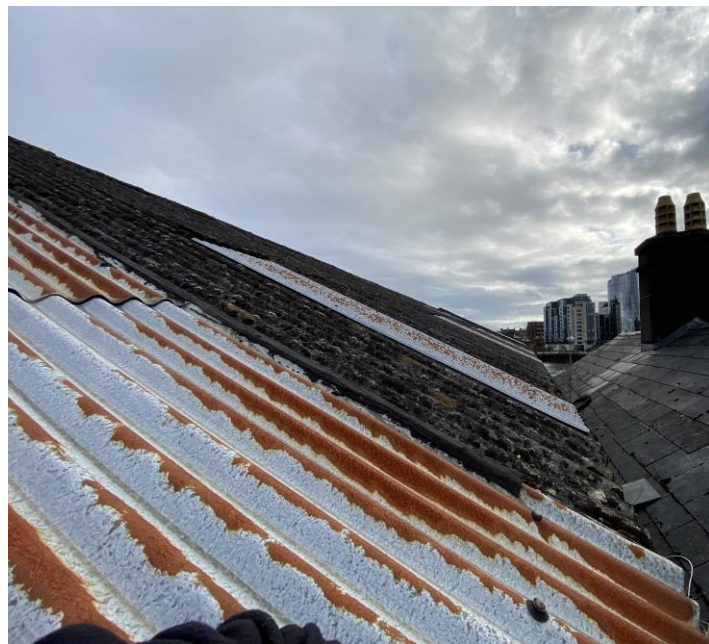
| Location | Roof |
| Extent/<br>Amount | 305 m <sup>2</sup> approx. floor area |

| | MATERIAL ASSESSMENT | | PRIORITY ASSESSMENT |
|---|---|---|---|
| Extent of damage | Medium | Likelihood of disturbance | N/A |

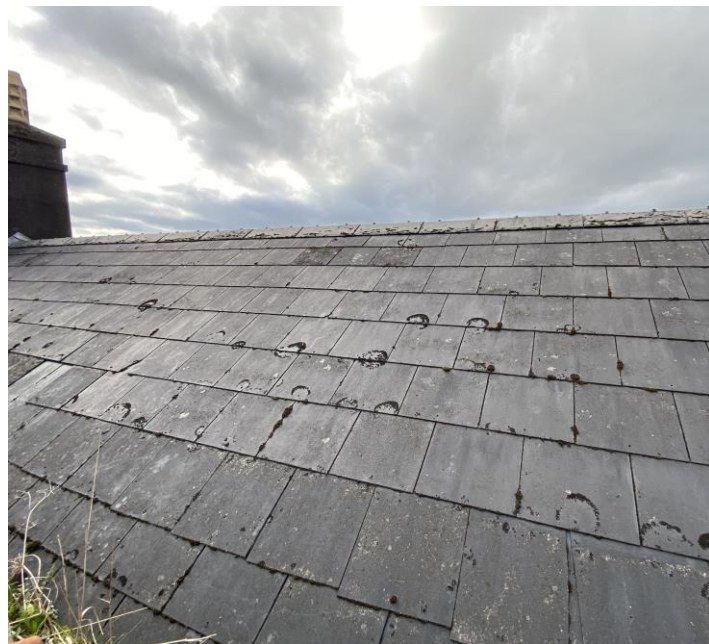
| Location | Side roof & rear porch area |
| Extent/<br>Amount | 70 m <sup>2</sup> approx. floor area |

| | MATERIAL ASSESSMENT | | PRIORITY ASSESSMENT |
|---|---|---|---|
| Extent of damage | Medium | Likelihood of disturbance | N/A |

All asbestos removal work must be carried out in accordance with S.I. No. 386 of 2006 Safety, Health and Welfare at Work (Exposure to Asbestos) Regulations 2006-2010

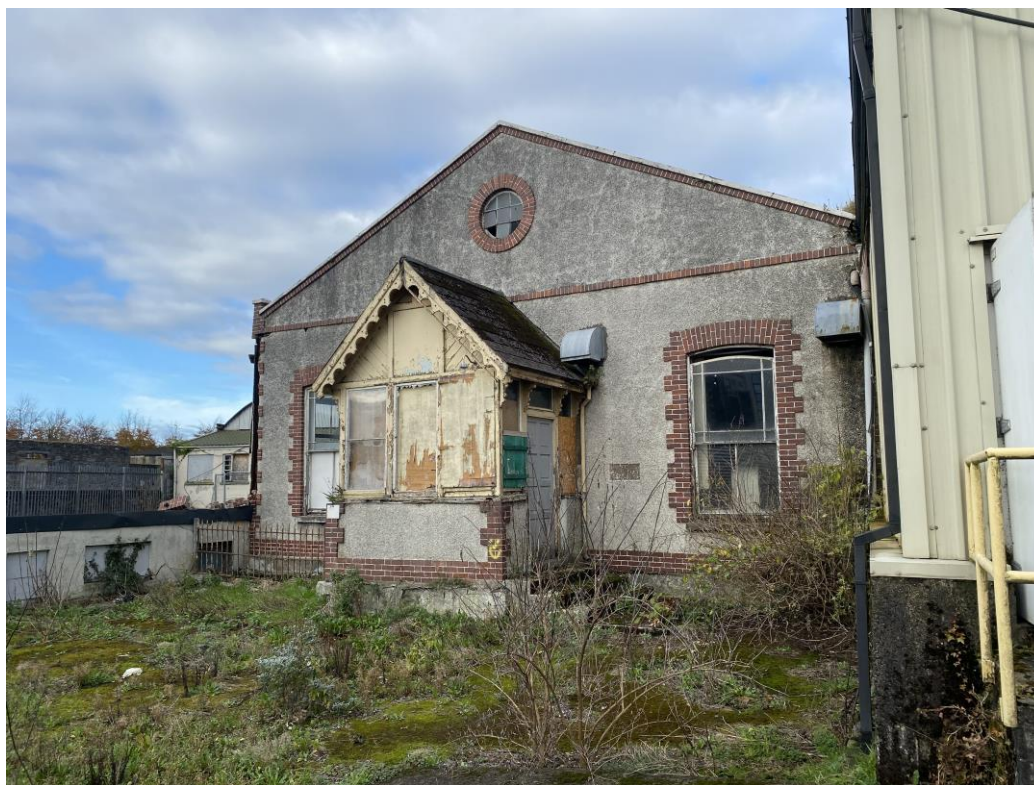
View of the slates on the rear porch roof

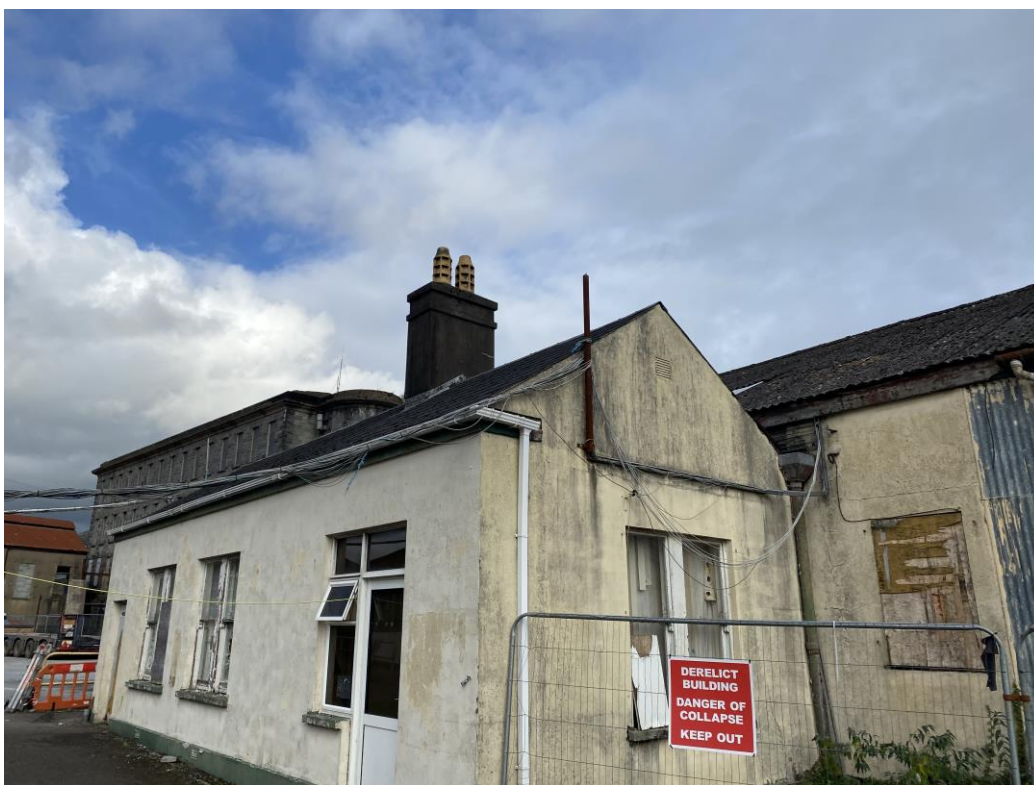
View of the side building which contains the asbestos cement slates

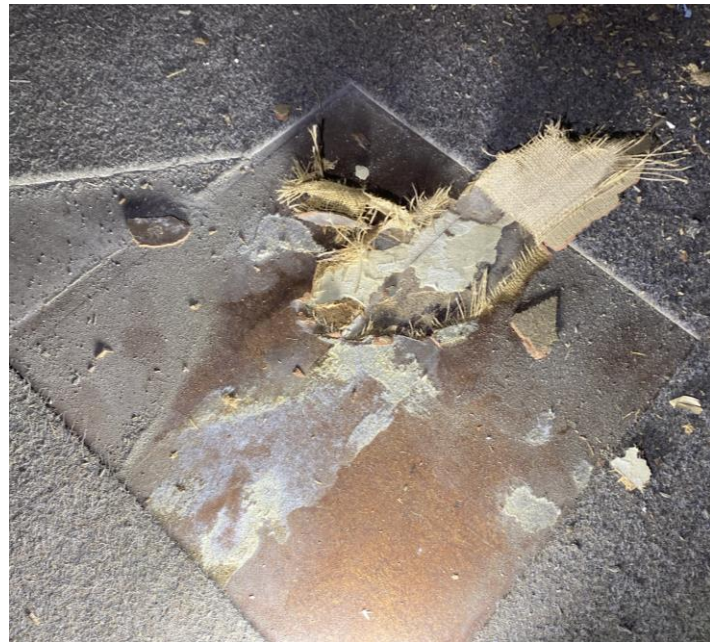
| Location | Main office area |
| Extent/<br>Amount | 75 m <sup>2</sup> approx. |

| | MATERIAL ASSESSMENT | | PRIORITY ASSESSMENT |
|---|---|---|---|
| Extent of damage | Medium | Likelihood of disturbance | N/A |

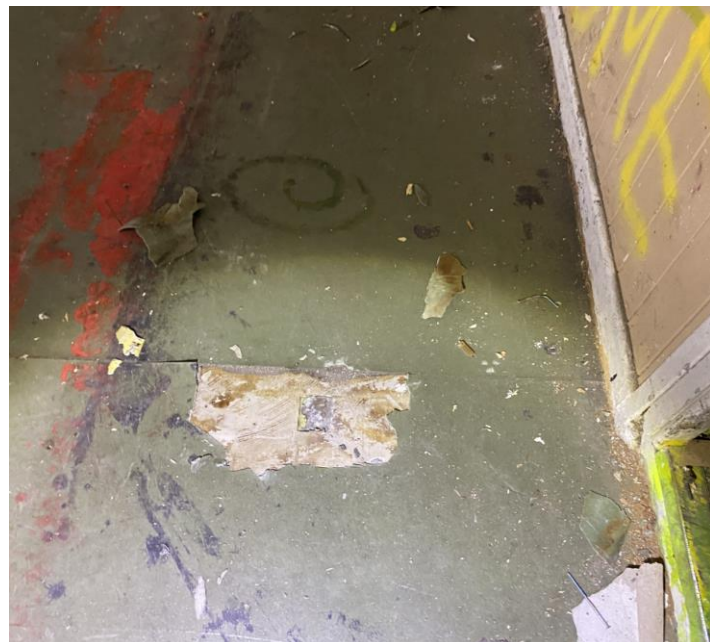
| Location | Office and lobby area |
| Extent/<br>Amount | 50 m <sup>2</sup> approx. |

| | MATERIAL ASSESSMENT | | PRIORITY ASSESSMENT |
|---|---|---|---|
| Extent of damage | Medium | Likelihood of disturbance | N/A |

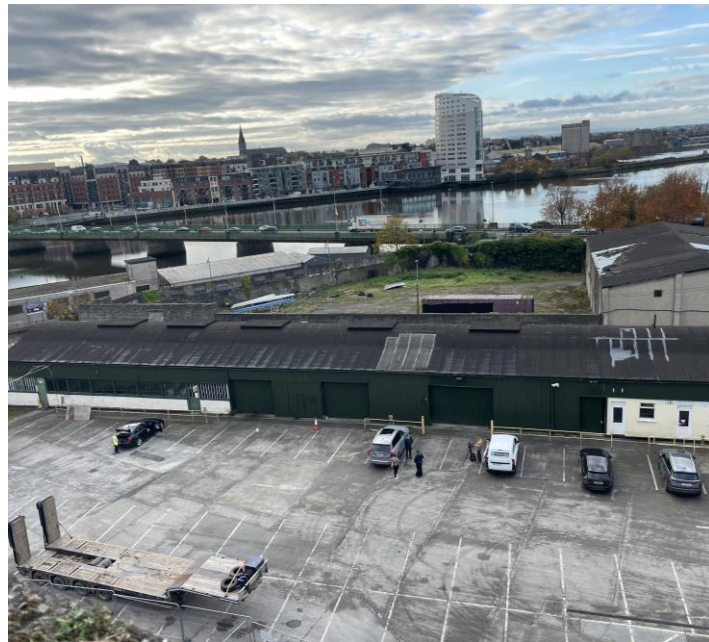
| Location | Roof |
| Extent/<br>Amount | 700 m <sup>2</sup> approx. floor area |

| | MATERIAL ASSESSMENT | | PRIORITY ASSESSMENT |
|---|---|---|---|
| Extent of damage | Low | Likelihood of disturbance | N/A |

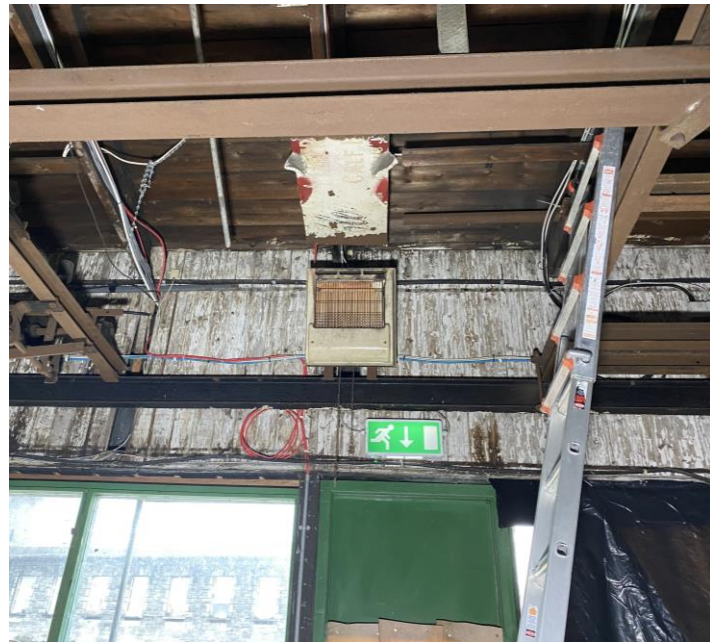
| Location | High level |
| Extent/<br>Amount | Over 2 high heaters & on 1 timber truss |

| | MATERIAL ASSESSMENT | | PRIORITY ASSESSMENT |
|---|---|---|---|
| Extent of damage | High | Likelihood of disturbance | N/A |

The millboard panels should be removed under controlled conditions by a specialist asbestos removal contractor and disposed of as asbestos waste before the works commence. This work will require a 14 day notification to the HSA prior to the work commencing

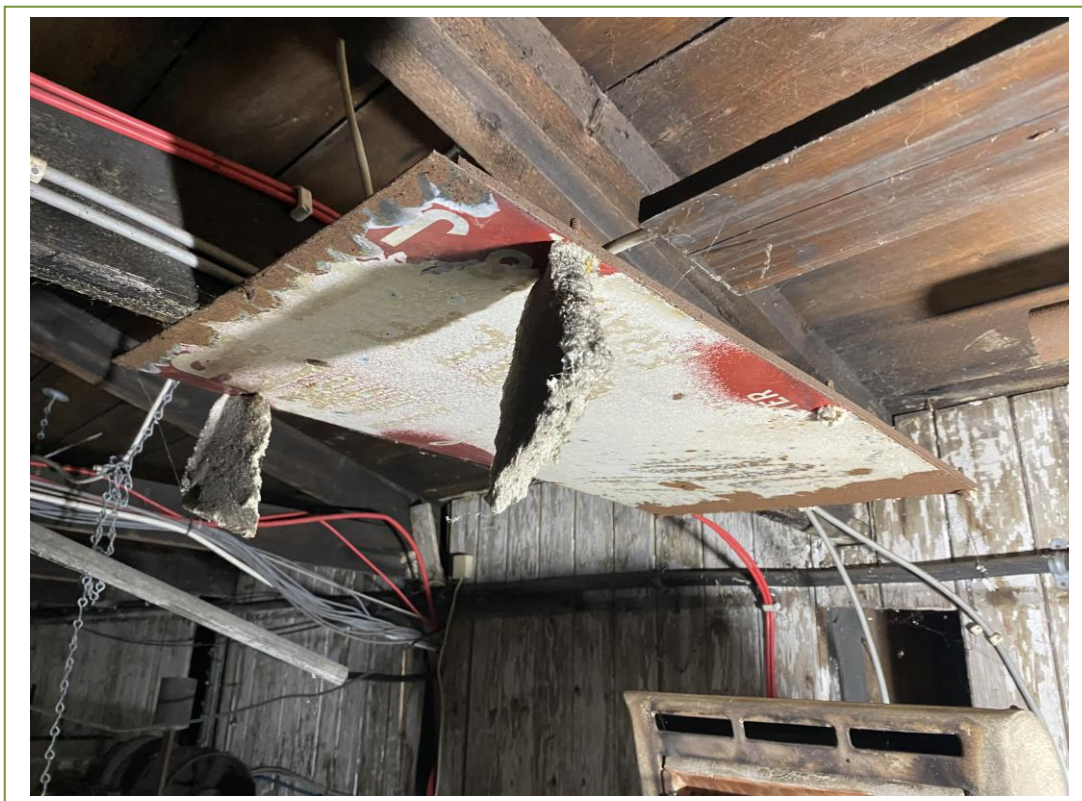
Closeup view of the remaining millboard on one of the panels over the heater

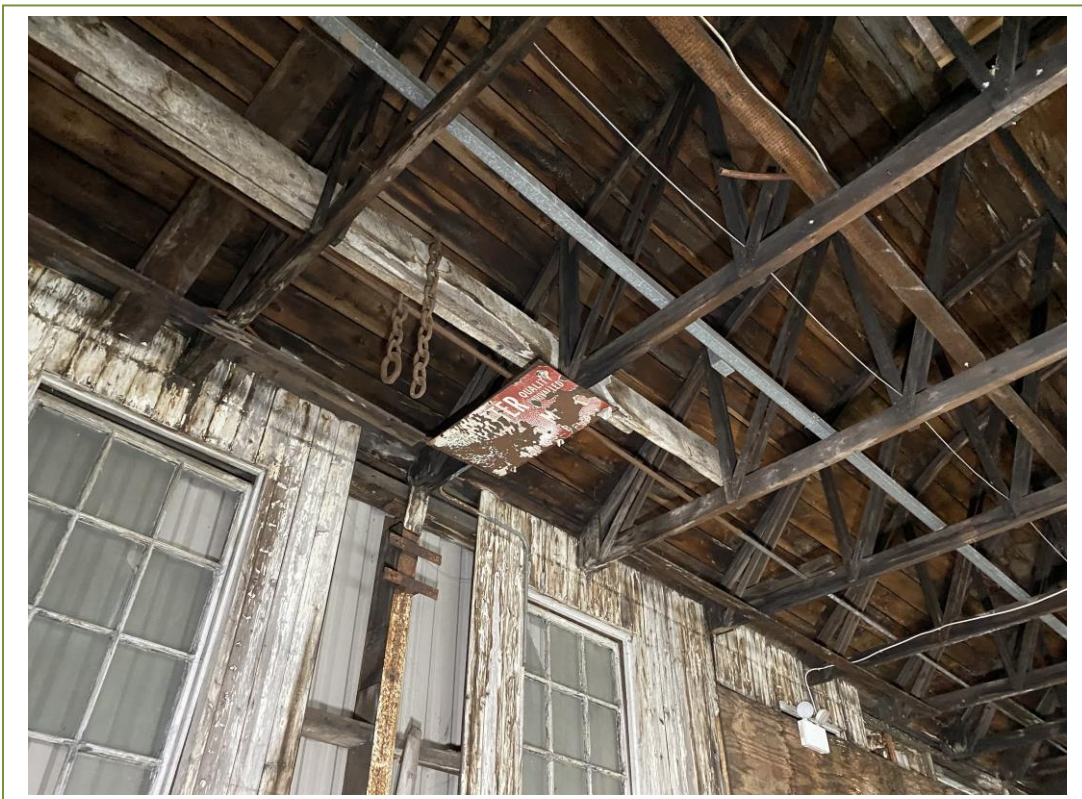
View of the other panel which was originally over a heater

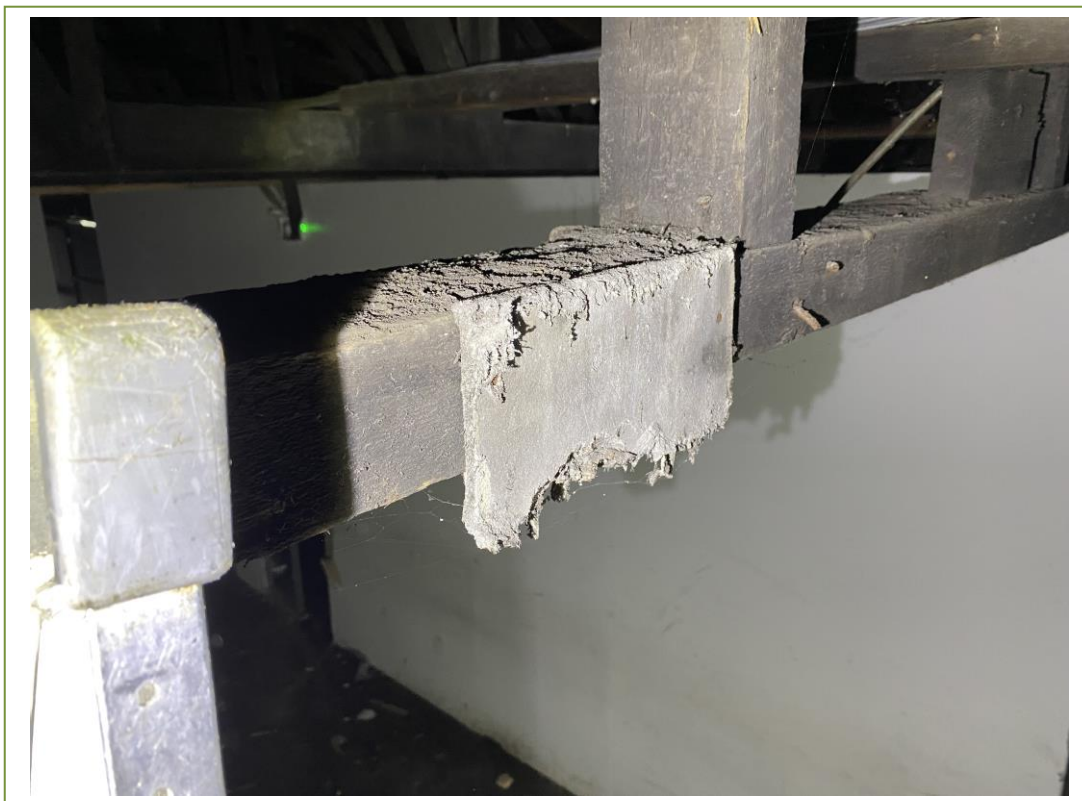
Closeup view of the remaining millboard on the lower level of the truss

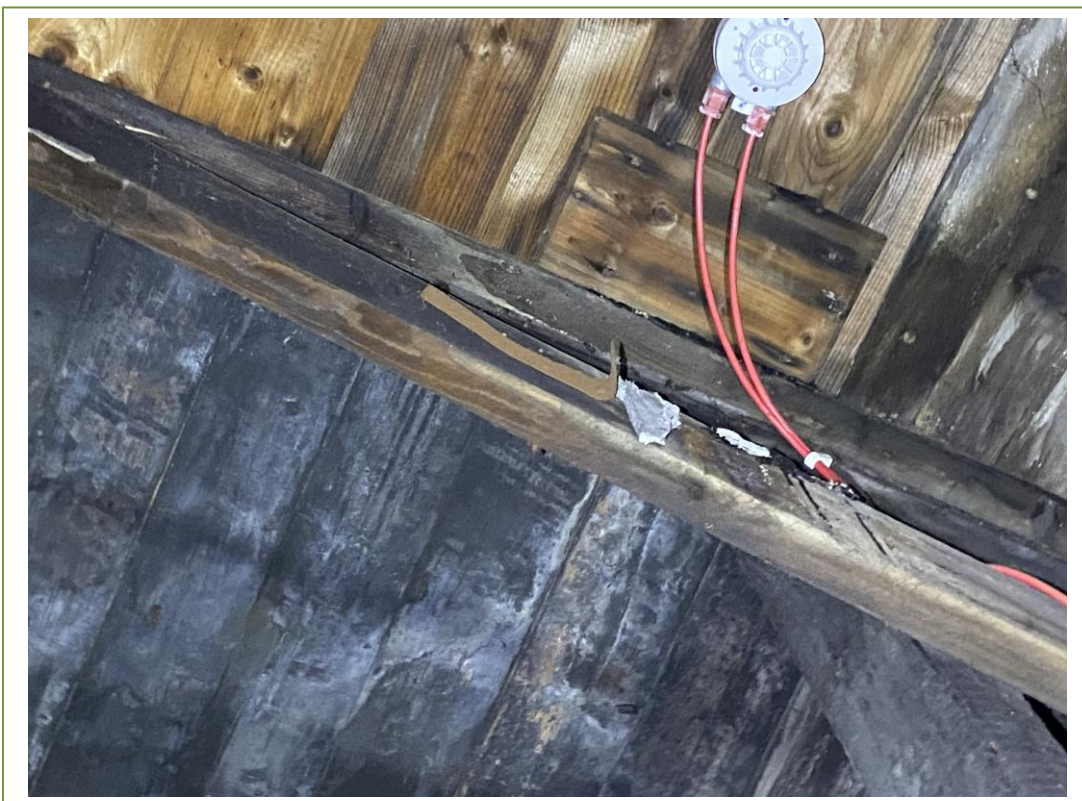
View of the remaining millboard on the higher level of the truss

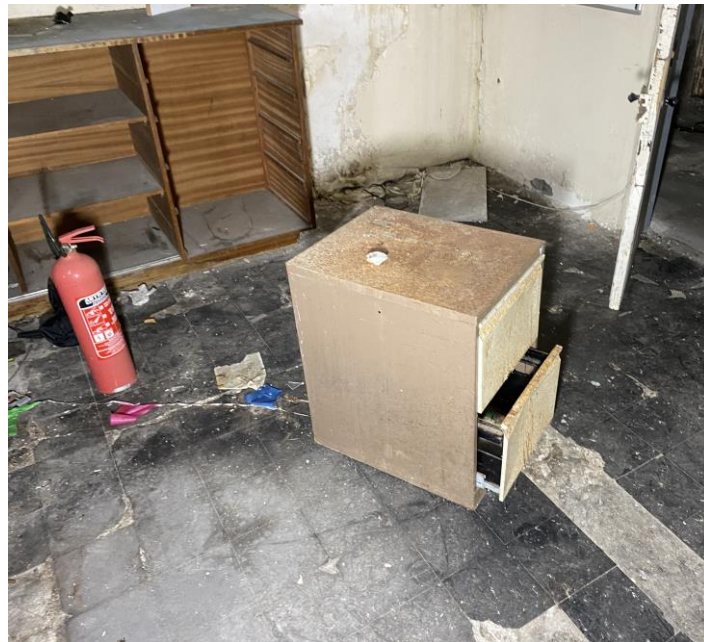
| Location | Storeroom |
| Extent/<br>Amount | 20 m <sup>2</sup> approx. |

| | MATERIAL ASSESSMENT | | PRIORITY ASSESSMENT |
|---|---|---|---|
| Extent of damage | Medium | Likelihood of disturbance | N/A |

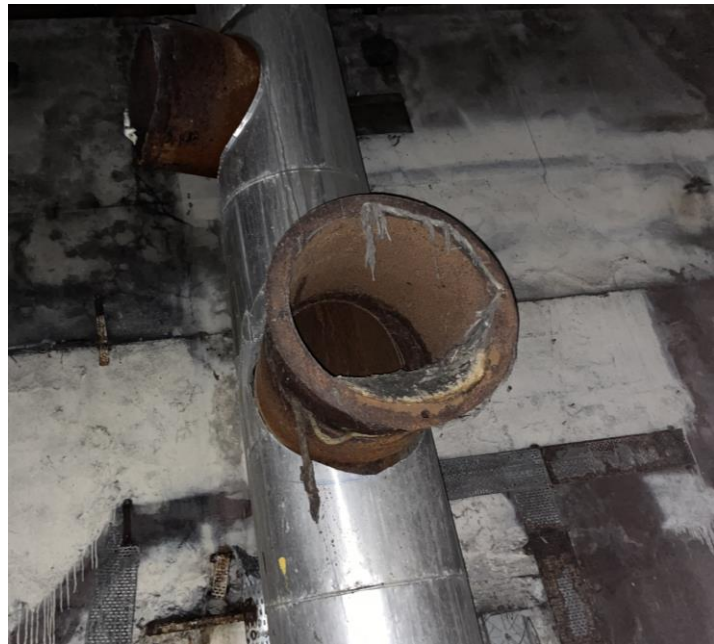
| Location | Boiler room |
| Extent/<br>Amount | Around flue pipe |

| | MATERIAL ASSESSMENT | | PRIORITY ASSESSMENT |
|---|---|---|---|
| Extent of damage | High | Likelihood of disturbance | N/A |

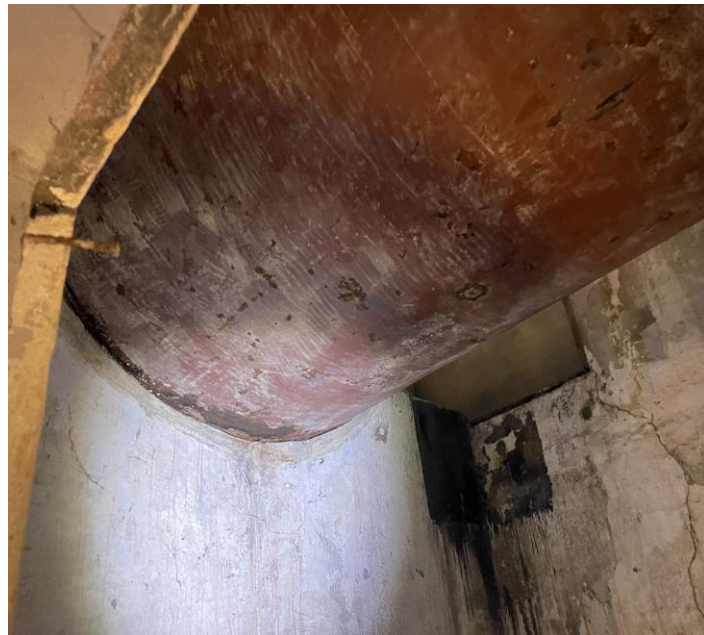
| Location | Boiler room |
| Extent/<br>Amount | Throughout |

| | MATERIAL ASSESSMENT | | PRIORITY ASSESSMENT |
|---|---|---|---|
| Extent of damage | High | Likelihood of disturbance | N/A |

The thermal insulation should be removed under controlled conditions by a specialist asbestos removal contractor and disposed of as asbestos waste before the demolition works commence.

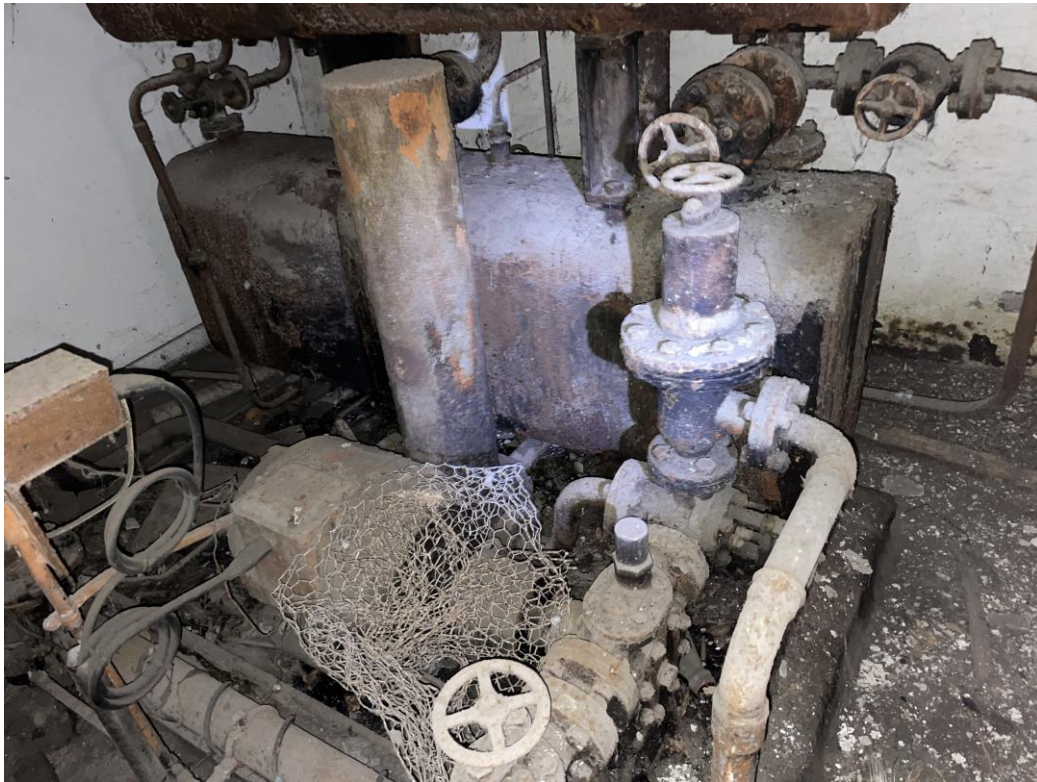
Asbestos containing thermal insulation residue on the boiler unit in the boiler room

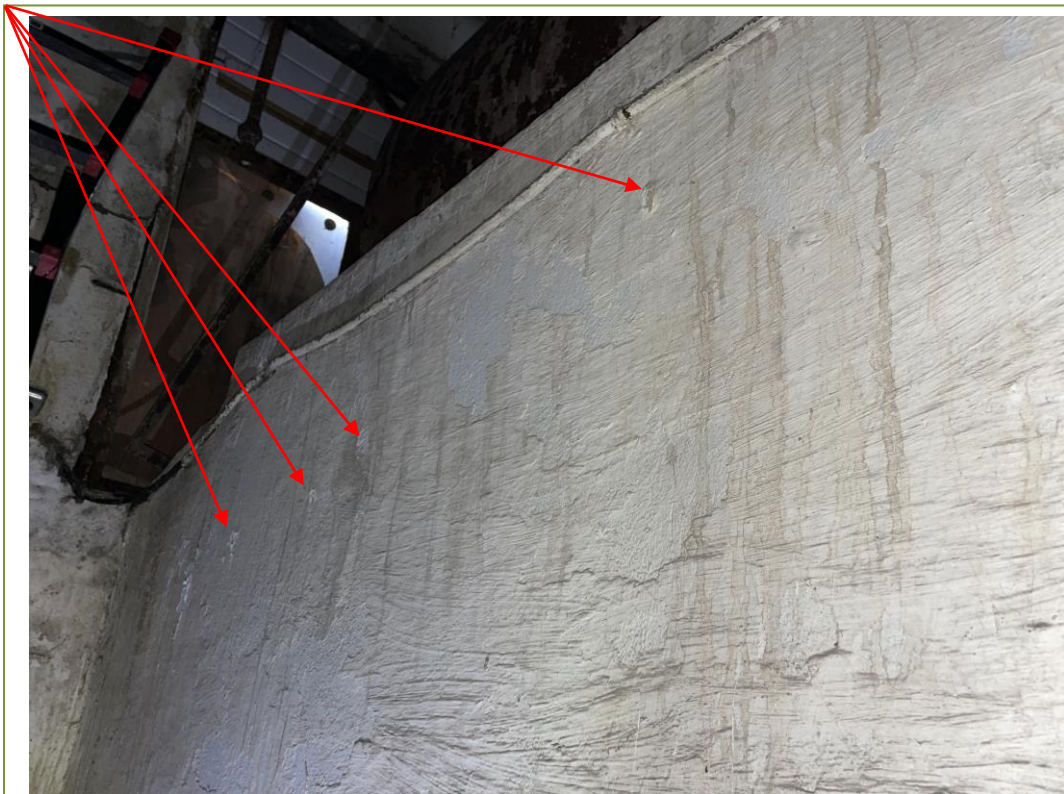
Asbestos containing thermal insulation residue on the walls and pipework in the boiler room

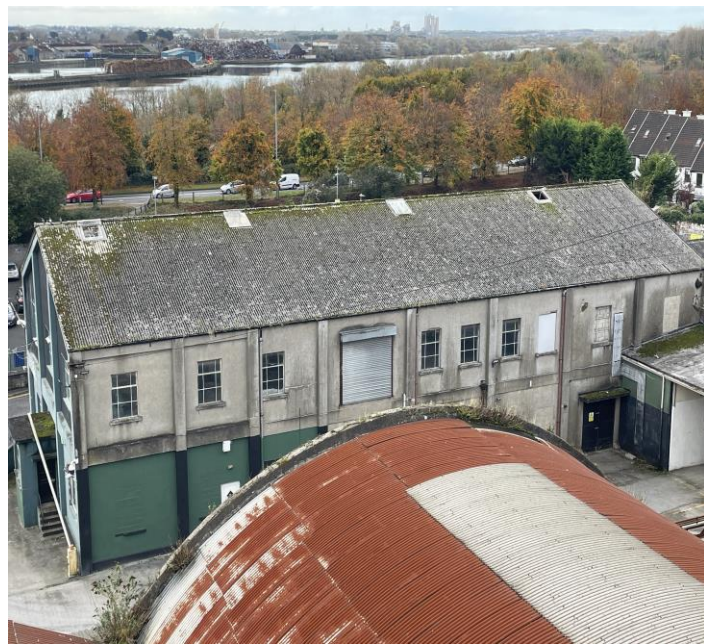
| Location | Roof |
| Extent/<br>Amount | 650 m <sup>2</sup> approx. |

| | MATERIAL ASSESSMENT | | PRIORITY ASSESSMENT |
|---|---|---|---|
| Extent of damage | Medium | Likelihood of disturbance | N/A |

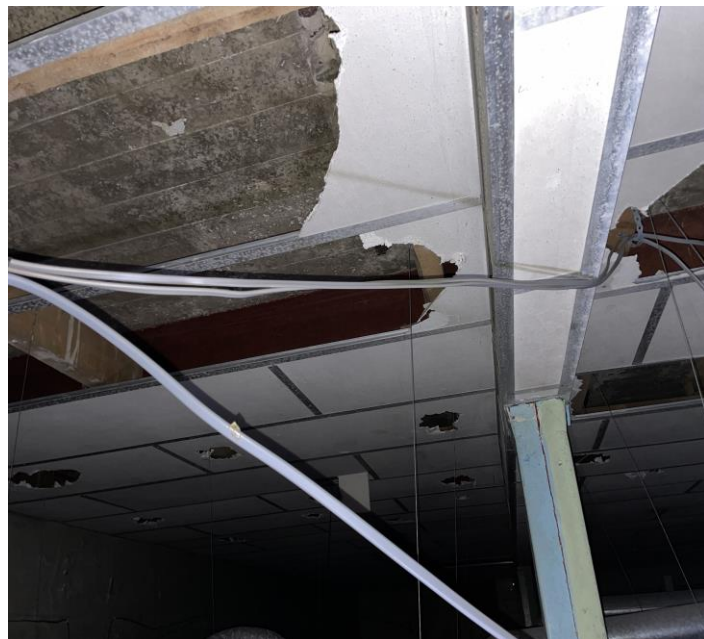
| Location | Ceiling |
| Extent/<br>Amount | 440 m <sup>2</sup> approx. |

| | MATERIAL ASSESSMENT | | PRIORITY ASSESSMENT |
|---|---|---|---|
| Extent of damage | Medium | Likelihood of disturbance | N/A |

The insulation board should be removed under controlled conditions by a specialist asbestos removal contractor and disposed of as asbestos waste before the demolition works commence.

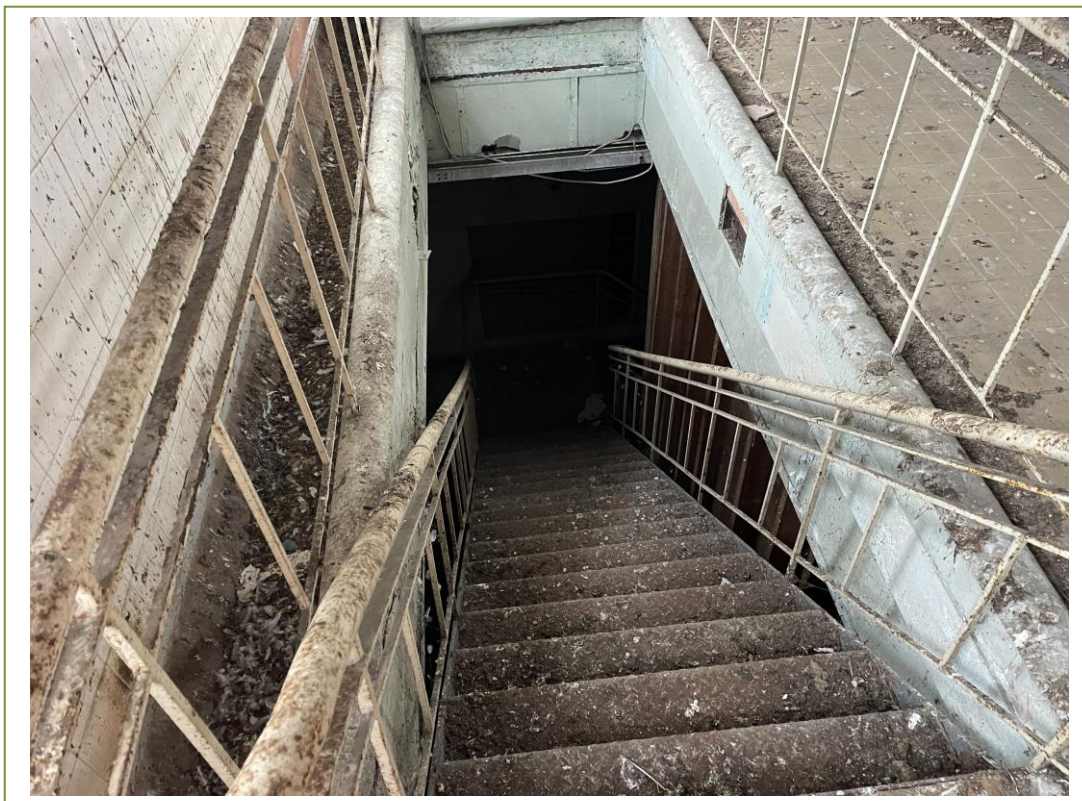
Asbestos insulation board on the walls of the stairs to the 1<sup>st</sup> floor in Building 12

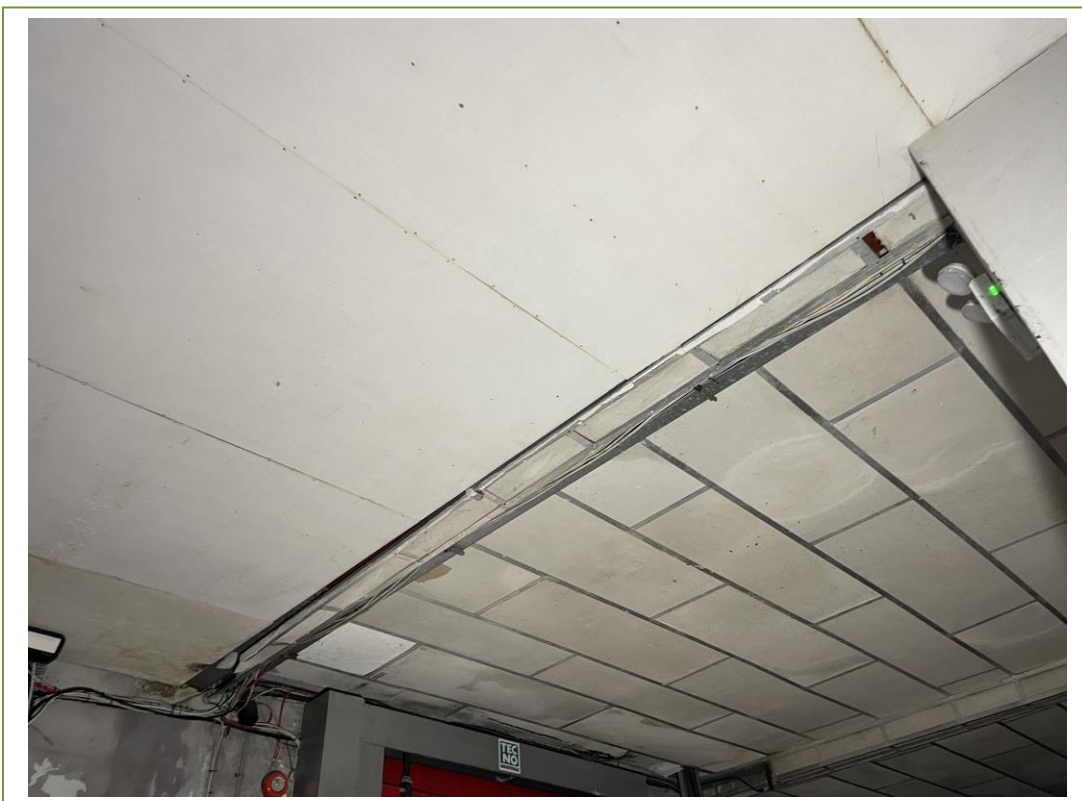
Asbestos insulation board on the ceiling and around the beams in Building 12

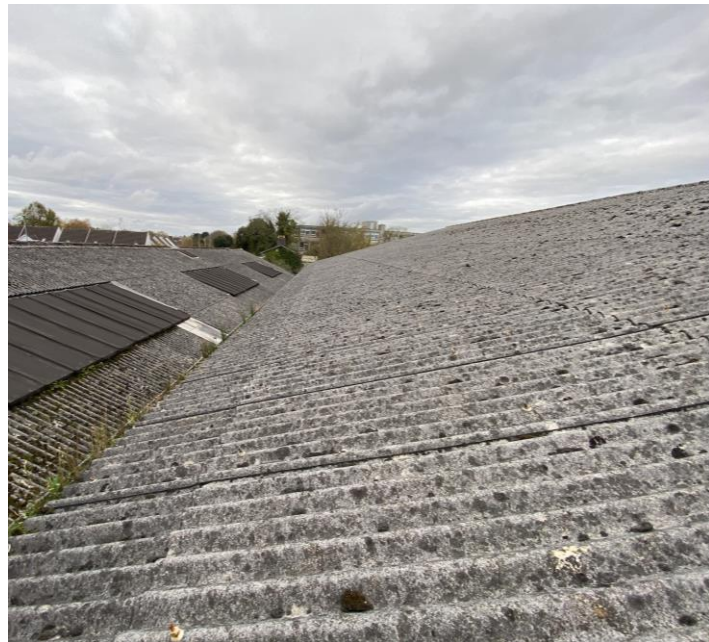
| Location | Roof |
| Extent/<br>Amount | 900 m <sup>2</sup> approx. floor area |

| | MATERIAL ASSESSMENT | | PRIORITY ASSESSMENT |
|---|---|---|---|
| Extent of damage | Weathered | Likelihood of disturbance | N/A |

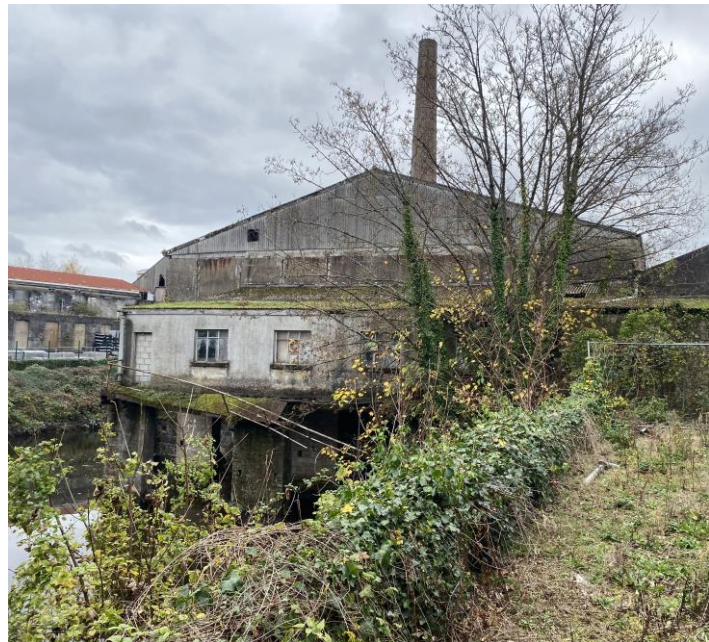
| Location | Roof |
| Extent/<br>Amount | 175 m <sup>2</sup> approx. floor area |

| | MATERIAL ASSESSMENT | | PRIORITY ASSESSMENT |
|---|---|---|---|
| Extent of damage | Medium | Likelihood of disturbance | N/A |

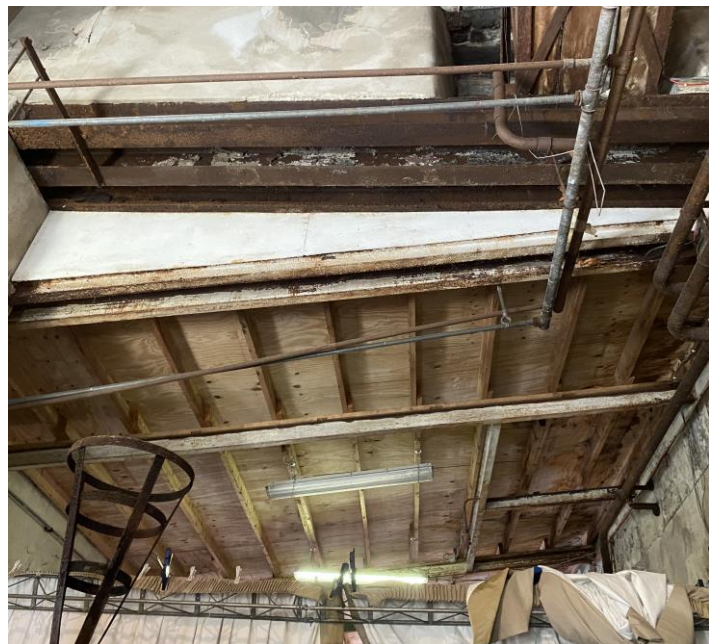
| Location | Ceiling |
| Extent/<br>Amount | 5 linear meters approx. |

| | MATERIAL ASSESSMENT | | PRIORITY ASSESSMENT |
|---|---|---|---|
| Extent of damage | Low | Likelihood of disturbance | N/A |

When access is available, the board should be sampled. If it is found to be asbestos insulation board, the insulation board should be removed under controlled conditions by a specialist asbestos removal contractor and disposed of as asbestos waste before the demolition works commence.

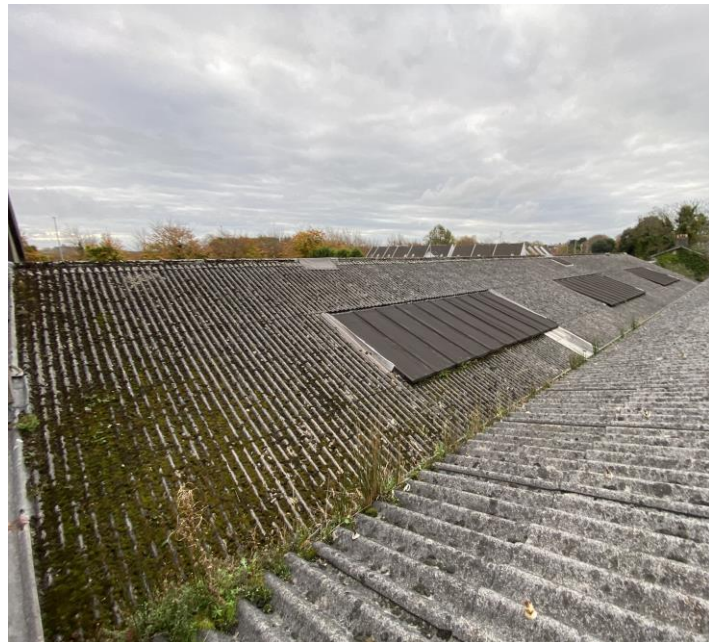
| Location | Roof |
| Extent/<br>Amount | 565 m <sup>2</sup> approx. floor area |

| | MATERIAL ASSESSMENT | | PRIORITY ASSESSMENT |
|---|---|---|---|
| Extent of damage | Weathered | Likelihood of disturbance | N/A |

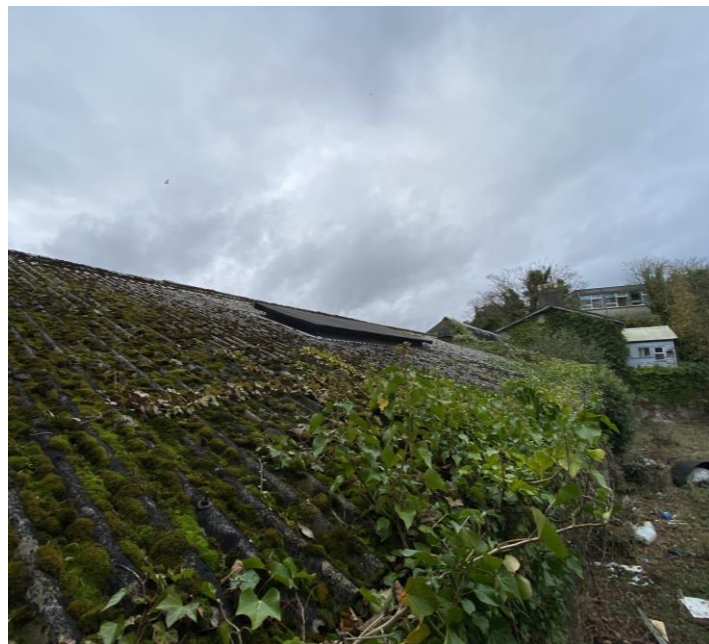
| Location | Roof |
| Extent/<br>Amount | 165 m <sup>2</sup> approx. |

| | MATERIAL ASSESSMENT | | PRIORITY ASSESSMENT |
|---|---|---|---|
| Extent of damage | Medium | Likelihood of disturbance | N/A |

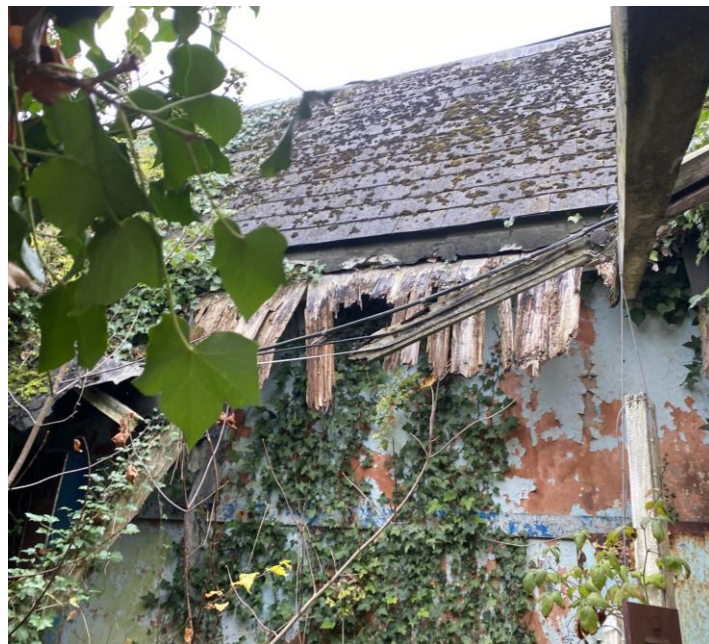
| Extent/<br>Amount | 50 m <sup>2</sup> approx. floor area |

| | MATERIAL ASSESSMENT | | PRIORITY ASSESSMENT |
|---|---|---|---|
| Extent of damage | Medium | Likelihood of disturbance | N/A |
