# **ENVIRONMENTAL IMPACT ASSESSMENT REPORT**

### Appendix 19-1 Asbestos Survey Report

## ASBESTOS SURVEY REPORT

**Location:** The Cleeves Site,  
North Circular Road, Limerick

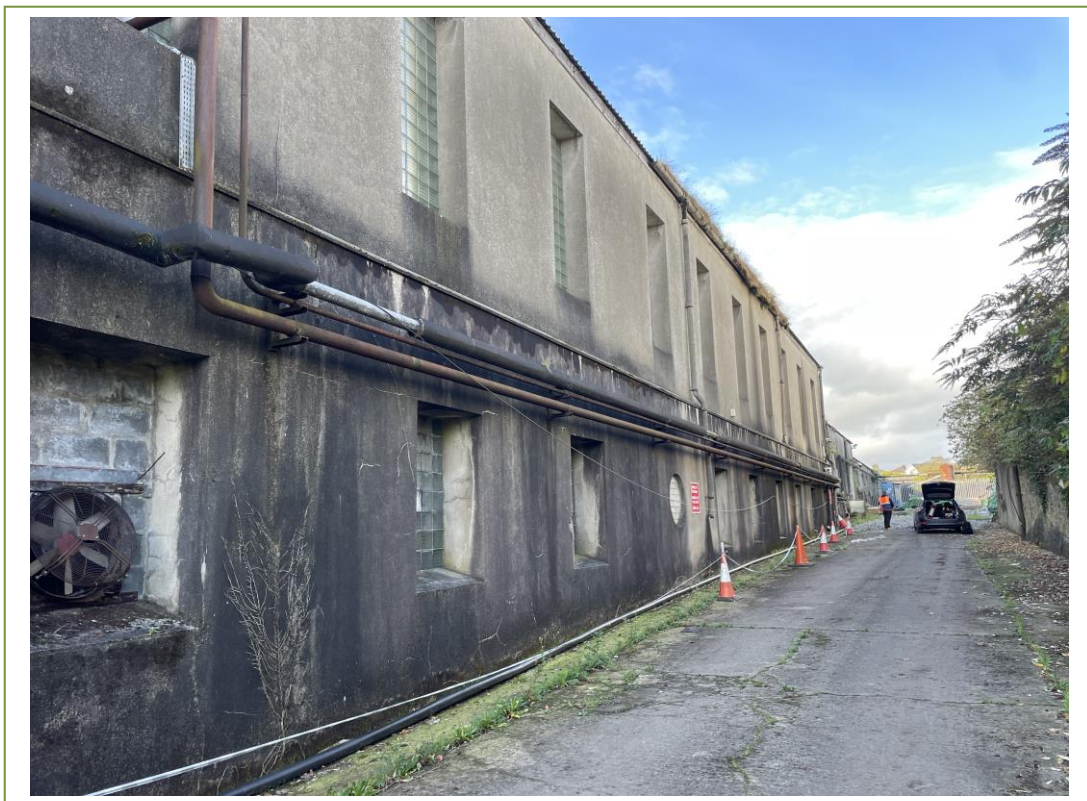
View of the asbestos cement gutters and downpipes on building 4

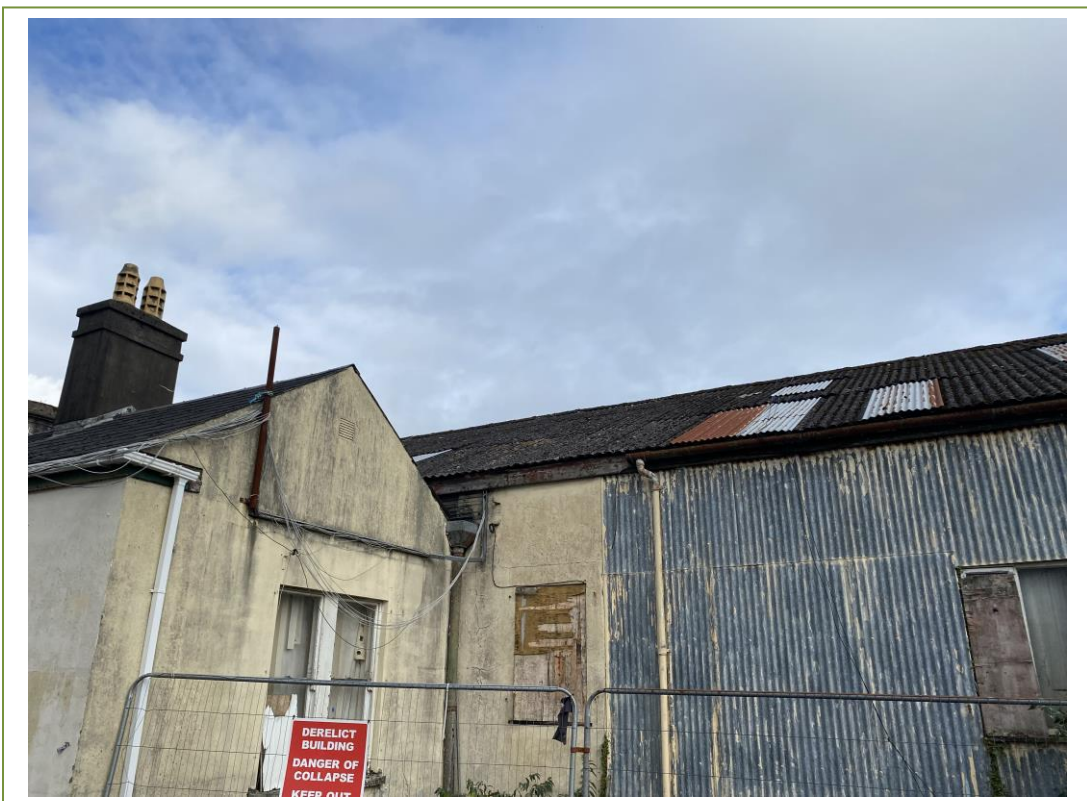
View of the asbestos cement gutters and downpipes on building 9

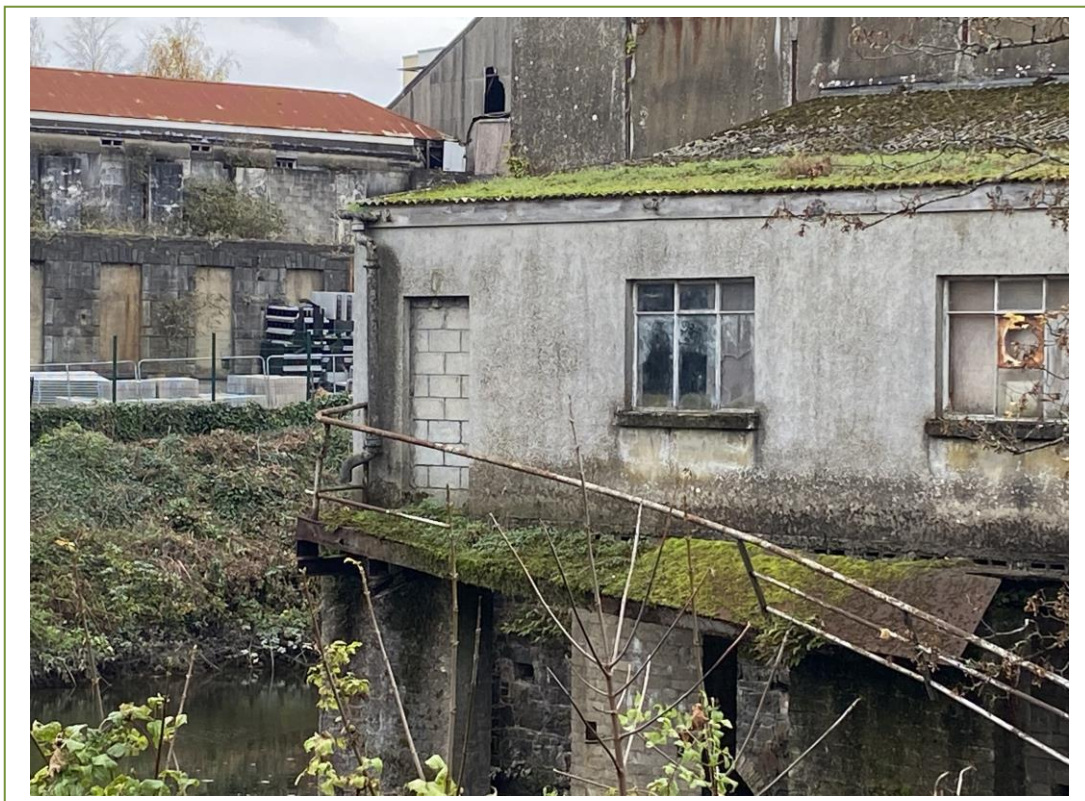
View of the asbestos cement gutters and downpipes on building 14

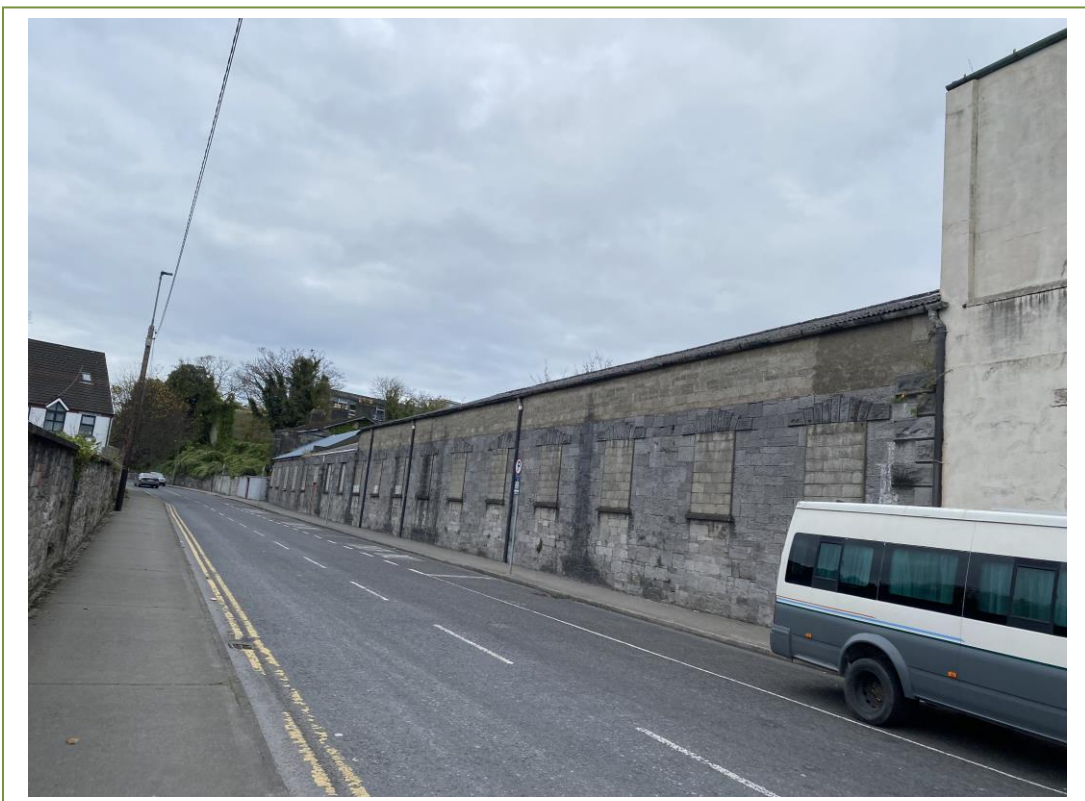
View of the asbestos cement gutters and downpipes on building 15

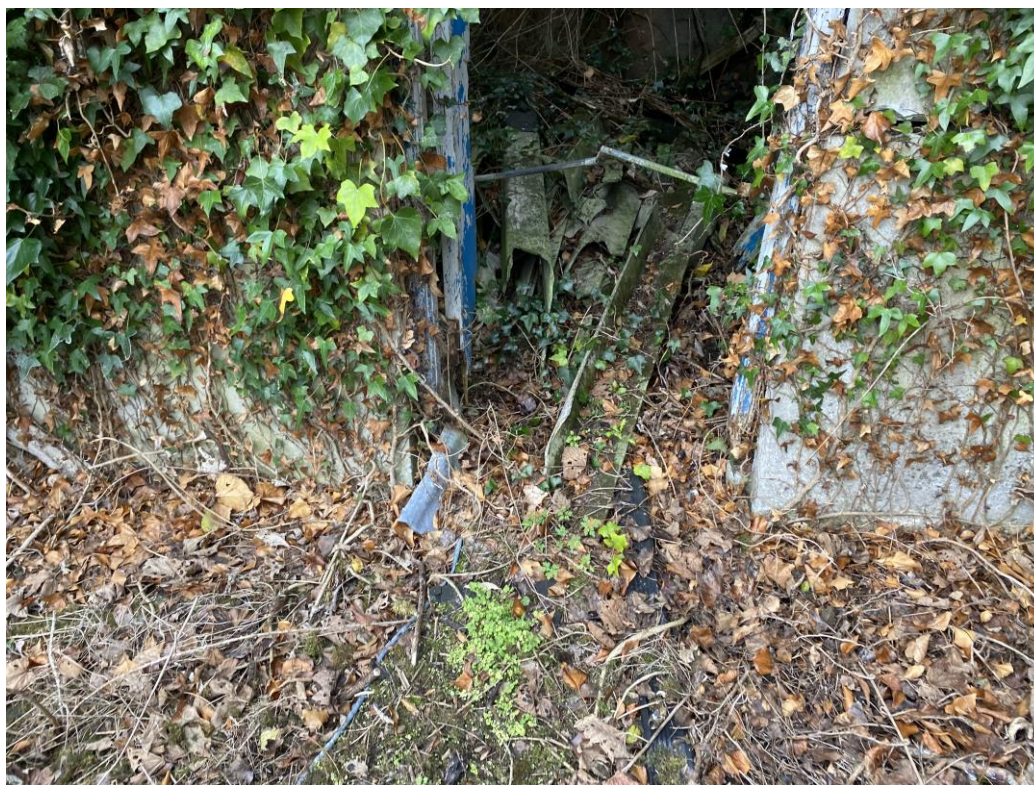
Asbestos cement debris in the rear of Building 17

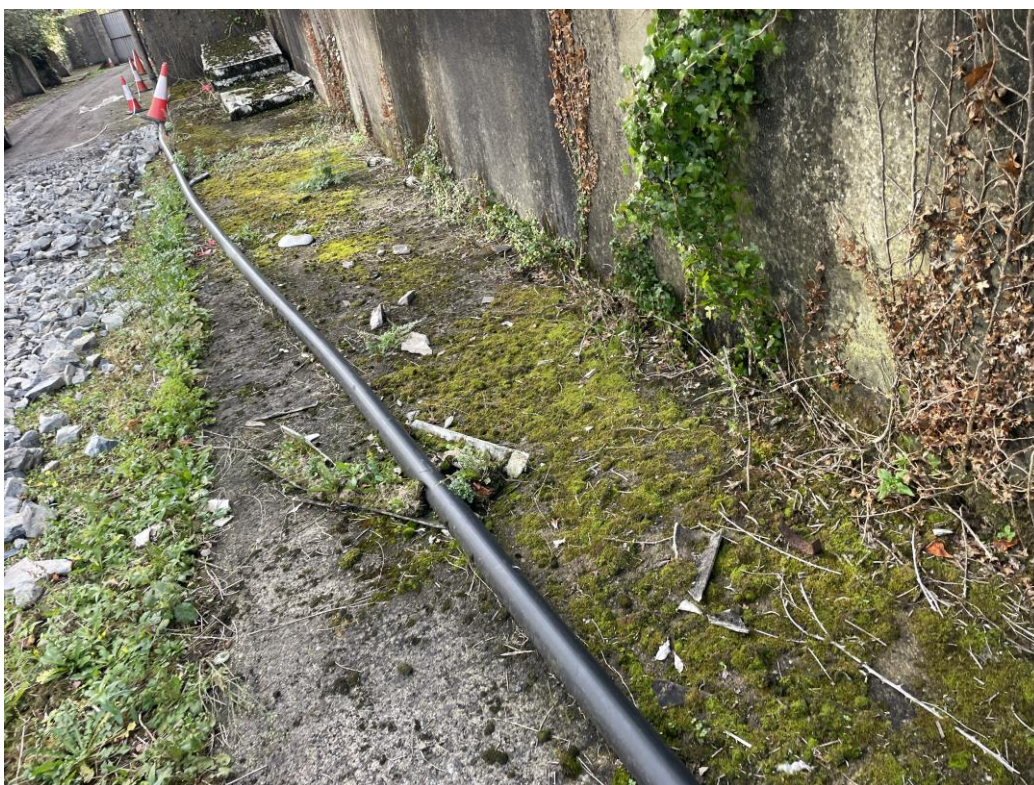
Asbestos cement debris along the rear of building 4

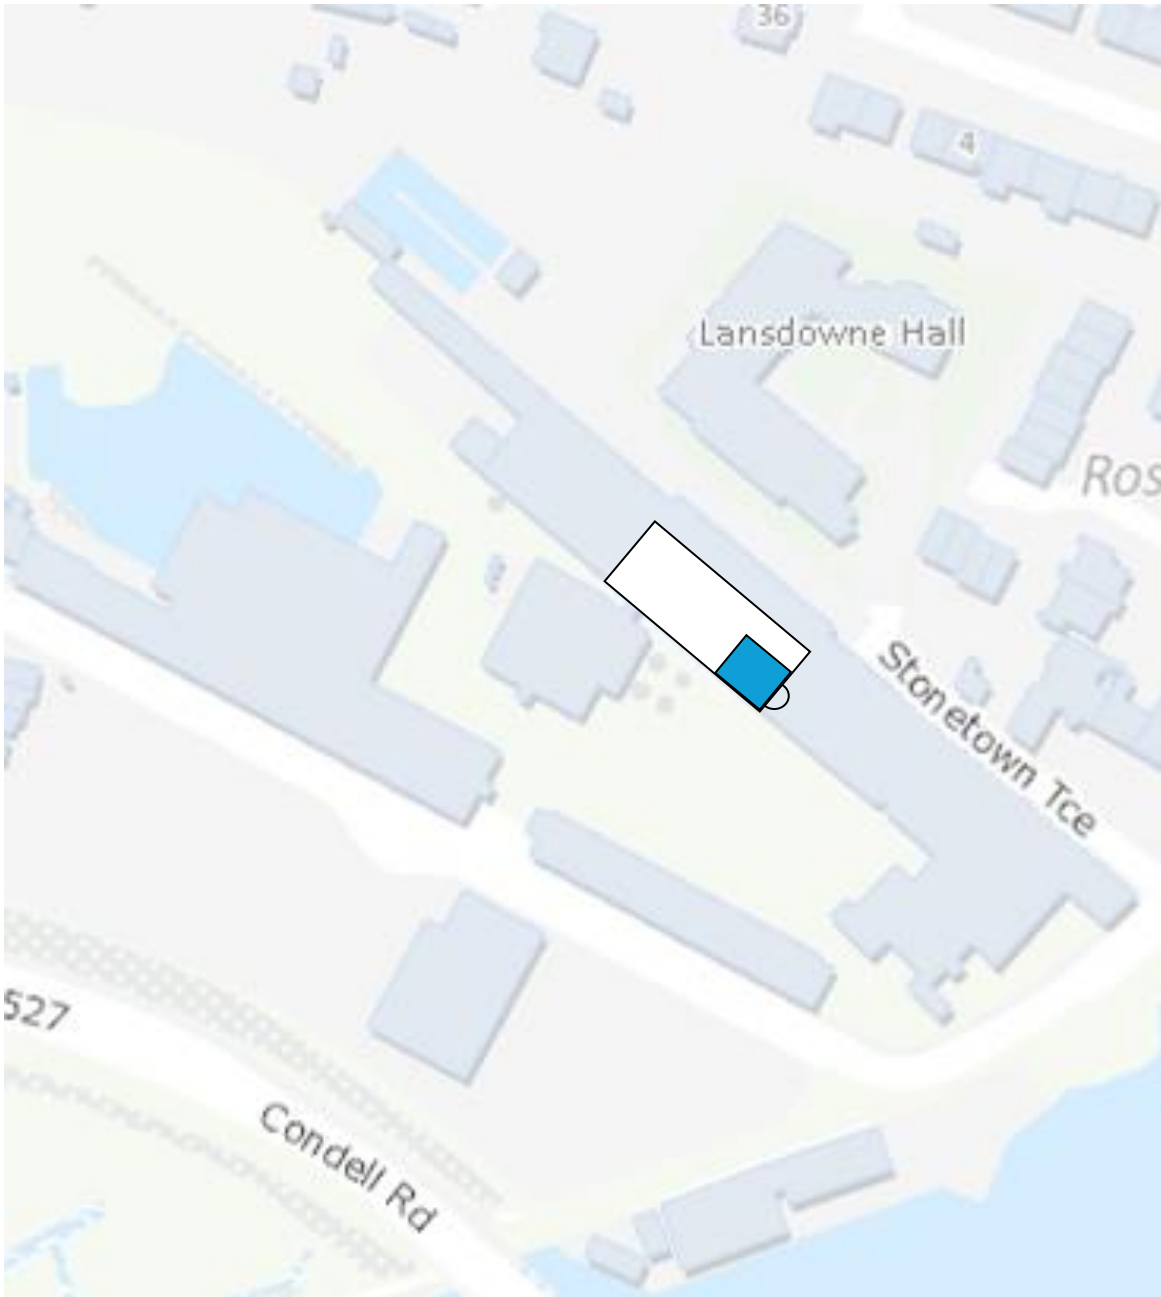
| SITE LAYOUT (4 <sup>TH</sup> FLOOR PLAN) | | | |

| | Area where asbestos containing thermal insulation was identified on the boiler unit | | |
| Note: | Cement debris, CAF gaskets and asbestos rope were identified throughout the site | | |
