Appendix 4.2 J Road Safety Audit

Title: Stage 1 ROAD SAFETY AUDIT

Proposed Data Centre R409, Naas, Co. Kildare

Report reference: 1918R01

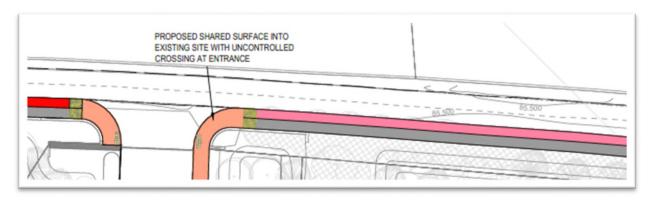
3.1 Problem

Drawing 2232-DOB-ZZ-ZZ-Dr-C-1600, R409

It is proposed to provide a cycle track to the proposed development and beyond in the northbound direction. It is not however proposed to provide cycling facilities for those returning from the development to Naas in the southbound direction. A lack of segregated facilities in the southbound direction will lead to less protection for cyclists from general traffic.

It is recommended that southbound facilities be provided.

3.1	YES	No	DOBA have discussed and agreed the extent of the required works to the R409 with K.C.C. Roads Dept. The works will be limited to the development side of the R409. These works will not prevent K.C.C. from carrying out additional upgrade works to the pedestrian and cycle infrastructure along the R409 in the future.	Yes

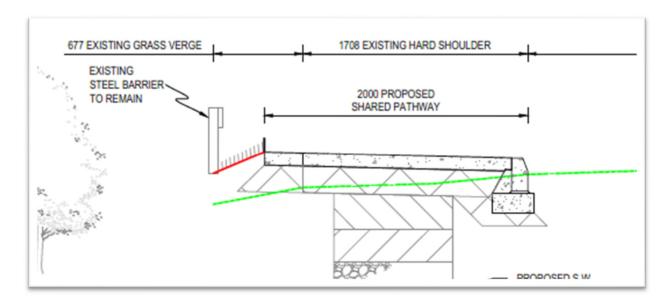
3.2 Problem

Drawing 2232-DOB-ZZ-ZZ-Dr-C-1600, R409, Existing Safety Barriers.

There are approach and departure safety barriers at the structure protecting errant vehicles from the high embankments and motorway below. With the provision of a kerbed edge and paved surface above the existing level the barriers may no longer contain errant vehicles if they are too low. It is also observed during the site visit that the safety barriers may not be EN1317 compliant.

It is recommended that the safety barrier be upgraded as necessary to ensure that errant vehicles will be contained.

3.2	YES	YES	The road barrier will be raised up to be in accordance with the requirements of TII	
3.3	YES	YES	The parapet railing will be raised, if necessary, in consultation with TII

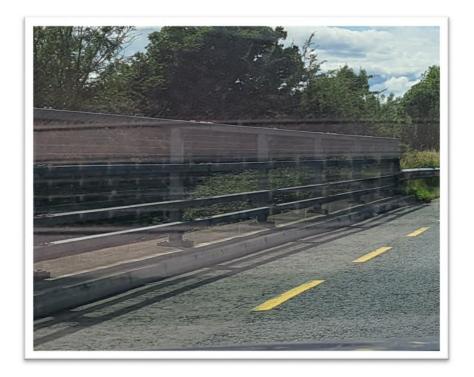
3.3 Problem

Drawing 2232-DOB-ZZ-ZZ-Dr-C-1600, R409, Existing Parapet railings.

The existing parapet railing were observed to be relatively high. It is unclear if they will be high enough to contain cyclists should they wobble against them during high winds or if passed by a HGV, leading to loss of control.

It is recommended that suitable height parapet railing adjacent to cyclists be provided on the M7 overbridge.

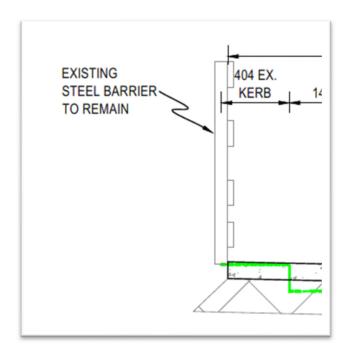
3.4 Problem

Drawing 2232-DOB-ZZ-ZZ-Dr-C-1600, R409, Existing Parapet upstand.

It is unclear if the existing parapet on the M7 overbridge will function as intended if struck by a HGV if there is no concrete upstand. A lack of containment could lead to vehicles descending onto the motorway below.

It is recommended that the adequacy of the parapet without a upstand be checked to ensure that it will contain errant vehicles as intended.

3.4	YES	YES	The parapet railing will be assessed to ensure its function is not degraded by the proposed works in consultation with TII.	
3.5	YES	NO	DOBA have discussed and agreed the provision and location of the bus stop with Kildare Co. Council. This work would also impact on 3 rd party land owners and is outside of the scope of the proposed project.	Yes

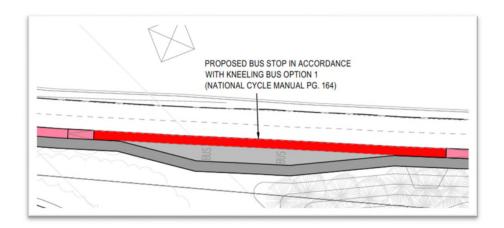
3.5 Problem

Drawing 2232-DOB-ZZ-ZZ-Dr-C-1600, R409, Bus Layby.

It is proposed to provide a bus layby that will presumably serve both the proposed development and the Oberstown Industrial Park. No provision has been made for crossing bus users or those getting the return bus to Naas. A lack of crossing facilities could lead to pedestrians stepping out from in front of or behind parked buses leading to collisions with through traffic.

It is recommended that a bus stop be provided on the opposite side of the R409 and that a crossing facility also be provided.

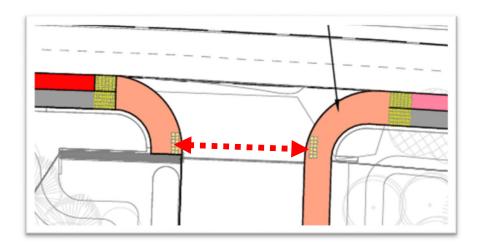
3.6 Problem

Drawing 2232-DOB-ZZ-ZZ-Dr-C-1600, R409, New access junction.

The crossing point at the proposed access junction for cyclists and pedestrians is set back from the through route, is narrow for both users and may be close to the gate which could obscure an exiting driver's visibility to those crossing vulnerable road users. This could lead to collisions between cyclists and pedestrians as they share space, collisions with exiting vehicles or lack of use of the cycle track as cyclists see the crossing as being too far off the desire line and opt to remain on the carriageway instead.

It is recommended that a wider crossing be provided closer to the desire line.

3.6	YES	YES	The crossing will be relocated closer to the R409 along the desire line for pedestrians and cyclists.	
3.7	NO	NO	A raised table will adversely impact on HGVs and other vehicles entering and exiting the site. It will require vehicles to slow to very low speeds in order to mount the table.	Yes

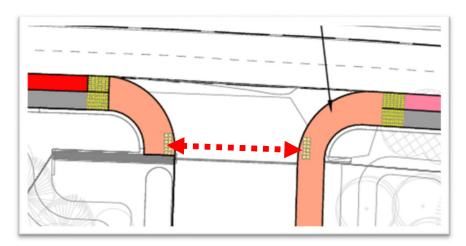
3.7 Problem

Drawing 2232-DOB-ZZ-ZZ-Dr-C-1600, R409, New access junction.

The main access junction has a wide cross sectional width due to the splitter island and need to cater for HGVs. This will lead to high turning speeds for smaller vehicles and thereby increase the risk of collisions with crossing pedestrians and cyclists.

It is recommended that a raised table be provided to cater for crossing pedestrians and cyclists.

This will cause potential queuing issues and static vehicles making left-in turns on the R409. It will also result in slow start-off speeds for HGVs and other vehicles existing the site onto the R409. There will be very low use of the footpath and cycle track to the west of the site access as the pathway is discontinued at the western extent of the site and therefore road crossings by vulnerable road users will be limited.	
3.8	YES	YES		
3.9	YES	YES

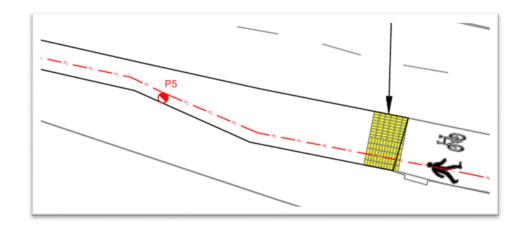
3.8 Problem

Drawing SES 04723 Issue 1, Public Lighting.

It is proposed to provide the public lighting columns within the new and existing footpaths. The columns could be hazards for pedestrians if they are looking down and are distracted and the columns also reduce the effective width of the footpath.

It is recommended that the columns be set back off the footpaths into the verge behind.
