Hydrant Testing Report

Naas, Co. Kildare

Client:	Donnacadh O'Brien Associates
Site Contact:	Richard Kiernan
Project:	Hydrant Testing & 7 Day Logging Naas, Co. Kildare
Technician:	Aaron Hogan
Start/Finish of Survey	17/01/2023

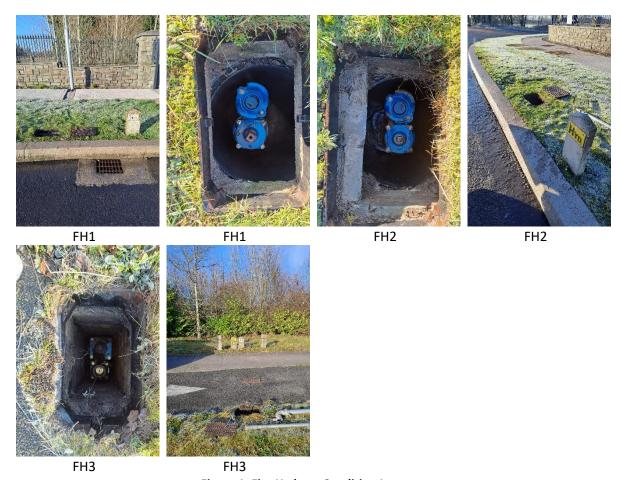
Figure 1: Fire Hydrant Condition Images

- All Hydrants are accessible and have spindles in place, except for FH2 where the Spindle is missing.
- All Hydrant Pits are in good condition, and the hydrants Frames/Covers are in poor condition.
- Hydrant outlet FH1 and FH2 connections are LUG, FH3 is an LRT connection.
- All Hydrants have marker plates to identify hydrant location/details.
- The covers to the Hydrant chambers are NOT painted canary yellow.
