# ARBORICULTURAL REPORT

Cornamaddy,

Westmeath County Council

**30<sup>th</sup> June 2025**

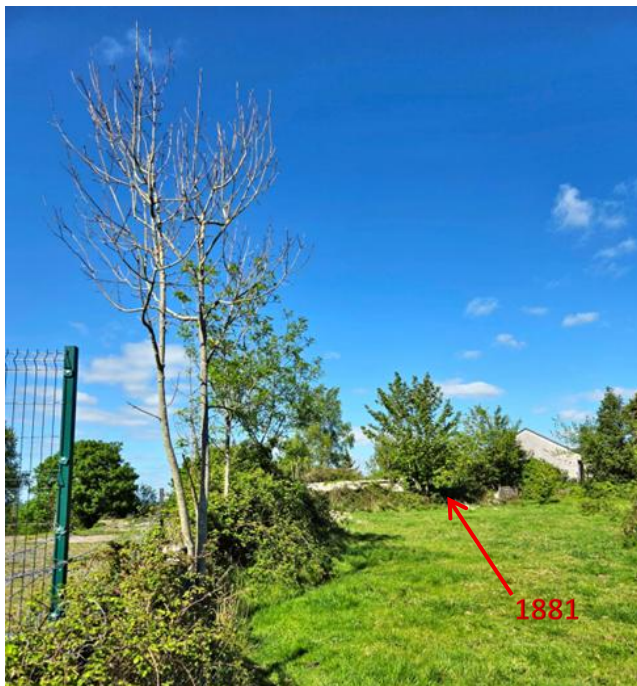
- 6.3** The southeast of the site looks to have been an old agricultural area based off google earth images and the concrete remaining in the site. The area has not been beneficial to tree growth due to the concrete base and construction work (possible compaction) that has occurred in the past (Images 1 & 2). The area has been left unmaintained with brambles now growing throughout the area and ivy growing through the crowns of some of the trees. Tree Line No. 1 and Tree Group No. 2, among others, have wounds present around their stems possibly due to machinery and/or livestock. These wounds may develop into cavities affecting the structural soundness of the trees.

**Image 1:** Looking north at Tree Line No. 1 in the left foreground with Tag No. 1881 in the background in the old agricultural area of the site

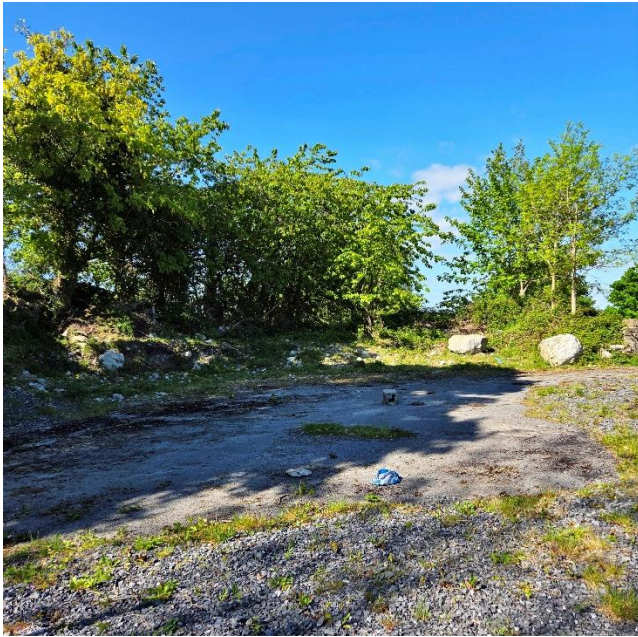
**Image 2:** Looking north at Tree Group 4 surrounding a concrete and gravel base once used as an agricultural yard

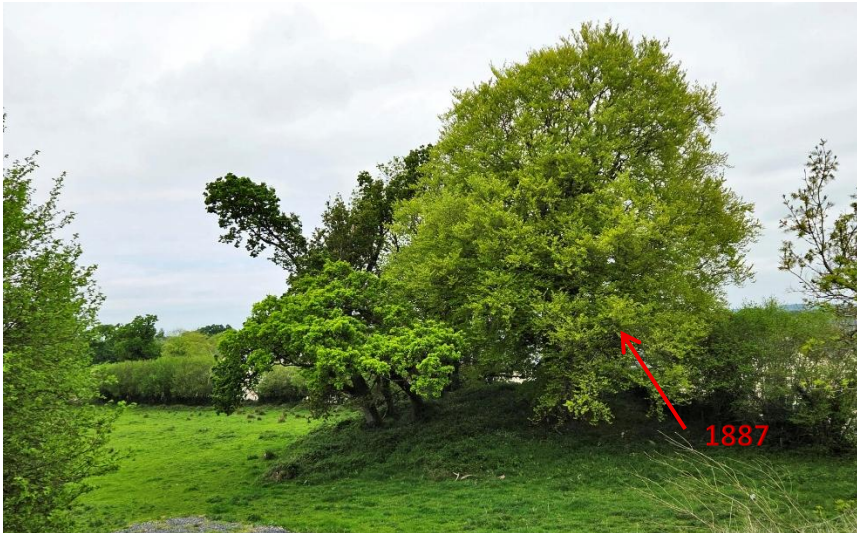
- 6.4** Heading north, down the slope at the edge of the agricultural area, there is a group of eight veteran trees along the eastern border – six of which are high-quality Category A (Tag Nos. 1887, 1889, 1890, 1892, 1894). The group is situated on a distinct mound within the field, elevating the trees above the surrounding terrain and enhancing their visibility and prominence in the landscape (Image 3), thereby contributing to their value as an amenity tree group. It contains a broadleaf mix of oak, beech and sycamore with large diameter trunks and well-developed, combined canopies. These trees have some structural defects, including cavities and decay fungi, which is expected with their age, but they are largely out of falling distance from the adjoining residences, except for Tag No. 1895 which is overhanging the eastern boundary (Image 4) toward the recent housing development – it was pruned for clearance with the adjoining house in the recent past but is regrowing and will continue to need pruning to maintain c. 2 m building clearance. Tag No. 1888 contains a decayed base (Image 5) along with a slight lean towards the house to the east, and it will need a heavy reduction to take it out of falling distance from the neighbouring development. The group holds ecological and landscape value due to the size and age of the trees.

**Image 3:** Looking north at the group of mature trees with Tag No. 1887 to the right of the group

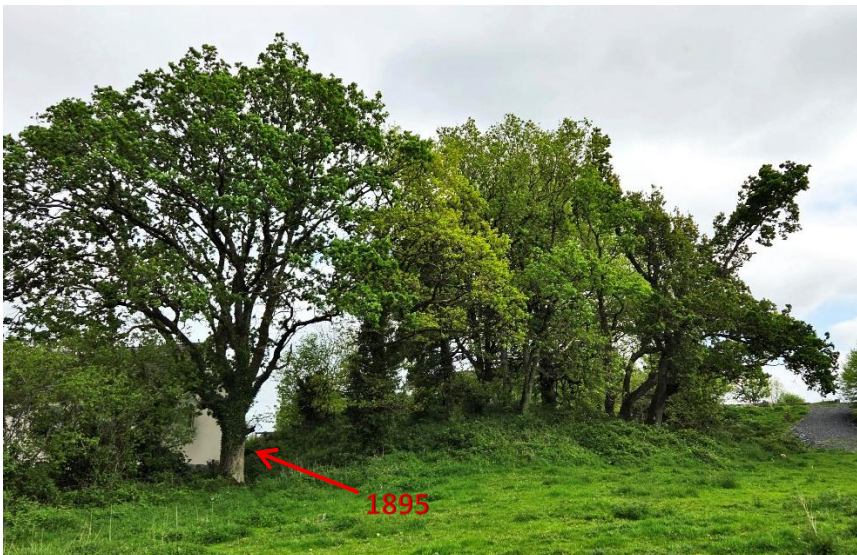
**Image 4:** Looking south at the mature tree group with Tag No. 1895 to the left of the picture

- 7.6** Tag Nos. 1889, 1891, 1892, 1895, 2509, 2511, 2512 will require light pruning and dead wooding to reduce risk to the proposed development (see management recommendations for these trees in the Tree Survey Appendix 1).

- 7.10** The proposed block walls within the RPA of Tag Nos. 1895, 2508, 2511 should be built with a pad raft foundation to minimise and localise root damage.

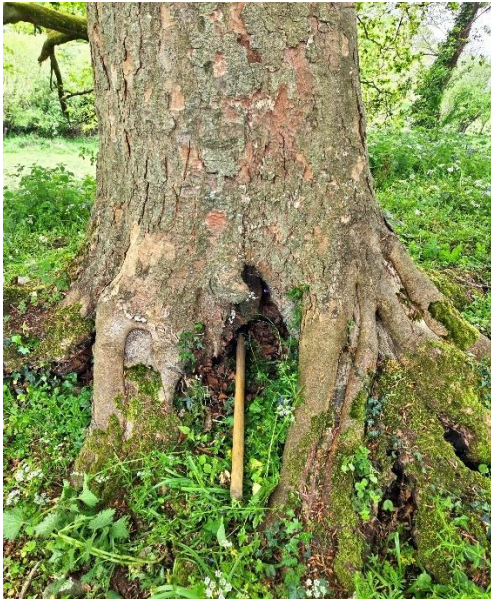
**Image 5:** Tag No. 1888 – sycamore with extensive basal decay

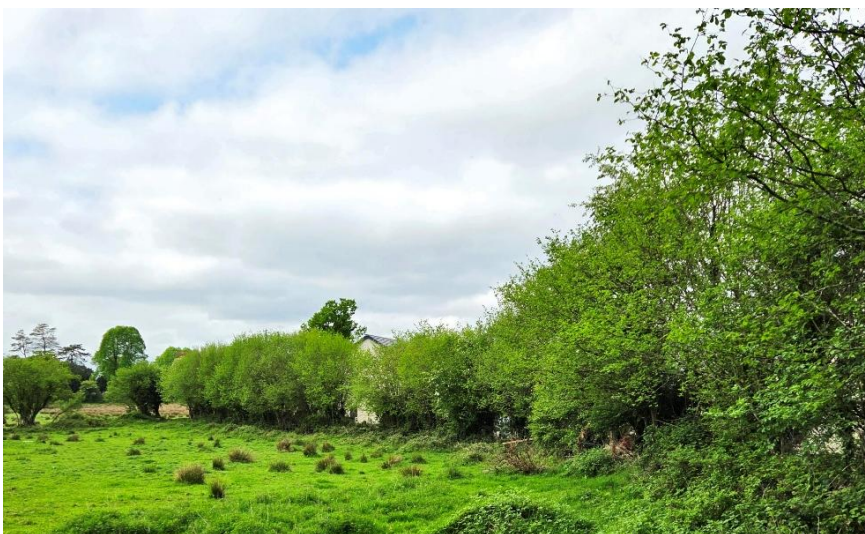
- 6.5** The eastern border comprises a linear hedge line that runs north to south and follows a dry ditch with a mix of broadleaf trees growing from the original hedge (Image 6). The hedge itself is made up of a large understory of hawthorn and brambles, some sycamore has self-seeded and are growing as part of the hedge, adding to its thickness. The tree spacing through the hedge is irregular and is a mix of mature and semi mature trees (Image 7). Trees that need individual work have been tagged in the survey. The trees and hedge both contribute to a screen from the adjoining construction site. While many of the trees are in good condition, there are several trees that will require work, such as the ash trees located on the northern part of the hedge (Tree Line No. 4), which have symptoms of ash dieback (causal agent: *Hymenoscyphus fraxineus*) and will need to be reduced into the hedge to reduce the risk to the adjoining residences.

**Image 6:** Looking north at Hedge No. 3 which separates the survey site from a housing development to the east.

- 7.12** Hedge Nos. 3 and 4 will need to be pruned/faced to provide space along the proposed back garden areas. The heights of these hedges should also be pruned, and any gaps infilled with native hedge species to create a more cohesive hedge structure.

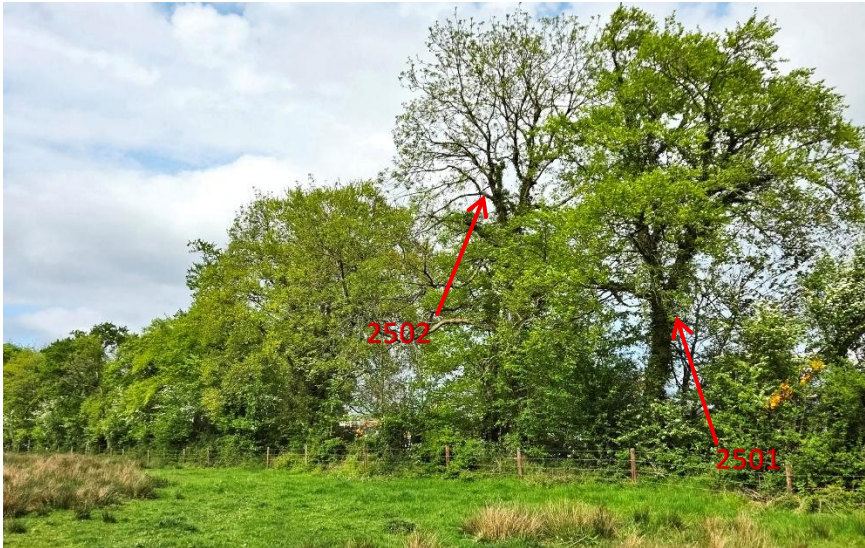
**Image 7:** Looking east at the middle of Hedge No. 3. Tag No. 2501, beech, and 2502 (ash)

have damaged roots due to building works from housing.			
2502	<b>ash</b> ( <i>Fraxinus excelsior</i> )	Early Mature	11	500	4	4	4	7	2	6	Poor	Fair	Tree is growing from hedge line. The tree shows symptoms of ash dieback. The tree is growing on the top of a 2 m ditch. Tree may have damaged roots due to building works from housing.	Cut tree to height of hedge and retain for hedge bulking.	<10	U
2503	<b>common beech</b> ( <i>Fagus sylvatica</i> )	Early Mature	11	390	3	3	1	2	1	5	Good	Fair	Tree is growing from hedge line. The tree is multi-stemmed. The tree is growing on the top of a 2 m drain but is overhanging the ditch. Tree may have damaged roots due to building works from housing.	Reduce to height of hedge and maintain as hedge bulking / ecological value.	10+	C1
2504	<b>ash</b> ( <i>Fraxinus excelsior</i> )	Early Mature	10	380	1	1	1	1	1	3	Poor	Poor	The tree shows symptoms of ash dieback. The tree is growing on the top of a 2 m ditch. Tree may have damaged roots due to building works from housing.	Cut tree to hedge level and retain for hedge bulking.	<10	U

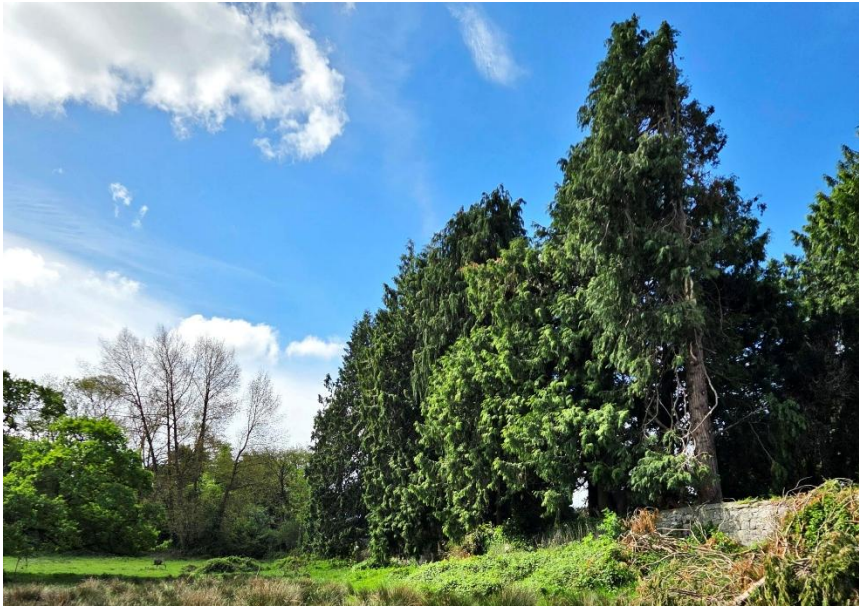
**Image 9:** Looking south at Tree Group No. 7 (Lawson cypress) which grows in Cornamagh Cemetery to the west of the site.

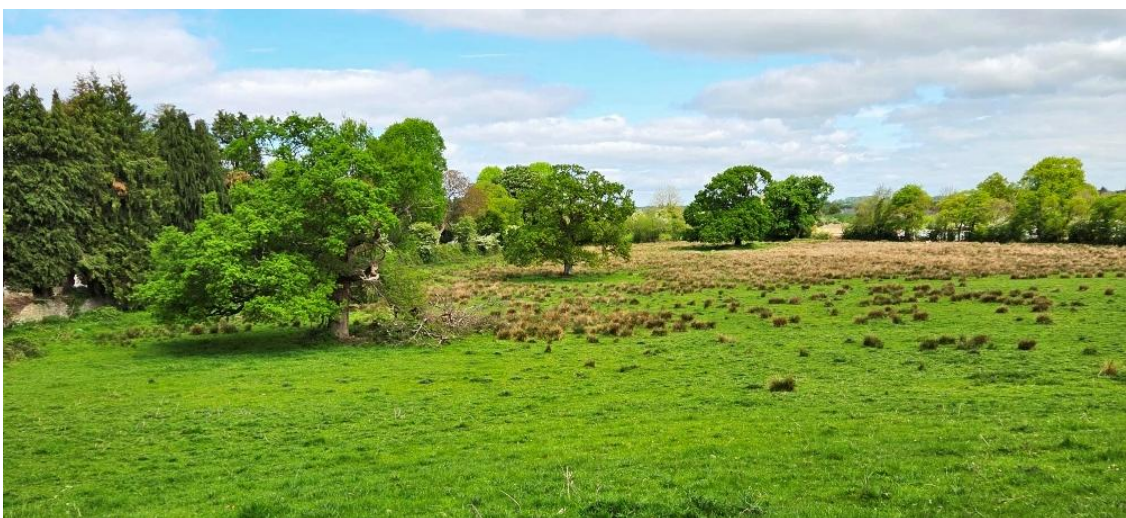
- 6.7** Through the middle of the site is a loose line of four, high-quality (Category A) oak trees Tag Nos. 2508, 2509, 2511 and 2512 (Image 10). Each tree exhibits varying degrees of veteran characteristics, including deadwood, hollowing, fissured bark, and habitat features such as cavities and limb retrenchment. These features contribute significantly to the biodiversity value of the trees. Due to their location in an agricultural landscape, the trees may have been subject to root zone compaction from grazing or machinery, as well as minor crown damage over time. Despite this, they retain good overall vitality and structural integrity and should be considered key ecological and landscape assets within the site.

**Image 10:** Looking north at a line of four mature oak trees running through the survey site.

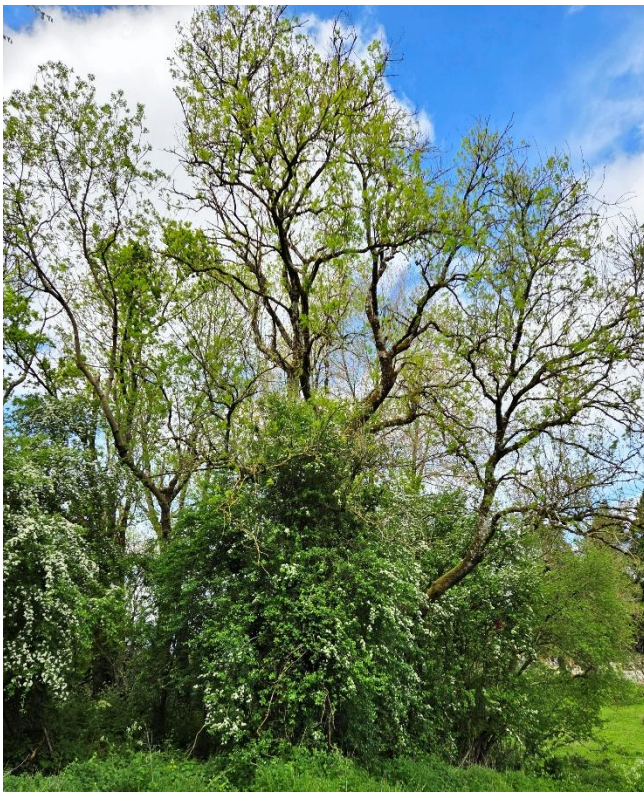
- 6.8** The southwest of the site comprises a small, wooded area, along with a hedge that borders some residential properties. The woodland is a mix of broadleaf species surrounded by a hawthorn hedge and an understory of brambles (Image 11). The wooded area consists of mostly ash, which show symptoms of ash dieback (Tree Group No. 9) and are in varying levels of decline. There are two, high-quality (Category A) oak trees (2513 & 2514) growing centrally in this group. The unmanaged hedge line runs east across the site separating two fields and consists largely of an understory of brambles and ivy with sycamore occurring frequently as both multi-stemmed shrubs and medium-height trees emerging through the main hedge body (Image 12). Beech trees are established sporadically along the length of the hedge, growing to full canopy height and contributing to an irregular upper canopy.

**Image 11:** Looking west at Tree Group 9 which is mostly ash, with Hedge No. 6 in the understory, predominantly made up of hawthorn.

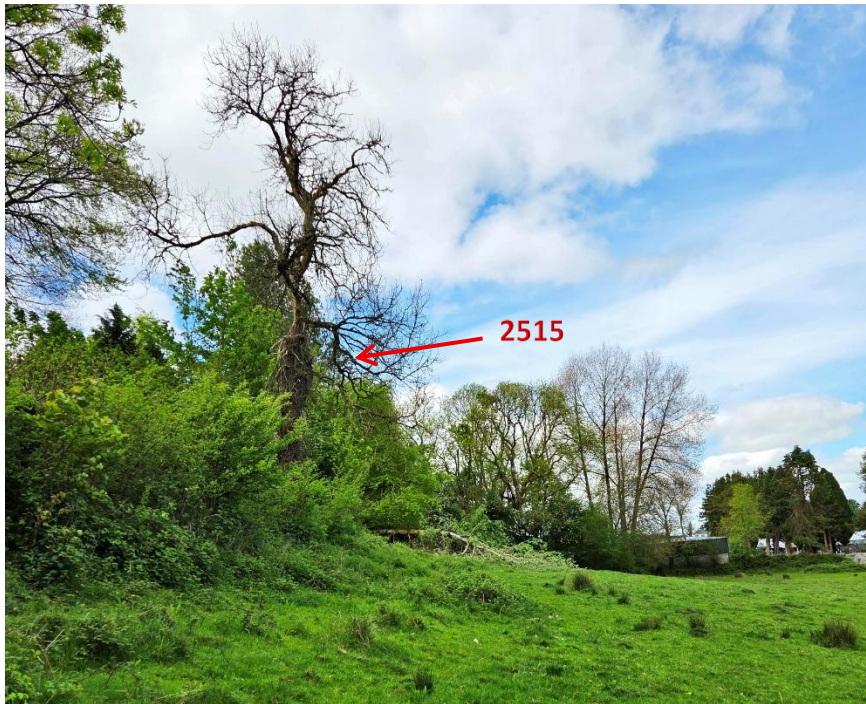
**Image 12:** Looking west along Tree Line No. 2 to the left. Tag No. 2515 can be seen growing from the hedge with a mostly dead crown due to ash dieback. Tree Group No. 8 and Tree Group No. 9 can be seen in the background of the picture.

- 7.2** Seventeen of the Category U trees—Tree Nos. T1, T2, T4, T5, 1896, 1900, 2505, 2510, 2515, 2516, 2522, 2523, 2524, 2525, 2529, 2532, and 2534—along with Tree Line Nos. TL4, TL5, and TL6, have been recommended for removal to reduce risk, regardless of the proposed development. In addition, Tag No. 1888 (Category C) requires a heavy crown reduction due to structural concerns. The remaining Category U trees in Table 2 (T6, 2502, 2504, 2506, 2507,) have a life expectancy of less than 10 years but are in low-risk areas and may be retained to decline naturally if the development does not proceed/

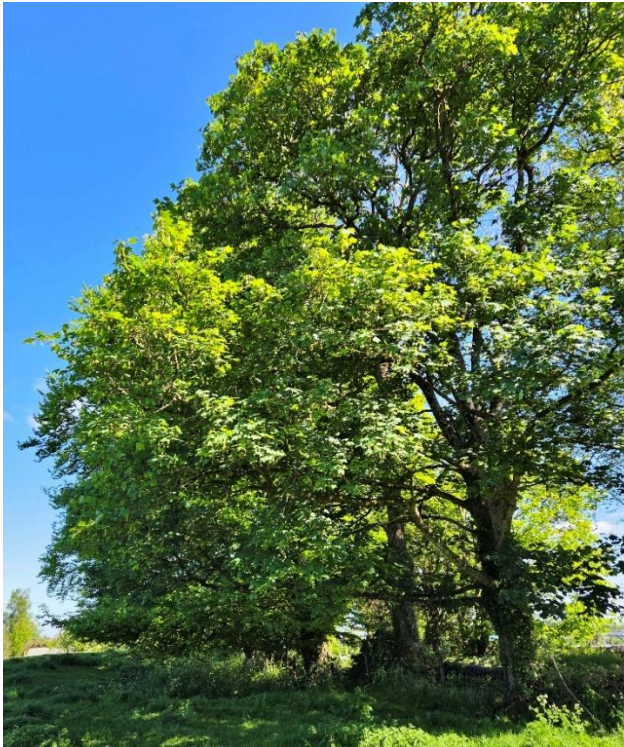
- 6.9** The southeast of the site contains a linear group of mature trees lining a small, quiet, public road. The trees are within 1 m of the road resulting in limited rooting space and potential ongoing interaction with the road (Image 13). Some of the trees are growing over a dry-stone wall that separates the road from the field, with root systems likely extending beneath or through the wall structure, causing displacement of the wall in places. The canopy extends over the road in areas, contributing to enclosure of the route and providing significant visual value (Image 14). Some of the trees show evidence of past pruning or crown management on the roadside. The ash trees in this area are all in various stages of decline due to ash dieback and will all need to be cut back into the hedge as they are in falling distance of the road. The tree line develops into an escaped hedge line of semi mature trees which provides good screening value to the agricultural lands.

**Image 13:** looking east along the line of trees by the road at the south of the site. Tag No. 2528 can be seen in the right of this picture.

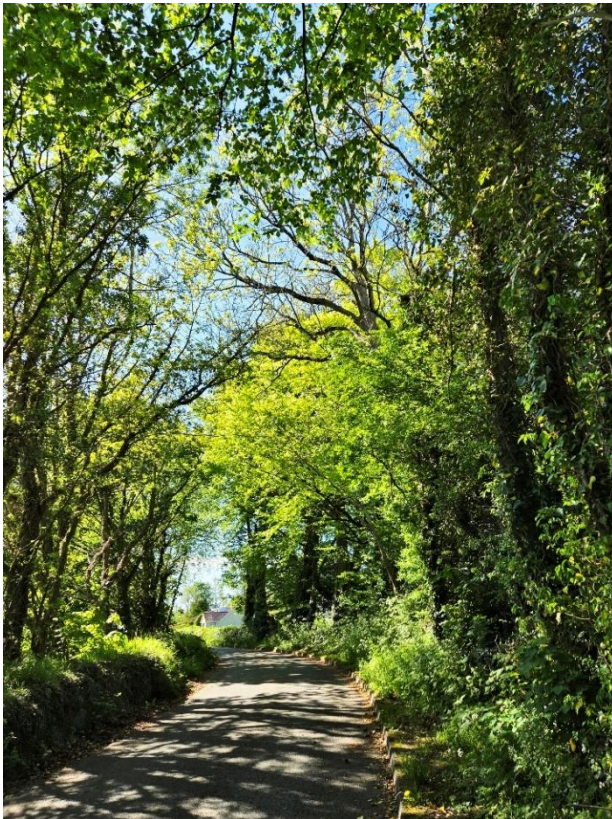
**Image 14:** Looking west at Tree Line No. 6 with an understory of Hedge 9, running along the right side of the road at the south of the survey site.

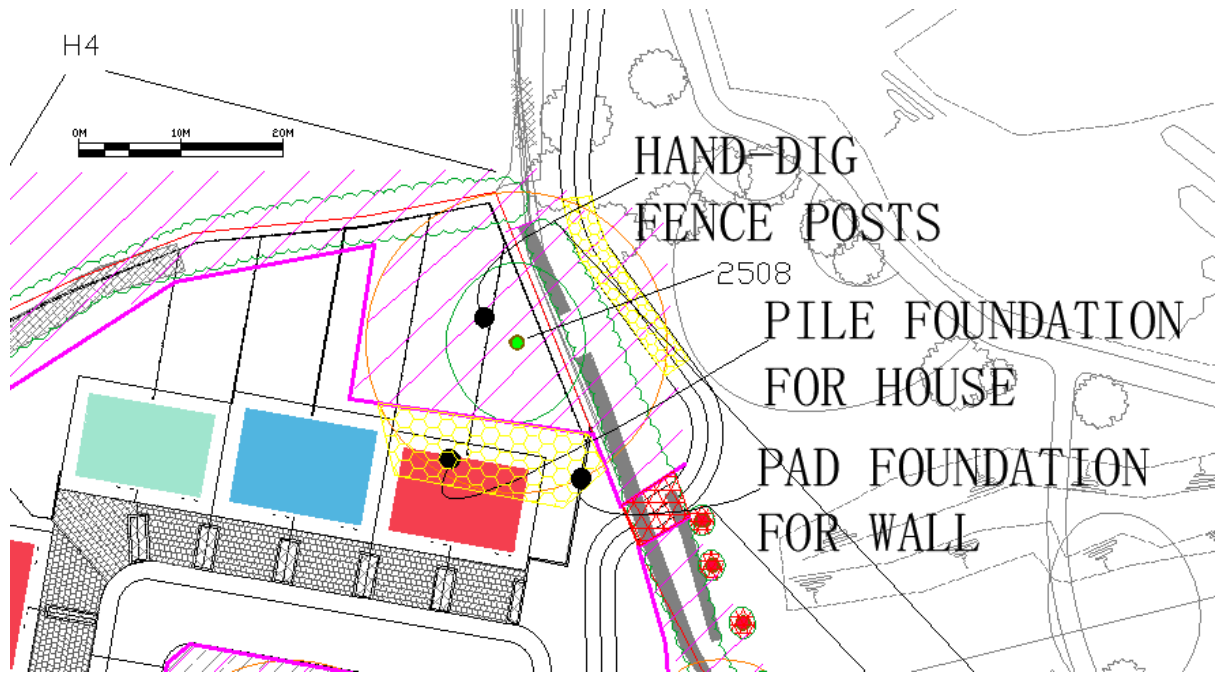
- 7.11** The proposed construction works would have a negative impact on two high quality (Category A) oaks (Tag Nos. 2508, 2509) even with mitigation measures implemented. From an arboricultural perspective, it would therefore be more prudent to relocate these houses to protect these high value trees (see Figures 1-3)

**Figure 1:** Excerpt from TPR-CM-01 showing the proximity of the high quality oak (Tag No. 2508) to the proposed development, which will need pile foundation, ground protection and pruning to reduce conflicts.

- 7.8** To avoid damage to the roots of Tree No. 3 and Tag No. 2508, pile foundations (sec 8.11) and ground protection (sec 8.9) would be needed to mitigate soil and root damage. Ground protection and No-Dig methods will also be needed for the path installation within the RPA of Tag Nos. 2508, 2509 - see TPR-CM-01 for ground protection locations and houses that would need pile foundations.

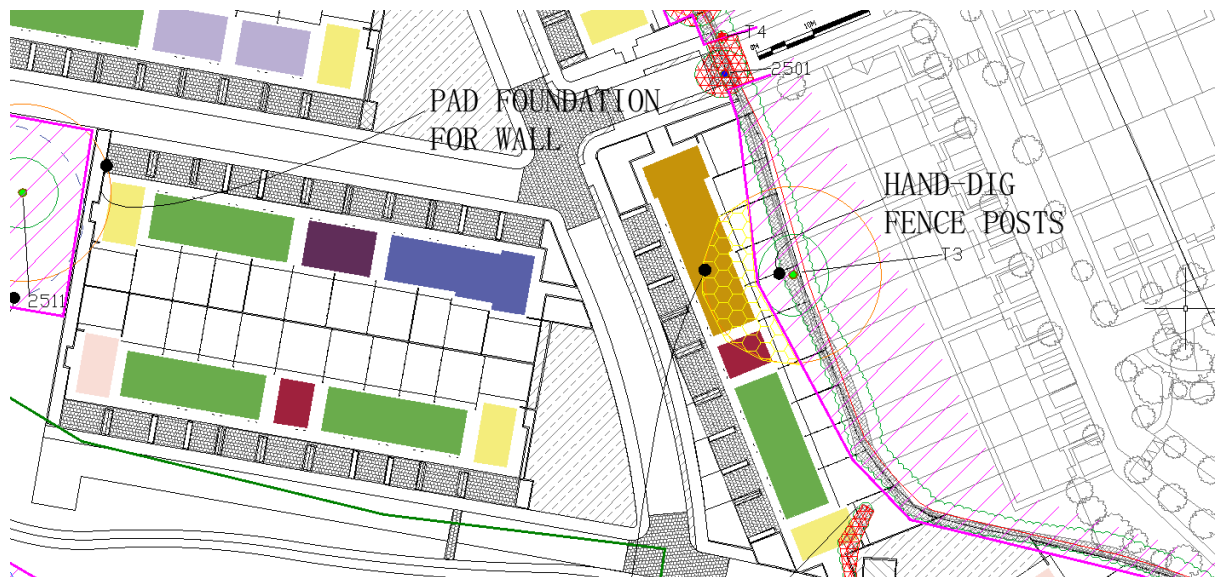
**Figure 2:** Excerpt from TPR-CM-01 showing the proximity of the high quality oak (Tree No. 3) to the proposed development, which will need pile foundation, ground protection and pruning to reduce conflicts.

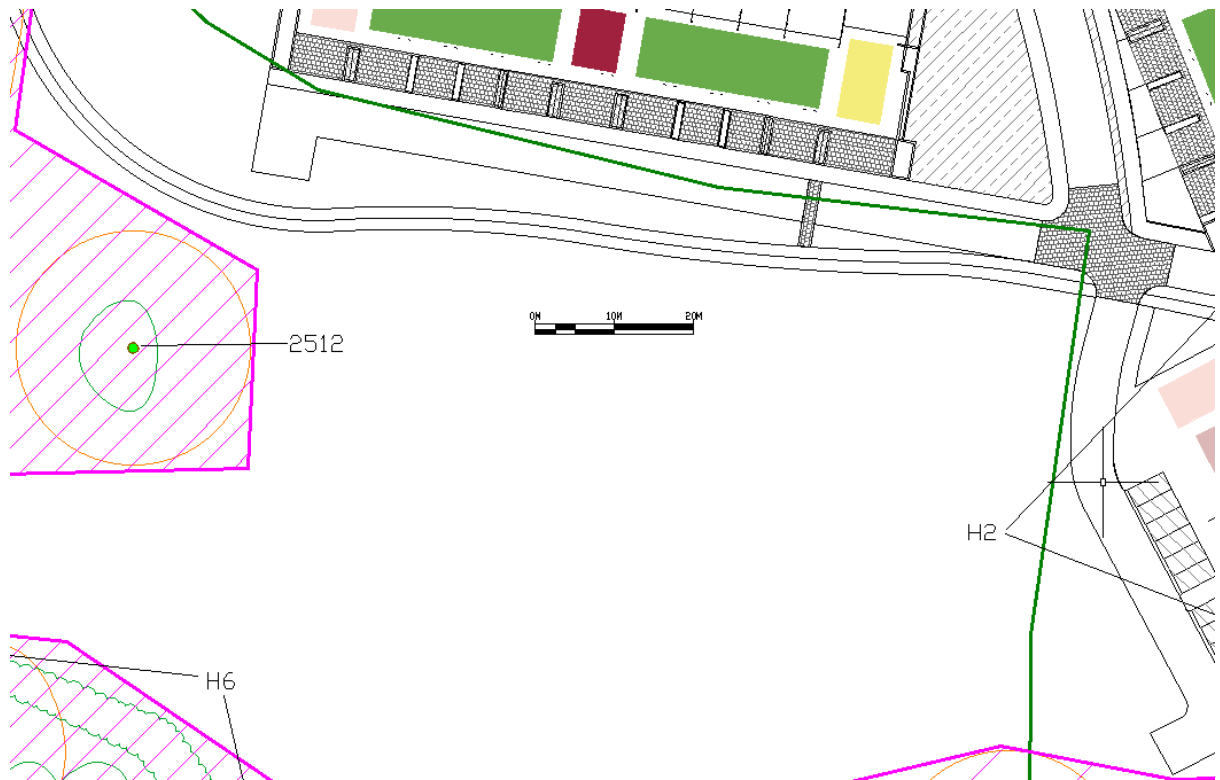
**Figure 3:** Excerpt from TPR-CM-01 showing the open space to the south of the site where the six houses that will impact on Tree No. 3 and Tag No. 2508 should ideally be built to reduce impacts on the high value oaks.
