## **Stage 1 Road Safety Audit**

**Ballyfasy Wind Farm, Co Kilkenny**

On behalf of **Manogate Ltd**

**October 2025**

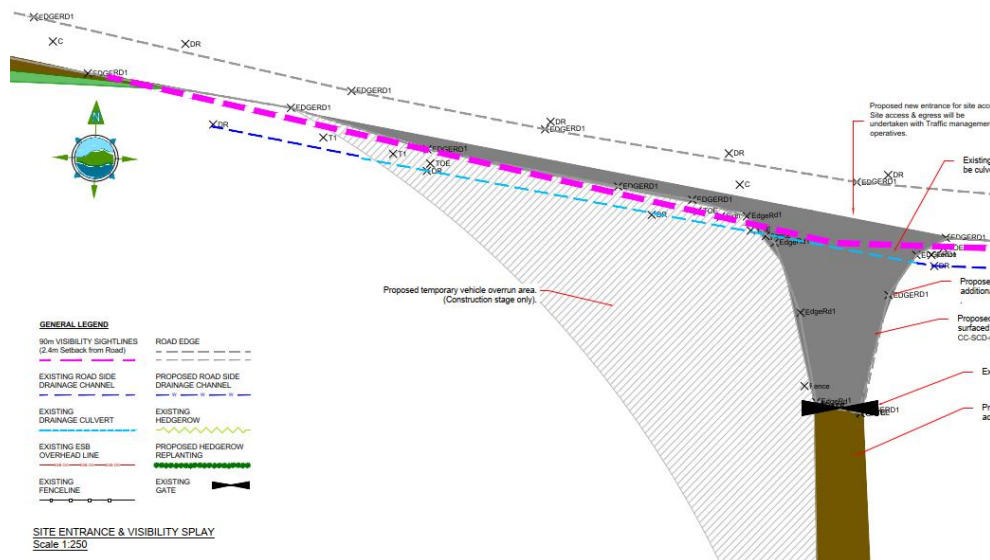
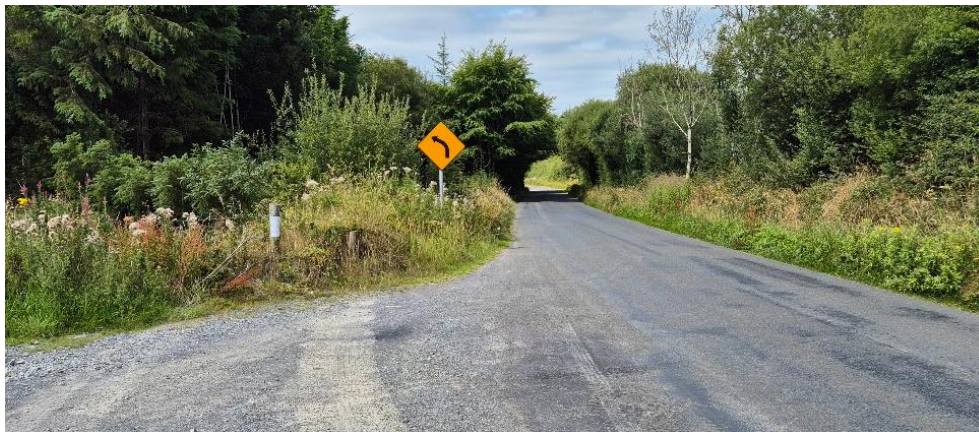
### 4.2.1 Entrance Location 4

**Problem:** There is a bend in the road to the west of the development junction. The dense vegetation / trees on the knuckle of the bend may impact with the required junction visibility envelope.

**Hazard:** Development traffic may exit the junction into the path of oncoming traffic.

**Recommendation:** The Design Team should ensure suitable junction visibility splays are provided and maintained.

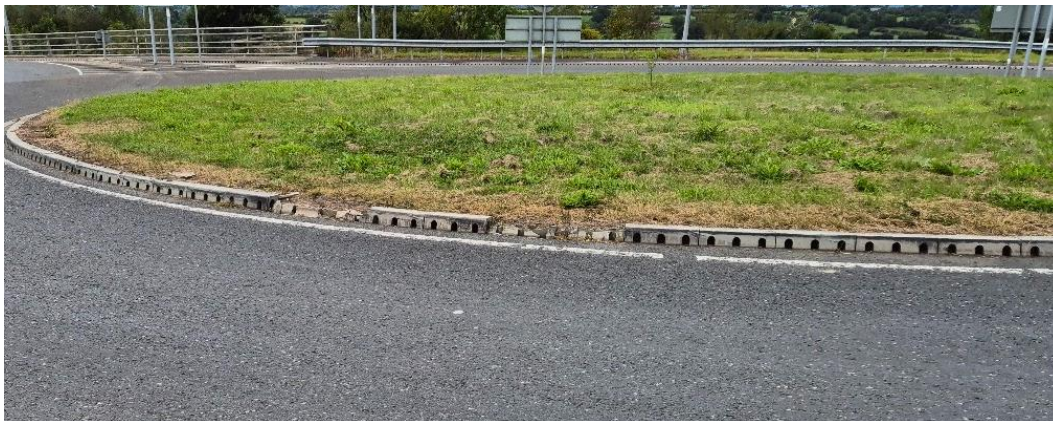
### 4.3.2 Drainage Kerbs

**Problem:** The roundabout central island at locations 5 and 6 utilises combined drainage kerbs. Some of these kerbs show evidence of damage, possibly caused by over-run of vehicles. There is concern the further over-running of the kerbs by the turbine delivery vehicles will further damage the kerbs and reduce the drainage capacity of the units.

**Hazard:** The carriageway may flood, resulting in aquaplaning type collisions.

**Recommendation:** The Design Team should ensure adequate protection of the kerbs is provided to prevent damage to the kerb unit.

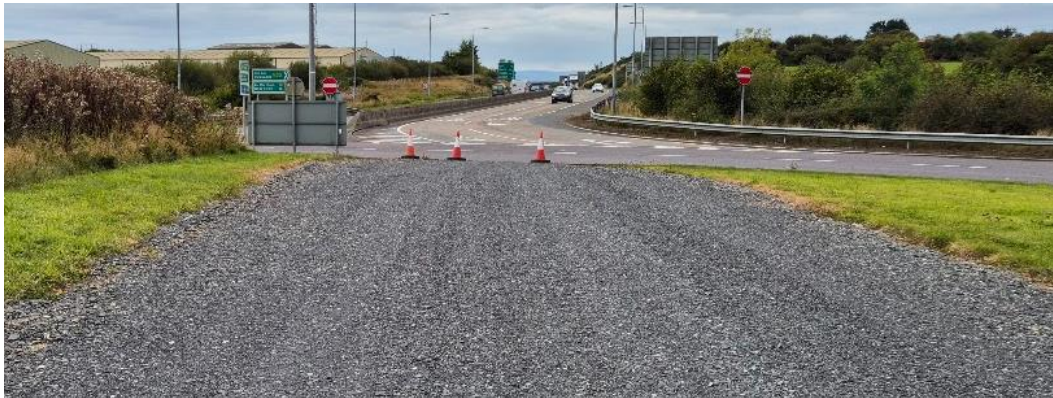
#### 4.3.4 Temporary Over-run Areas (1)

**Problem:** Although no surface finish is shown for the temporary over-run areas, the material used for previous deliveries are a graded stone. There is concern some of the new or previous material may be dragged onto the main carriageway by the delivery vehicles.

**Hazard:** Powered two wheeled vehicles may lose control on the stone scatter.

**Recommendation:** The Design Team should ensure no stone scatter occurs due to the passage of the development traffic.

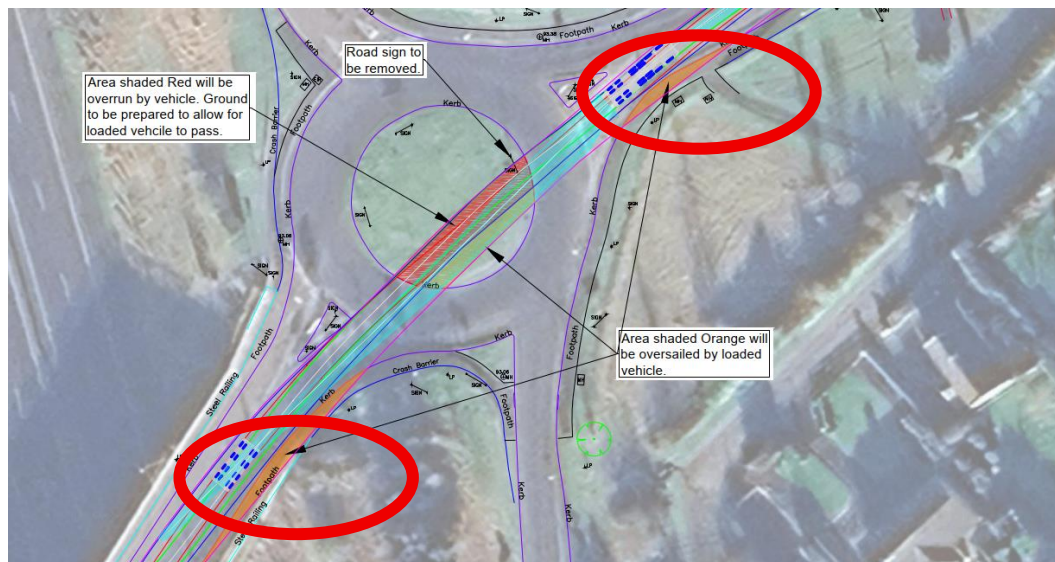
#### 4.3.8 Footpaths

**Problem:** There are a number of areas where the turbine delivery vehicle or vehicle load over sails the footpath.

**Hazard:** Pedestrians, possibly sightseers, may be struck.

**Recommendation:** The Design Team should physically close the problem areas of footpath and provide a suitable diversion route for the duration of delivery.

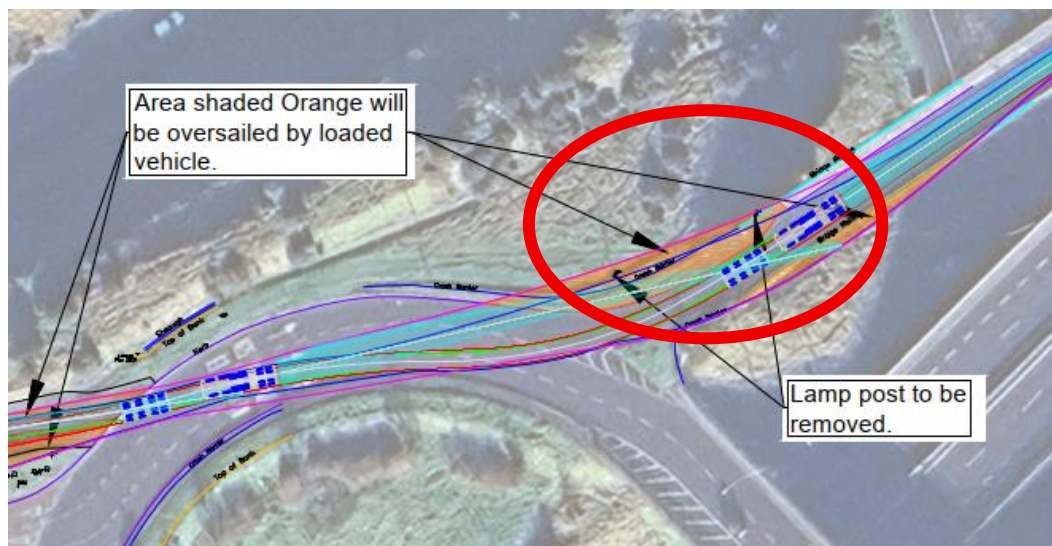
### 4.4.1 Location 5 – Pedestrian Parapet

**Problem:** The turbine delivery is shown to over sail the pedestrian parapet at the N5 / N29 interchange. The pedestrian parapet is higher than the remaining vehicle restraint system in the area and may be struck by the turbine delivery vehicle. There is concern the delivery vehicle team will be required to stop and wait while these elements are removed / vehicle load adjusted, therefore delaying completion of the turbine delivery.

**Hazard:** Increased duration of road closures and diversions may result in collisions by diverted traffic.

**Recommendation:** The Design Team should assess the load height and parapet height, and ensure the proposals work workable.

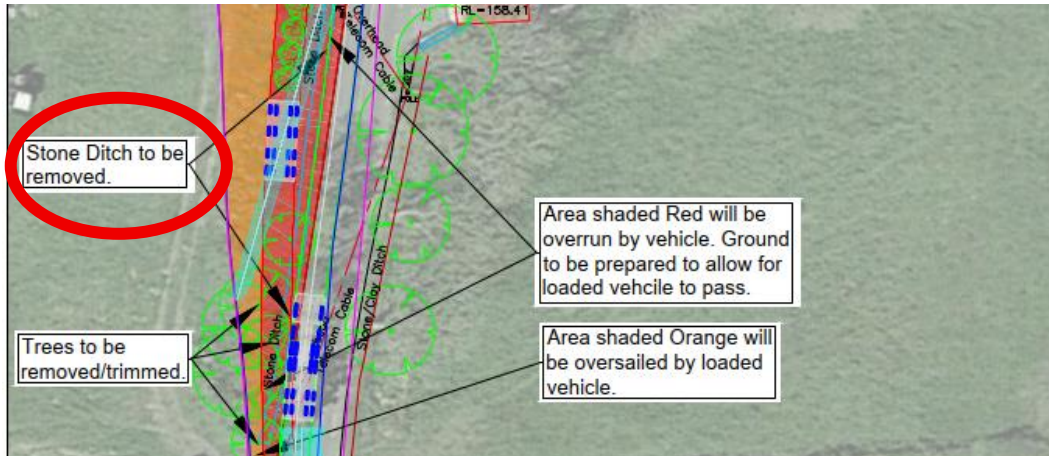
#### 4.4.2 Location 10

**Problem:** The existing roadside stone ditch is proposed to be removed by the works. There is concern removal of this ditch will result in surface water flooding of the adjacent carriageway.

**Hazard:** Aquaplaning type collisions may result.

**Recommendation:** The Design Team should ensure suitable drainage systems are installed to replace the stone ditch.

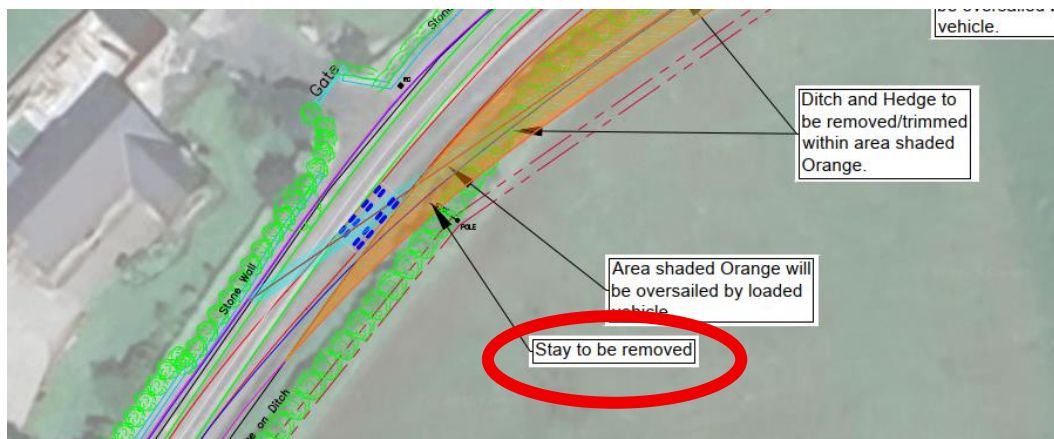
#### 4.4.3 Location 13 – Utility Pole Stay

**Problem:** There is a utility pole stay indicated to be removed by the works. Removal of this stay may result in the associated pole and cable falling into the carriageway.

**Hazard:** Impact from passing traffic may result.

**Recommendation:** The Design Team should ensure the pole and cable are secure.
