Title: **STAGE 2 ROAD SAFETY AUDIT**  
**For;**  
**Main Street Ardee**

Client: **Louth County Council**

Report reference: **2067R02 Rev 2**

VERSION: **March 2025 Addendum.**

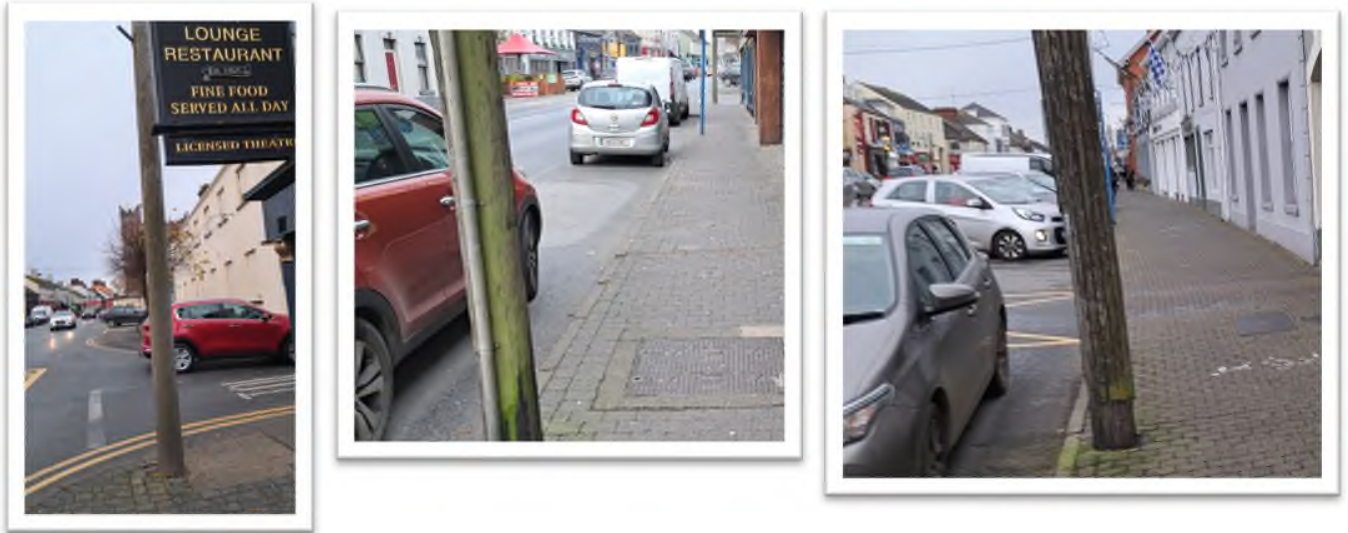
There are some substantial utility poles in the footpaths along the scheme. It is unclear if these poles are to be removed. If they are to remain they present hazards for pedestrians who may collide with them if not looking up, or if the pedestrians are visually impaired and also the poles reduce the effective width of the footpath to such an extent that some pedestrians may step onto the carriageway to avoid them thereby increasing the risk of being struck by a passing vehicle.

It is recommended that the poles be removed.

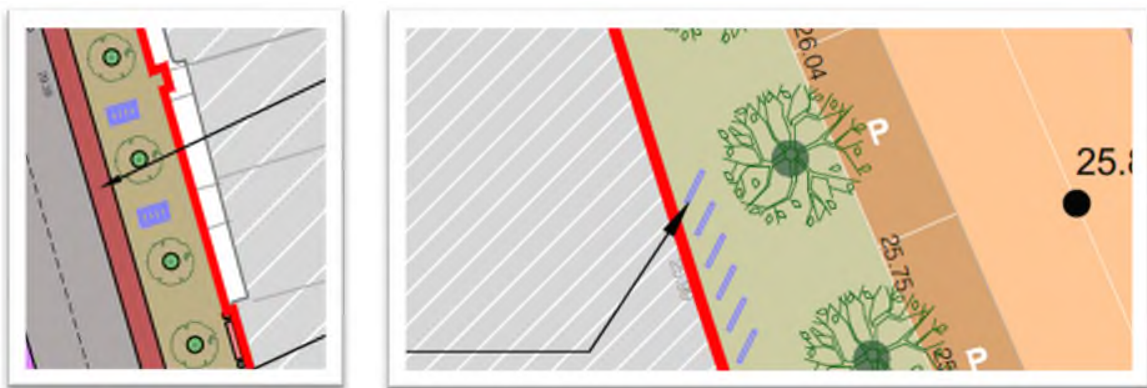
It is proposed to provide street furniture including trees along the scheme. There is a risk that the effective width of the remaining footpath may be less than the capacity needed to cater for the volumes using it. This could lead to collisions between pedestrians, spillover of pedestrians into cycle tracks or pedestrian collisions with street furniture.

*Examples only*

It is recommended that a suitable effective width of footpath be maintained throughout the scheme to cater for the typical volumes in Ardee, including increased future pedestrian use as a result of this scheme.

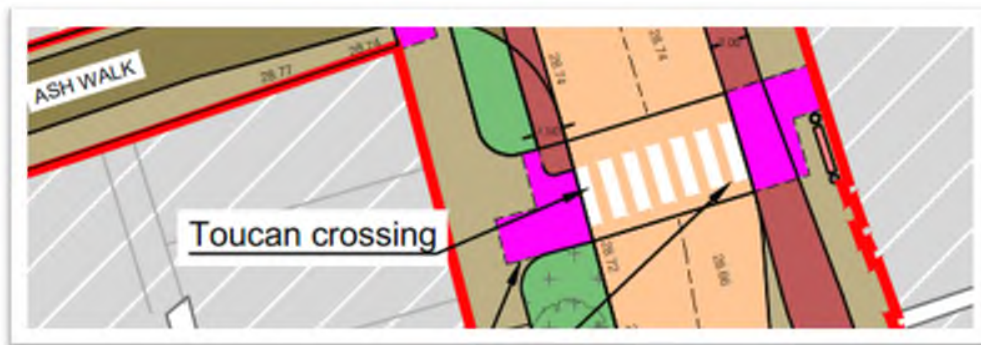
The northbound cycle track commences within the L-shaped tactile paving. This area should be shared use and access to the push buttons should be available. The Zebra type road markings should not be provided at toucan crossings as priority may be confusing. A lack of clarity could lead to collisions between vulnerable road users and passing traffic.

It is recommended that a standard layout toucan crossing be provided.

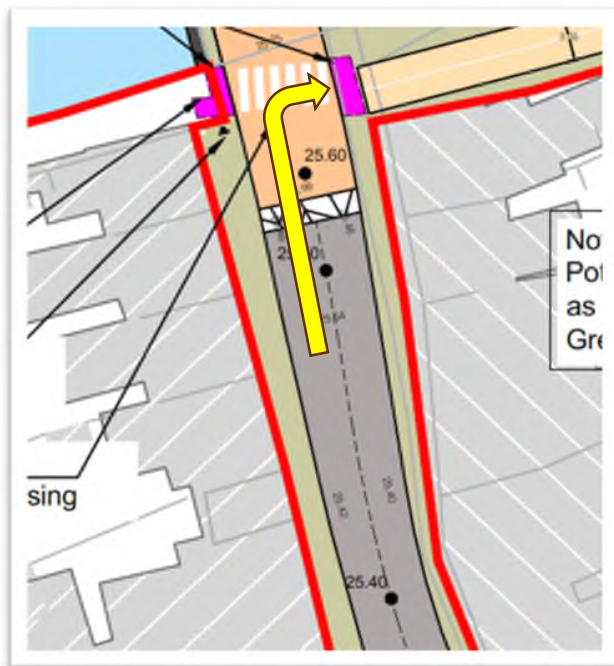
There is no provision for northbound cyclists to exit the N2 and wait to cross the signalised crossing. Cyclists will therefore continue travelling northbound on the Main Street carriageway thereby increasing the risk of collisions with general traffic. A proposal to direct cyclists via Hale Street was suggested in the Feedback Form of the Stage 1&2 Road Safety Audit. That proposal does not appear to be included in this design update.

It is recommended that a transition from on-road to off-road be provided for cyclists.

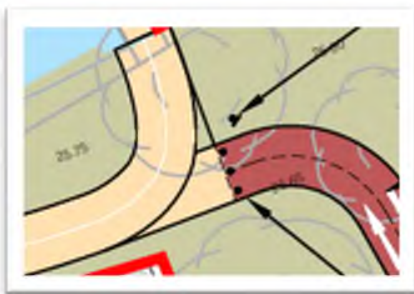
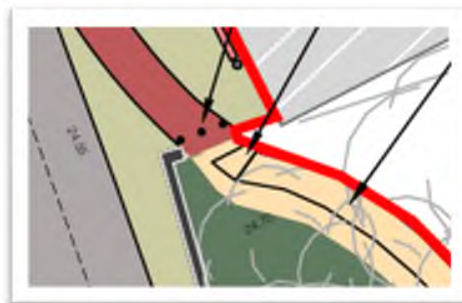
A lack of guidance at the interface of shared use and cycle only facilities could lead to blind or partially sighted pedestrians entering a cyclists only area which would increase the likelihood of a collision with cyclists.

It is recommended that suitable tramline tactile paving be provided at the interfaces.

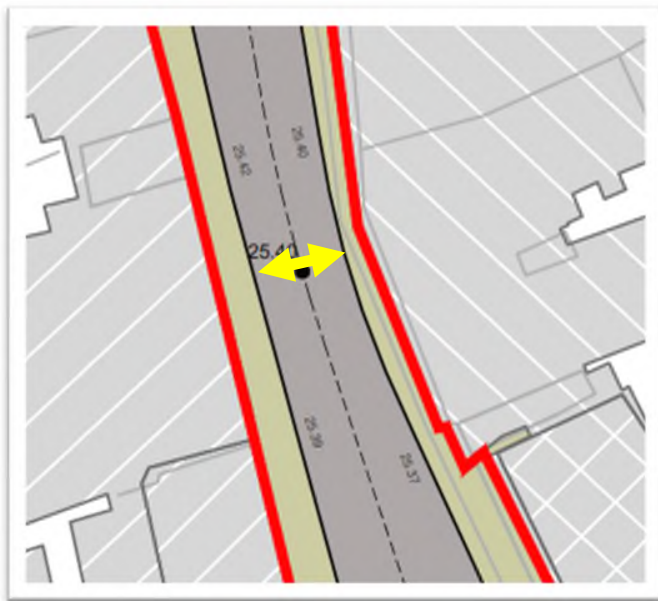
There is a pinch point in the carriageway south of the bridge. Wide vehicles currently operate an informal shuttle system to pass each other. This may not be possible with the introduction of the new crossing as vehicles may be stuck in position while queuing at the signals. This could lead to side-swipe collisions, damage to bollards and mounting of the footpath. It is noted from the site visit that queuing on the N2 is common for long periods of each day. (It was observed during the most recent site visit that flexible bollards in the footpath at this location have been struck many times and have collapsed)

It is recommended that an analysis be carried out of the likelihood of queues at the pinch point and the possible need for a longer formal shuttle system.

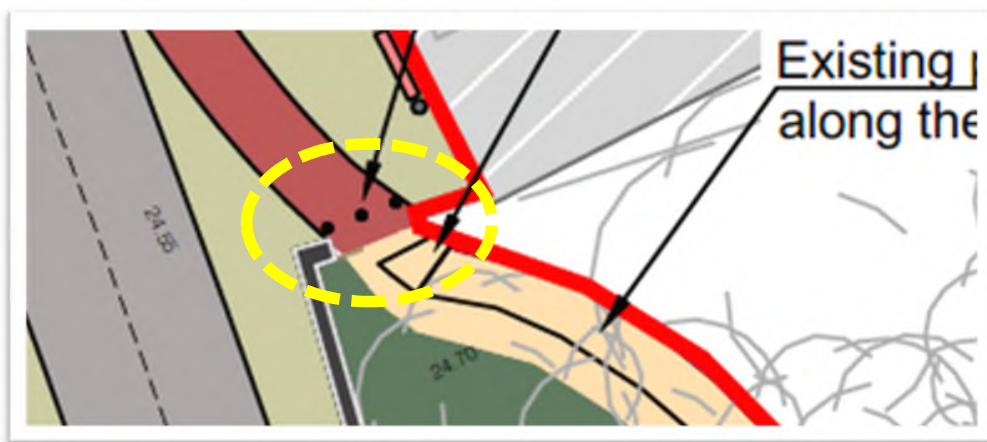
The two-way cycle track leads to a shared use area on approach to the bridge. Pedestrians have no area to join the shared use area. This could result in pedestrians crossing the road bridge which has a very narrow footpath and pedestrians would be subject to wind forces from heavy goods vehicles possibly leading to loss of balance.

It is recommended that an area be provided for pedestrians to access the pedestrian bridge.

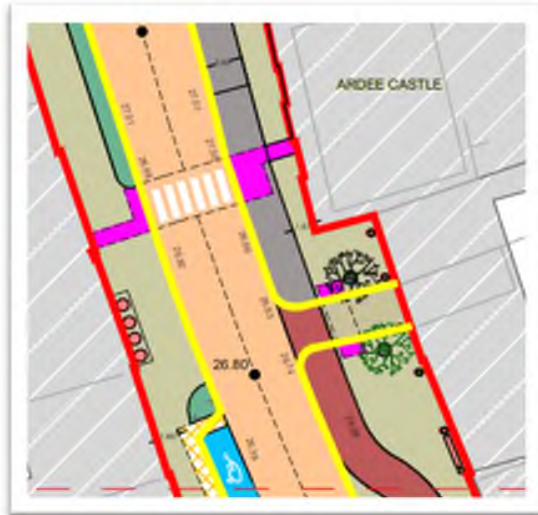
It is proposed to provide flush kerbs between the footpaths and cycle tracks at areas of raised tables. Given the arterial nature of the N2 and the high percentage of HGVs there will be no resistance to overrun by wide vehicles and no containment of errant vehicles. The flush kerbs will lead to higher turning speeds at side roads and private accesses which would increase injury severity if a vulnerable road user is struck. The flush kerbs also provide no warning for blind or partially sighted pedestrians that they could be entering an area trafficked by vehicles.

It is recommended that a suitable kerb upstand be provided except at pedestrian crossing areas.

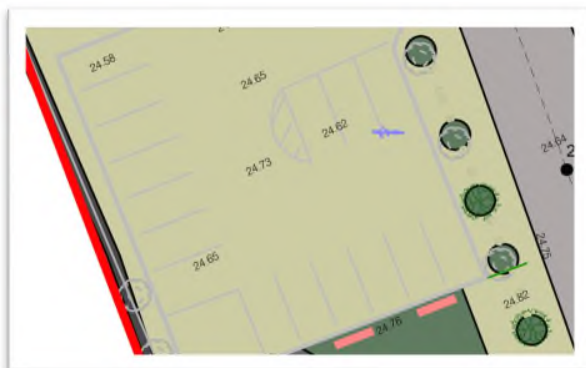
Some proposed car parking spaces appear to be difficult to enter and egress especially if the adjacent spaces are occupied. This could lead to material damage of vehicles or inaccessibility for some users with mobility impairment but not sufficient to be entitled to use the disabled spaces.

It is recommended that adequate turning space be provided for all car parking spaces.

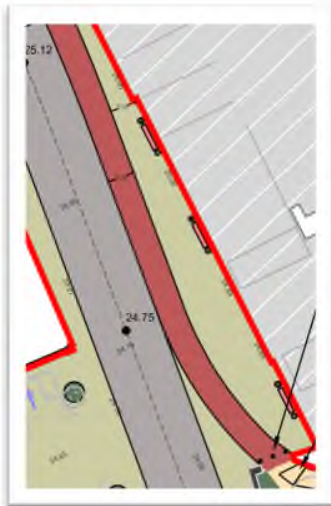
The two-way cycle track along the eastern side may not be obvious to all users that it is two-way. This could lead to lack of discipline by cyclists travelling side by side thereby increasing the risk of collisions with oncoming cyclists.

It is recommended that additional cycle road marking logos with arrow heads be provided at regular intervals. (These are provided on some drawings).

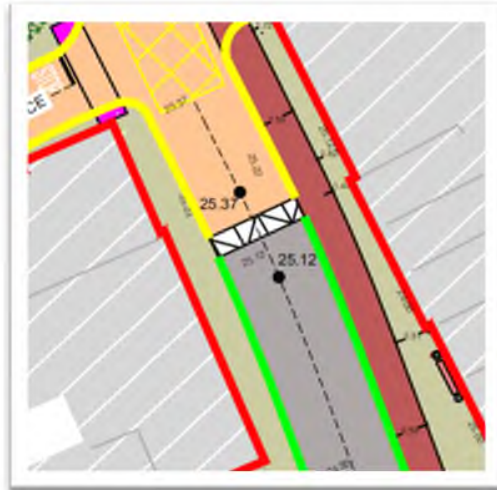
especially if affected by the wind forces associated with HGVs, resulting in collisions. This may particularly be an issue at raised tables where there are flush kerbs only to segregate cyclists from general traffic. There was a suggestion of having a 30km/hr speed limit in Ardee town centre in the feedback form of the Stage 1&2 Road Safety Audit. This does not however appear to be part of the current proposal.

It is recommended that the 30km/hr speed limit be confirmed or that a buffer zone, bollards or a suitable kerb upstand be provided.

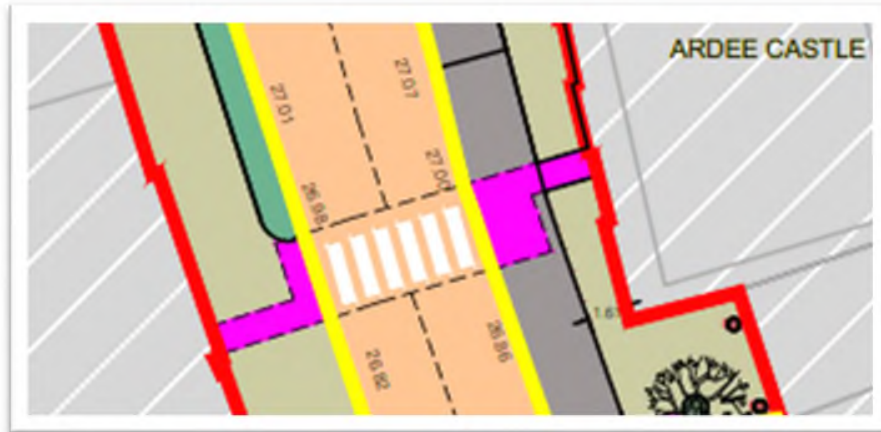
The pedestrian crossing at Ardee castle has a two-way cycle track on the eastern side. A lack of warning could lead to blind or partially sighted pedestrians not realising they are sharing space with cyclists.

It is recommended that a well-defined shared area be provided with suitable ladder and tramline tactile paving at either side. This applies to other similar crossings throughout the scheme.

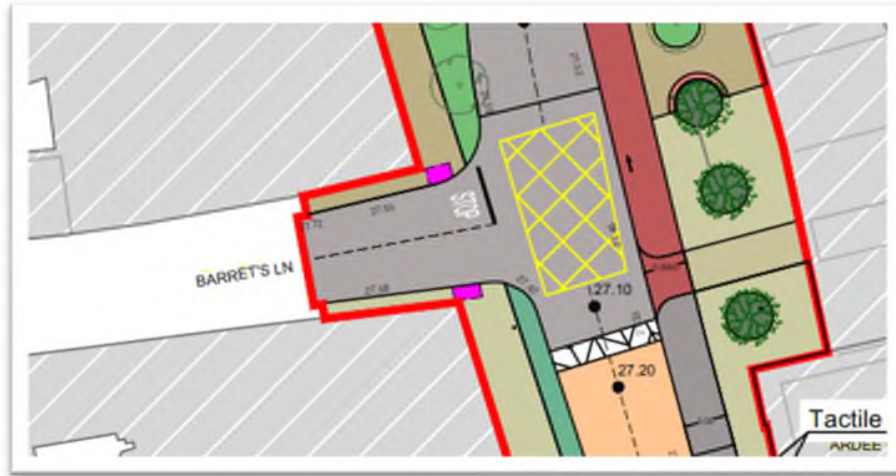
The N52 is a national secondary road which is proposed to bypass Ardee in the future as part of a separate scheme. There is however no guarantee that this scheme will progress and a high volume of HGVs will continue to use the N52 if this scheme progresses. Although the N52 junction is being built out from its current layout it is unclear if HGVs will be able undertake the turning manoeuvres from and to the N2 in both directions. A lack of space would lead to overrunning of the footpaths, cycle track or side swipe/head-on collisions with other vehicles.

It is recommended that a swept path analysis be carried out for HGVs to ensure that turning manoeuvres can be undertaken. If this cannot be achieved a signalised junction may be required.

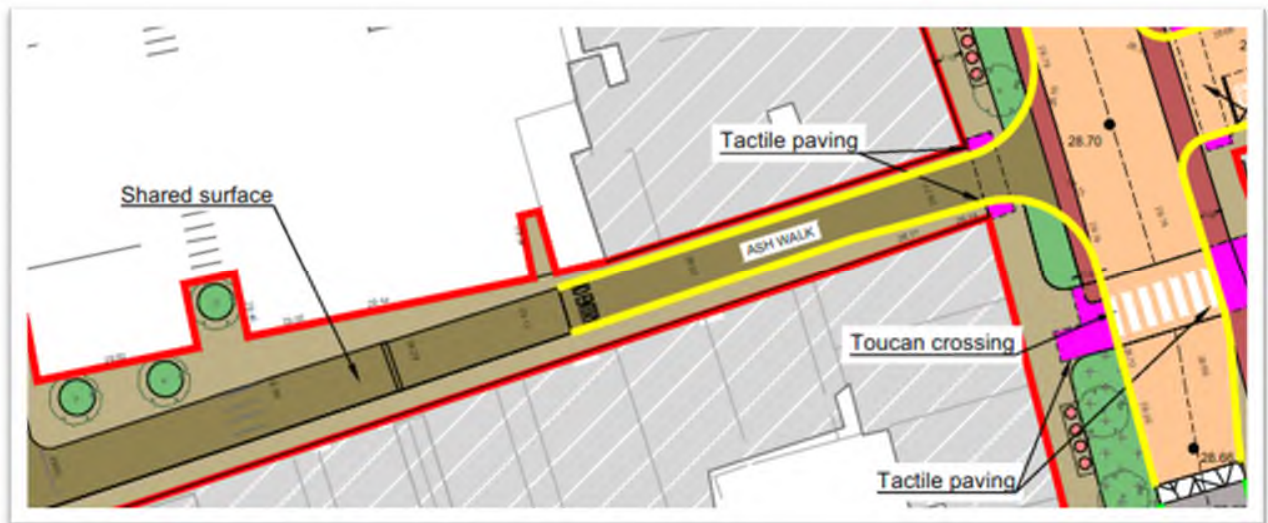
Ash Walk is shown to be a 'Shared Street' It is unclear what distinguishing features or what signage will be provided to indicate this to users, especially drivers, as they enter this area. It appears that the footpaths are to be retained beyond the initial section from the N2 which does not signify a shared street but segregated facilities for pedestrians. A lack of clarity can lead to drivers presuming priority resulting in collisions.

It is recommended suitable details be provided to denote a 'shared street' at its transition from the N2.

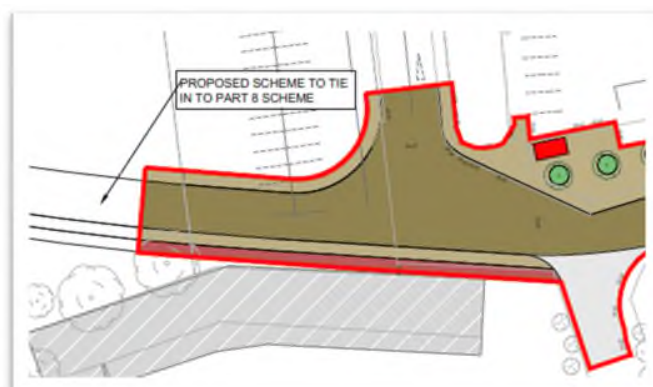
Ash Walk is shown to tie-into a Part 8 scheme at the western end. Ash Walk is shown as a 'Shared Street'. It is unclear if the Part 8 scheme is to be a shared street and if its nature and use will therefore be consistent. A change of street type could increase the risk of collisions with vulnerable road users.

It is recommended that consistency in street type be provided.

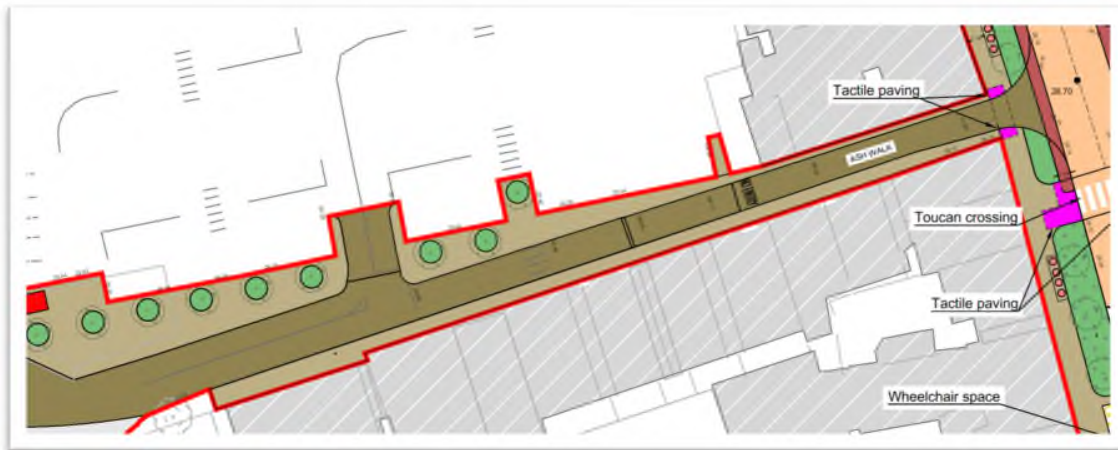
Ash Walk is relatively long and straight and one-way. This could lead to high vehicle speeds. High speeds leads to high injury severity if a vulnerable road users is struck by an errant vehicle.

It is recommended that traffic calming be provided along Ash Walk. (It is unclear if an existing raised table is to be retained)

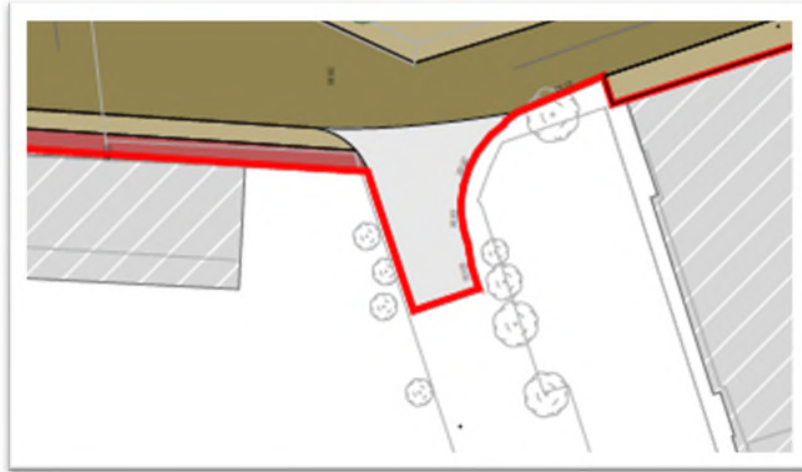
The link road to the N52 from Ash Walk is not shown to be a shared street. A change of street type could increase the risk of collisions with vulnerable road users.

It is recommended that that consistency in street type be provided or that a suitable transition be provided.

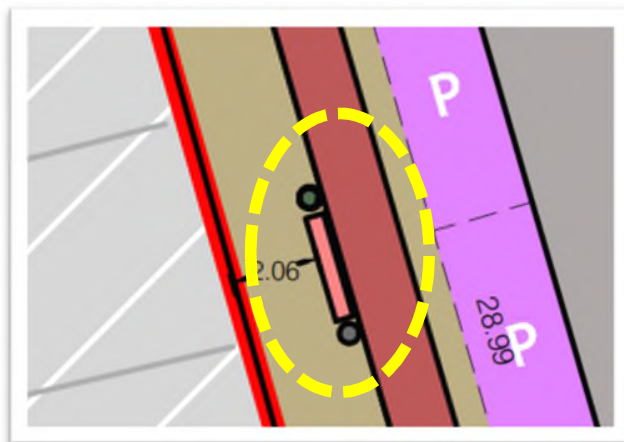
It is proposed to provide benches adjacent to the cycle track. If they are located too close to the cycle track they may be hazards for cyclists who may get their handlebars caught leading to loss of control and falls.

It is recommended adequate offset be provided at the edges of the cycle track without obstacles.

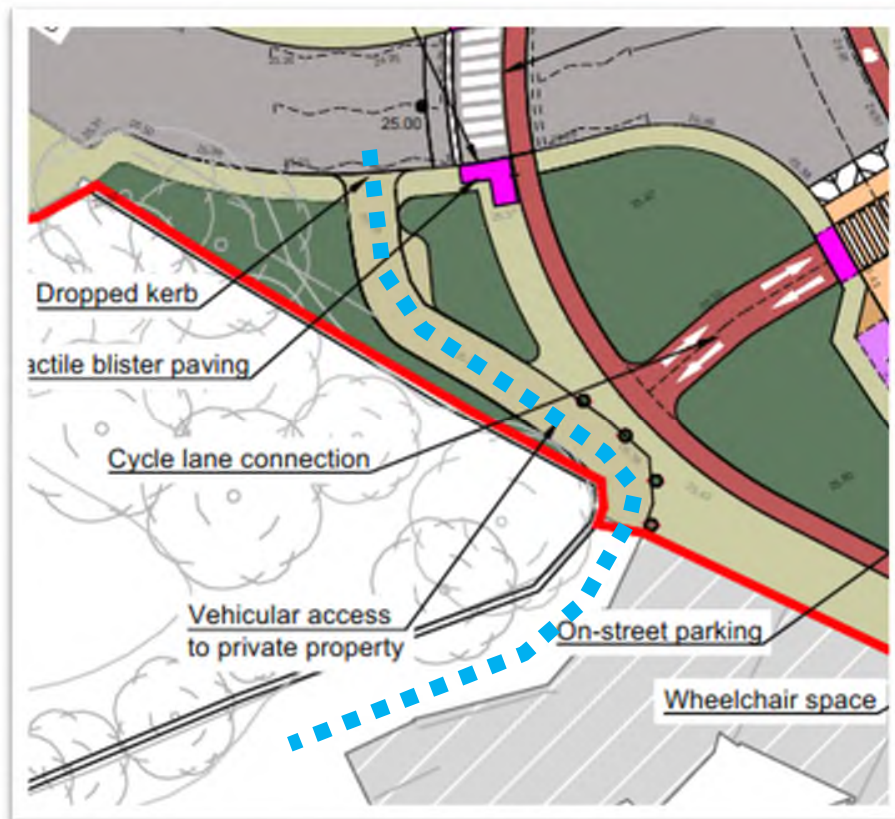
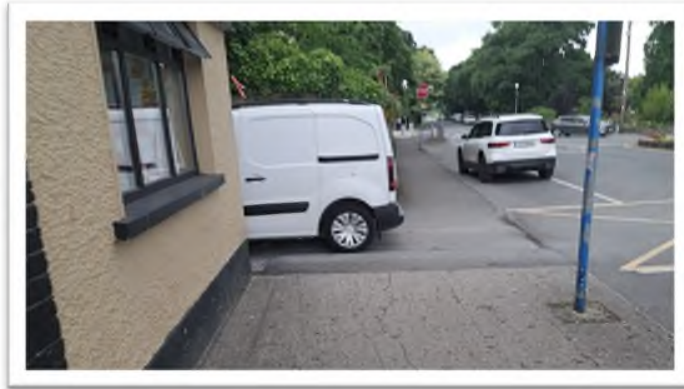
The vehicular access to the car park of the bar at the junction of Golf Links Road is for a single vehicles only. Drivers entering the route will not have inter-visibility to drivers leaving which could lead to reversing onto Golf Links Road resulting in collisions with through traffic or crossing pedestrians.

It is recommended that a passing bay be provided. Depending on the amount of usage this lane may need to be segregated from the pedestrian route.

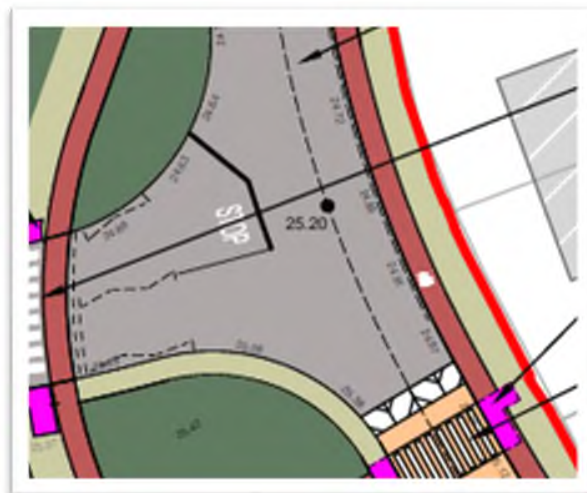
The corner radii at the Golf Links Road junction with the N2 are large. This could lead to high turning speeds and thus higher severity collisions.

It is recommended that the corner radii be reduced

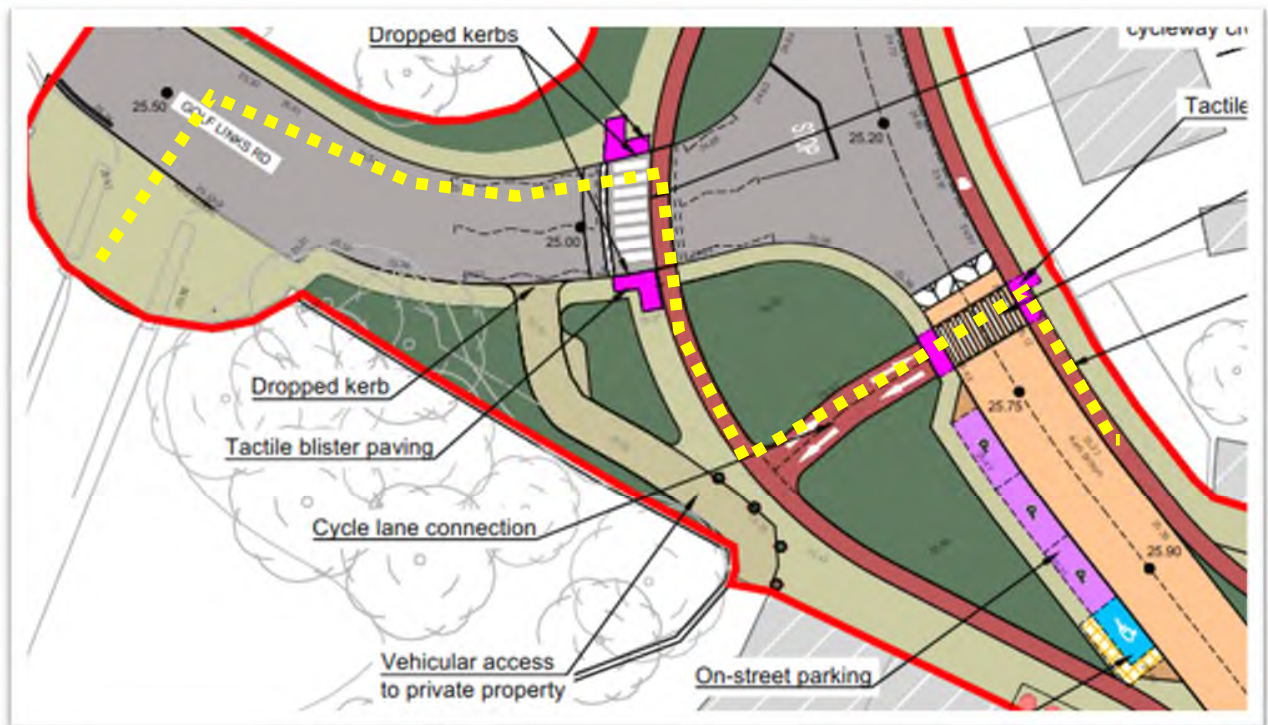
A two-way section of cycle track is proposed to allow cyclists access the southbound cycle track. There is however no link for cyclists coming from Golf Links Road to do so. The new developments on the St. Joseph's site will generate cyclists movements that are not catered for. A lack of facilities will lead to cyclists travelling contra flow on the northbound cycle track which would increase the likelihood of collisions with other cyclists.

It is recommended that a link to the southbound site be provided to avoid cyclists travelling contraflow on the northbound cycle track.

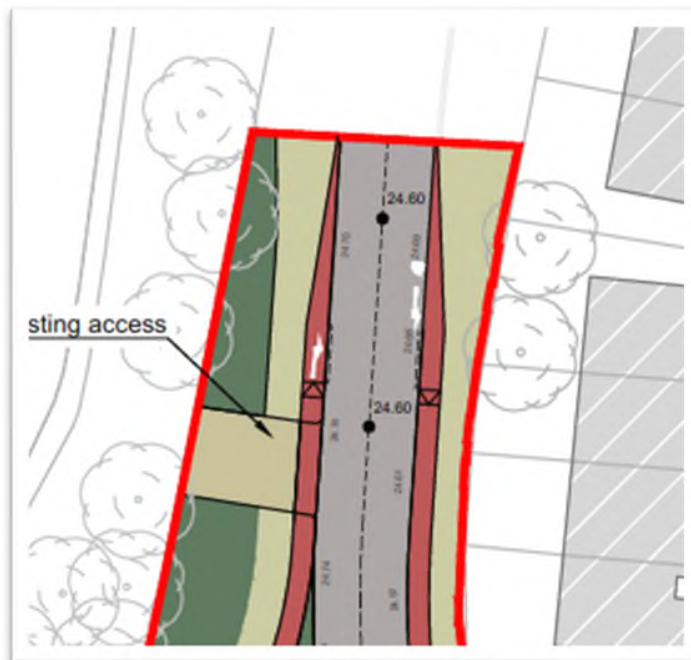
The northbound cycle track tapers gently from off-road to on-road. This could lead to cyclists entering the busy N2 without looking to see if traffic is approaching. This could lead to ‘squeezing’ and collisions especially as the N2 carriageway width has been reduced.

It is recommended that the cycle track be terminated with a jug turn type arrangement whereby cyclists will be perpendicular to traffic and will have to stop before entering the carriageway.

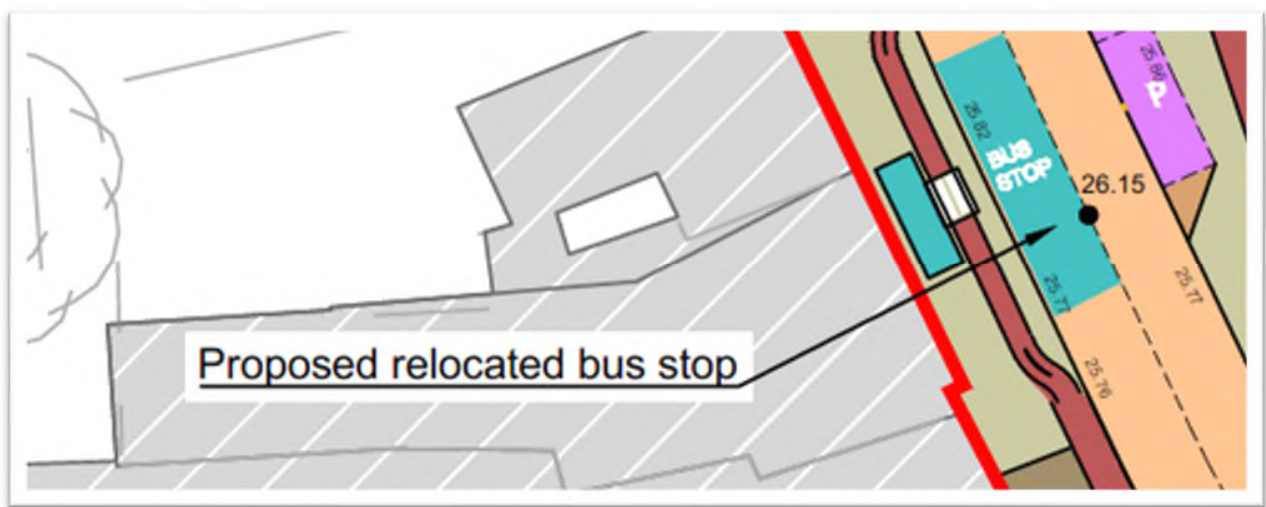
It is unclear what type of bus shelter is proposed at the relocated northbound bus stop. A full panel shelter could lead to a lack of space for pedestrians to pass leading to some pedestrians entering the cycle track where they would be at risk of being struck by passing cyclists.

It is recommended that a suitable type shelter be provided to avoid excessive restrictions in the footway.

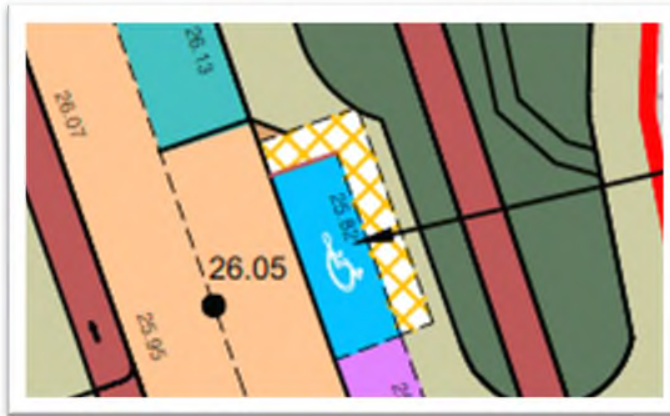
The buffer zone for the disabled parking space to the south of the southbound bus stop coincides with the footpath. It is unclear what the levels will be and if a wheelchair user will be able to use the space freely to access all areas of the car. A lack of space could lead to users entering the carriageway where they would be at greater risk of being struck by a passing vehicle.

It is recommended that the footpath be rerouted to the rear of the buffer zone.

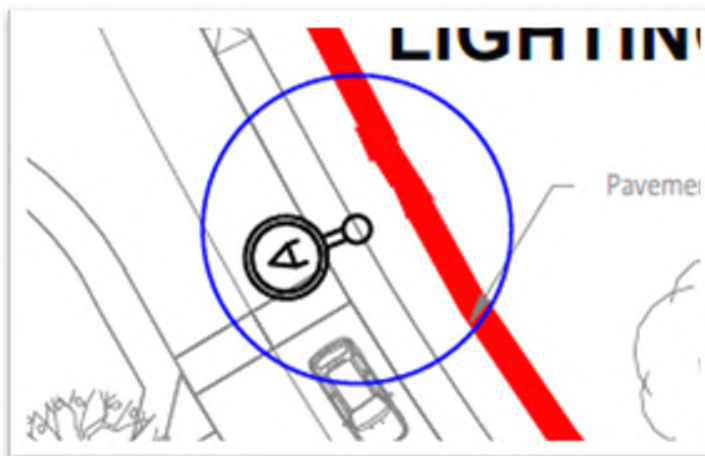
Some lighting column locations are shown on the boundary between the cycle track and the footpath. The columns would be hazards for both cyclists and pedestrians.

It is recommended that the columns be located to the rear of the footpath or in green areas.

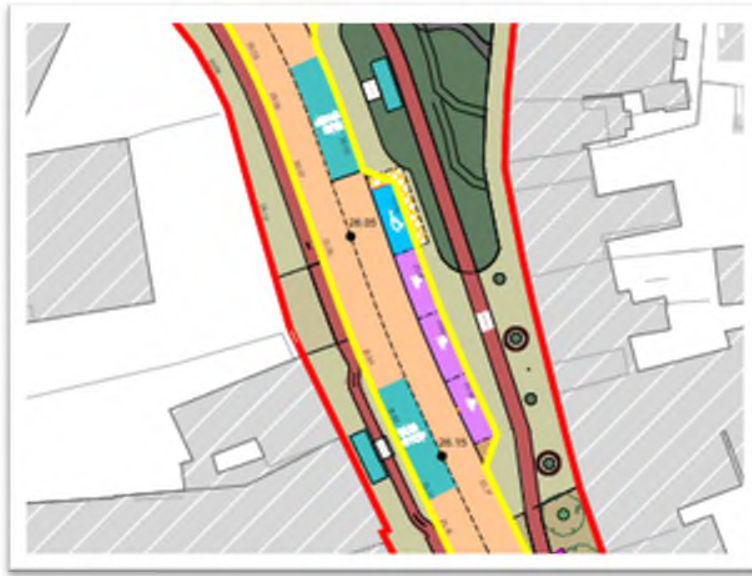
Flush kerbs are shown at the bus stops. This could lead to inaccessibility for some users resulting in loss of balance and falls.

It is recommended that kassel kerbs be provided at the bus stops with suitable transition gradients.

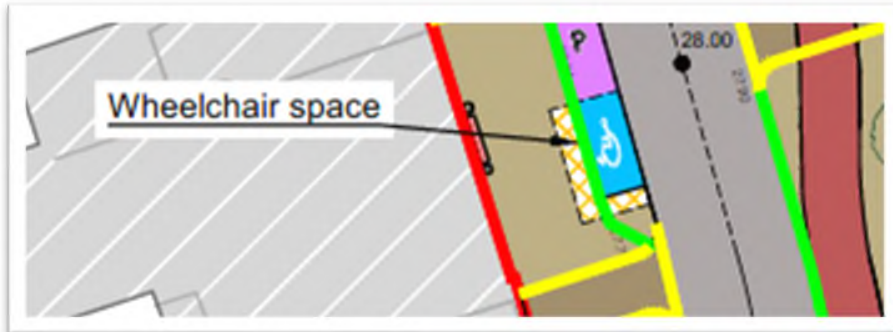
Full height kerbs are shown through the buffer zones of the disabled parking spaces. This could lead to inaccessibility, loss of balance, inability to use wheelchairs and to users entering the carriageway where they would be at greater risk of colliding with passing vehicles.

It is recommended that suitable kerbing and access to the footpath be provided outside the buffer zones.

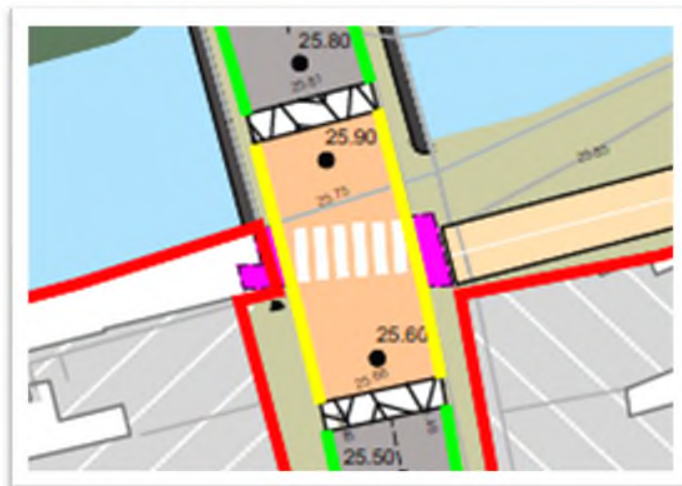
Flush kerbs are shown at the raised table partially over the river Dee bridge. A lack of kerb upstand will lead to no resistance to errant vehicle whose driver may lose concentration even at low speed resulting in a collision with the bridge parapet. This could lead to structural damage.

It is recommended that flush kerbs only be provided at the crossing point.

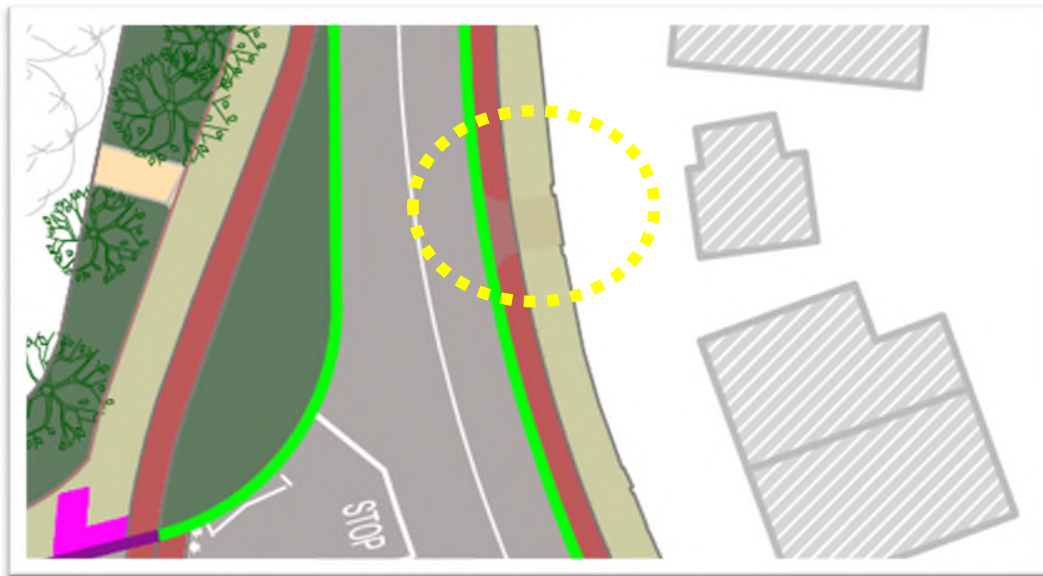
The drawing shows a 125mm high kerb at the proposed vehicular access to the private garage on the eastern side of the N2 just north of the Golf Links Road junction. A high kerb could lead to vehicles 'bouncing back' when trying to access the driveway to the garage resulting in rear-end collisions.

It is recommended that the kerb height be adjusted to facilitate vehicular access.

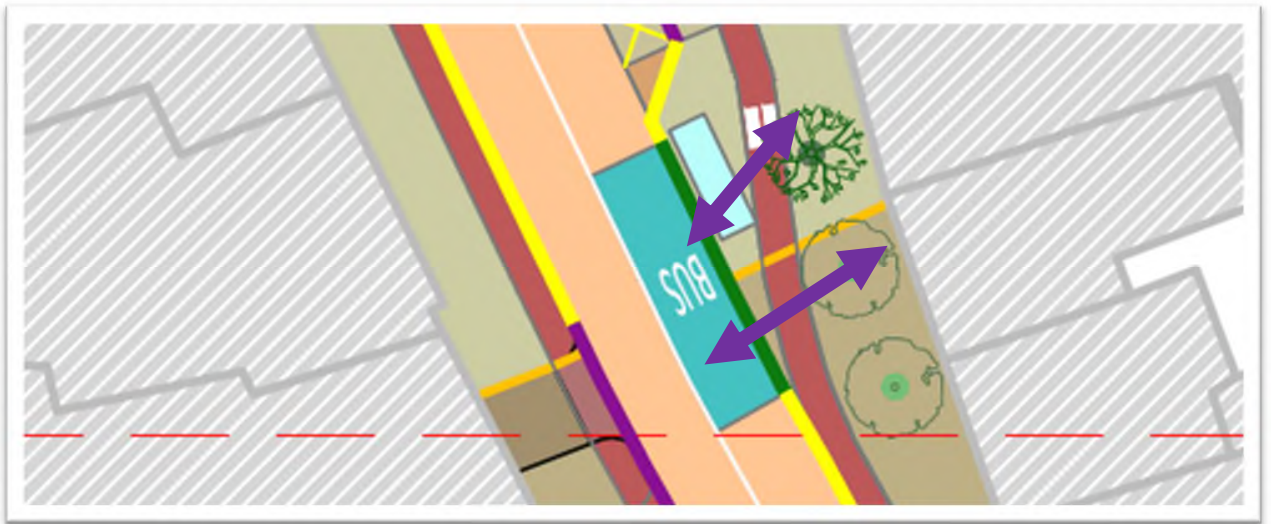
The location of the bus shelter between the bus stop and the pedestrian crossing of the cycle track does not appear to allow enough space for pedestrian movements from the footpath if the shelter will have a back or front panels. This could lead to pedestrians crossing the cycle track away from the highlighted striped areas resulting in a higher likelihood of collision with cyclists who do not expect pedestrians to cross. Also, if passengers alight from the front of the bus there is very little space between where they will step out and the cycle track. This could lead to collisions with passing cyclists.

It is recommended that the layout be changed to provide adequate space for bus users without conflict with cyclists.

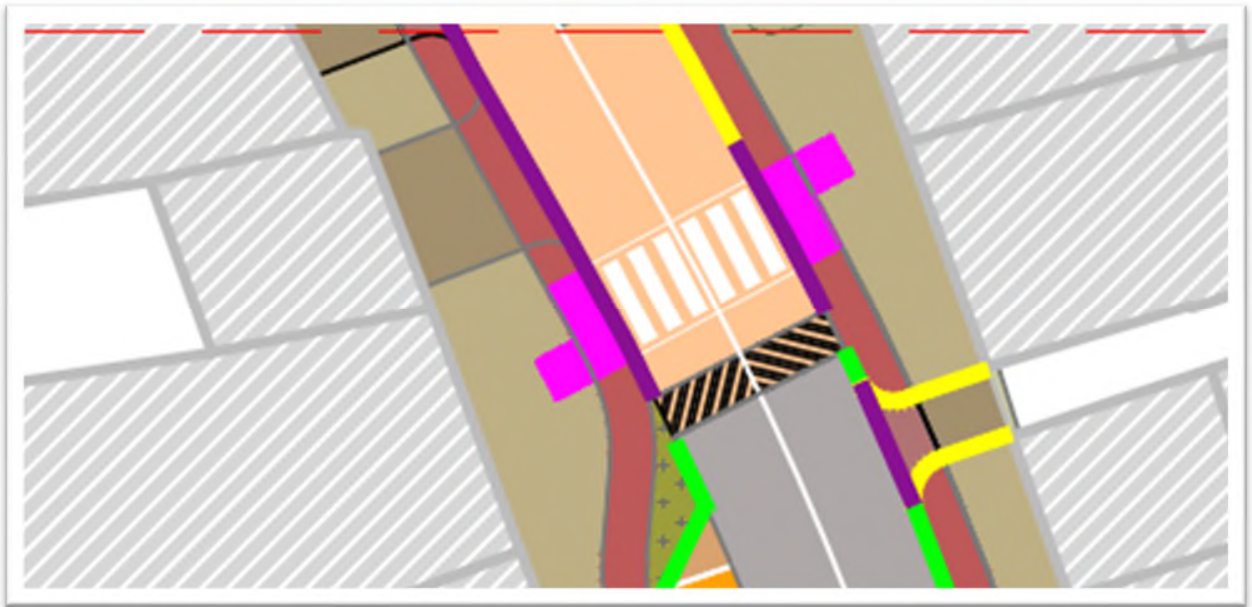
The tactile paving for the zebra crossing is within the cycle lane. It may not be clear to cyclists that pedestrians have priority as they approach the crossing. This could result in collisions between the two user groups.

It is recommended that a shared use area be developed at both sides of this zebra crossing and other similar crossings.

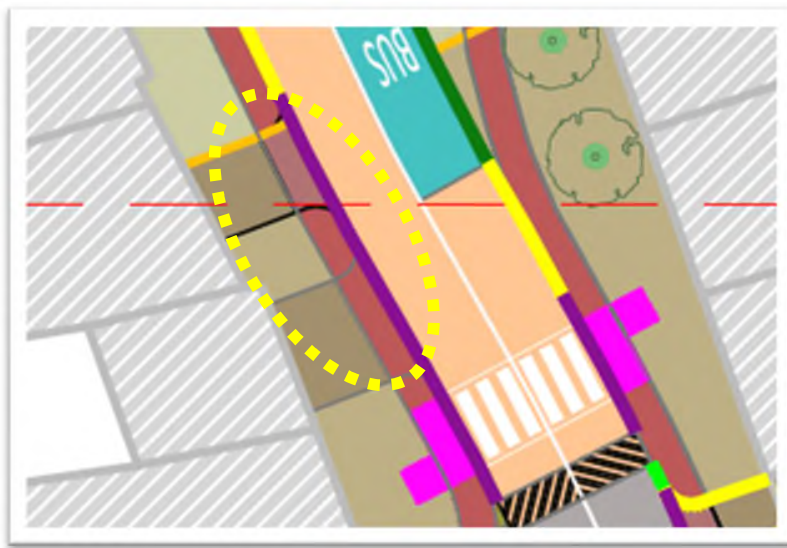
Flush kerbing is provided beyond the extents of the crossing areas at the zebra crossing. A blind or partially sighted pedestrian may inadvertently enter the carriageway if they cannot detect a level difference. This could result in collisions with passing vehicles.

It is recommended that flush kerbs only be provided at crossing points or access areas for pedestrians only.

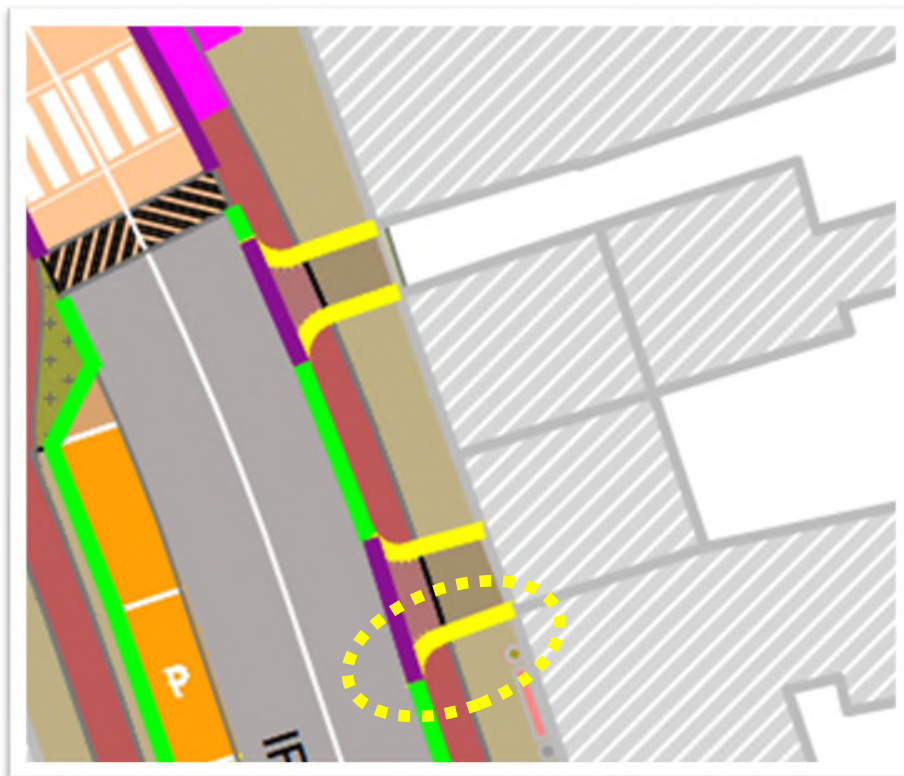
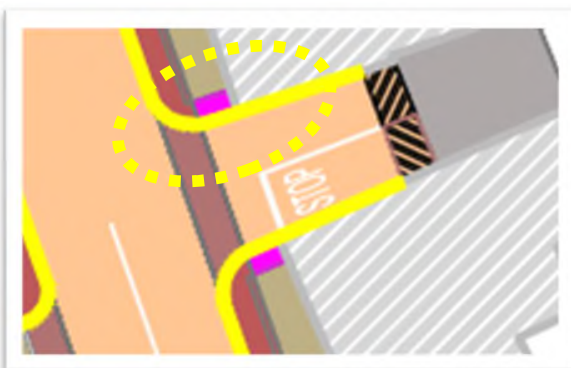
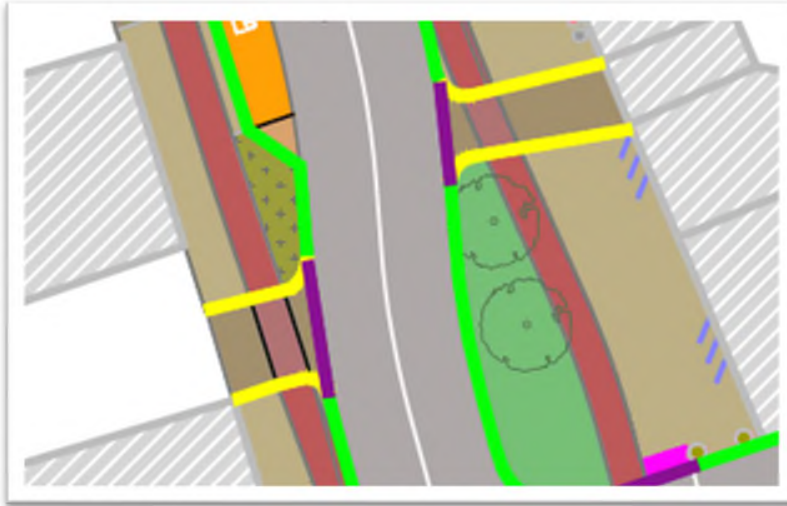
It is proposed to provide 50mm high kerbing at some accesses across the footpath. This would be a trip hazard and would lead to inaccessibility for mobility impaired pedestrians.

It is recommended that flush kerbs be used or no kerbs and that continuous footpath and cycle track facilities be used.

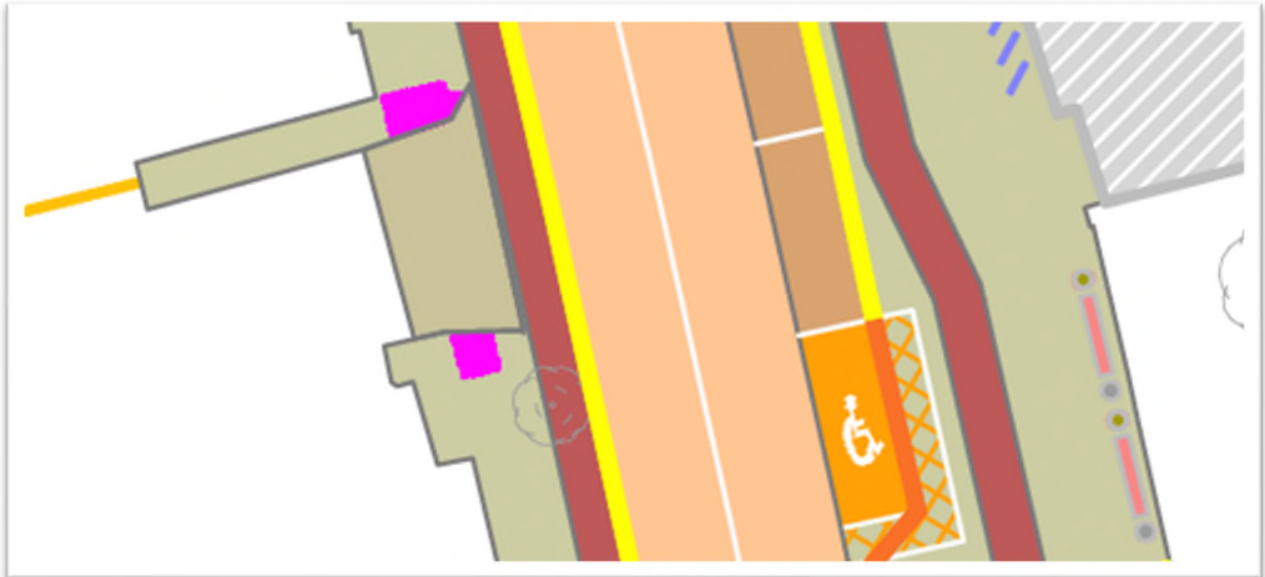
The tactile paving shown at the western side crossing does not match in extent on both sides. There is a risk that blind or partially sighted pedestrians may use the tactile paving as a guide to have completed the crossing however may not detect it is not provided directly across from the start. In addition, the shading for the uncontrolled tactile paving is shown the same as controlled tactile paving. It is assumed that this is just a draughting issue and that buff coloured tactile paving will be used at uncontrolled crossings.

It is recommended that the extent of the tactile paving be matched on both sides.

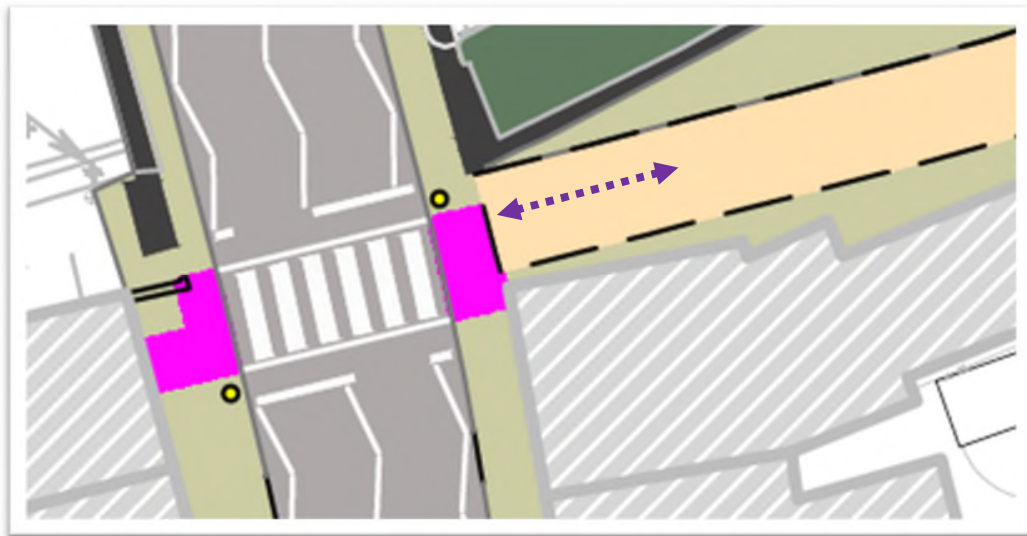
There is a slight misalignment of the extent of the tactile paving associated with the zebra crossing and the shared use path on the eastern side. However this may be required to ensure there is enough room for mobility impaired users to get around the belisha beacon pole. The shape of the tactile paving may be confusing and not help guide a blind or partially sighted pedestrian to the crossing.

It is recommended that a stem be provided on the tactile paving so that such vulnerable road users will know that it is a crossing where they have priority and the stem may be detected by those travelling on the shared use path.

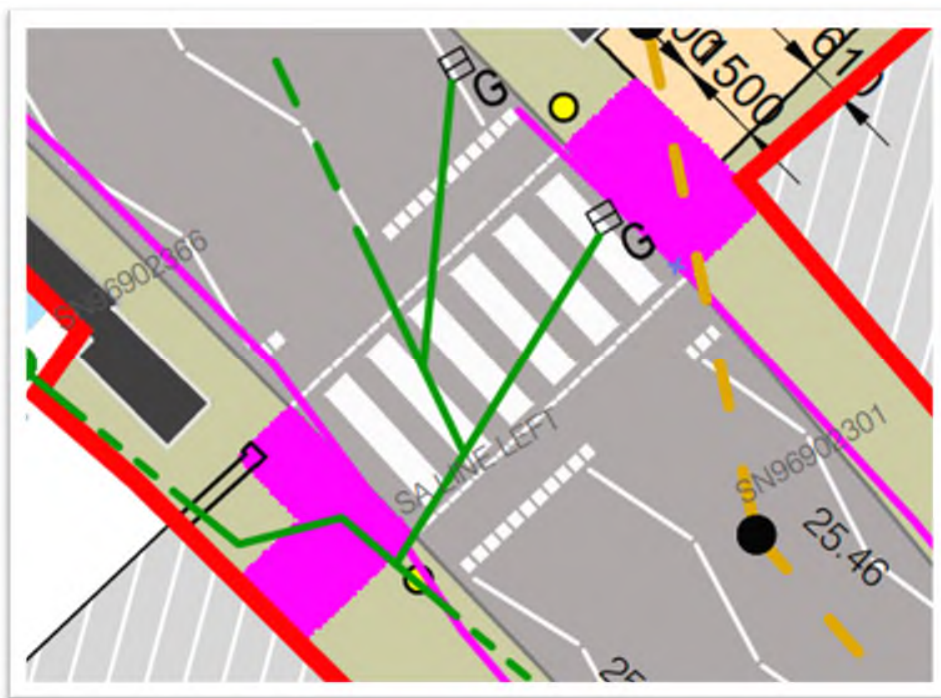
It is proposed to provide a road gully at the zebra crossing. This could lead to narrow wheels getting stuck or to those wearing narrow heels getting stuck and injured. There is also a risk that if the gully becomes blocked that surface water ponding will take place at the crossing location which could result in pedestrians crossing at another location where drivers do not expect or to slips and falls in icy conditions.

It is recommended that gullies be provided immediately upstream of the dropped kerb and not along the path of the crossing.
