**Maughanaclea Renewable Energy  
Development**  
Stage 1 Road Safety Audit

## Stage 1 Road Safety Audit

March 2026

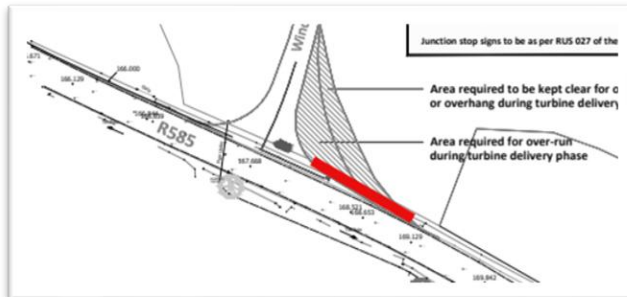
Figure 2.1 – Location Where Passing Motorists Could Access the Overrun Area (When Not in Use)

**Location:** Junction A | Existing mainline carriageway to the east of the site

The over-run area might create confusion for passing motorists, who could access the overrun area by mistake, leading to sudden braking, loss of control or conflicts with construction traffic.

The Designer should ensure that a suitable barrier is put in place to prevent passing motorists from accessing the abnormal load overrun area when it is not in use.

2.1	Yes	Yes	A suitable barrier will be put in place at all times during the construction stage and opened only on the nights that the abnormal loads are delivered. On these occasions the deliveries will be accompanied by a Garda escort and the opened junction will be attended by site staff. On the completion of construction the over-run areas will be closed off permanently.	Yes

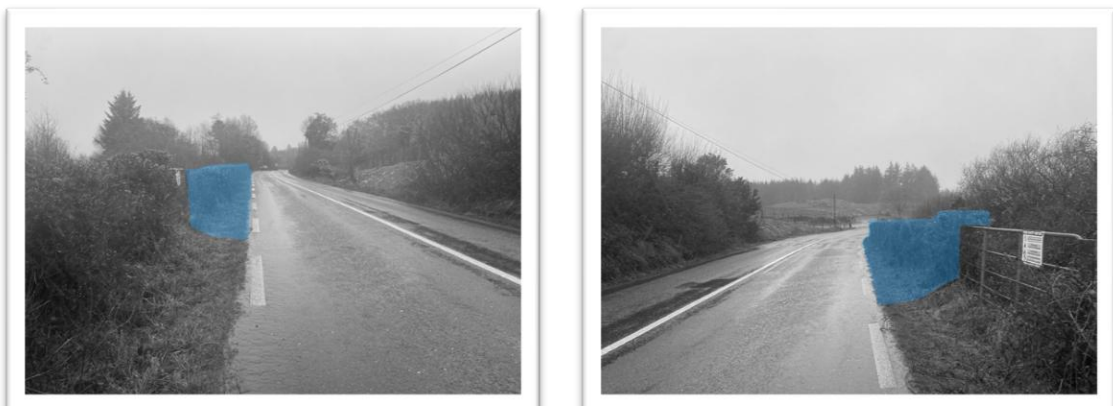
Figure 2.2 – Visibility Splays Partially Obscured in Both Directions at Site Entrance A

**Location:** Junction A | Existing boundary treatments either side of access

Drivers attempting to leave the access will have their view blocked in both directions by the existing field boundary. This limited visibility could increase the risk of side-impact collisions at the access.

The field boundary should be modified to ensure that an appropriate level of visibility can be provided for drivers exiting the access

2.2	Yes	Yes	It is confirmed that the visibility splays described and shown in Figure 15-25 will be provided at all times.	Yes
2.3	Yes	Yes	The same response provided to 2.1 applies.	Yes

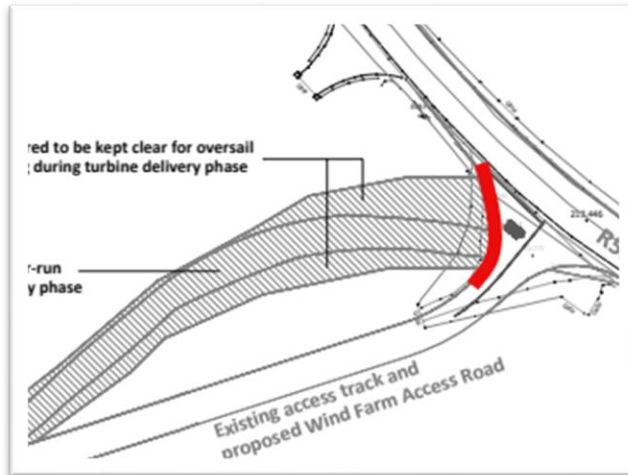
Figure 2.3 – Location Where Passing Motorists Could Access the Overrun Area (When Not in Use)

**Location:** Junction B | Existing mainline carriageway to the south of the site

The over-run area might create confusion for passing motorists, who could access the overrun area by mistake, leading to sudden braking, loss of control or conflicts with construction traffic.

The Designer should ensure that a suitable barrier is put in place to prevent passing motorists from accessing the abnormal load overrun area when it is not in use.

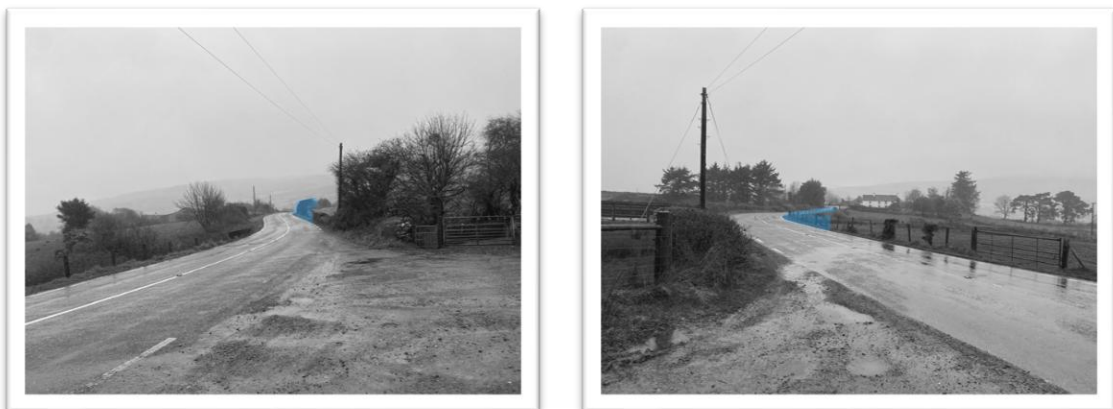
Figure 2.4 – Visibility Splays Partially Obscured in Both Directions at Site Entrance b

**Location:** Junction B | Existing boundary treatments either side of access

Drivers attempting to leave the access will have their view blocked in both directions by the existing field boundary. This limited visibility could increase the risk of side-impact collisions at the access.

The field boundary should be modified to ensure that an appropriate level of visibility can be provided for drivers exiting the access

2.4	Yes	Yes	It is confirmed that the visibility splays and forward visibility shown in Figure 15-30 will be provide at all times.	Yes
2.5	Yes	Yes	Suitable drainage will be installed as part of the proposed improved junction.	Yes

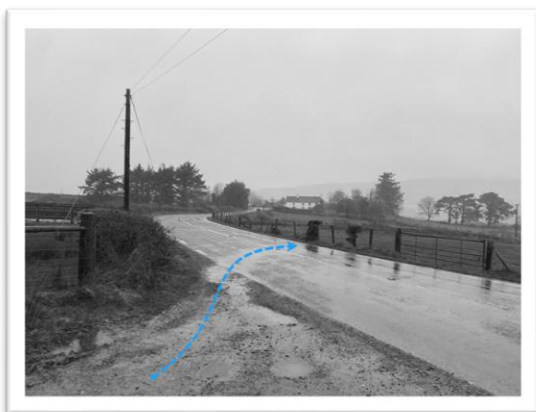
Figure 2.5 – Downhill path of storm water from Local Road into site entrance

**Location:** Junction B | R585 Regional road to the west of the site entrance

The site access road's steep downhill gradient is likely to channel surface water runoff onto the road from the site entrance where it could accumulate and wash out unbound surface materials onto the carriageway leading to loss of control type collisions.

Suitable drainage measures should be provided here to prevent ponding and unbound surface materials from being washed into the carriageway.

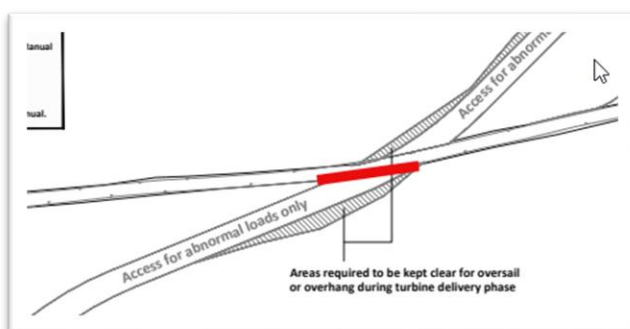
Figure 2.6 – Location Where Passing Motorists Could Access the Overrun Area (When Not in Use)

**Location:** Junction C | Existing mainline carriageway to the east of the site

The over-run area might create confusion for passing motorists, who could access the overrun area by mistake, leading to sudden braking, loss of control or conflicts with construction traffic.

The Designer should ensure that a suitable barrier is put in place to prevent passing motorists from accessing the abnormal load overrun area when it is not in use.

2.6	Yes	Yes	A suitable barrier will be installed at all times and opened only on the nights that the abnormal loads are delivered	Yes
2.7	Yes	Yes	It is confirmed that the vertical alignment has been checked for visibility and at all junctions. The attached Sketch A shows that visibility splays are provided from a driver height of 1.05m to an object height of 1.05m to the extent of the 90m visibility splay required in both directions.	Yes

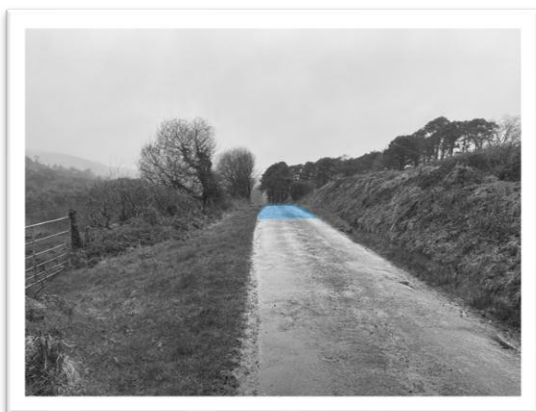
Figure 2.7 – Visibility Splays Partially Obscured on the left at Site Entrance C

**Location:** Junction C | Existing vertical alignment of L8777

Drivers attempting to leave the access will have their line of sight partially blocked to the left by the vertical alignment of the existing L8777. This limited visibility could increase the risk of side-impact collisions at the access.

The site access arrangements should be modified to ensure that an appropriate level of visibility can be provided in both directions for drivers exiting the access.

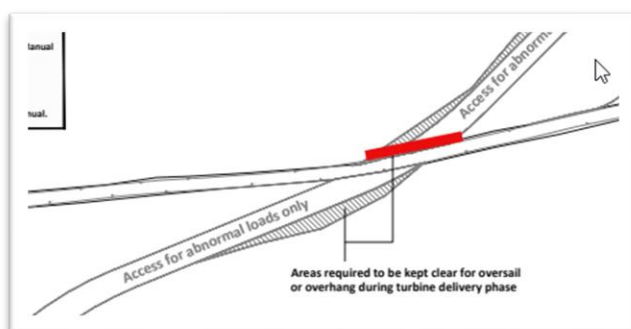
Figure 2.8 – Location Where Passing Motorists Could Access the Overrun Area (When Not in Use)

**Location:** Junction D | Existing mainline carriageway to the west of the site

The over-run area might create confusion for passing motorists, who could access the overrun area by mistake, leading to sudden braking, loss of control or conflicts with construction traffic.

The Designer should ensure that a suitable barrier is put in place to prevent passing motorists from accessing the abnormal load overrun area when it is not in use.

2.8	Yes	Yes	A suitable barrier will be installed at all times and opened only on the nights that the abnormal loads are delivered.	Yes

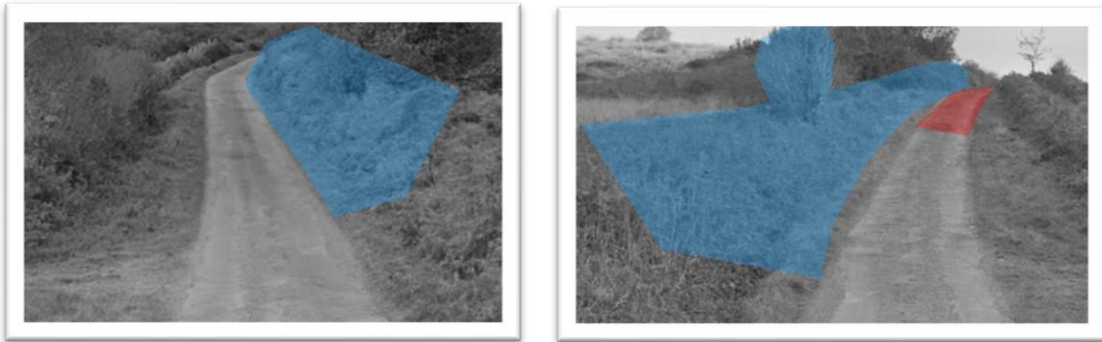
**Figure 2.9 – Visibility Splays Partially Obscured in Both Directions at Site Entrance D**

**Location:** Junction D | Existing boundary treatments either side of access

Drivers attempting to leave the access will have their line of sight partially blocked in both directions by the existing field boundary, and by the crest of the L8777 road to the left. This could increase the risk of side-impact collisions at the access.

The site access arrangements should be modified to ensure that an appropriate level of visibility can be provided for drivers exiting the access

Problem Reference (Section 2)	Designer Response Section			Audit Team Response Section
	Problem Accepted ( yes / no )	Recommended Measure Accepted ( yes / no )	Alternative Measures or Comments	Alternative Measures Accepted ( yes / no )
2.9	Yes	Yes	The required 90m visibility splays in the horizontal plane shown in Figure 15-35 will be provided at all times and Sketch B shows that visibility splays are available from a driver height of 1.05m to an object height of 1.05m to the extent of the 90m visibility splay required.	Yes
