ST. EDMUNDSBURY HOSPITAL, LUCAN, CO. DUBLIN

Volume 1 Part 1: Conservation Report -
Architectural Inventory, Condition Report & Appraisal

November 2023

Ref: 22037

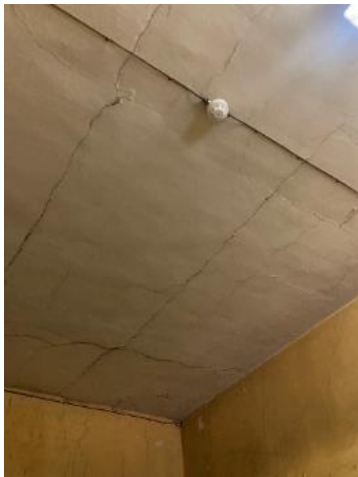
Description (materials, construction, location)	Ceilings are generally flat plastered and painted or have a modern suspended ceiling. Cement plaster to ceiling in room B-37. Gypsum plasterboard ceiling in room B-38. Historic brick vault in room B-39. Coved ceilings in rooms 1-04, 1-07, 1-12, 1-13, 1-21, 1-23, 1-34, 1-35, 1-37.
Condition	Flat plastered ceilings have cracks in rooms B-02, B-18, B-19, B-20, B-21, B-22, 0-06, 0-24, 0-25, 1-01, 1-02, 1-03, 1-07, 1-08, 1-12, 1-13, 1-28, 1-34. Cracks visible on the brick ceiling vault in B-39.
Probable causes/consequences	Unbreathable paint was applied. Structural movement. Damp.
Recommended measures	NOTE: no ceilings have been opened up to confirm the exact finish. All finishes to historic ceilings such as lash and plaster or lime based plaster on the hard to be breathable. Repairs to historic ceilings should be made on a like for like basis. Structural engineer to inspect cracks and make recommendations.

Symptoms	Condition class (CC)	Urgency	Urgency class (UC)
No symptoms	CC 1	Intermediate term	UC 1

Fig.86: B-22, Cracks to ceiling, most likely a 20th C plasterboard finish.

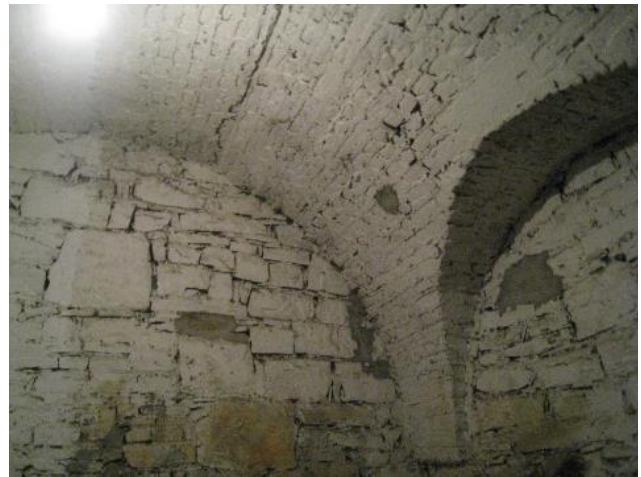
Fig.87: B-39, Crack to brick vault. No works are planned in this room.

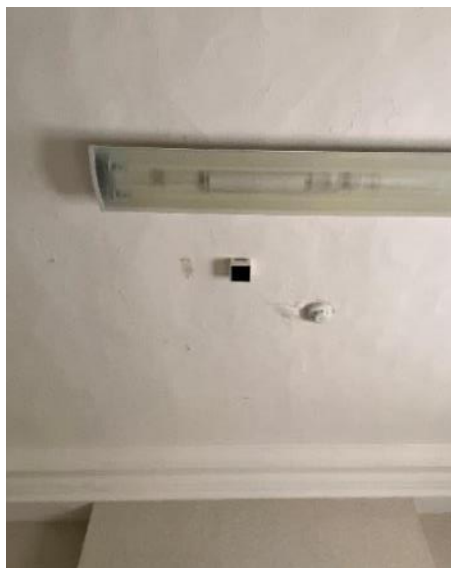
Fig.88: 1-01, Cracks to ceiling.

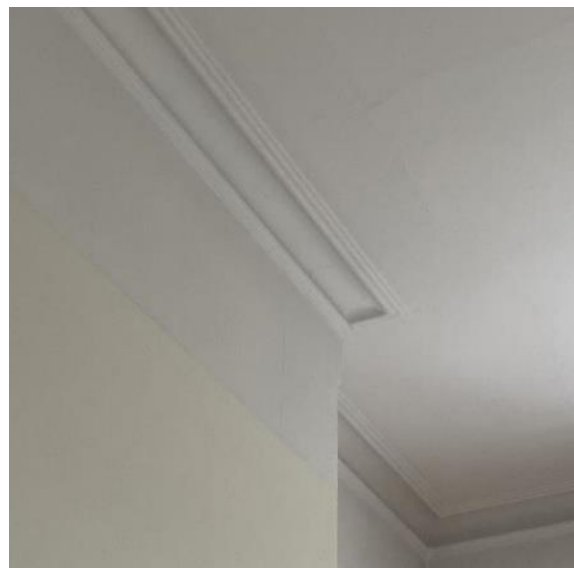
Fig.89: 0-24, Cracks to ceiling

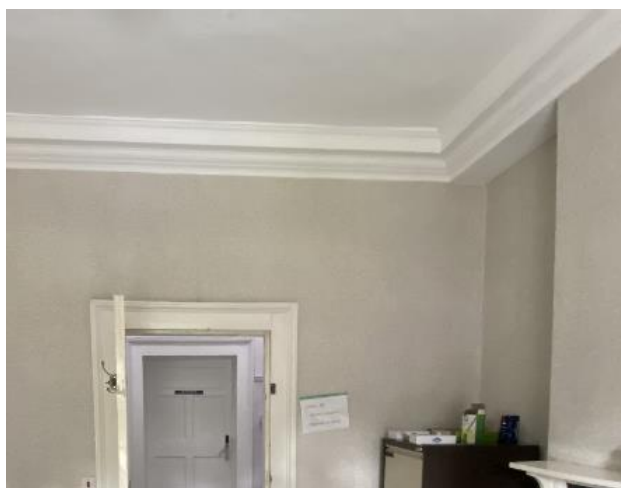
Description (materials, construction, location)	This section will only focus on the cornices that are scheduled to be removed. Running mould type cornices.
Condition	Cornices in room 0-24, 0-25, 1-01, 1-12, 1-13, 1-19, 1-23, 1-27, 1-28, 1-31, 1-32 are in good condition.
Probable causes/consequences	-
Recommended measures	Historic cornices should be carefully removed to be salvaged.

Fig.90: 1-01, historic cornice in good condition

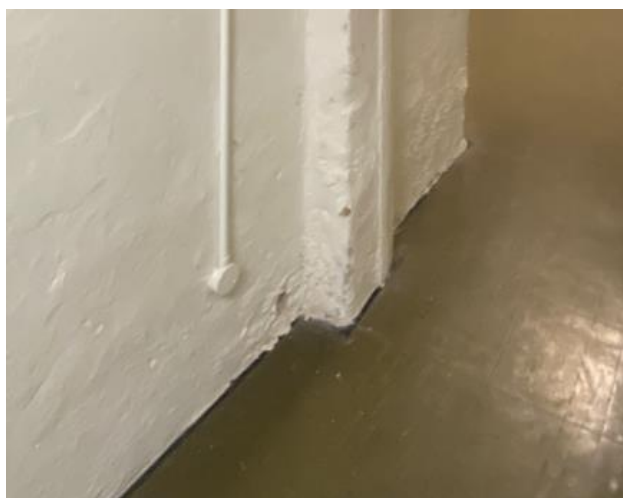
<p>Paint finish is flaking in room B-21.</p> <p>Paint finish is bubbling in rooms B-02, B-04, B-17, B-20, 0-02, 0-06, 0-08.</p> <p>Bottom section in room B-18 was overplastered.</p> <p>Cracks are described below.</p>
Probable causes/consequences	<p>Inappropriate non-breathable paint and cement render have been applied, trapping damp in the walls.</p> <p>Damp, age, structural settlement.</p>
Recommended measures	<p>All finishes to traditional wall construction to be breathable.</p> <p>Structural engineer to inspect cracks and make recommendations.</p> <p>Opening-up works.</p>

Fig.91: B-04, plaster is crumbling and coat of paint was applied over it.

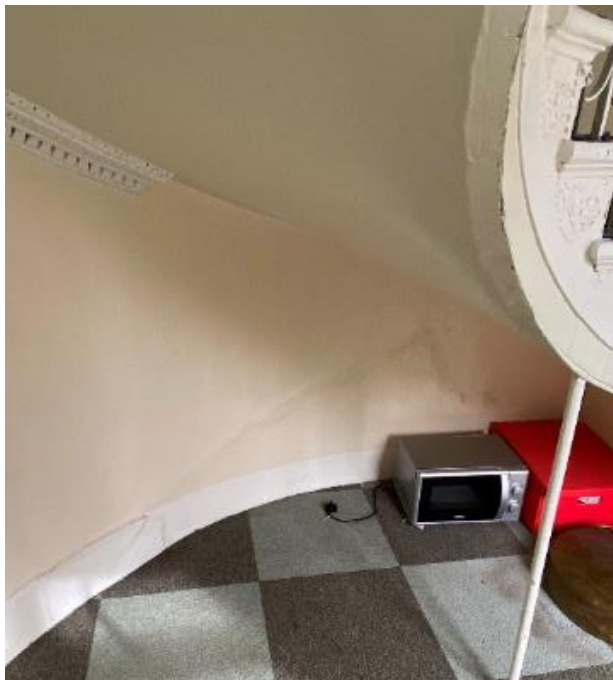
Fig.93: 0-02, plaster is crumbling and coat of paint was applied over it.

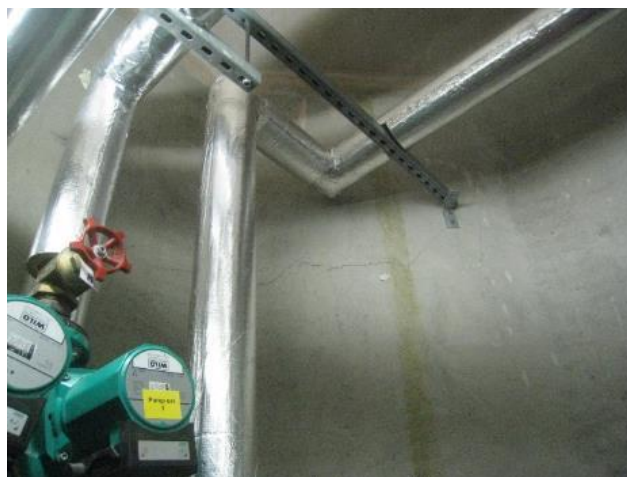
Fig.96: B-37, Inappropriate cementitious render, cracks visible.

B-37: Cracks to the walls

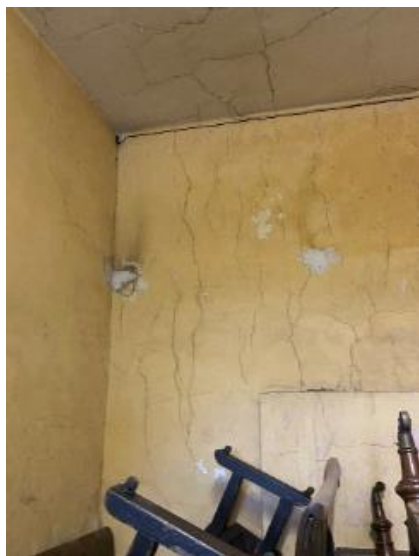
B-22: Several cracks to the east, west and south walls.

Fig.97: B-22, several cracks

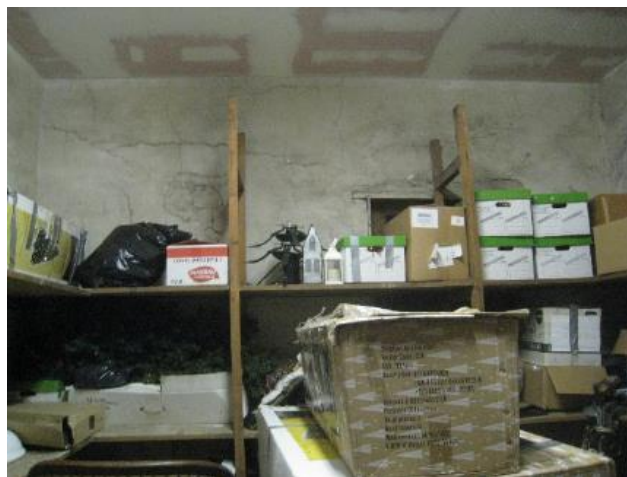
B-38: Cracks to the east, west and north walls.

Fig.98: B-38, cracks to the east wall

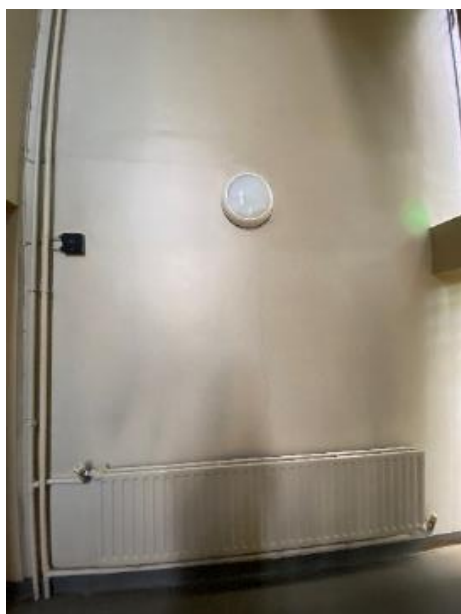
0-11: Horizontal crack to the west and south walls.

Fig.99: 0-11, Crack to the south wall

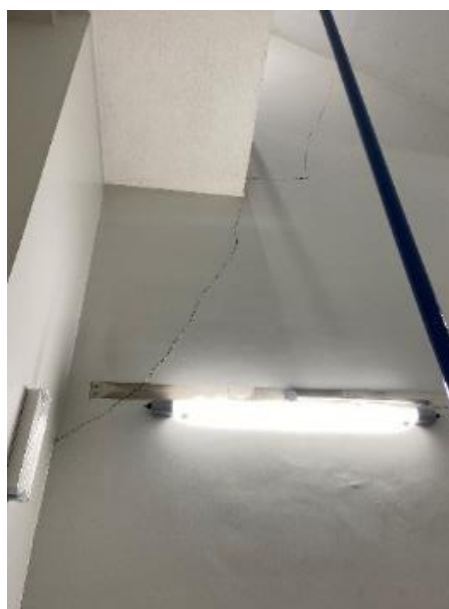
0-16: Crack to the east wall south corner. Crack to the east wall at the south of window at half-landing.

Fig.100: 0-16, Crack to the east wall, south corner

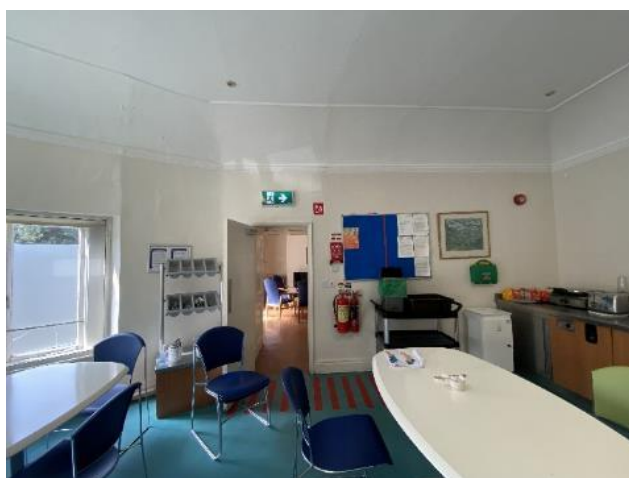
1-06: Vertical crack to the west of western window and to the east of eastern window. Cracks to the west wall.

Fig.101: 1-06, Cracks to the west wall

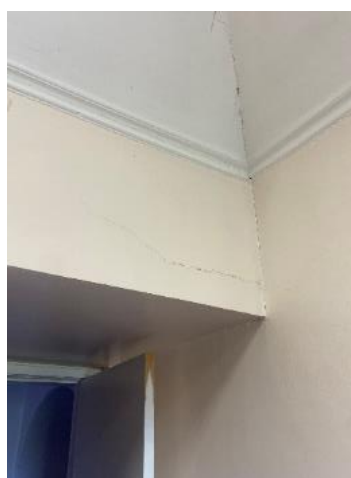
1-12: Crack running from above door to ceiling

Fig.102: 1-12, Crack running from above door to ceiling

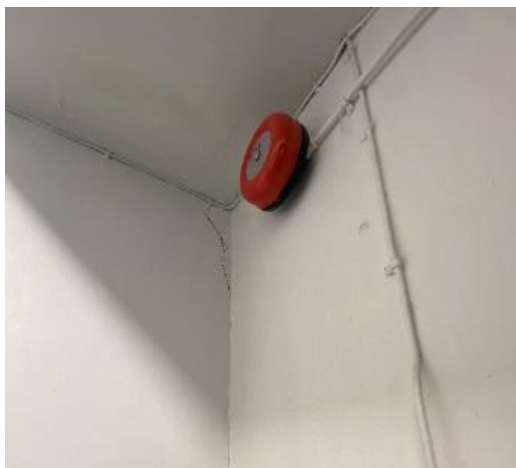
1-16: Crack to door lintel, crack to southeast corner wall

Fig.103: 1-16, Crack to southeast corner wall

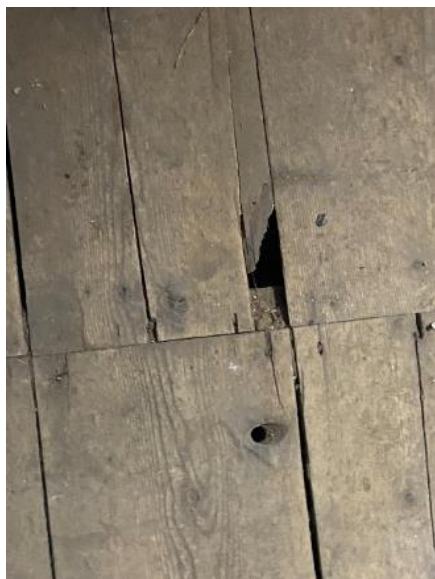
Description (materials, construction, location)	<p>No historic finish floor remain except in basement rooms B-21 and 0-06 which have historic timber boards and B-23 where a historic ceramic tile floor is visible.</p> <p>It is not possible to determine the floor built-up from visual inspection.</p> <p>In general, the finish floor is a modern vinyl finish, modern tiles, modern timber floor or carpet. Where visible, the basement has generally a concrete floor slab.</p>
Condition	<p>The historic timber floorboard in room B-21 is in poor condition and shows signs of wear and tear. There are missing sections and gaps between the boards.</p> <p>The historic timber floorboard in room 0-06 is in good condition.</p> <p>The ceramic tile floor in room B-23 is in poor condition, with cracks and missing sections.</p>
Probable causes/consequences	Age, wear and tear, previous interventions.
Recommended measures	<p>NOTE: no floors have been opened up to confirm exact built-ups.</p> <p>Repair.</p>

Fig.104: B-21, historic timber floorboards, missing section and gaps between the boards.

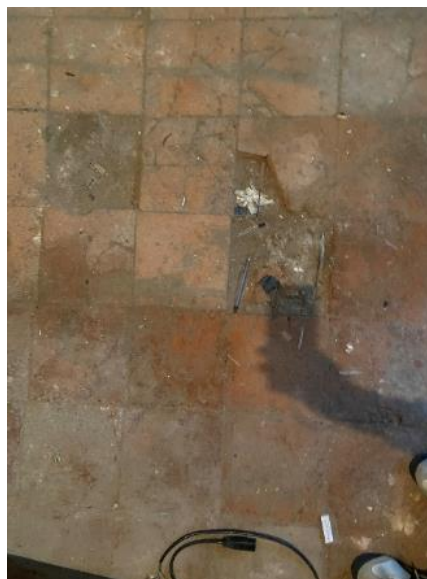
Fig.105: B-23, historic ceramic tiles, missing sections and cracks.

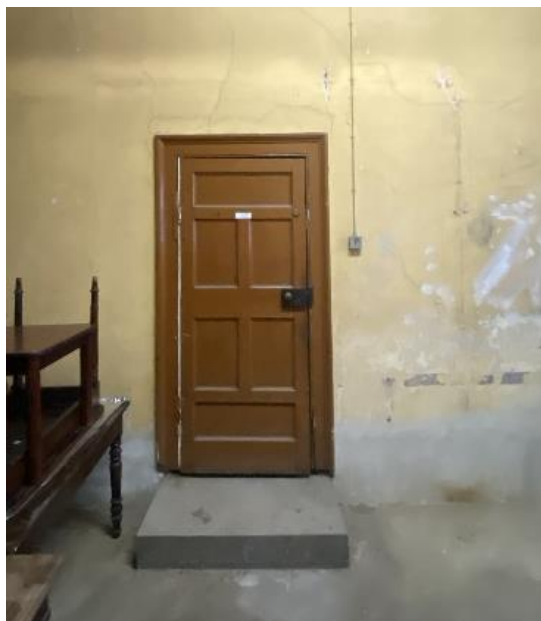
Description (materials, construction, location)	This section will focus only on the historic door architraves and skirting that are scheduled to be removed.
Condition	<p>Door architraves in rooms B-21, B-22 are in good condition.</p> <p>It was not possible to inspect the condition of the timber skirting in room B-21 due to the amount of furniture.</p> <p>Timber skirting in room B-17 is in fair to poor condition.</p> <p>Timber skirtings are in good condition in rooms 0-24, 0-25, 1-12, 1-13, 1-19, 1-22, 1-23, 1-27, 1-28, 1-31, 1-32, 1-37.</p> <p>Timber skirting is in poor condition in room 1-01. It has been altered by services.</p>
Probable causes/consequences	Wear and tear.
Recommended measures	Historic door architraves and skirtings should be carefully removed to be salvaged.

Fig.106: B-22, historic door architrave

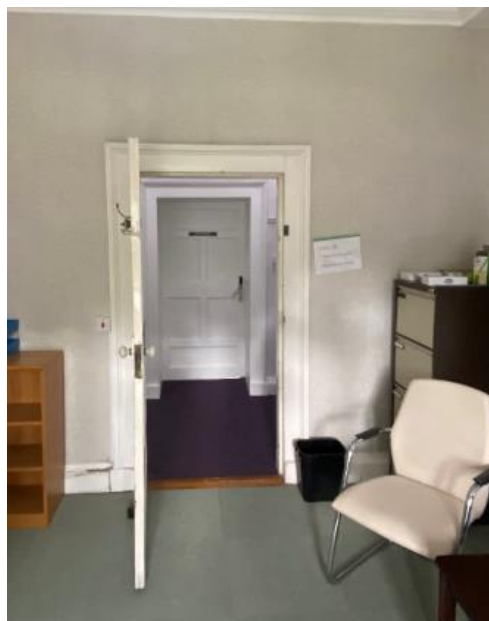
Fig.107: 1-01, historic door architrave

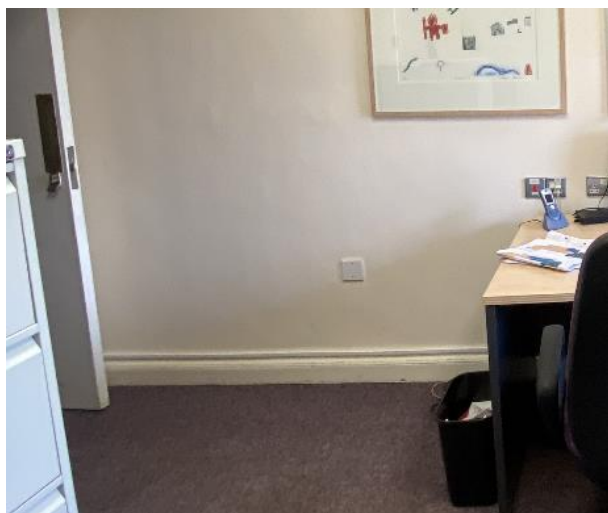
Fig.108: 1-12, historic timber skirting in good condition

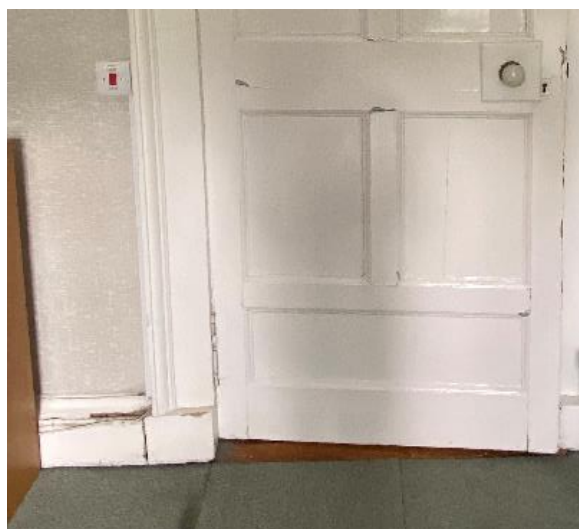
Fig.109: 1-01, historic timber skirting in poor condition

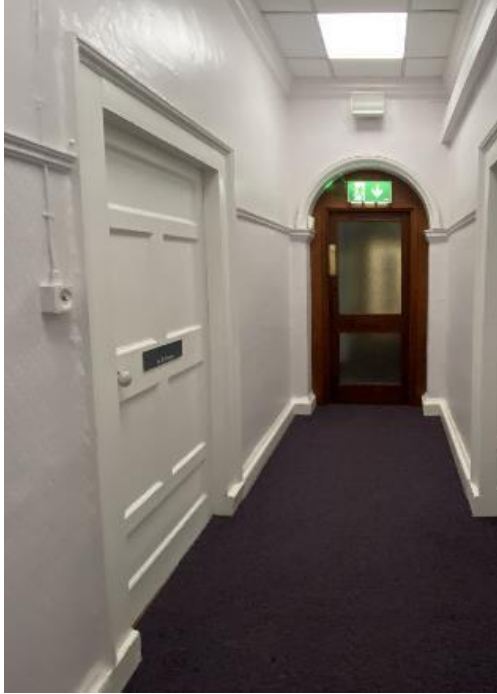
Description (materials, construction, location)	This section will focus only on the historic door that are scheduled to be removed. Door B-21/B-22: 5 panel timber door.
Condition	Doors B-21/B-22, 1-01/1-37 are in condition.
Probable causes/consequences	-
Recommended measures	Door should be carefully removed to be salvaged.

Fig.110: 1-37, historic six panel timber door

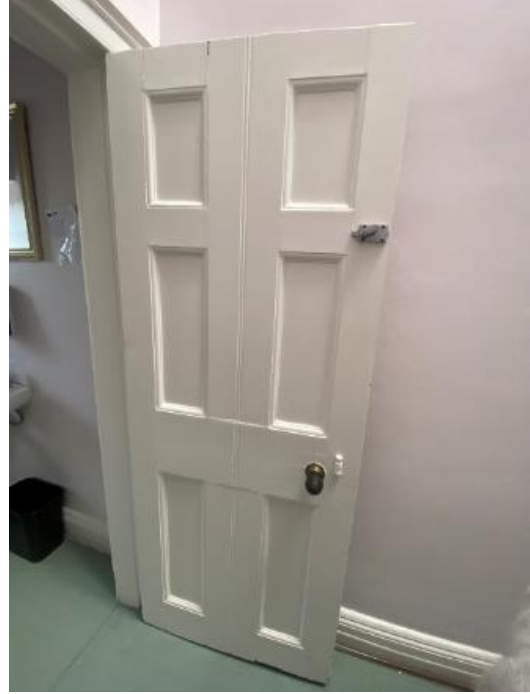
Fig.111: 1-22, historic four panel timber door
