ST. EDMUNDSBURY HOSPITAL, LUCAN, CO. DUBLIN

Volume 1 Part 2: Conservation Report -
Architectural Inventory, Condition Report & Appraisal

November 2023

Ref: 22037

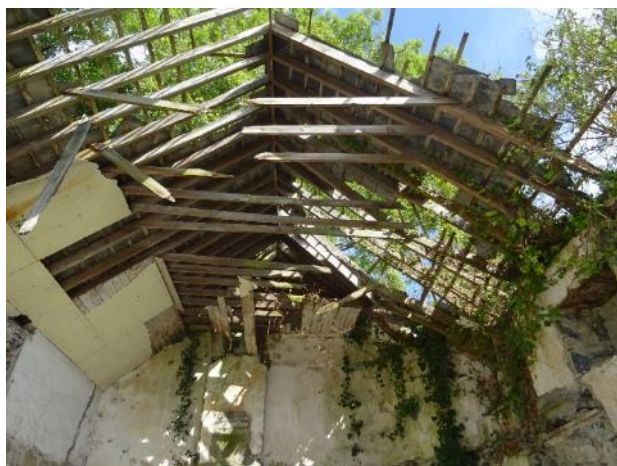
Description (materials, construction, location)	Double pitched slate roof.
Condition	Poor condition. The roof is generally missing, with just a small section remaining at the north end of the building. The timber trusses are in extremely poor condition.
Probable causes/consequences	Wear and tear. Water ingress over the years.
Recommended measures	Roof replacement.

Symptoms	Condition class (CC)	Urgency	Urgency class (UC)
Major symptoms	CC 3	Urgent and immediate	UC 3

Fig.3: Barn, remaining section of the roof at the north.

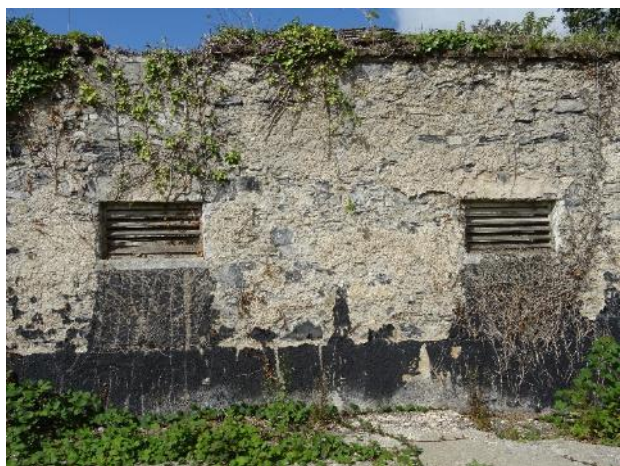
Description (materials, construction, location)	Rubble stone walls with roughcast lime render. Brick course at the top of the wall on the east elevation.
Condition	Generally the lime render has worn away, though small areas remain. Vegetation overgrowth: ivy Bituminous paint at the bottom section on the east elevation. Concrete render on the south elevation.

Modern concrete blocks infill beneath each window opening. This suggests that the original window openings were taller.
Probable causes/consequences	Wear and tear. Water ingress. Previous interventions. Risk of destabilisation and collapse.
Recommended measures	Remove vegetation. Carefully remove cement render and replace with lime render, in line with conservation specification. Carefully remove cement-based mortar and replace with lime mortar, in line with conservation specification. Remove bituminous paint. Rebuild brick course at the top of the wall on the east elevation in line with conservation specification. SE to inspect structural stability of the barn and make recommendations.

Fig.5: Barn, east elevation, bituminous paint at the bottom part, concrete brick infill below the window opening, ivy developing and lime render has fallen in some areas

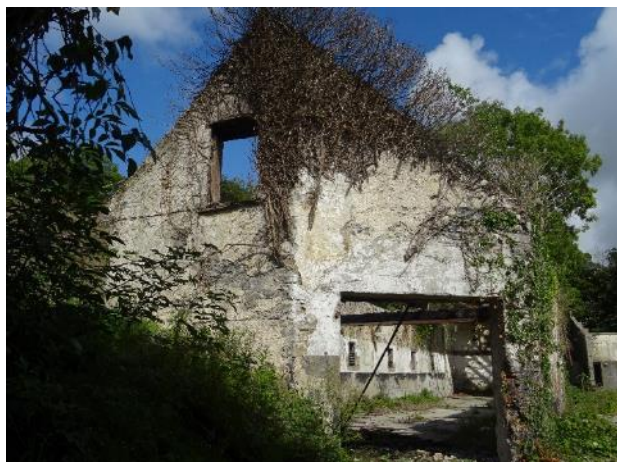
Fig.7: Barn, south elevation, lime render has degraded, vegetation overgrowth.

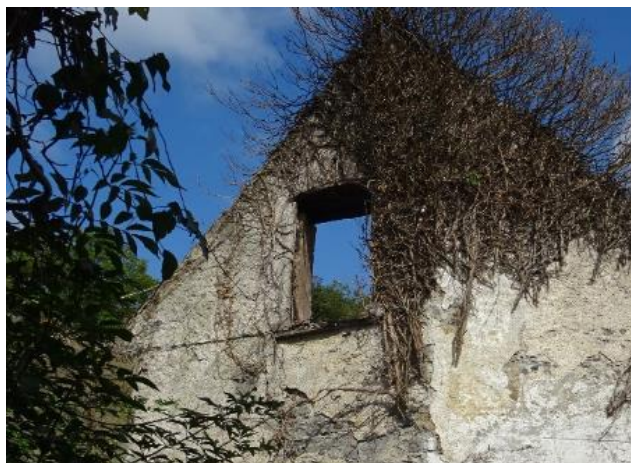
Fig.8: Barn, south elevation, low arch window opening with brick lintel.

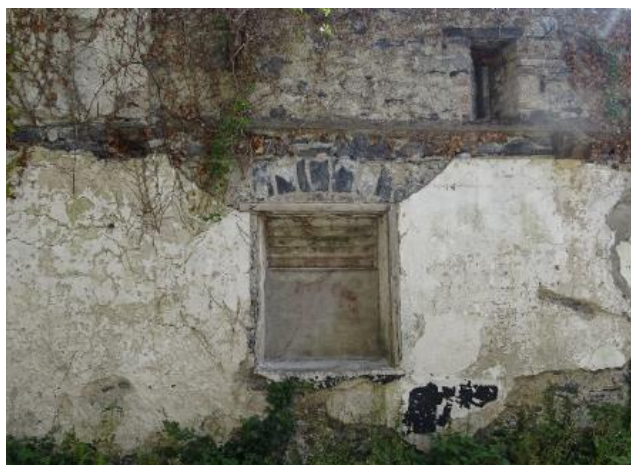
Fig.10: Barn, east internal elevation, arrow slit window at the top part was blocked-up, window opening bottom section was blocked-up.

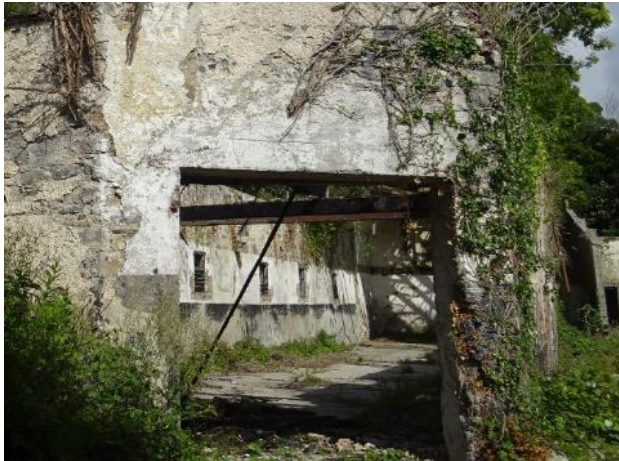
Description (materials, construction, location)	1 modern no. square-headed door opening on the south elevation with a concrete lintel and concrete reveal. 1 no. square-headed door opening on the east elevation with a timber lintel.
Condition	The door opening lintel on the east elevation is in poor condition.
Probable causes/consequences	Previous interventions.
Recommended measures	Rebuild top section and base of the round-headed archways. Lime mortar repointing. Repair timber door. Replace boarding-up.

Fig.11: Barn, external south elevation, square-headed door opening with concrete lintel and reveal.

Structural Engineer to inspect and make recommendations.
--	---

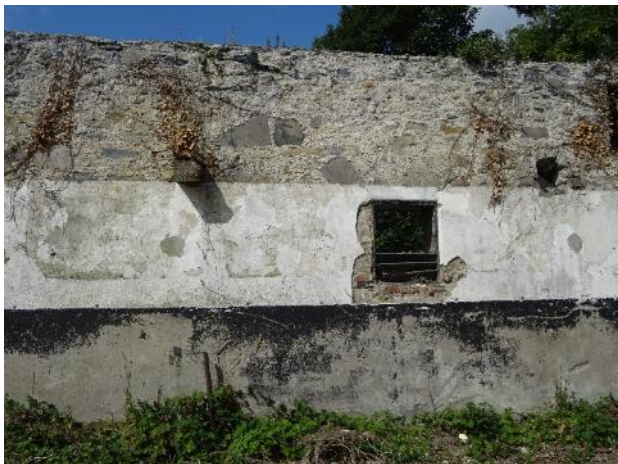
Description (materials, construction, location)	Rubble stone walls. Lime based plaster. Timber beam sections inserted in the internal walls indicate that there was previously a floor at first floor level.
Condition	Inappropriate concrete render and bitumen paint at the bottom section. Lime plaster in poor condition. Vegetation overgrowth.
Probable causes/consequences	Water ingress due to the missing roofing. Previous interventions. Vegetation overgrowth.
Recommended measures	Remove vegetation. Remove concrete render. Replace lime plaster. Structural engineer to inspect and make recommendations

Fig.16: Barn, internal west elevation, concrete render and bitumen paint, timber beam section inserted in the wall indicate that there was previously a floor over the whole layout.

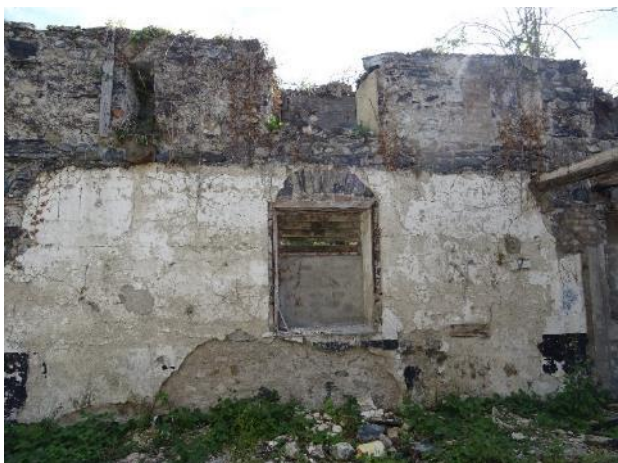
Fig.18: Barn, internal east elevation, lime plaster with cement patch repair.

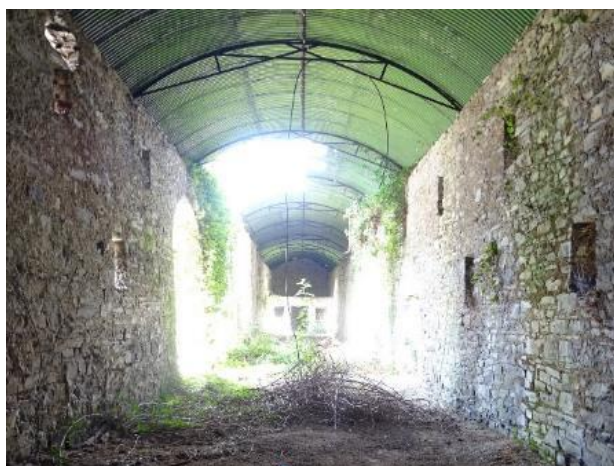
Condition	Poor condition. The corrugated metal sheets have lost their coating and are rusting. A section of the roof is missing at the centre.
Probable causes/consequences	Wear and tear. The roofing does not ensure the watertightness of the building.
Recommended measures	Roof replacement.

Symptoms	Condition class (CC)	Urgency	Urgency class (UC)
Major symptoms	CC 3	Urgent and immediate	UC 3

Fig.23: Corrugated steel sheeting supported by curved steel trusses. The roofing is missing at the centre.

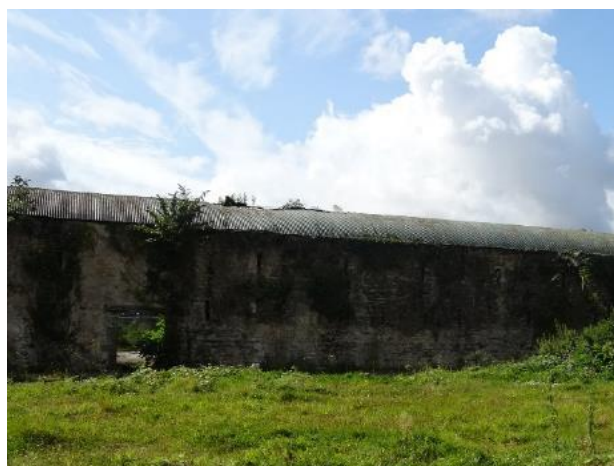
Fig.24: Looking north elevation, the corrugated metal sheeting is detaching.

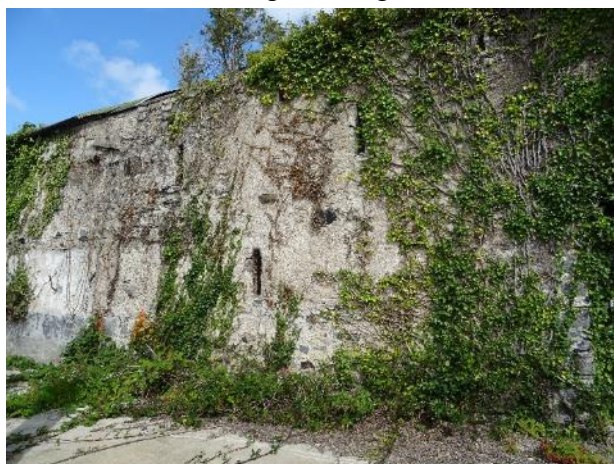
Fig.25: South elevation. The corrugated metal sheeting is missing.

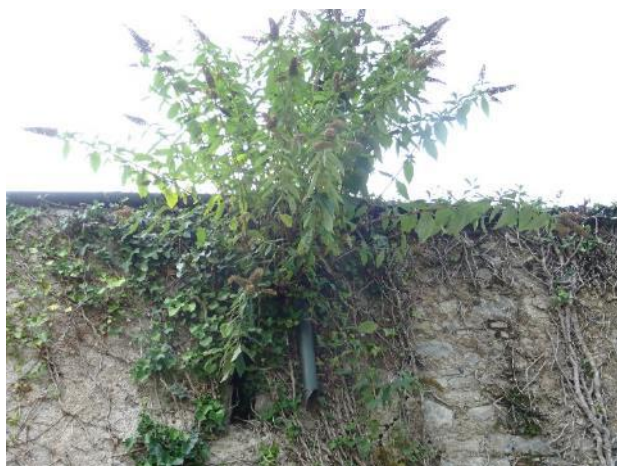
Description (materials, construction, location)	There are steel gutters running along the north, south and east elevations. There are 2 no. rainwater pipes: 1 no. cast iron rainwater pipe on the east elevation and 1 no. steel rainwater pipe.
Condition	Poor condition. The bottom section of the steel rainwater pipe is missing and vegetation is developing here. The cast iron rainwater pipe is rusting and is concealed by the overgrowth.
Probable causes/consequences	Wear and tear. Vegetation overgrowth. The walls are exposed to water ingress which could destabilise the structure.
Recommended measures	Remove vegetation. Remove steel rainwater pipe and gutter. Repair cast iron rainwater pipe. New rainwater goods and drainage system, sized for deluge rainfall events, to be incorporated into design of new roof.

Fig.26: Coach House, west section, north elevation, section above the central door opening. Broken steel rainwater pipe and buddleia is growing.

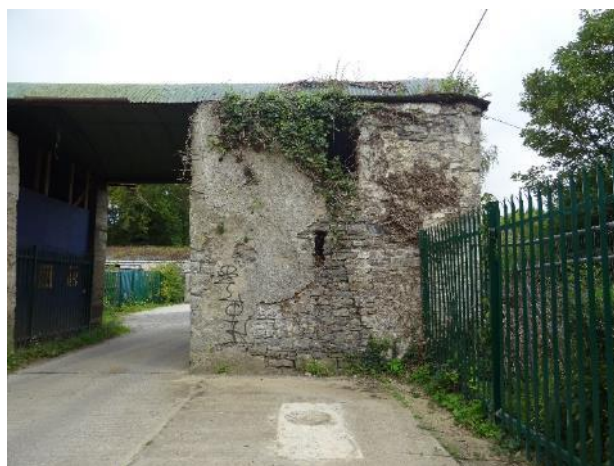
Fig.27: Coach House, east section, south elevation, there is a remaining section of gutter.

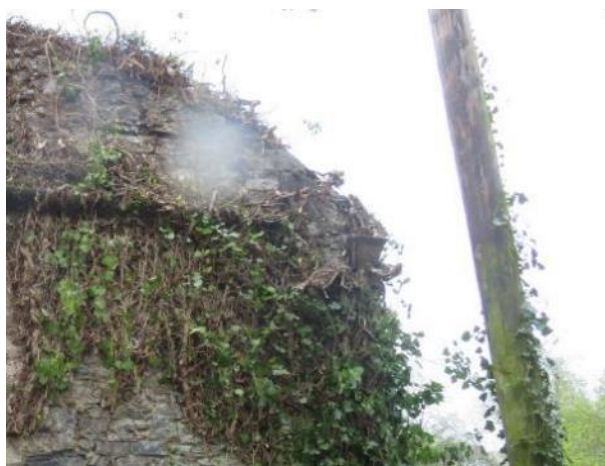
Fig.28: Coach House, east section, east elevation. Damaged gutter and cast iron rainwater pipe at the north corner.

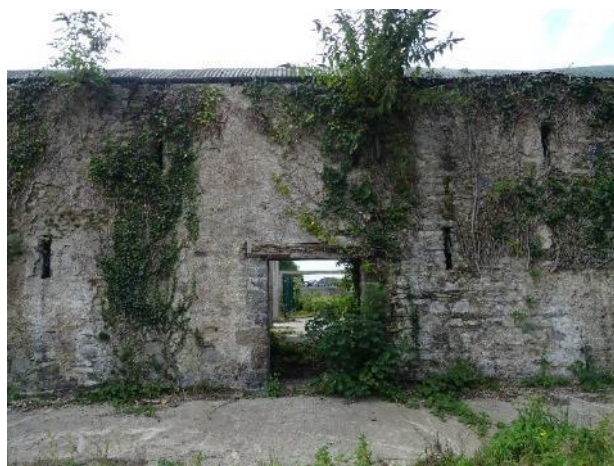
Fig.29: Coach House, west section, north elevation. Damaged steel gutter running along the elevation.

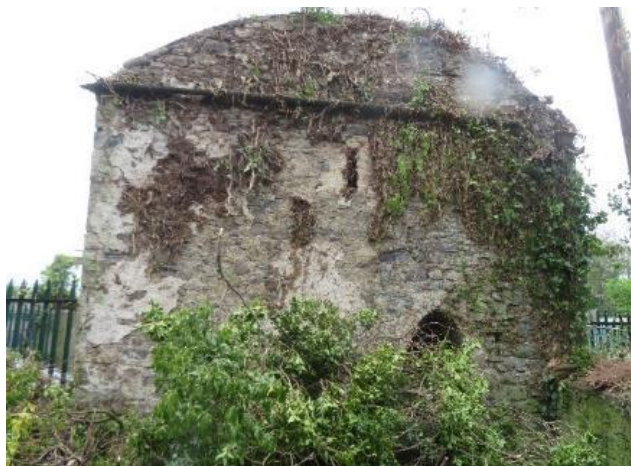
<p>Generally, the lime render has degraded. The vegetation is developing.</p> <p><u>East section, east elevation</u></p> <p>The lime render has fallen in some areas. There are open joints at the bottom section. Vegetation is developing at the section at the north. There is a crack on the south section.</p>
Probable causes/consequences	<p>Wear and tear.</p> <p>Water ingress.</p> <p>Previous interventions: timber beams and concrete slab.</p> <p>Risk of destabilization and collapse.</p>
Recommended measures	<p>Repoint open joints.</p> <p>Remove vegetation.</p> <p>Remove cement render.</p> <p>Remove modern fixings.</p> <p>Replace lime render.</p> <p>Remove graffiti.</p> <p>Structural engineer to inspect the cracks and the wall leaning and make recommendations.</p> <p>Conservation consultants to carry out a mortar analysis to specify mortar replacement.</p>

Fig.30: Coach House, east section, east elevation. Vegetation overgrowth, open joints and missing lime render.

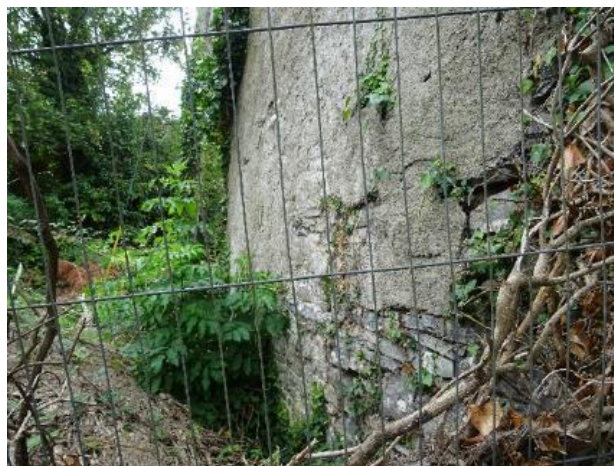
Fig.31: Coach House, east section, north elevation. Missing pointing and crack.

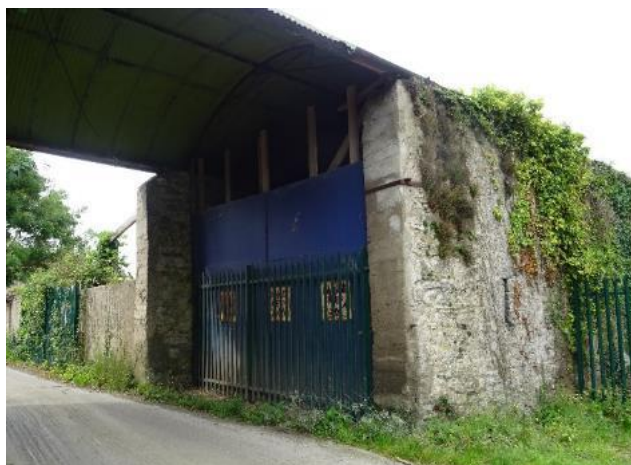
Fig.32: Coach House, west section, north elevation concrete was cast in situ, vegetation overgrowth.

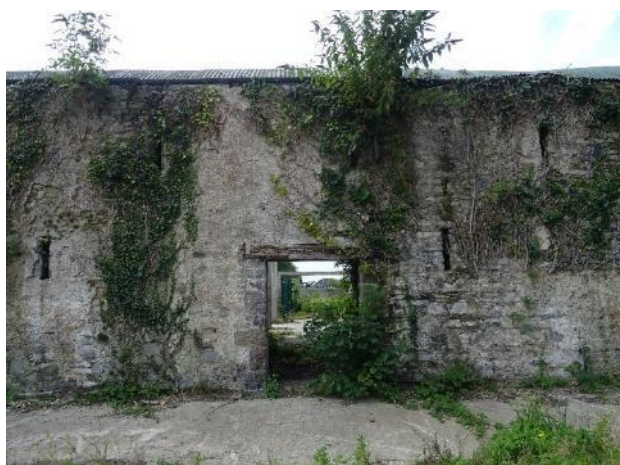
Fig.34: Coach House, west section, north elevation, remaining lime render, vegetation overgrowth.

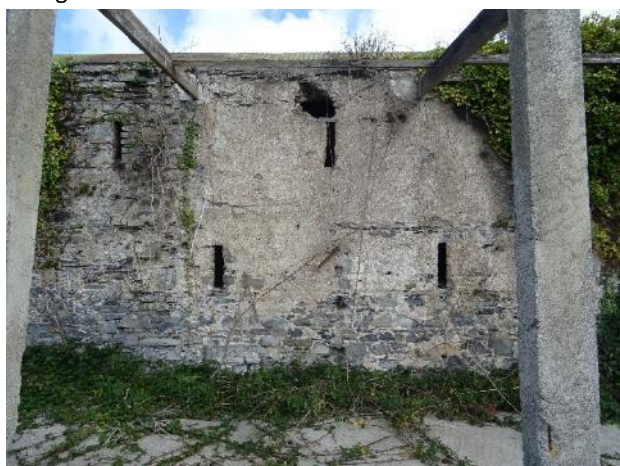
Fig.38: Coach House, west section, south elevation, missing stones, open joints on the top and bottom section, alterations due to the timber beams, vegetation overgrowth.

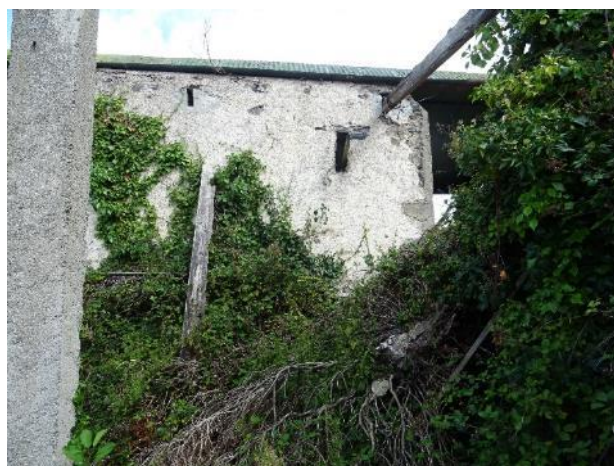
Fig.39: Coach House, west section, south elevation, concrete was cast in situ at the corner, vegetation overgrowth.

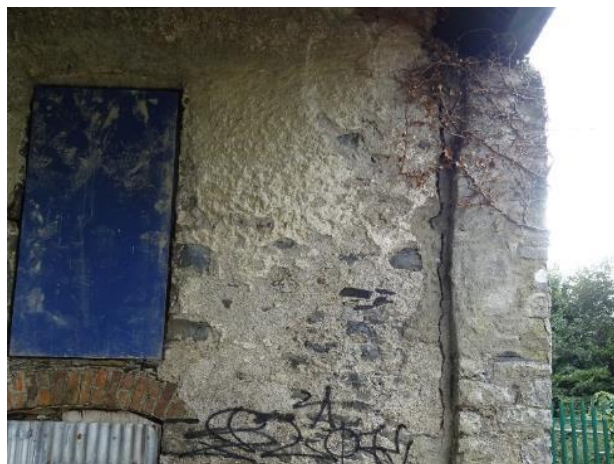
Fig.43: Coach House, east section, east elevation, crack and graffiti.

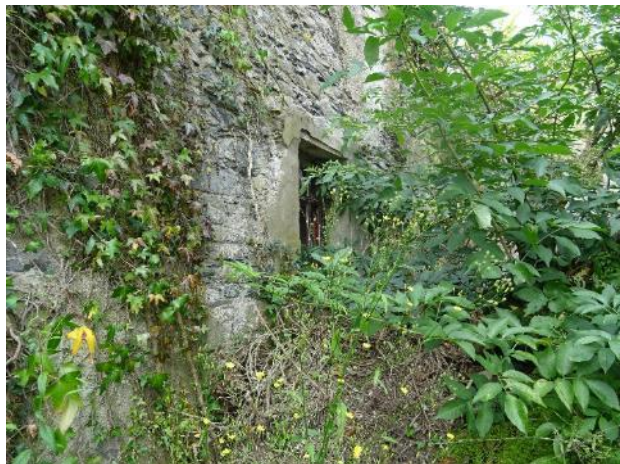
Description (materials, construction, location)	1 no. square headed window opening on the west section north elevation which is not historic. Timber lintel and timber window. 1 no. square headed window opening on the east section west elevation. There is evidence of a previous low arch brick lintel which was infilled. The window opening is boarded -up.
Condition	Timber window in poor condition.
Probable causes/consequences	Wear and tear.
Recommended measures	Windows to be replaced.

Fig.44: Coach House, west section, external north elevation, non-historic square-headed window.

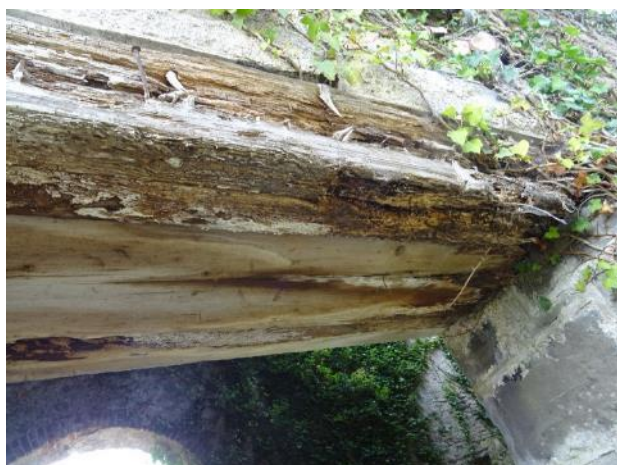
<p><u>Central round-headed archway west section south elevation</u></p> <p>The arch is leaning.</p> <p><u>Central square-headed opening west section north elevation</u></p> <p>Timber lintel on the external elevation is rotten and has moved downward. The timber lintel shows cracks on the internal elevation.</p> <p><u>Square-headed east section west elevation</u></p> <p>Opening was boarded-up with metal corrugated sheeting.</p> <p><u>Gothic arch door opening east section east elevation</u></p> <p>Timber door was removed and laid on the ground. Poor condition. The bottom section and one of side section is missing.</p>
Probable causes/consequences	Wear and tear. Overgrowth vegetation. Structural disorder.
Recommended measures	<p>Rebuild top section and base of the round-headed archways.</p> <p>Lime mortar repointing.</p> <p>Repair timber door.</p> <p>Replace boarding-up.</p> <p>Structural Engineer to inspect and make recommendations.</p>

Fig.47: Coach House, West section, external north elevation, central opening, the rotten timber lintel is moving downward

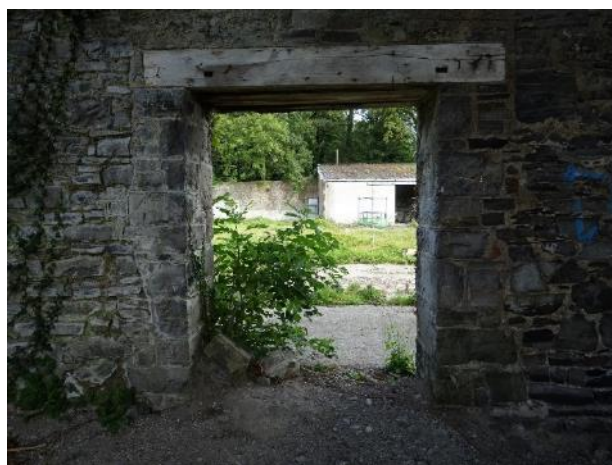
Fig.48: Coach House, West section, internal north elevation, central opening, timber lintel has cracks

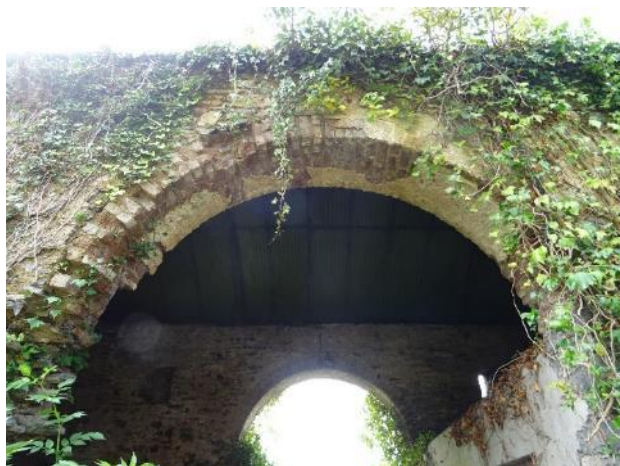
Fig.49: Coach House, West section, external north elevation, western opening, missing bricks and stones.

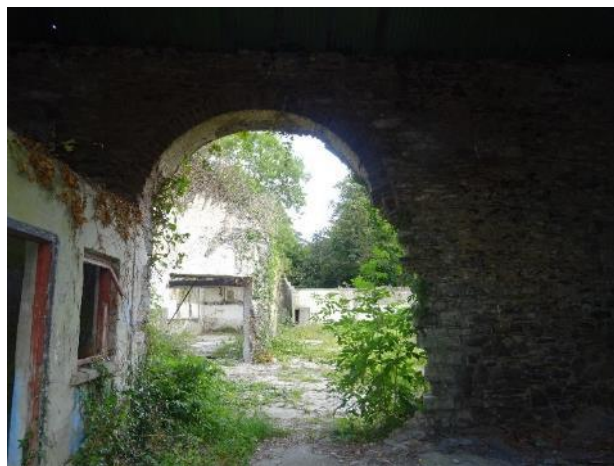
Fig.50: Coach House, West section, internal north elevation, western opening, missing bricks and stones.

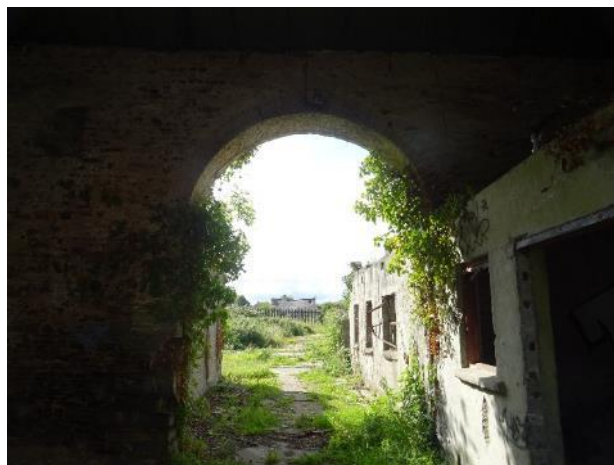
Fig.52: Coach House, West section, internal south elevation, western opening, missing stones at the base of the arch.

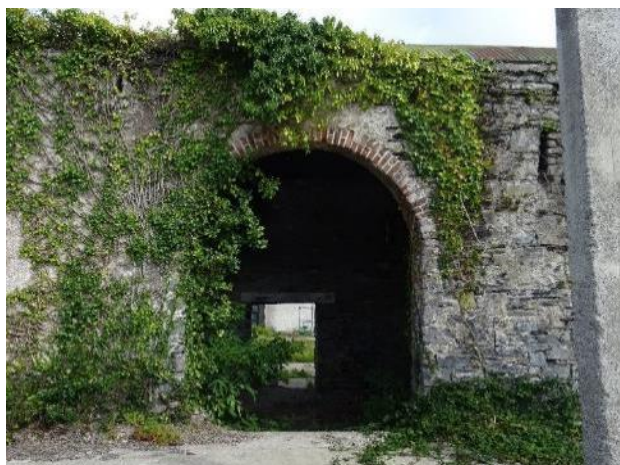
Fig.53: Coach House, West section, external south elevation, central opening, arch is leaning.

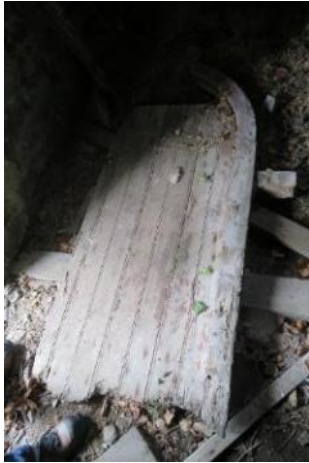
Fig.57: Coach House, timber door in poor condition, missing sections.

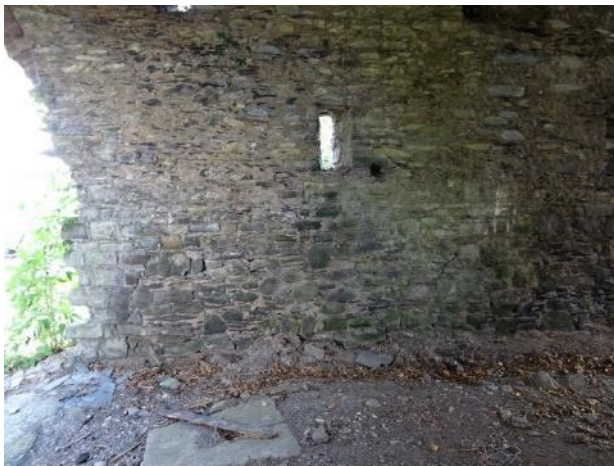
Description (materials, construction, location)	<p>Rubble stone walls.</p> <p>Cement render at the west internal elevation and western section of the internal north and south elevations.</p>
Condition	<p>There are open joints in some bottom sections.</p> <p>Vegetation overgrowth.</p> <p>Missing stones in some sections, for instance adjacent to the western entrance and the central opening on the north internal elevation, and close to the western entrance on the south internal elevation.</p> <p>Green moss.</p> <p>Stains from metal corrugated sheeting.</p> <p>Cracks:</p> <ul style="list-style-type: none"> - 1 no. in section close to the western entrance on the south elevation - 1 no. diagonal crack in section close to the central opening on the south elevation
Probable causes/consequences	<p>Water ingress causing material decay in particular where the roof is missing.</p> <p>Previous interventions.</p> <p>Vegetation overgrowth.</p> <p>Wear and tear.</p>

Fig.60: Coach House, west section, north internal elevation, missing stone, open joints, green moss.

Recommended measures	<p>Remove vegetation.</p>

<p>Remove late wall addition in the western section.</p> <p>Remove services.</p> <p>Remove concrete render.</p> <p>Rake out joints and repoint.</p> <p>Apply lime plaster.</p> <p>Structural engineer to inspect cracks and make recommendations.</p>
--	---

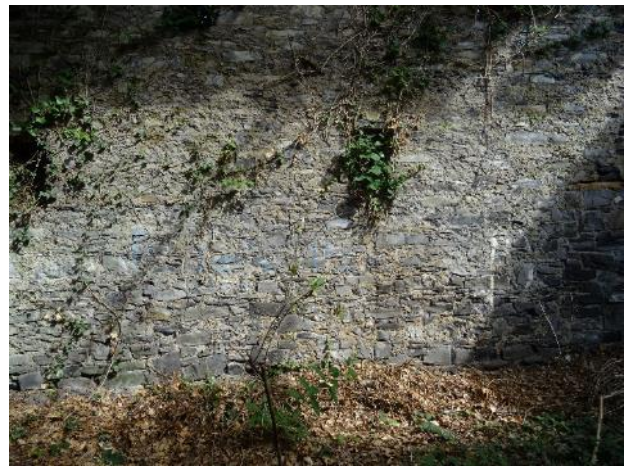
Fig.61: Coach House, west section, north internal elevation, vegetation overgrowth, open joints at the bottom section, graffiti.

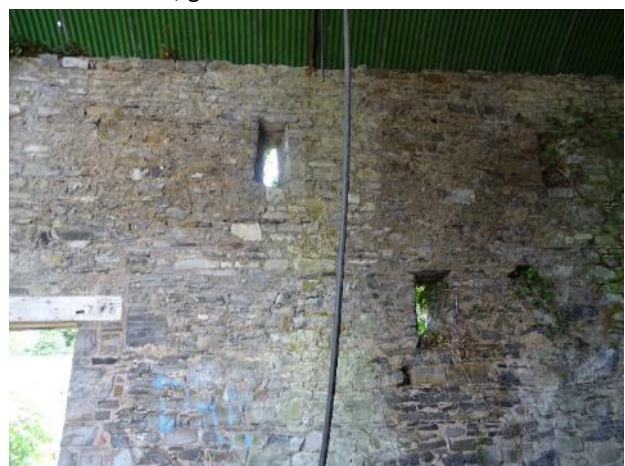
Fig.63: Coach House, west section, north internal elevation, missing stone.

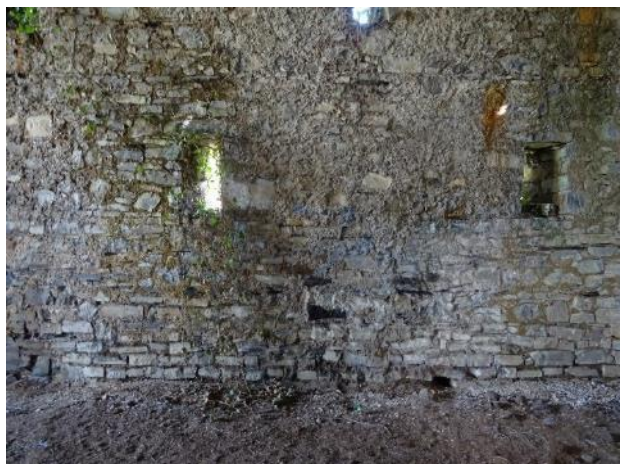
Fig.64: Coach House, west section, north internal elevation, missing stone at the bottom section and stains from the corrugated metal sheeting.

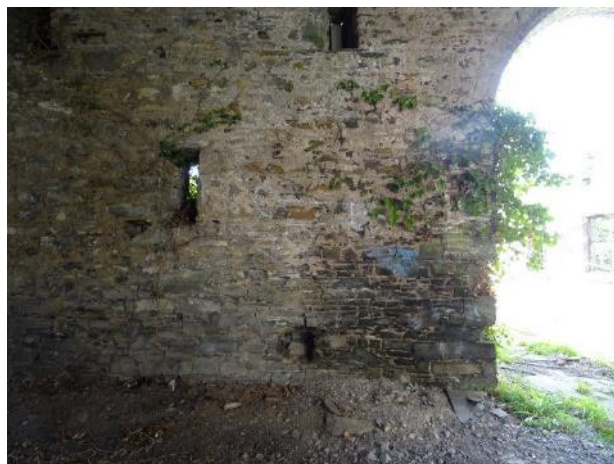
Fig.65: Coach House, west section, south internal elevation, missing stone at the bottom section and crack.

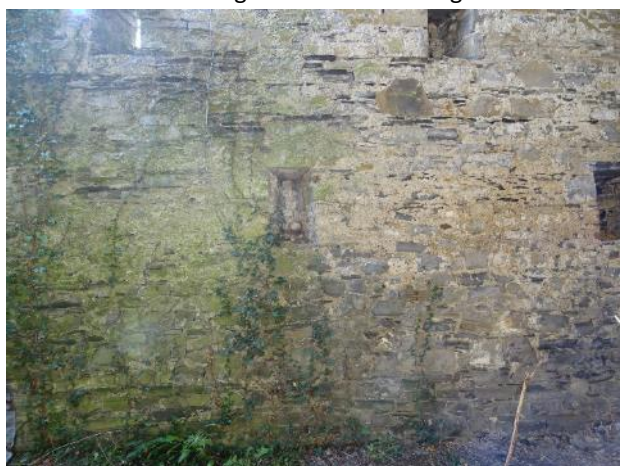
Fig.66: Coach House, west section, south internal elevation, blocked-up window opening and green moss.

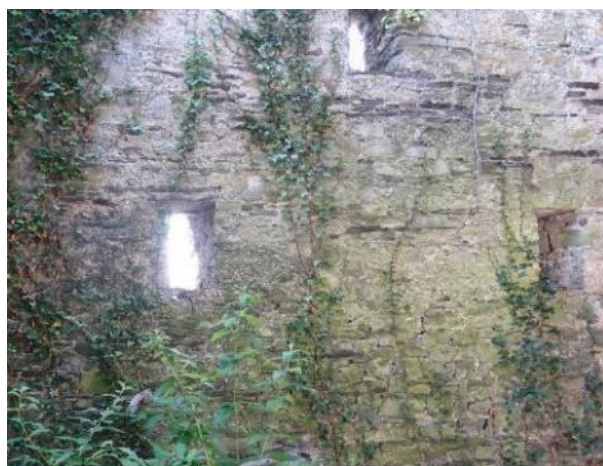
Fig.67: Coach House, west section, south internal elevation, section close to central opening, diagonal crack.

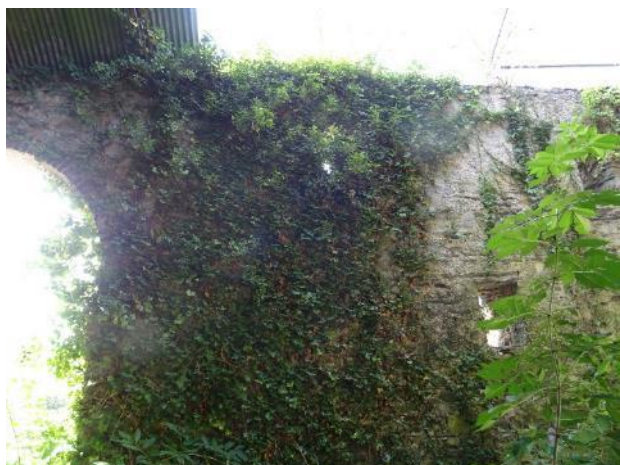
Fig.68: Coach House, west section, south internal elevation, ivy developing.

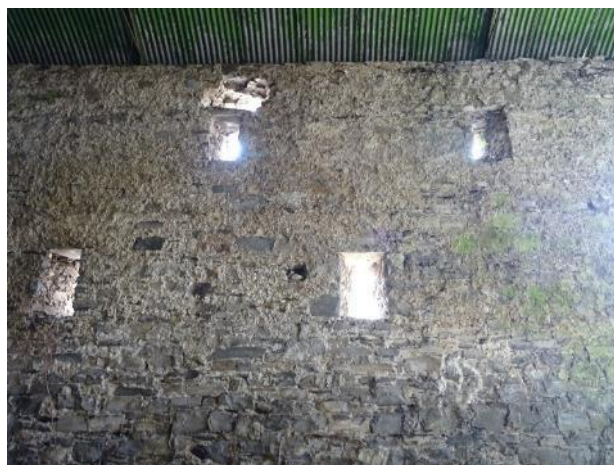
Fig.69: Coach House, west section, south internal elevation, missing stones.

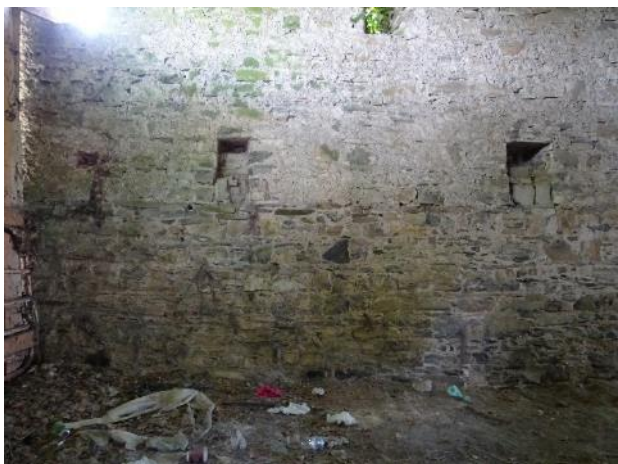
Fig.70: Coach House, west section, south internal elevation, window opening was blocked up.

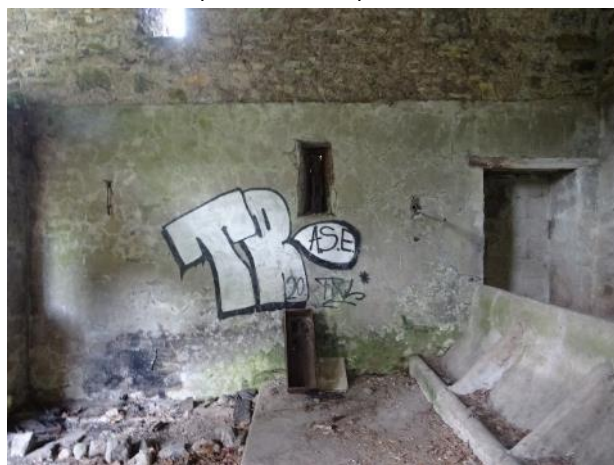
Fig.75: Coach House, west section, south internal elevation, cement render.

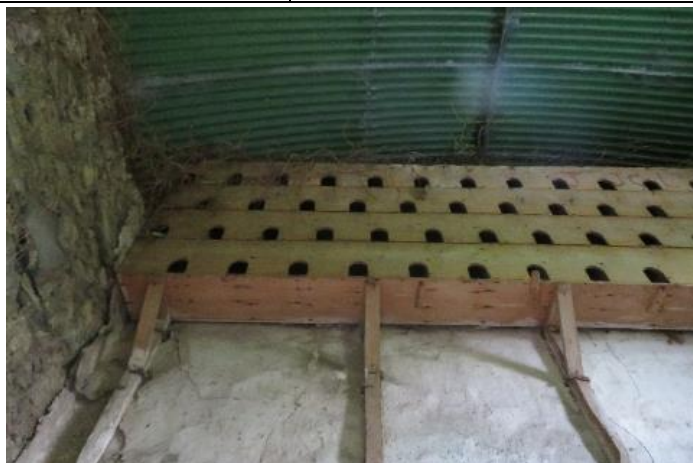
Description (materials, construction, location)	Dovecote in east section.
Condition	Fair to poor condition.
Probable causes/consequences	Wear and tear. Vegetation developing.
Recommended measures	Repair.

Fig.76: Coach House, east section, dovecote.

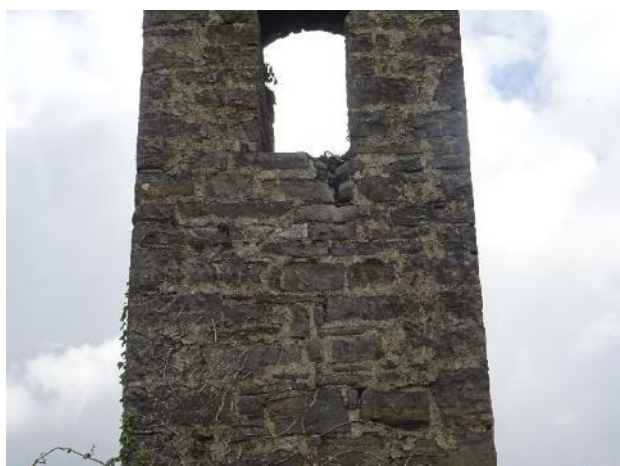
<p>Description (materials, construction, location)</p>	<p>Uncoursed rubble limestone wall and bell tower.</p> <p>Brick course at the top with flaunching.</p> <p>Remaining mortar flashing between the roof of the former 19th C building which was attached to the wall and the wall.</p> <p>Lime mortar pointing.</p> <p>Cement pointing.</p> <p>Cement render at the central bottom section to the east elevation of the wall.</p> <p>Modern concrete blockwork pillar.</p> <p>Modern concrete blockwork at the of the wall at the south of the Coach House.</p>
<p>Condition</p>	<p>Missing stone in some areas as for instance, beneath the bell tower opening to the west elevation and to the bottom section of the wall next to the modern concrete pillar on the east elevation.</p> <p>There are few areas with open joints.</p> <p>The brickcourse and flaunching at the top is missing in some sections.</p> <p>Stones are destabilised where the brickcourse is missing and at the south end of the wall.</p> <p>Vegetation developing: ivy.</p>

<p>Probable causes/consequences</p>	<p>Wear and tear.</p> <p>Previous interventions.</p> <p>Risk of structural disorder.</p>

Fig.78: Bell tower, west elevation, missing stone underneath the opening

Recommended measures	Repair brickwork course. Flaunch the top of the wall and bell tower where it is missing. Rebuilt the missing wall sections. Remove cement render and cement pointing. Repoint with lime mortar. Vegetation removal. Structural Engineer to inspect wall and bell tower and make recommendations.
-----------------------------	---

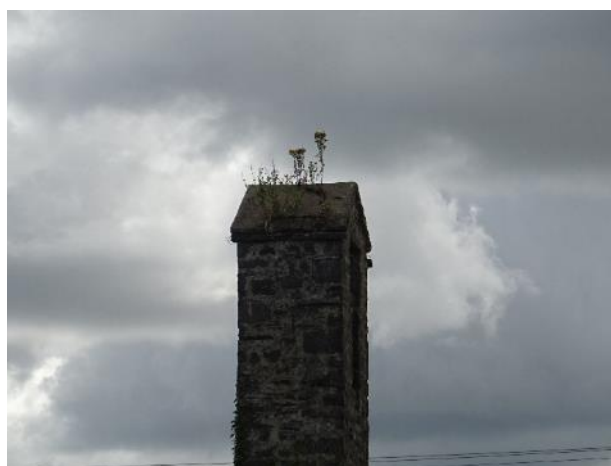
Fig.79: Bell tower, north elevation, missing flaunching and vegetation developing.

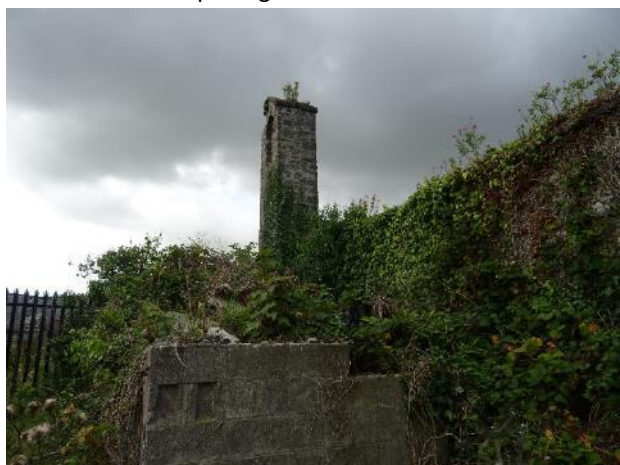
Fig.80: Wall and bell tower, north elevation, ivy developing

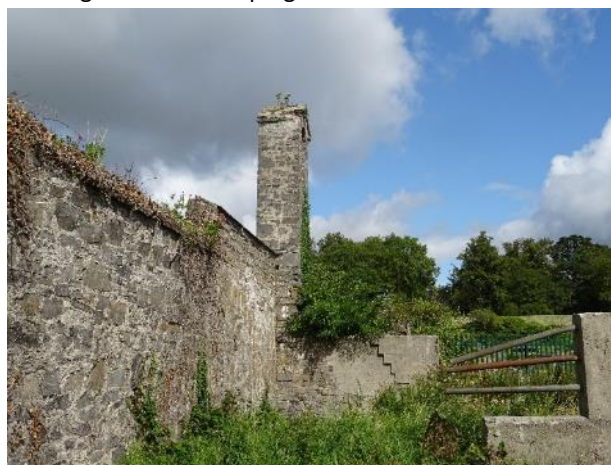
Fig.81: Bell tower, south elevation, missing stone and flaunching at the top of the bell tower.

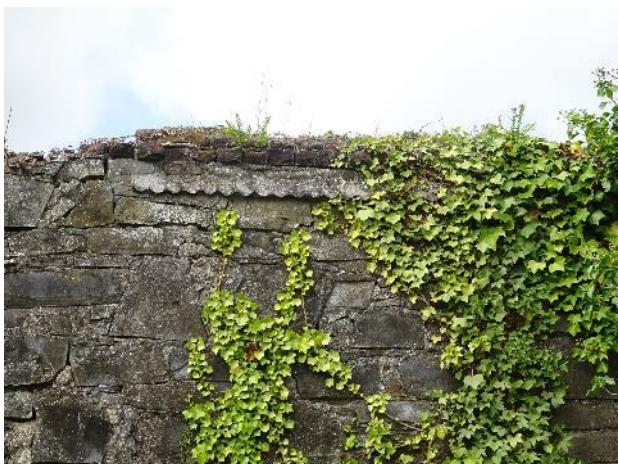
Fig.82: Wall, remaining mortar flashing between roof of the former 19th C building.

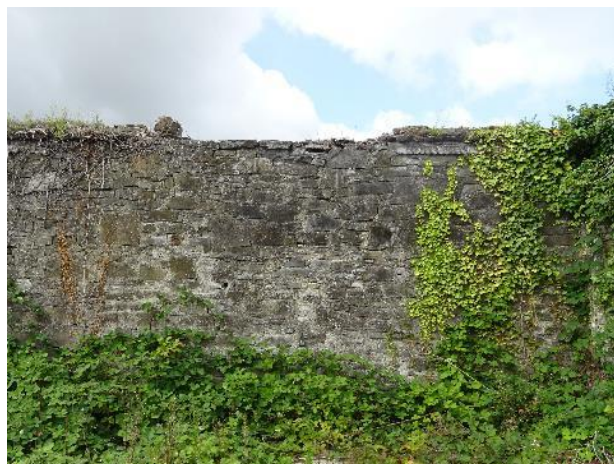
Fig.83: Stone is destabilised where the brickcourse is missing.

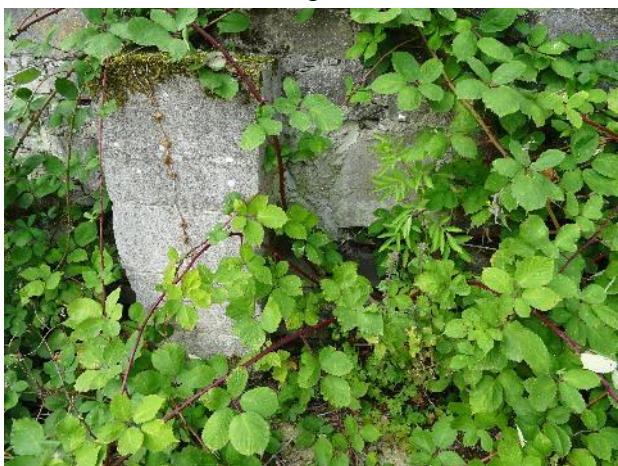
Fig.84: Wall, modern concrete blockwork and cement pointing, missing stone

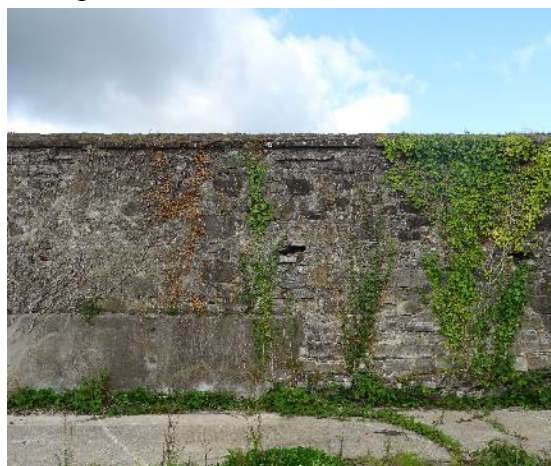
Fig.85: Missing stone, cement render

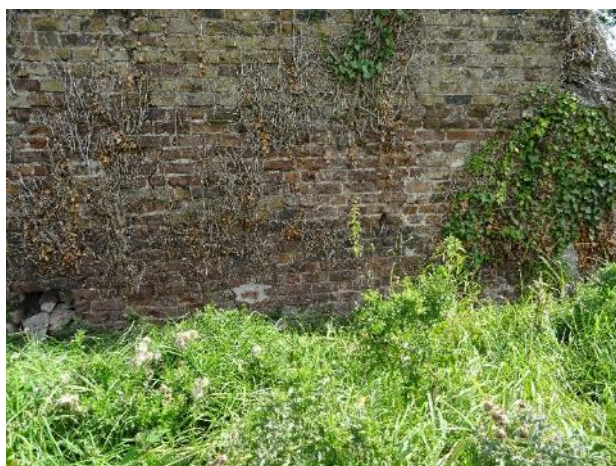
<p>Condition</p>	<p><u>East wall of the Walled Garden (Proposed to be demolished):</u></p> <p>Missing brickwork to the bottom section and top of the wall.</p> <p>Brickwork is in fair to poor condition. Some bricks have cracked. Lime mortar joint have failed.</p> <p>Lime mortar render is degraded in some sections.</p> <p>Missing flaunching.</p> <p>Ivy and vegetation developing.</p> <p><u>North wall of Walled Garden:</u></p> <p>Bricks are generally in fair condition. Some bricks are damaged.</p> <p>The lime render has failed to the bottom section.</p> <p><u>West wall of Walled Garden:</u></p>

Fig.92: East wall of Walled Garden, missing brickwork to the top section, brick fair to poor condition

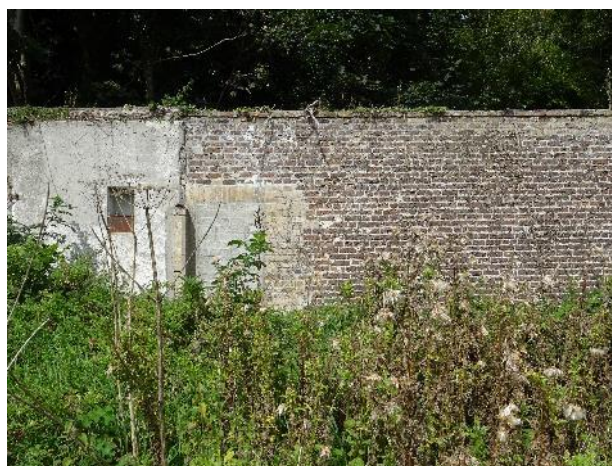
Fig.93: North wall of Walled Garden, south elevation, concrete based lime render and door opening has been boarded up with concrete blocks

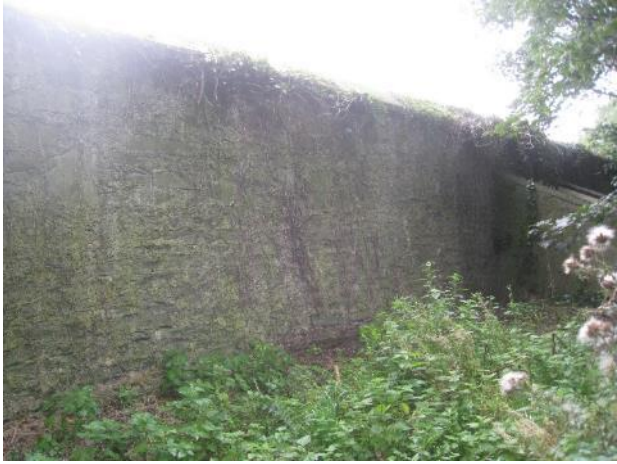
Fig.94: North wall of Walled Garden, north elevation, fair condition

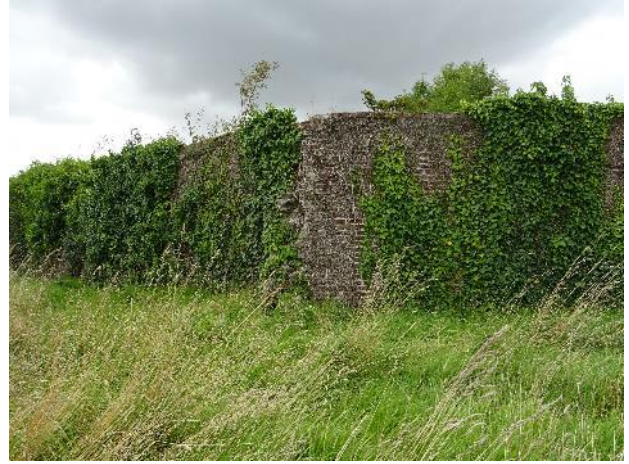
<p>Bricks are generally in fair condition. Some bricks are damaged.</p> <p>Brickwork have collapsed at the junction between walls and at the south section.</p> <p>Growing vegetation.</p> <p><u>South wall of Walled Garden:</u></p> <p>Failing lime mortar joint on the south elevation.</p> <p>Lime render is degraded to the bottom part.</p> <p>Growing vegetation.</p>
Probable causes/consequences	<p>Wear and tear.</p> <p>Previous alterations.</p>
Recommended measures	<p>East wall of Walled Garden to be salvaged.</p> <p>Replace damaged bricks with new matching bricks.</p> <p>Repoint with a lime-based mortar.</p> <p>Remove vegetation.</p> <p>Structural Engineer to inspect garden walls and make recommendations.</p>

Fig.95: West wall of Walled Garden, brickwork have collapsed.

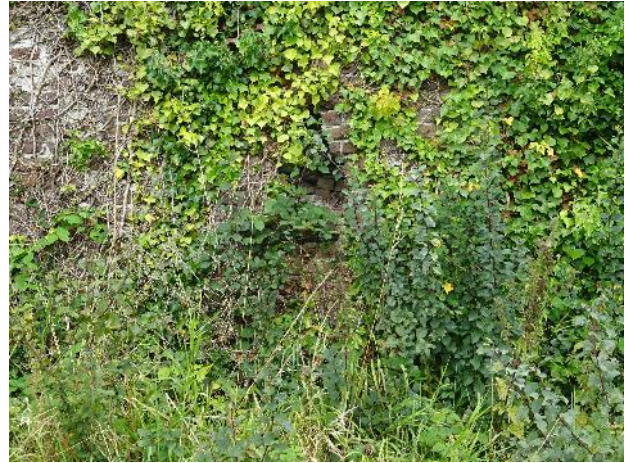
Fig.97: West wall of Walled Garden, brickwork have collapsed.

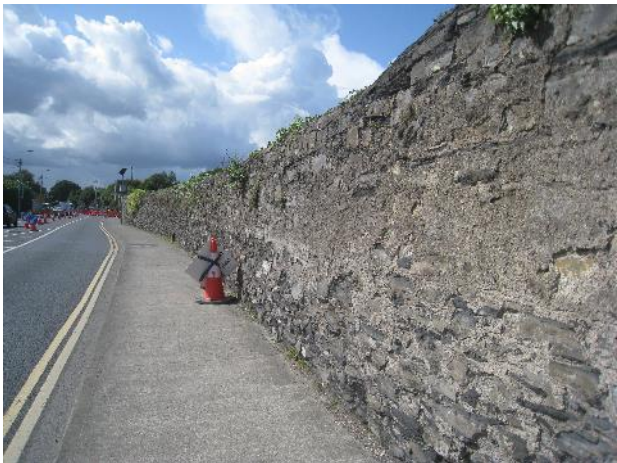
Fig.98: South wall of Walled Garden, lime render has failed to the bottom part revealing the uncoursed limestone.
