# Slieveacurry Renewable Energy Development

Stage 1 Road Safety Audit

Alan Lipscombe Traffic & Transport Consultants

April 2026

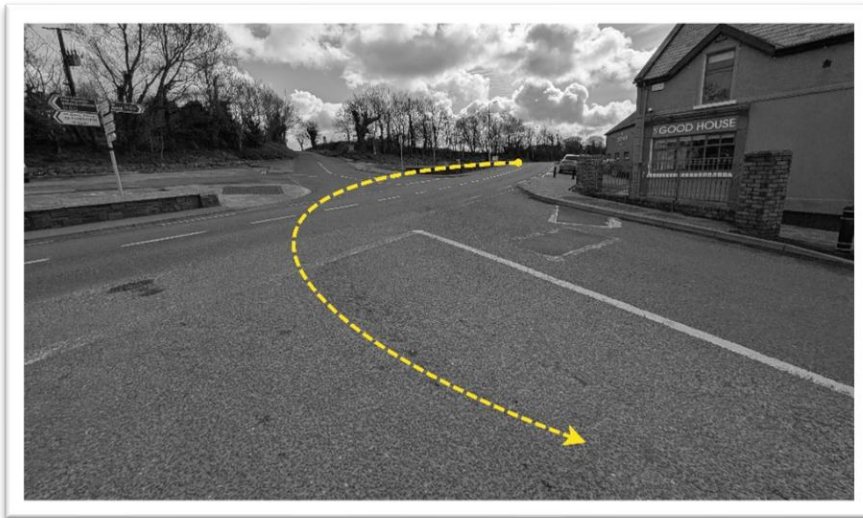
Figure 2.1 – Image of Location 1, N85 / R460 Junction for Record Purposes Only

No road safety issues were identified for this junction.

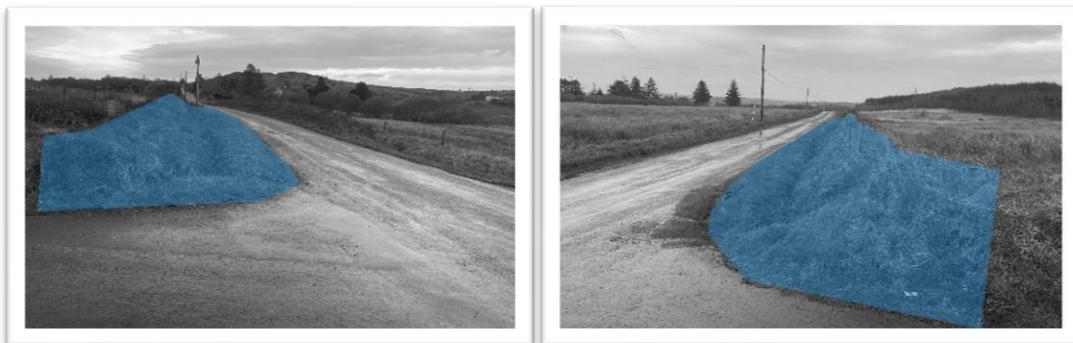
**Location:** Location 5 - L1076 / L6230 junction | Field Boundaries Either Side

Drivers attempting to turn left or right at the junction will have their view blocked in both directions by the existing field boundaries. This limited visibility could increase the risk of side-impact collisions at the junction.

Figure 2.2 – Visibility Splays Partially Obscured in Both Directions at Location 5 Junction

The field boundaries should be modified to ensure that an appropriate level of visibility can be provided for drivers exiting the access.

2.1	Location 1   For Record Purposes Only. No Safety Issues Identified.			
2.2	Yes	Yes	The required visibility splays are shown in Figure 15-15. It is noted that the visibility splays at this existing junction are partially constrained by shrubs and bushes on the southern verge of the L1076 between the carriageway edge and the boundary fence to the east and west of the junction with the L6230. As this is an existing junction it is assumed that maintenance works will be undertaken by Clare County Council to provide the required visibility splays at this junction. In the event that the splays are not maintained by Clare County Council, temporary traffic management measures, including traffic signs and the presence of a Flagman, will be introduced at this location on busy delivery days associated with the Proposed Project.	Noted and accepted

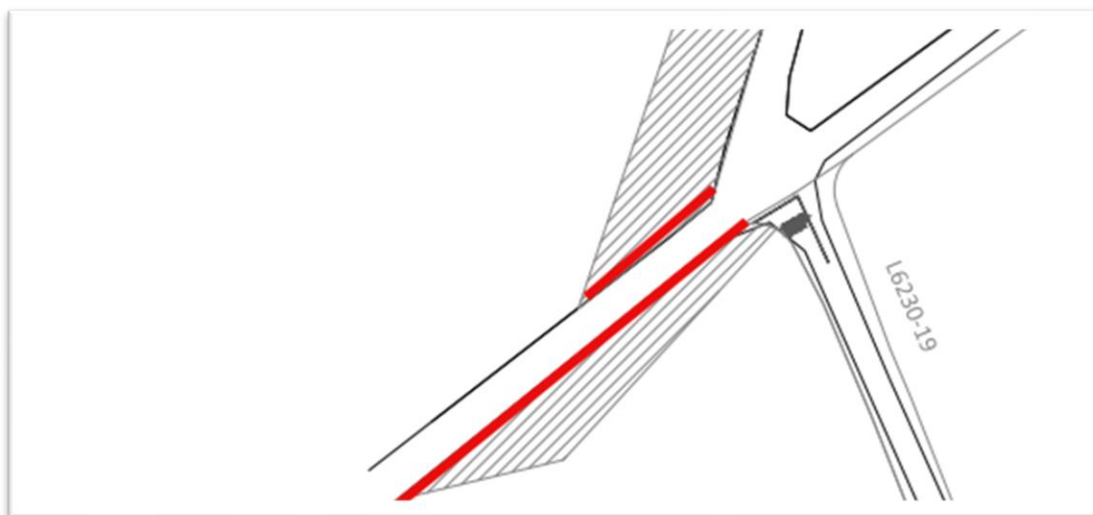
**Location:** Location 5 - L1076 / L6230 junction | Local Roads to the North & West

The temporary over-run area might create confusion for passing motorists, who could access it by mistake, leading to sudden braking, loss of control or conflicts with construction traffic.

Figure 2.3 – Location Where Passing Motorists Could Access the Overrun Area (When Not in Use)

The Designer should ensure that a suitable barrier is put in place to prevent passing motorists from accessing the abnormal load overrun area when it is not in use.

2.3	Yes	Yes	A suitable barrier will be installed at all times and opened only on the nights that the abnormal loads are delivered	Noted and accepted
2.4	Yes	Yes	It is confirmed that the visibility splays and forward visibility shown in Figures 15-19a / 15-19b will be provided at all times.	Noted and accepted

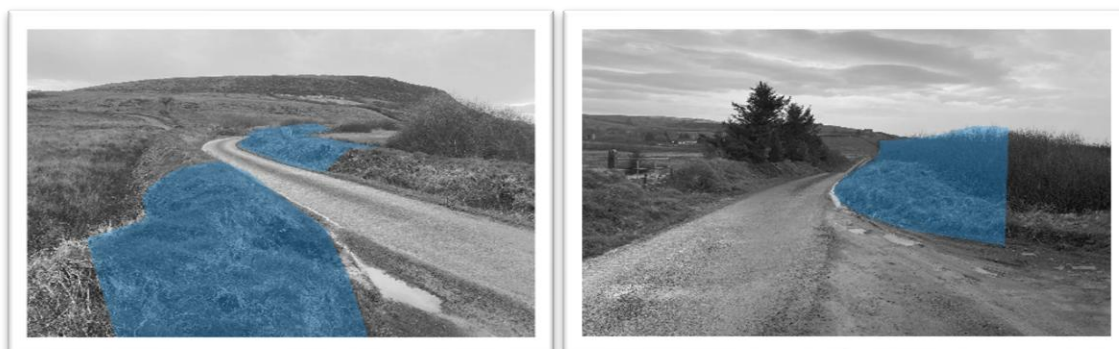
**Location:** Location 6 - L1076 / L6230 Access | Field Boundaries Either Side

Drivers attempting to leave the access will have their view blocked in both directions by the existing field boundaries. This limited visibility could increase the risk of side-impact collisions at the access.

Figure 2.4 – Visibility Splays Partially Obscured in Both Directions at Location 6 Forestry Access

The field boundaries should be modified to ensure that an appropriate level of visibility can be provided for drivers exiting the access.

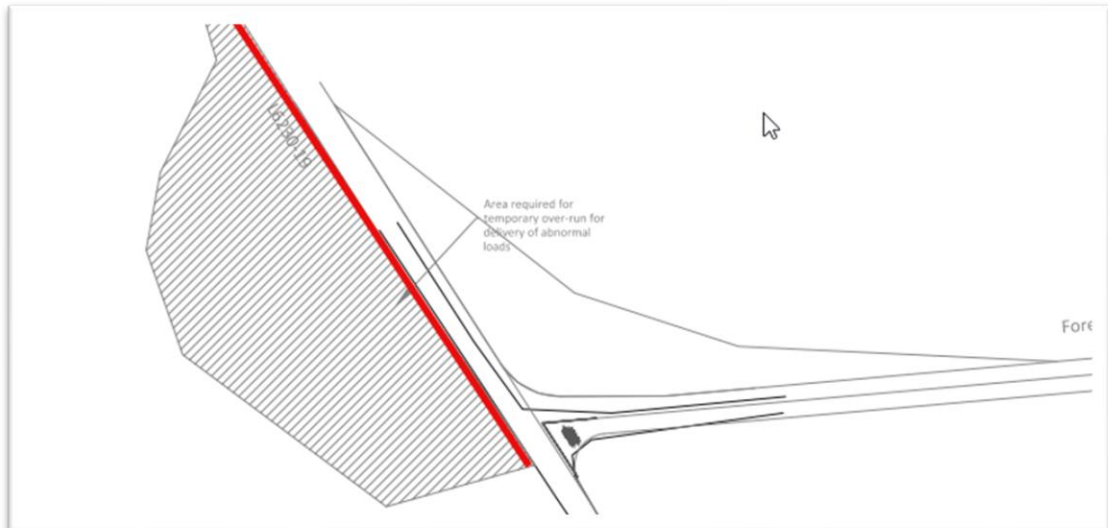
**Location:** Location 6 - L1076 / L6230 Access | Local Road to North & West

The temporary over-run area might create confusion for passing motorists, who could access it by mistake, leading to sudden braking, loss of control or conflicts with construction traffic.

Figure 2.5 – Location Where Passing Motorists Could Access the Overrun Area (When Not in Use)

The Designer should ensure that a suitable barrier is put in place to prevent passing motorists from accessing the abnormal load overrun area when it is not in use.

2.5	Yes	Yes	A suitable barrier will be installed at all times and opened only on the nights that the abnormal loads are delivered	Noted and accepted
