## **Stage 1 Road Safety Audit**

**Lissinagroagh Wind Farm, Manorhamilton, Co. Leitrim**

**On behalf of Future Energy Ireland**

**April 2026**

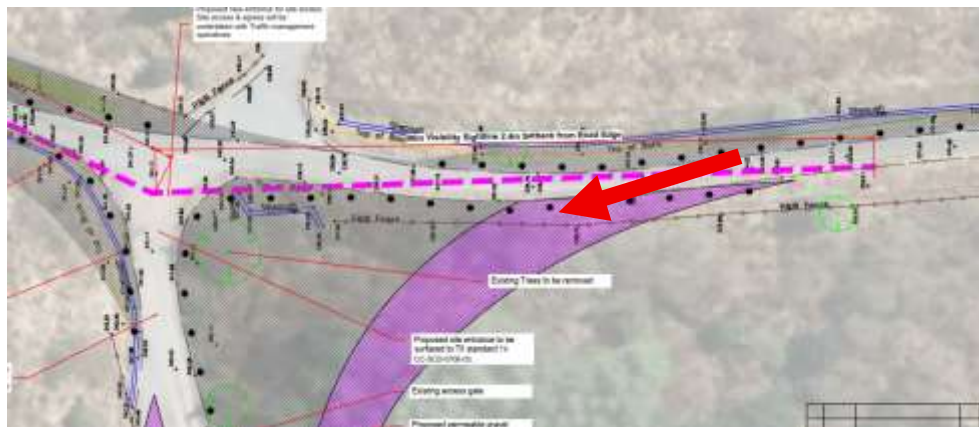
#### 4.1.5 Site Access “ – Temporary Over-run Area

**Problem:** The temporary over-run area forms a shallow angle junction with the existing public road. There is concern public vehicles or even contractors may use this temporary road for access to the wind farm.

**Hazard:** Vehicles may make this turn at high speed and lose vehicle control.

**Recommendation:** The Design Team should physically close off this temporary access when not in use for turbine deliveries.

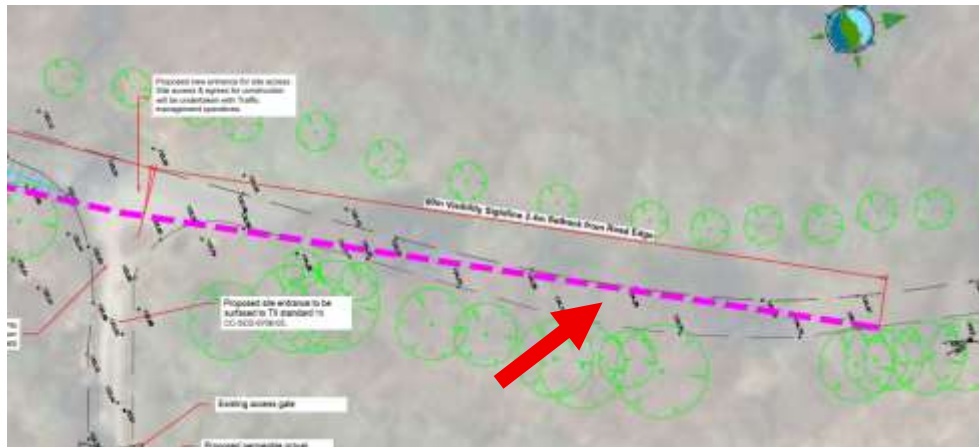
### 4.2.1 Site Access 1 - Junction Visibility

**Problem:** The junction visibility line to the right on exit does not include for the full mainline carriageway. There is concern a vehicle, possibly a motorbike, will be travelling towards the development junction behind the visibility line.

**Hazard:** Vehicles may exit the development road into the path of oncoming traffic.

**Recommendation:** The Design Team should ensure the full road to the right is within the junction visibility splay.

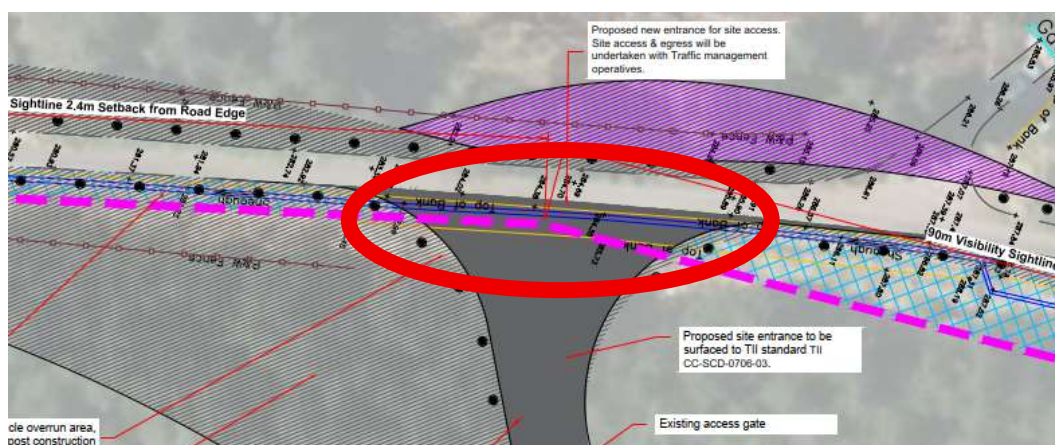
### 4.2.2 Site Access 4 - Drainage

**Problem:** The new access road crosses an existing roadside open drain. The access road may sever the drain such that flooding of the public road results.

**Hazard:** Aquaplaning type collisions may result.

**Recommendation:** The Design Team should provide a suitably sized culvert under the new road and connect the existing open drain to this culvert.

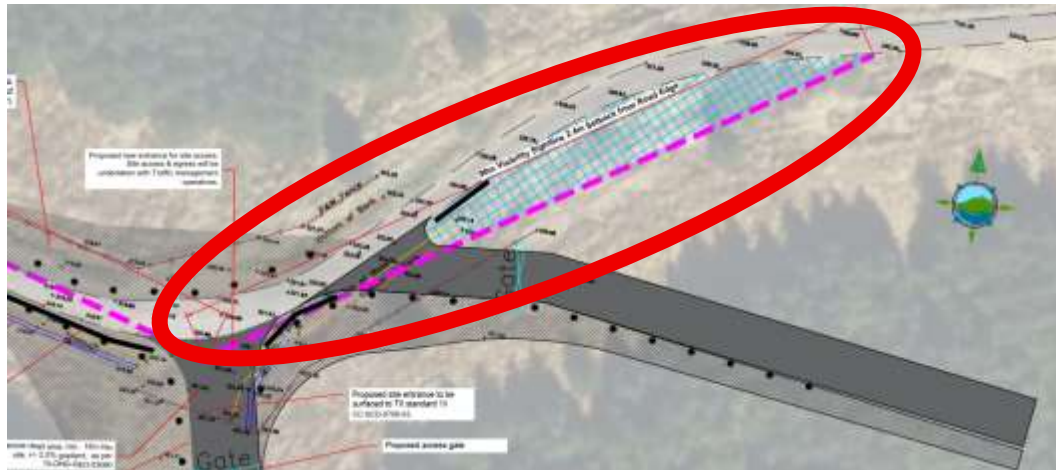
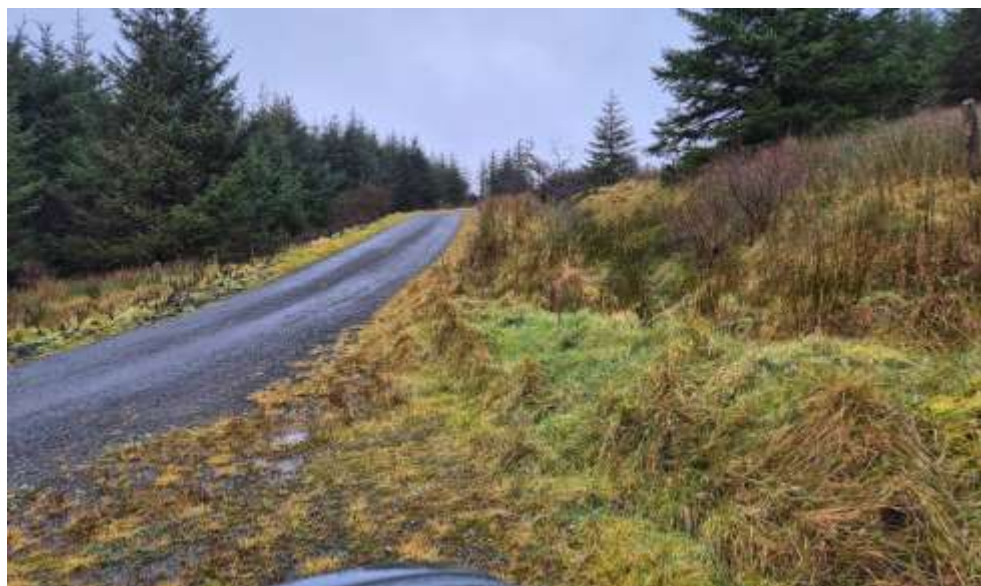
### 4.2.3 Site Access 5 & 6 – Junction Visibility

**Problem:** The lands rise in level to the east of the junction. Although the junction visibility splay is shown on the drawings, there is concern these splay crosses over the brow of the hill to the east. Motorists' visibility to the right when exiting may be restricted due to this hill.

**Hazard:** Development traffic may exit the junction into the path of oncoming traffic.

**Recommendation:** The Design Team should ensure vertical visibility is achieved at this location.

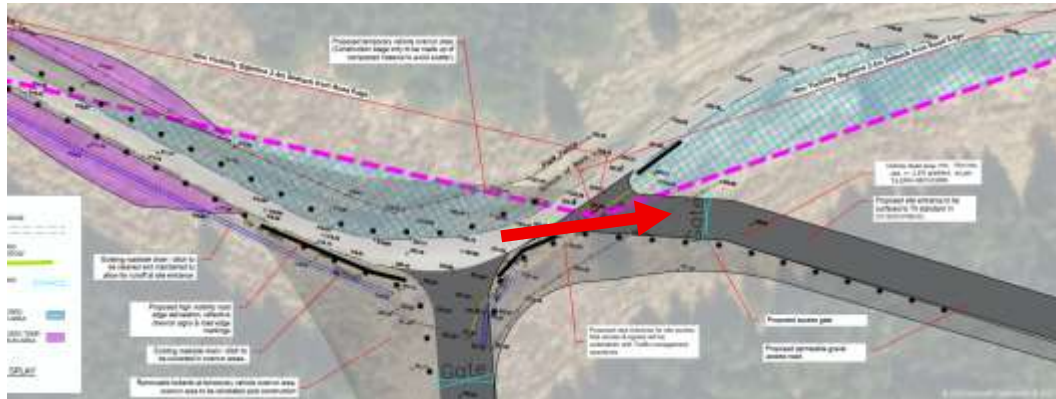
#### 4.2.4 Site Access 6 – Junction Angle

**Problem:** The new access at Entrance 6 is to an acute angle with the existing public road. There is concern eastbound public road users will errantly drive into this access rather than continue around the bend on the existing public road.

**Hazard:** Public road traffic may impact with the closed gate, especially during the hours of darkness.

**Recommendation:** The Design Team should realign the junction to be more perpendicular with the existing public road.

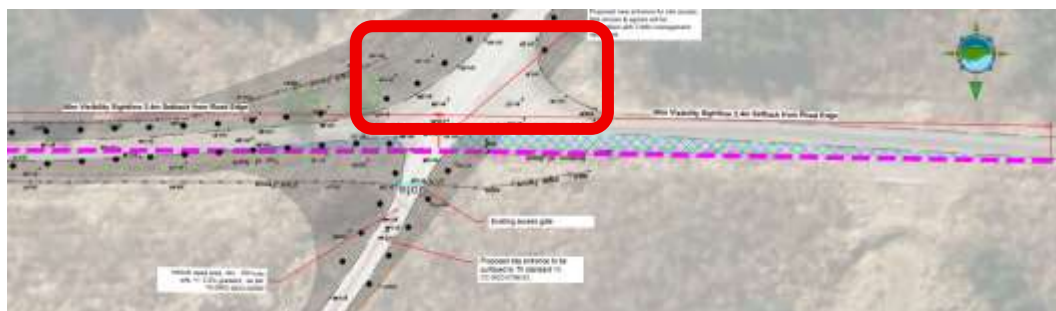
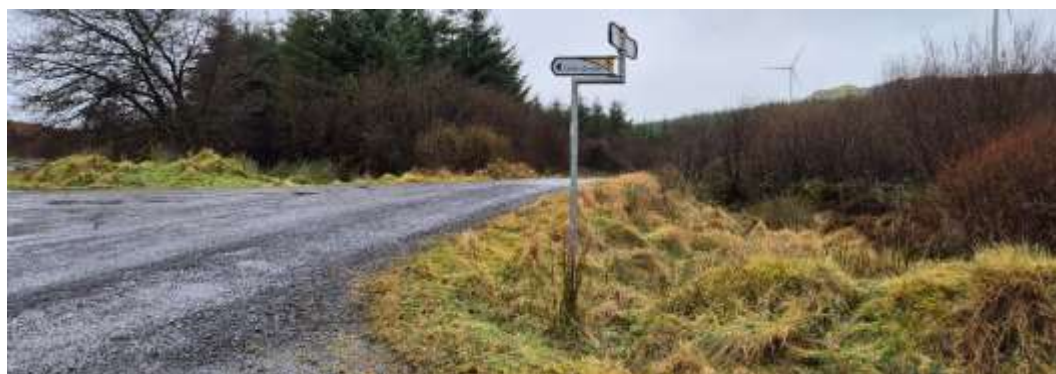
#### 4.2.5 Site Access No.7 – Junction Visibility

**Problem:** Site Access 7 is in the form of a crossroads junction. Junction visibility splays are shown for the northern side of the junction, but not for the southern side. There are high embankments and vegetation to the southern side that currently restrict visibility here.

**Hazard:** Development traffic may enter the public road into the path of oncoming public vehicles.

**Recommendation:** The Design Team should provide adequate junction visibility.
