# Appendix H. Tree Survey Report and Tree Protection Plan Drawings

# Independent Tree Surveys Ltd

## Tree Survey Report Mortarstown WWTP Upgrade Kilkenny Road Carlow

September 2025

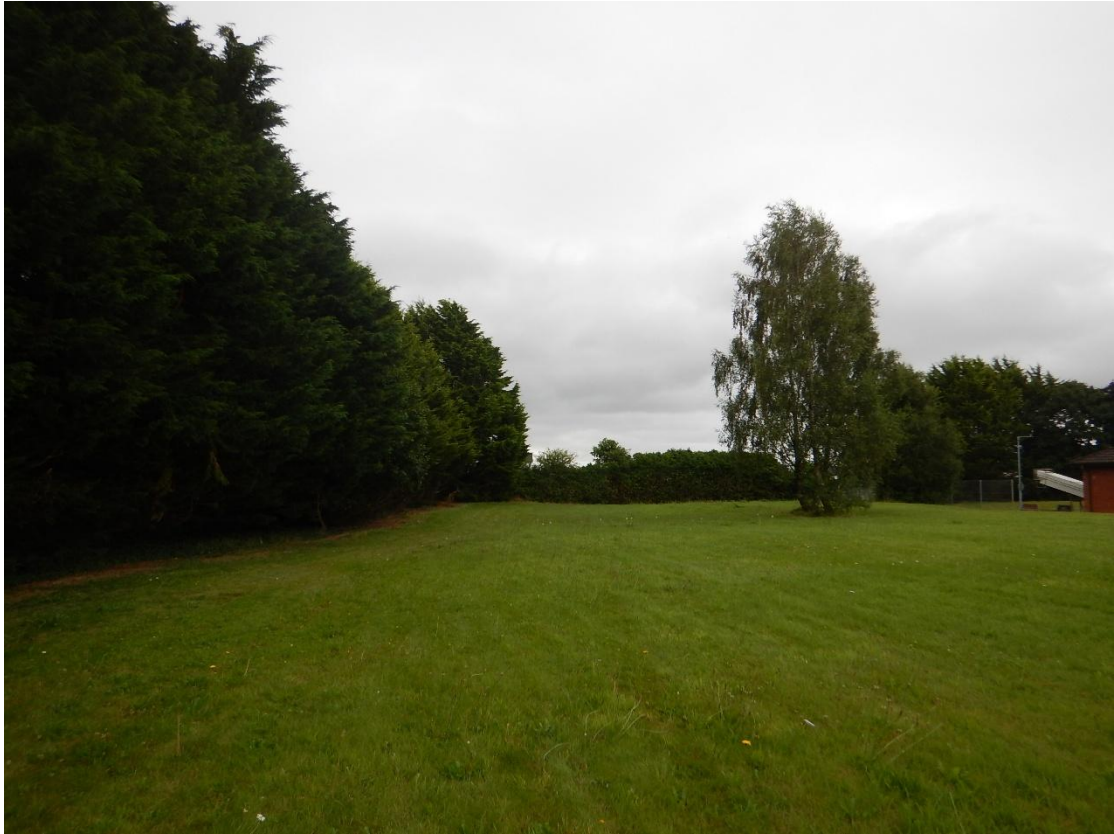
*Photo 1 Inside the WWTP - Cypress group G3 viewed from the west*

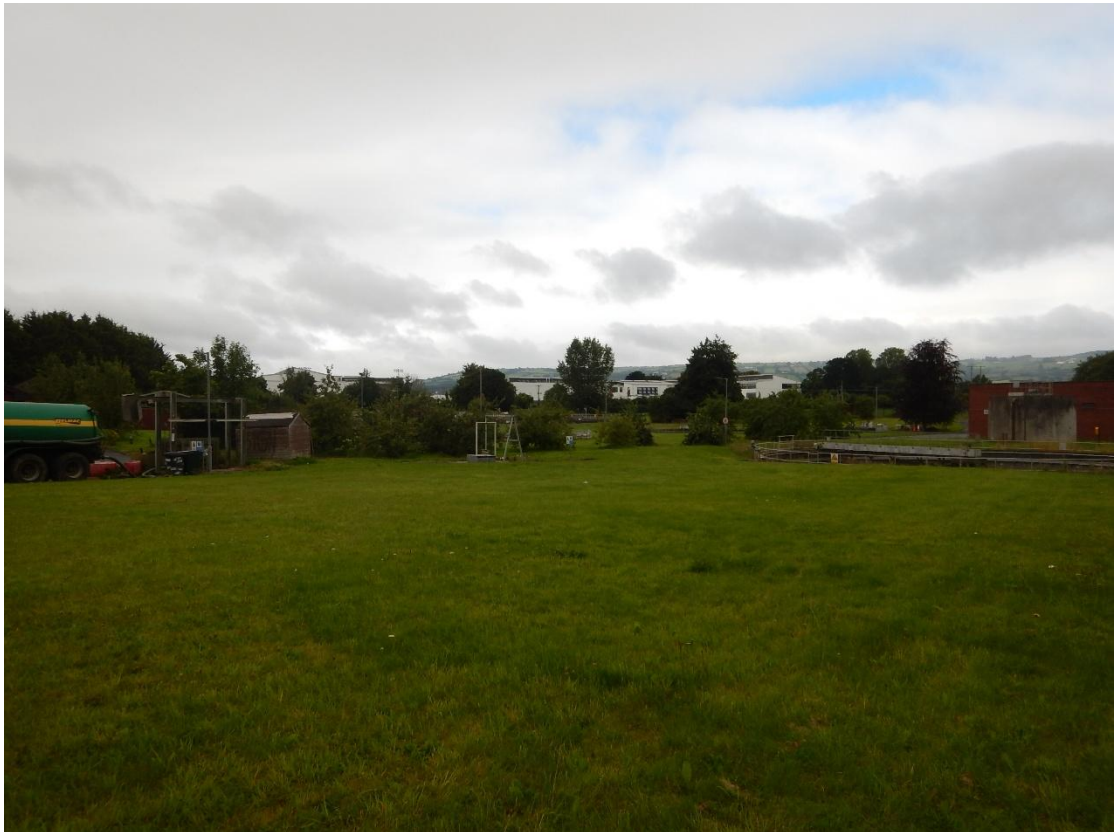
*Photo 2 Inside the WWTP - View from the northeast showing the trees planted for landscape around the facility*

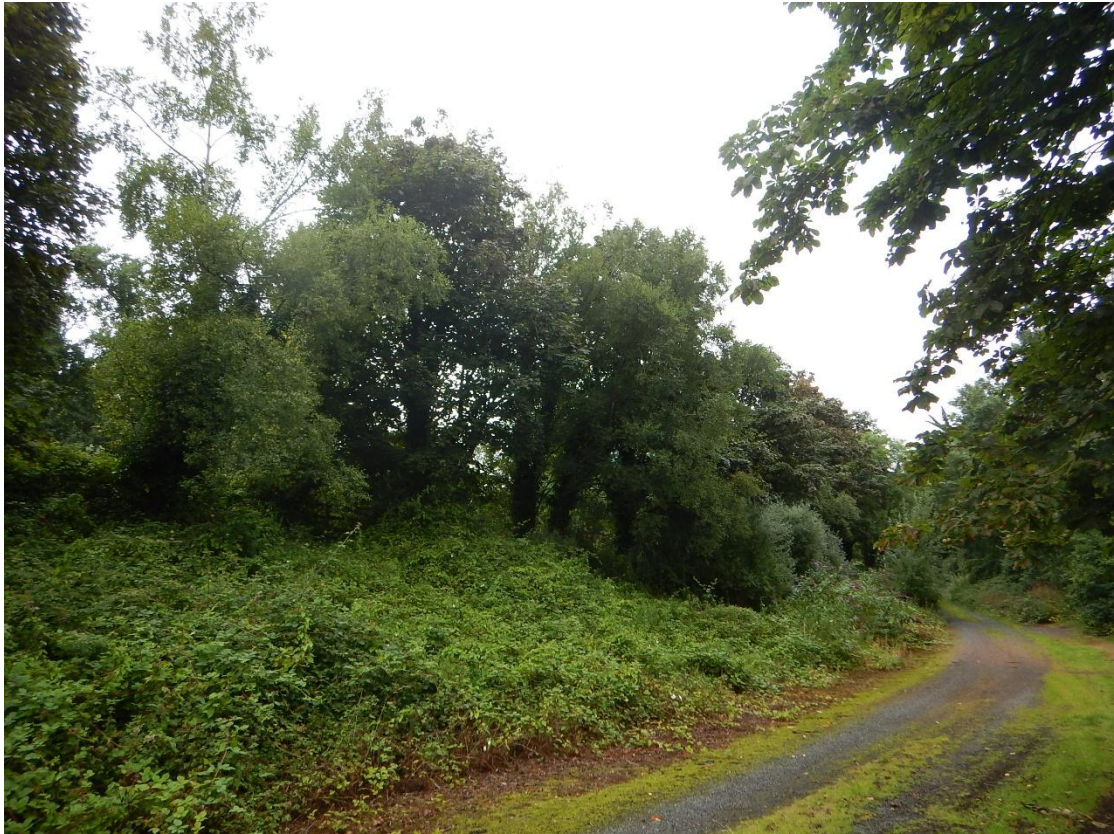
The trees (Acer and Betula spp.) tagged 525-537 and 682-687 are located within the roadside verge off Kilkenny Road and were evidently planted as amenity landscape trees. The trees are of moderate to low value based upon their condition and size. Trees 669-680 are associated with the adjacent cottage. Trees T1-T48 are in the grounds of private properties, housing estates and landscape verges along the southeast side of Kilkenny Road and include some trees of better quality. Trees T49-T60 are individual trees within the woodland areas between Kilkenny Road and the River Barrow.

*Photo 3 Mixed Betula and Acer trees on the landscape island between the old road to the east (right) and Kilkenny Road.*

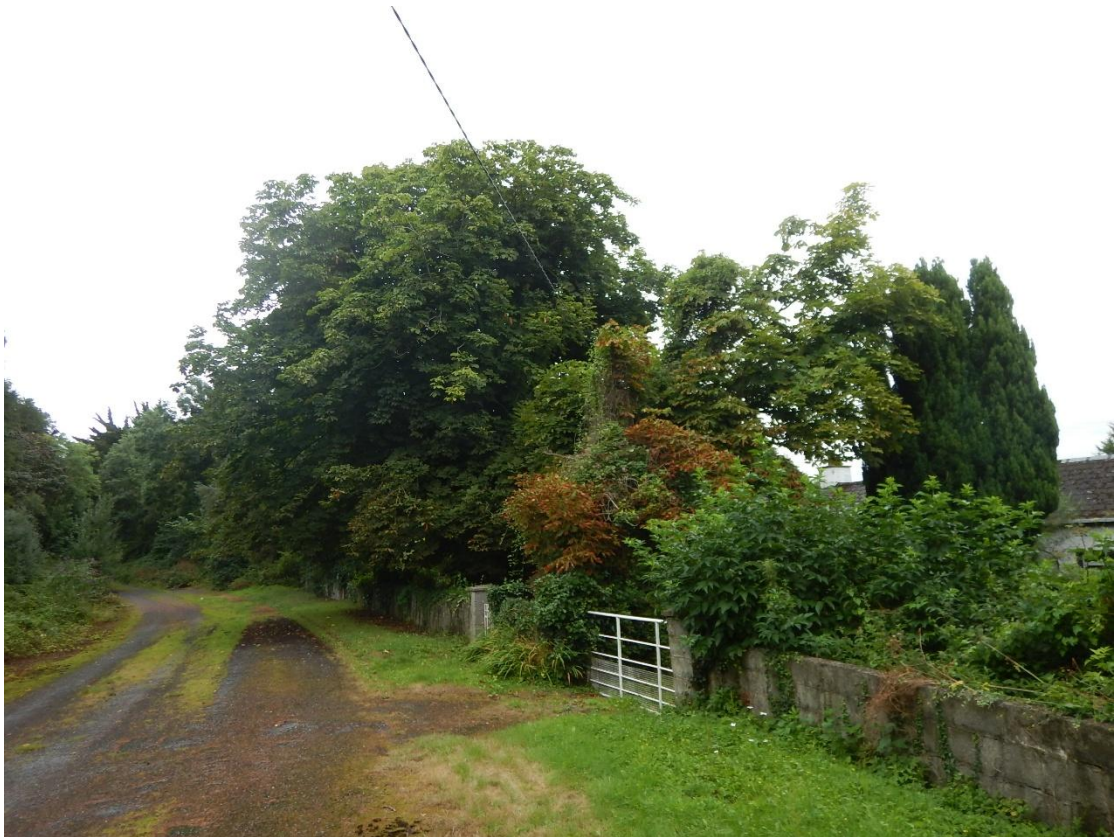
*Photo 4 Mature trees in the grounds of the old cottage off Kilkenny Road*

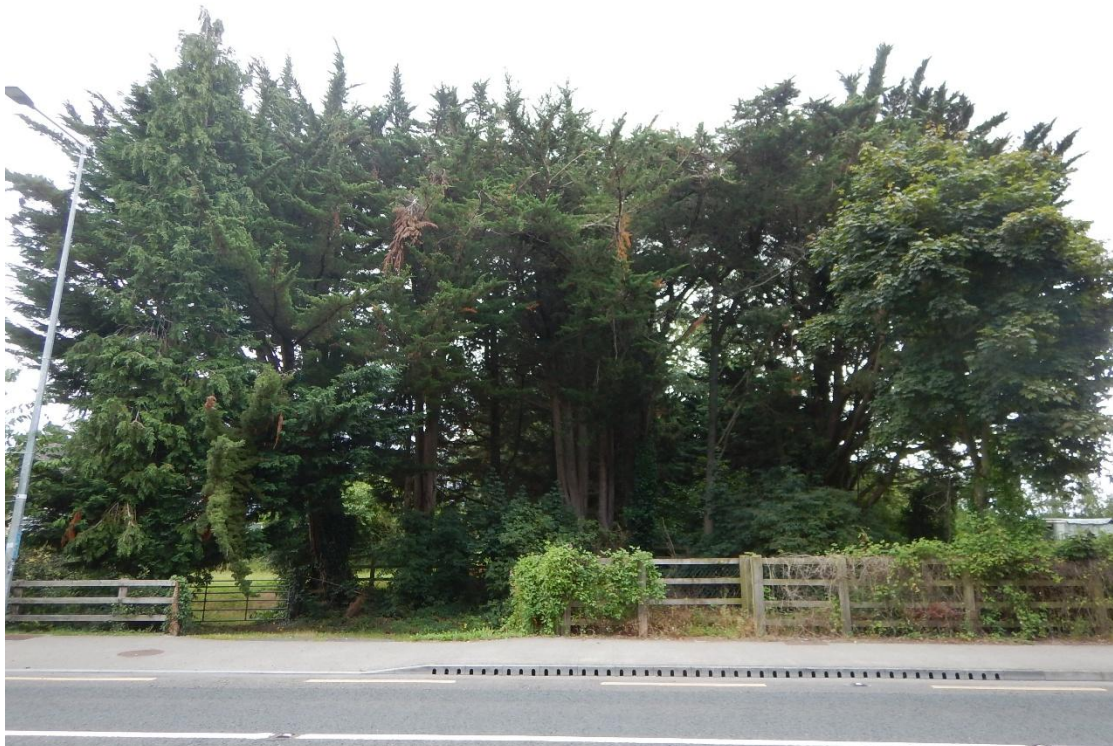
Photo 5. Cypress trees T5-T14 close to the east side of Kilkenny Road

| Type | No. | Species | Age | Ht (Cr)<br>m | Dbh<br>mm | St | N | S | E | W | ERC | Phys Cond | Structural Condition/Comments | Preliminary Recommendations | RPA<br>m | Cat |
|---|---|---|---|---|---|---|---|---|---|---|---|---|---|---|---|---|
| T | 5 | Cupressus macrocarpa (Monterey Cypress) | M | 18(5) | 1000 | 1 | 5 | 9 | 7 | 9 | 20+ | Fair | Fair. Medium sized tree. Minor dieback in crown. Storm damaged branches in crown. Recent storm damage. Not accessed. | Target prune broken/damaged branches. | 12 | B2 |
| T | 7 | Cupressus macrocarpa (Monterey Cypress) | M | 18(5) | 700 | 1 | 4 | 5 | 5 | 7 | 10+ | Fair | Fair/Poor. Medium sized tree. Stem divides above 1.5m. Recent storm damage. Previously topped. | Target prune broken/damaged branches. | 8.4 | C2 |

| Type | No. | Species | Age | Ht (Cr)<br>m | Dbh<br>mm | St | N | S | E | W | ERC | Phys Cond | Structural Condition/Comments | Preliminary Recommendations | RPA<br>m | Cat |
|---|---|---|---|---|---|---|---|---|---|---|---|---|---|---|---|---|
| T | 8 | Cupressus macrocarpa (Monterey Cypress) | EM | 15(5) | 450 | 1 | 4 | 2 | 2 | 5 | 10+ | Fair | Fair/Poor. Asymmetric form due to group competition. Storm damaged branches in crown. Previously topped. | Target prune broken/damaged branches. | 5.4 | C2 |
| T | 10 | Cupressus macrocarpa (Monterey Cypress) | M | 18(4.5) | 750 | 1 | 4 | 5 | 6 | 7.5 | 10+ | Fair | Fair. Minor dieback in crown. Storm damaged branches in crown. Previously topped. | Target prune broken/damaged branches. | 9 | C2 |

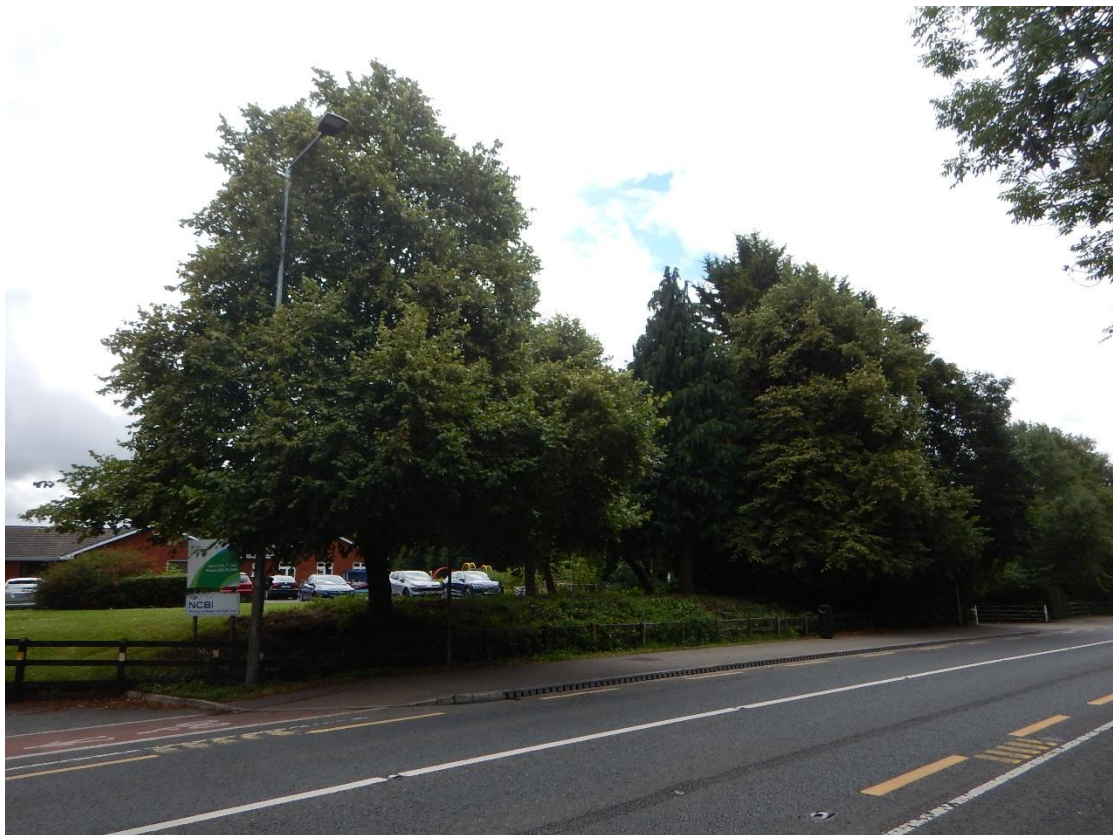
Photo 6. Trees T22-T25 and group G13 in the verge of the Irish Wheelchair Association premises on Kilkenny Road

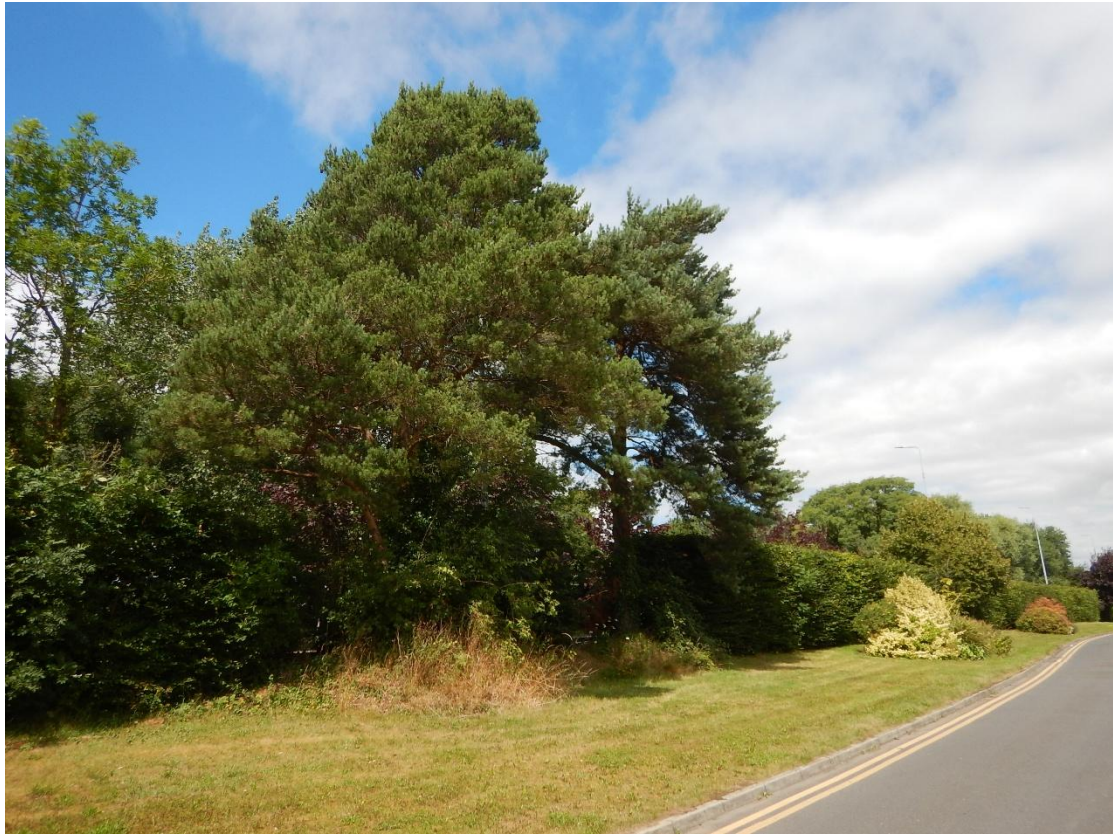
*Photo 7. Trees T30-31 in the landscape border of the Southern Gardens estate*

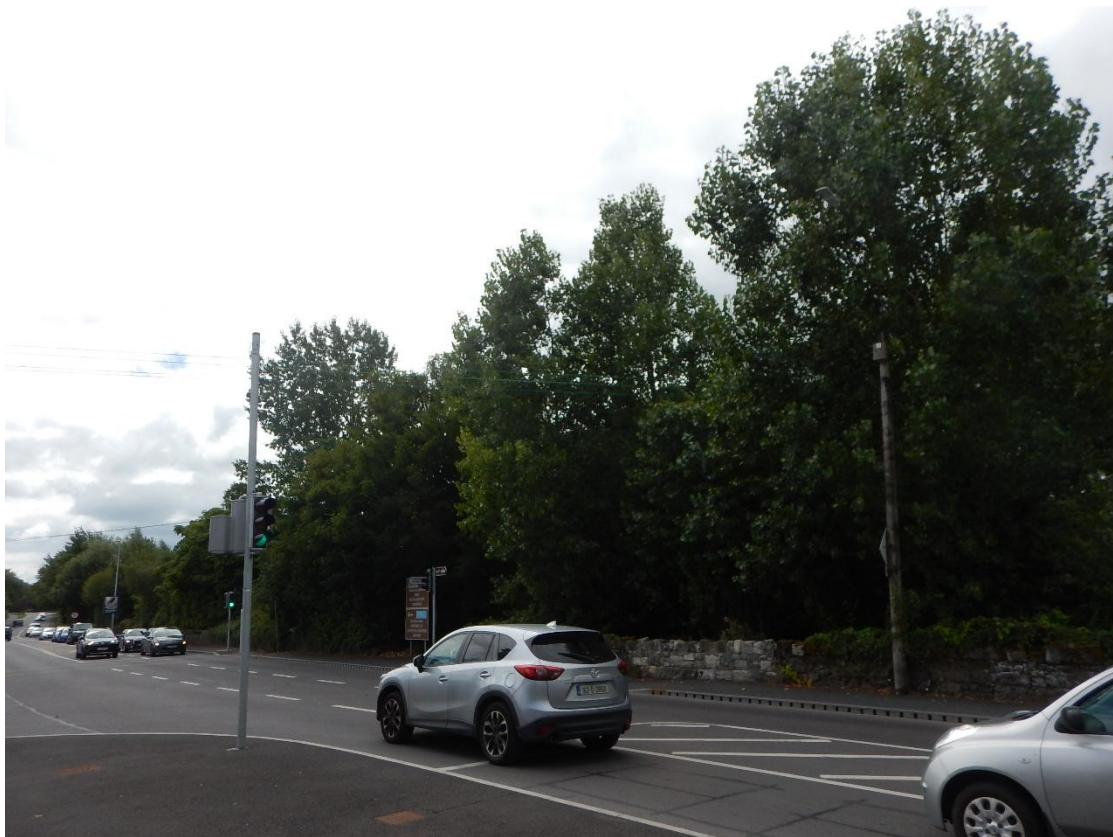
The woodland between Kilkenny Road and the River barrow extends along the western side of the survey area, from the Kilkenny Road pumping station in the north to the private dwellings in the south. Some of the larger mature Willows and Poplars are of moderate (or even high) arboricultural value, although there has been some storm damage and windthrow through the area. The woodland has been described as three separate areas (W1, W2 and W3) for the purposes of this survey, however, these areas all merge into the one greater wooded area. Woodland W1 refers to the area south of Kilkenny Road pumping station, W2 includes the low-lying riparian woodland towards the southern end of the woodland, and W3 is the scrub woodland covering

*Photo 8. Trees making up the edge of woodland W1 along Kilkenny Road*

The larger trees (Poplar and Ash) in the woodland (W1 and W2) along the roadside should be reviewed to check their structural condition. All Ash trees should be monitored to check the level of crown dieback from Ash Dieback disease.

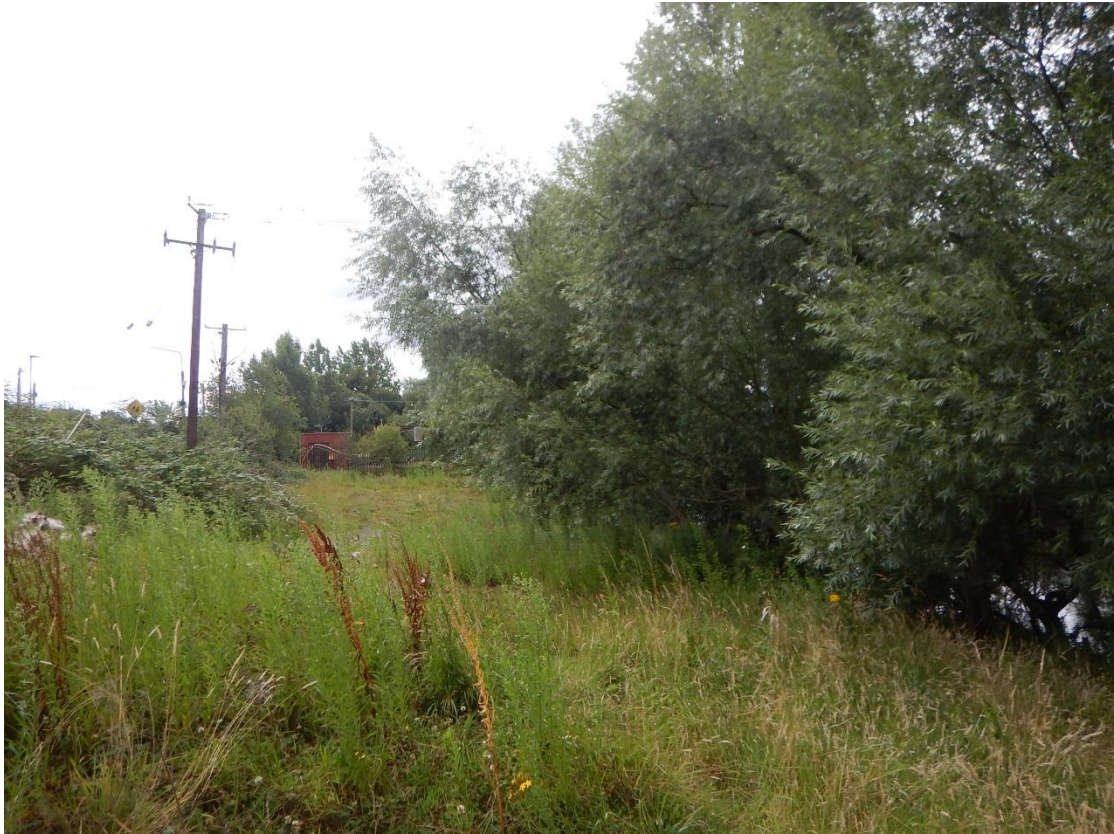
*Photo 9. Willow trees (group G21) growing along the bank of the River Barrow north of the pumping station*

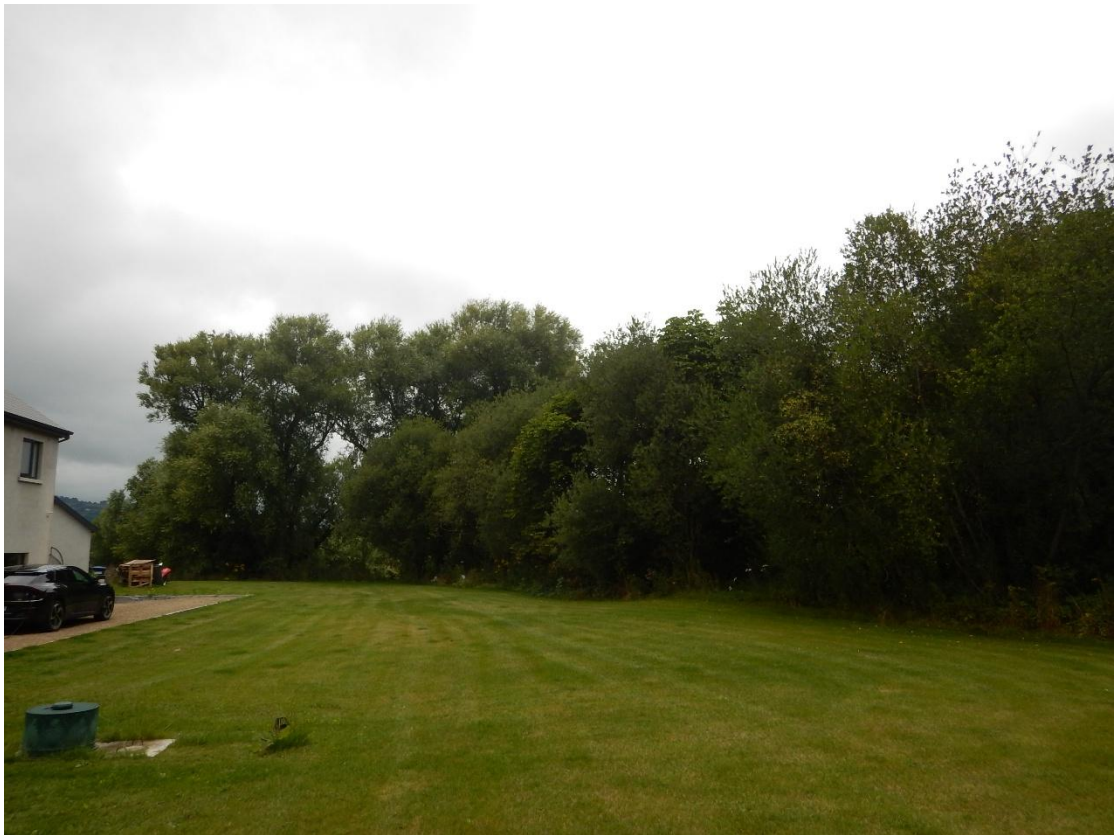
*Photo 10. Scrub woodland (W3) at the southern edge of the main woodland block, where it borders the private houses*
