# ASBESTOS REFURBISHMENT SURVEY REPORT

Carlow WWTP

Irish Water

| <b>Project Title</b> | 24535 Carlow WWTP Asbestos Survey |

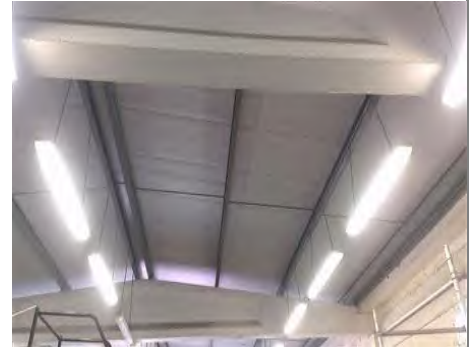
Building/Area : Sludge Dewatering  
Room/Section : Internal Areas  
Location : Roof  
Description : Lining and Insulation  
Sample No. : DKB20180626008  
Confirmation : Sample Taken  
Access : Full Access  
Normal Use : Plant Area  
Recommendations :

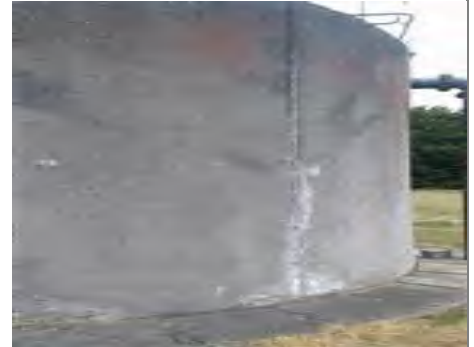
Building/Area : PFT 1 and 2  
Room/Section : External Areas  
Location : Expansion Joints  
Description : Mastic  
Sample No. : DKB20180626009  
Confirmation : Sample Taken  
Access : Full Access  
Normal Use : External  
Recommendations :

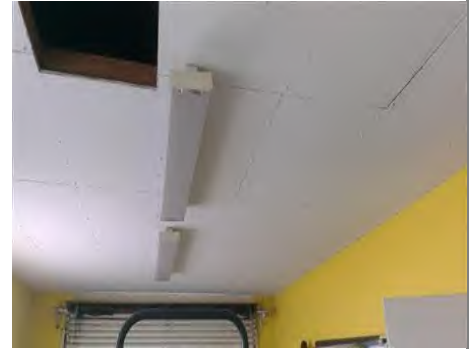
Building/Area : Administration Building  
Room/Section : Workshop  
Location : Ceiling  
Description : Ceiling Panels  
Sample No. : DKB20180626004  
Confirmation : Sample Taken  
Access : Full Access  
Normal Use : Office type use  
Recommendations :  
;
