# Crumhach Wind Farm, Co. Sligo

Stage 1 Road Safety Audit

Alan Lipscombe Traffic and Transport Consultants

August 2026

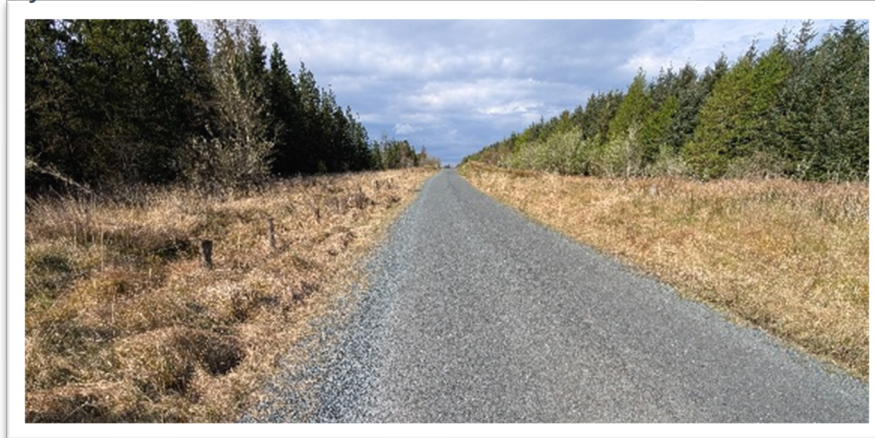
**Figure 2.1 – Image of Site Access A – Local Road L6309 Record Purposes Only**

No road safety issues were identified for this access.

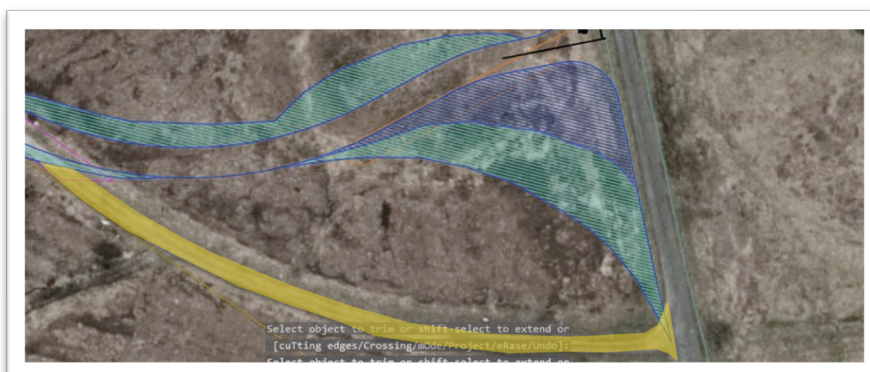
**Figure 2.2 – Location Where Passing Motorists Could Access the Redundant Access Track**

The existing section of access track (made redundant by Site Access B) might create confusion for drivers who could enter it by mistake, leading to sudden braking, loss of control or conflicts with construction traffic.

The section of redundant access track should be removed.

| Problem Reference<br>(Section 2) | Designer Response Section | | | Audit Team Response Section |
|---|---|---|---|---|
| 2.2 | Yes | No | It is proposed that the existing access will be retained for local access only and managed during the construction phase. It is proposed that both accesses are gated with the opening of each access managed on site during the construction phase. On the completion of construction the over-run areas will be closed off permanently. Appropriate signage will be put in place at both the existing and proposed new access tracks to clearly distinguish the existing access for local landowners from construction and operational access to the Proposed Wind Farm. | Yes |

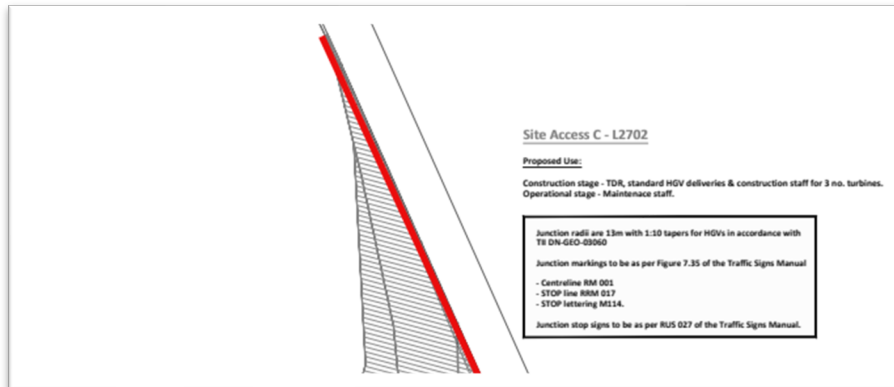
Figure 2.3 – Location Where Passing Motorists Could Access the Overrun Area (When Not in Use)

The temporary over-run area might create confusion for passing motorists, who could access it by mistake, leading to sudden braking, loss of control or conflicts with construction traffic.

The Designer should ensure that a suitable barrier is put in place to prevent passing motorists from accessing the abnormal load overrun area when it is not in use.

| Problem Reference<br>(Section 2) | Designer Response Section | | | Audit Team Response Section |
|---|---|---|---|---|
| 2.3 | Yes | Yes | A suitable barrier will be put in place at all times during the construction stage and opened only on the nights that the abnormal loads are delivered. On these occasions the deliveries will be accompanied by a Garda escort and the opened junction will be attended by site staff. On the completion of construction the over-run areas will be closed off permanently. | Comment noted |

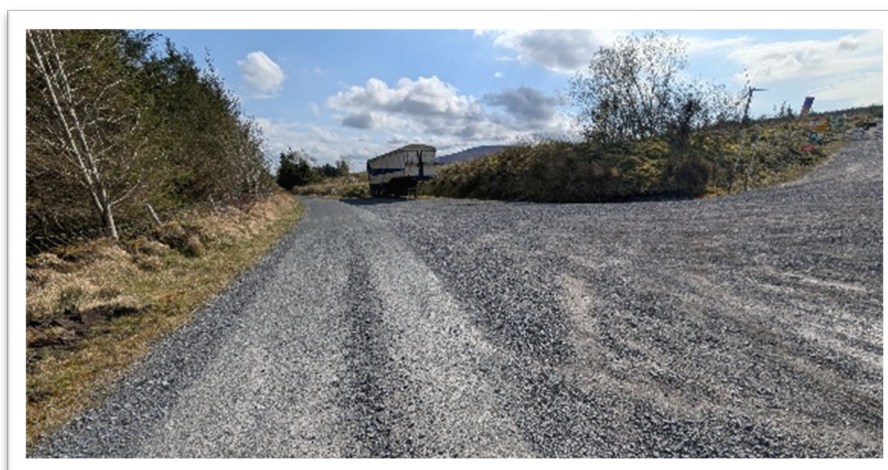
Figure 2.4 – Image of Access D, L6309 Access for Record Purposes Only

No road safety issues were identified for this access.

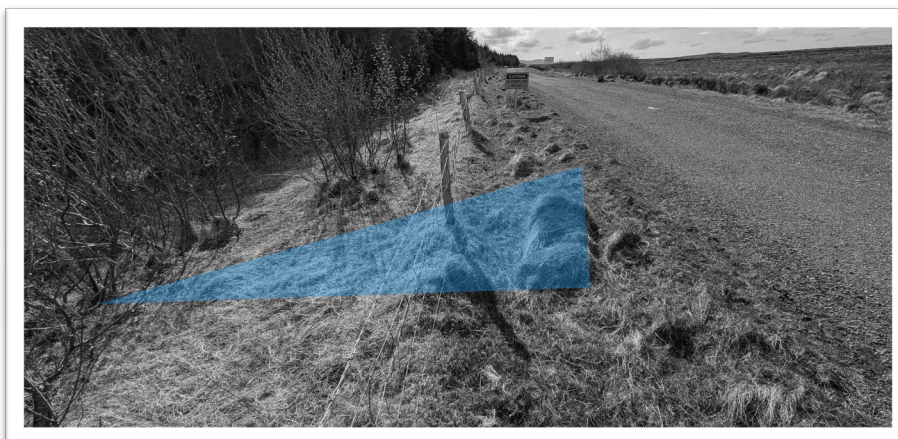
**Figure 2.5 – Steep Approach Gradient Where Site Access E Connects to the L6309**

There is a noticeable level difference between the existing L6309 and the location of the proposed access road. A steep access road in this location could result in vehicles rolling backwards down the incline or stalling as they attempt to join the local road.

The Designer should include a gentle gradient on the access road approach with a suitable dwell area where it meets the local road.

| Problem Reference<br>(Section 2) | Designer Response Section | | | Audit Team Response Section |
|---|---|---|---|---|
| 2.5 | Yes | Yes | The gradient for the substation access arm of the junction proposed on the L2702 will be raised to be in accordance with guidelines set out in Rural Road Link Design DN-GEO-03031, TII, June 2017, and will include a dwell area of a minimum of 15m which will have a gradient of a maximum of 2.5%. | Comment noted |
