# **Structural Condition Report**

## **Steeven's Lane 110kV Substation**

**The Electricity Supply Board (ESB)**

**July 2026**

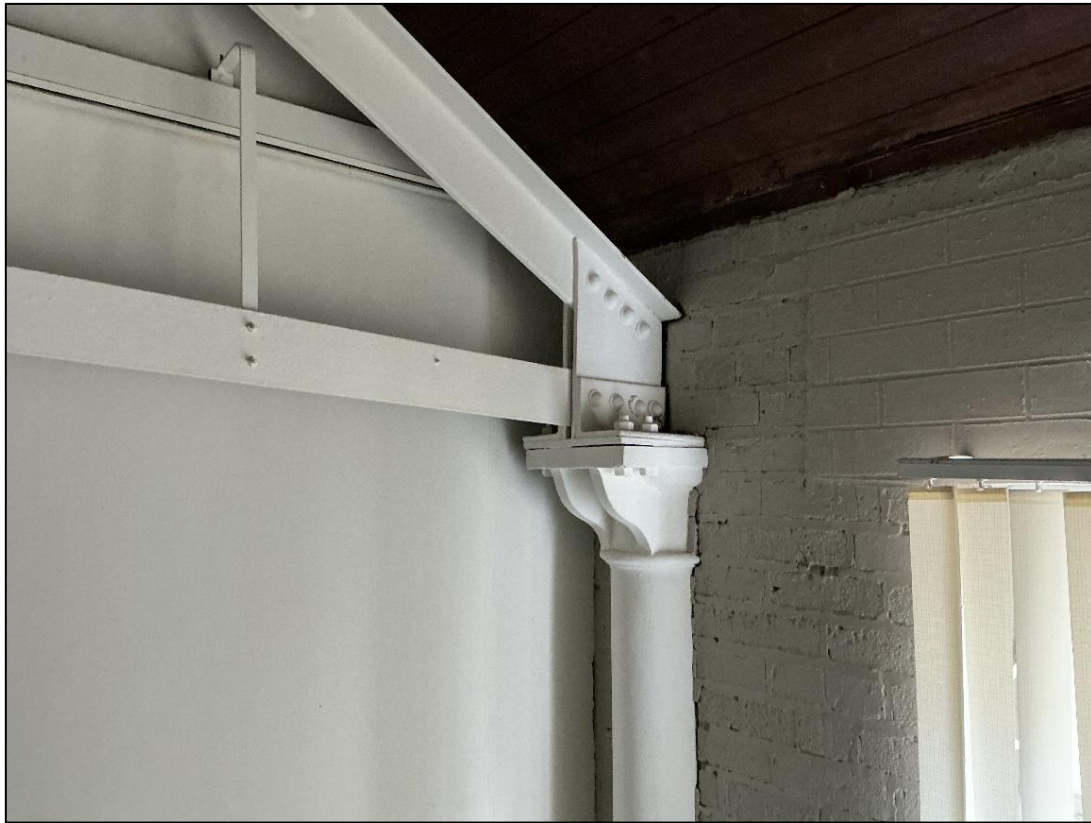
Figure 3: Existing Office Building Steel Roof Truss Connection Detail

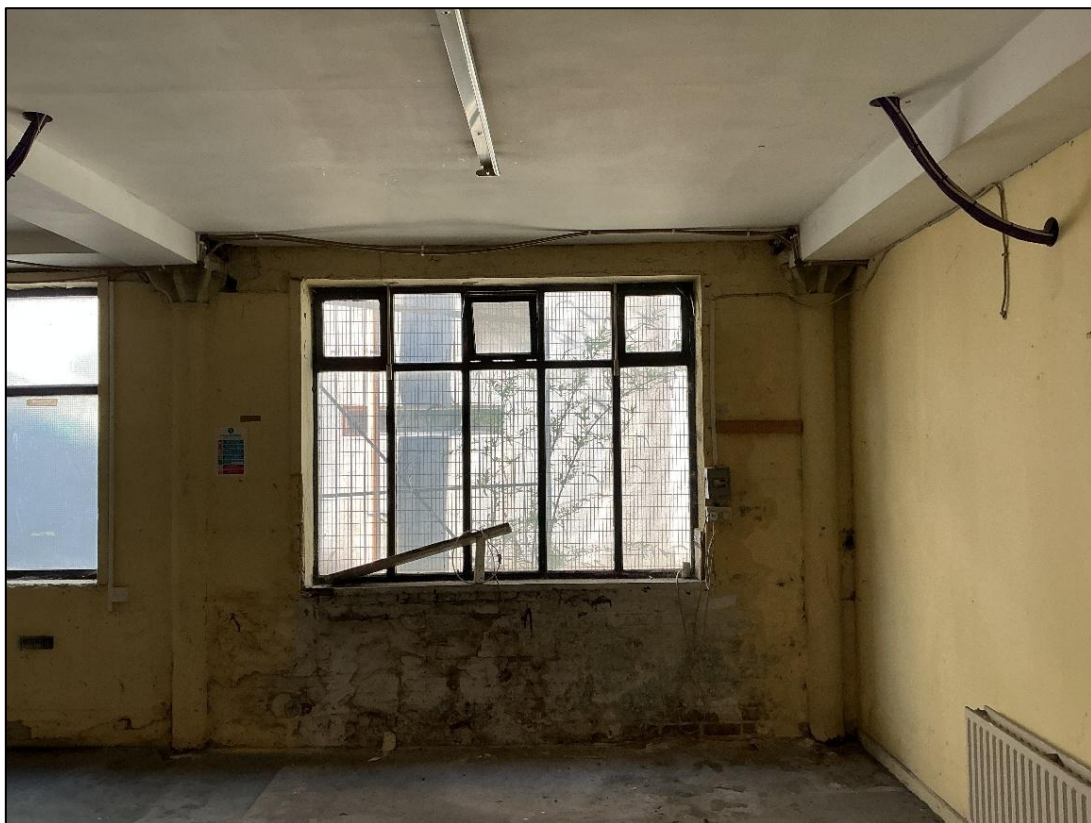
Figure 4: Existing Warehouse Building Deterioration of External Walls (northwest corner)

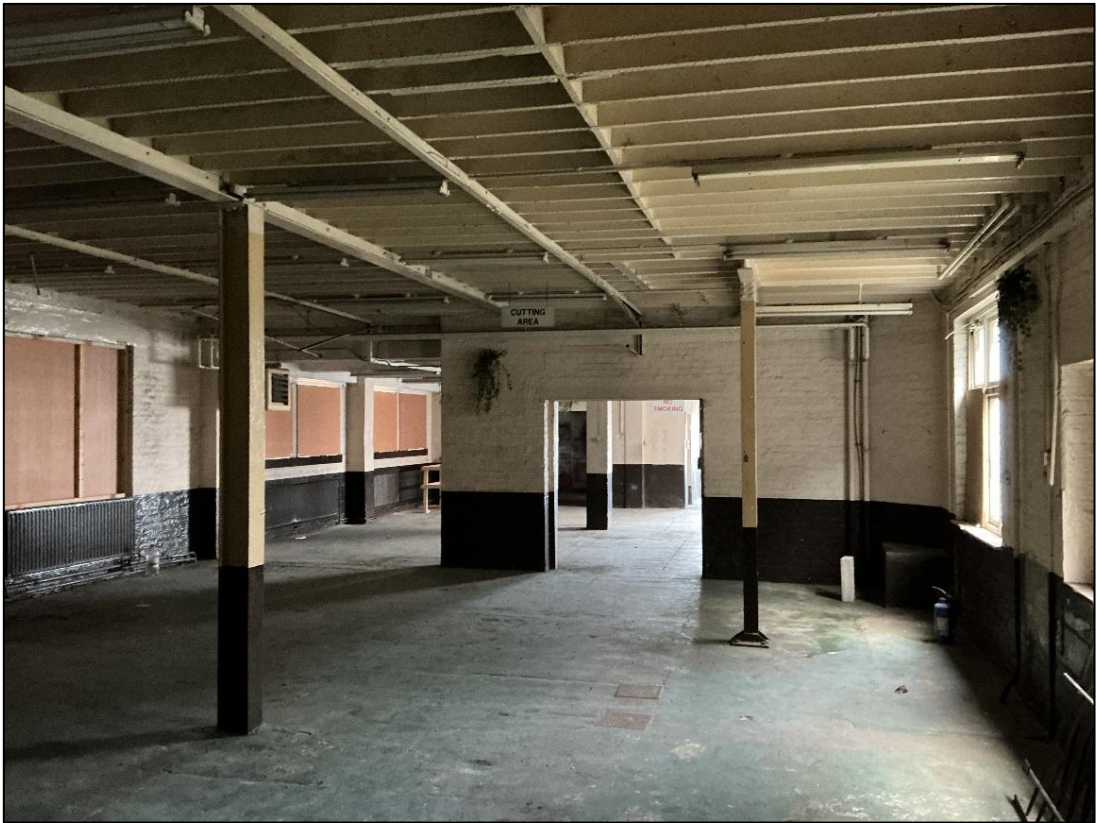
Figure 5: Existing Warehouse Ground Floor – General Internal Condition

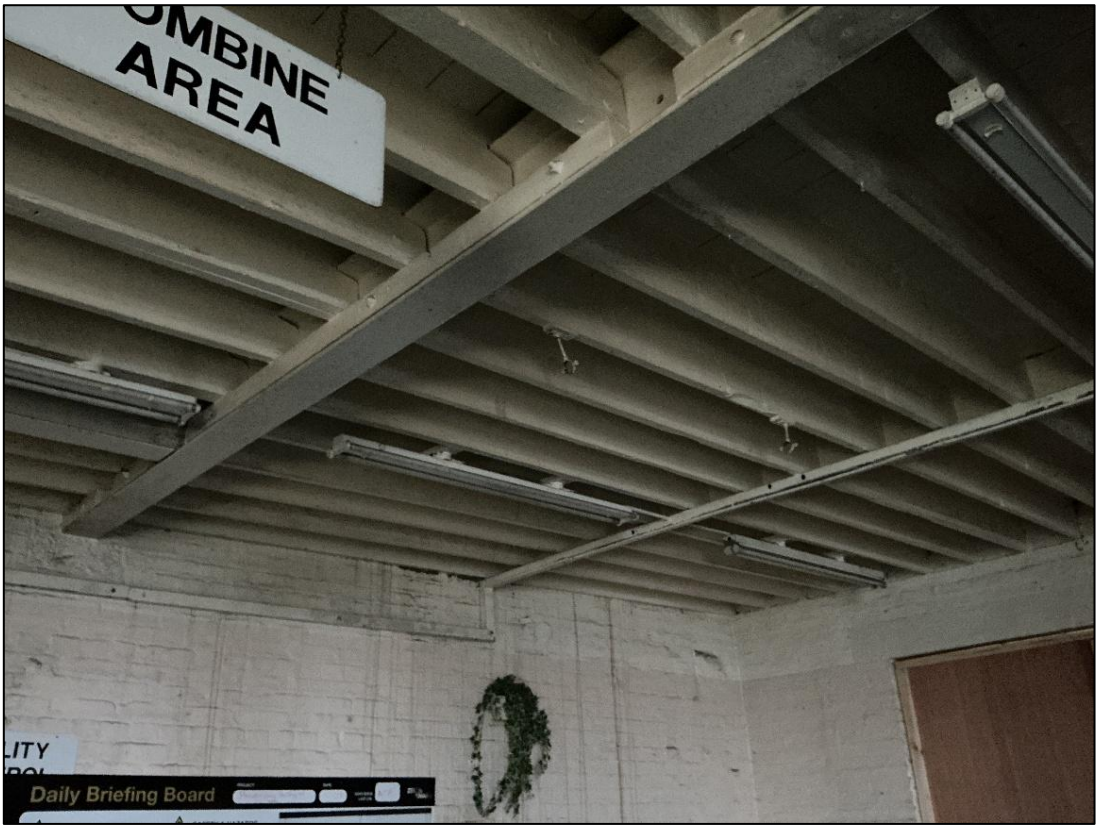
Figure 6: Existing Warehouse Ground Floor Interior Ceiling Framing

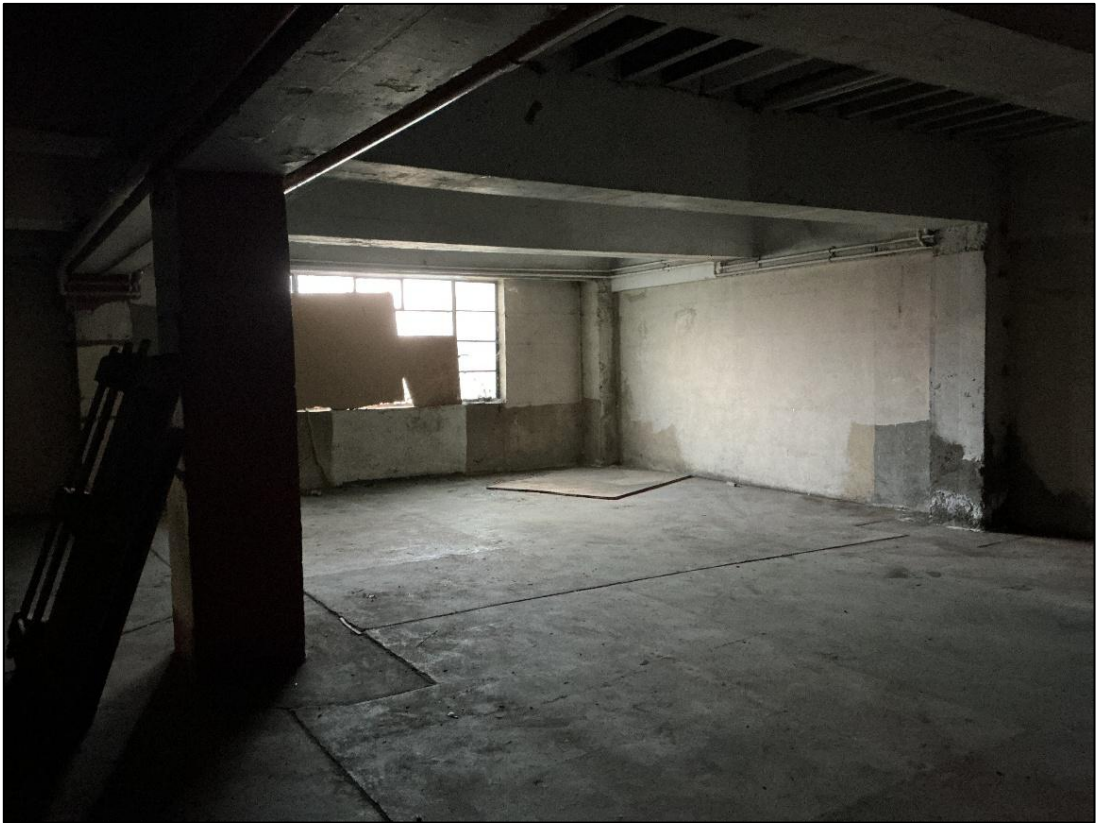
Figure 7: Existing Warehouse Basement – General Condition

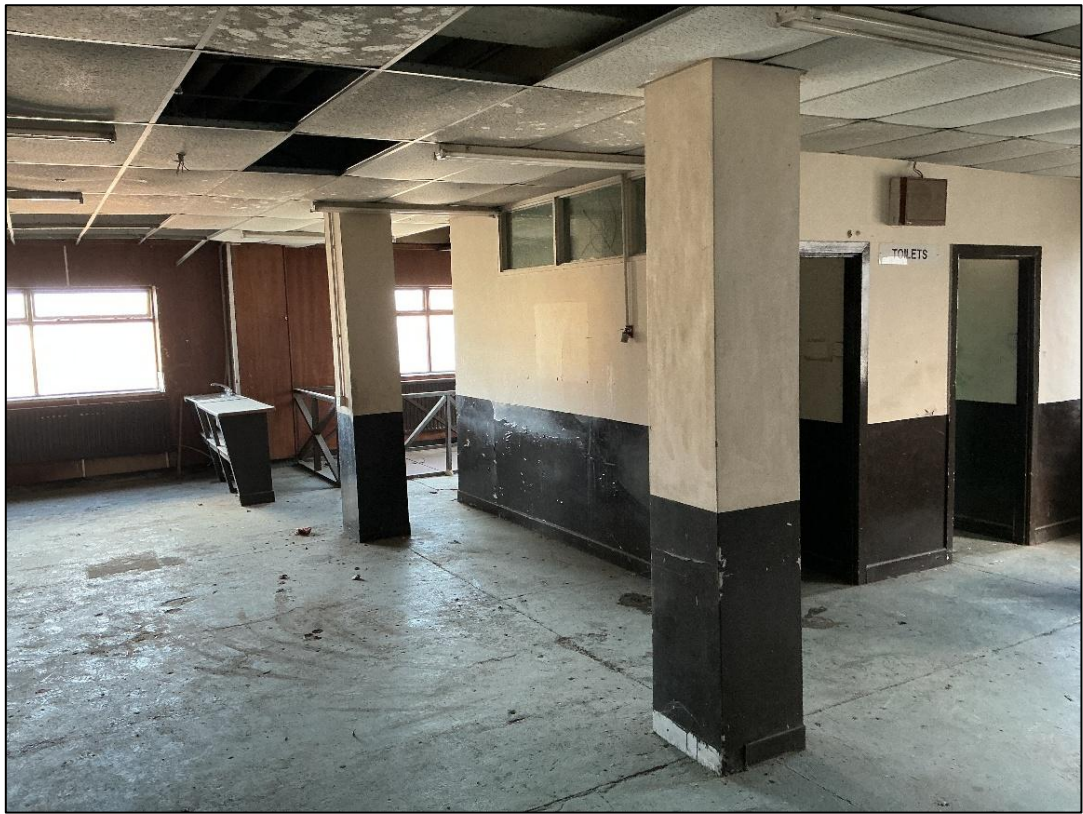
Figure 8: Existing Warehouse Upper Floor – General Condition

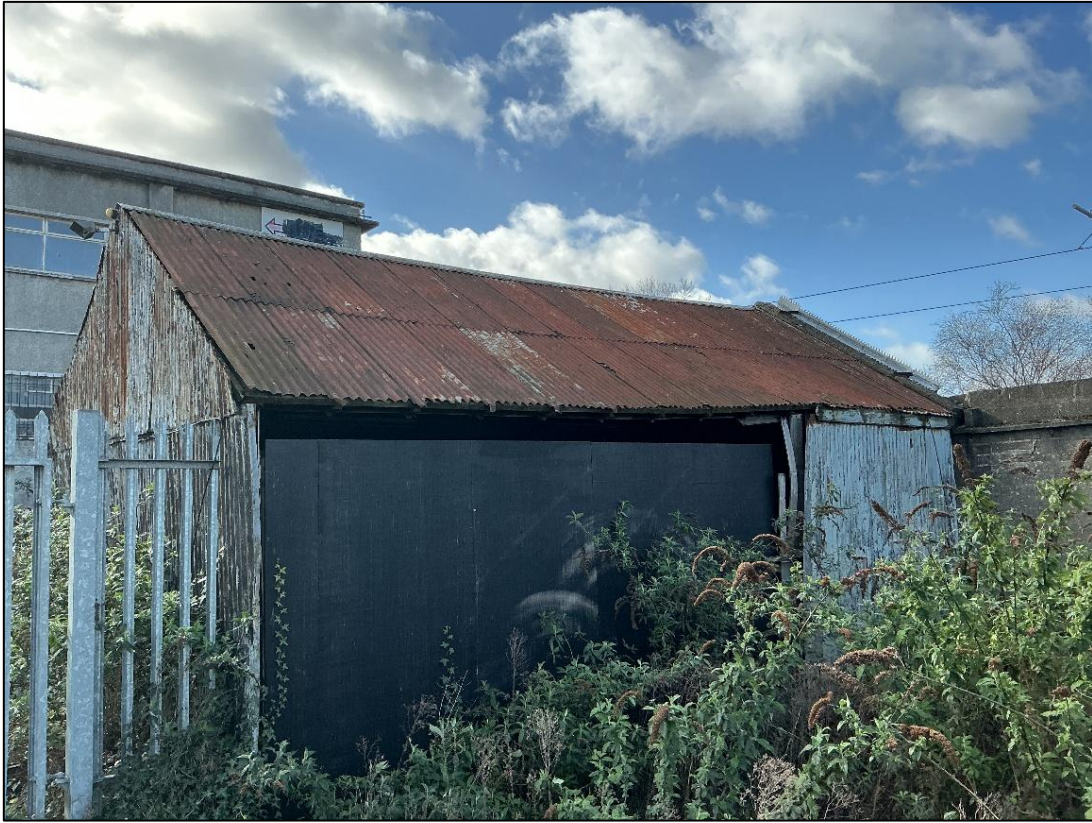
Figure 9: South External Façade of Existing Steel Shed

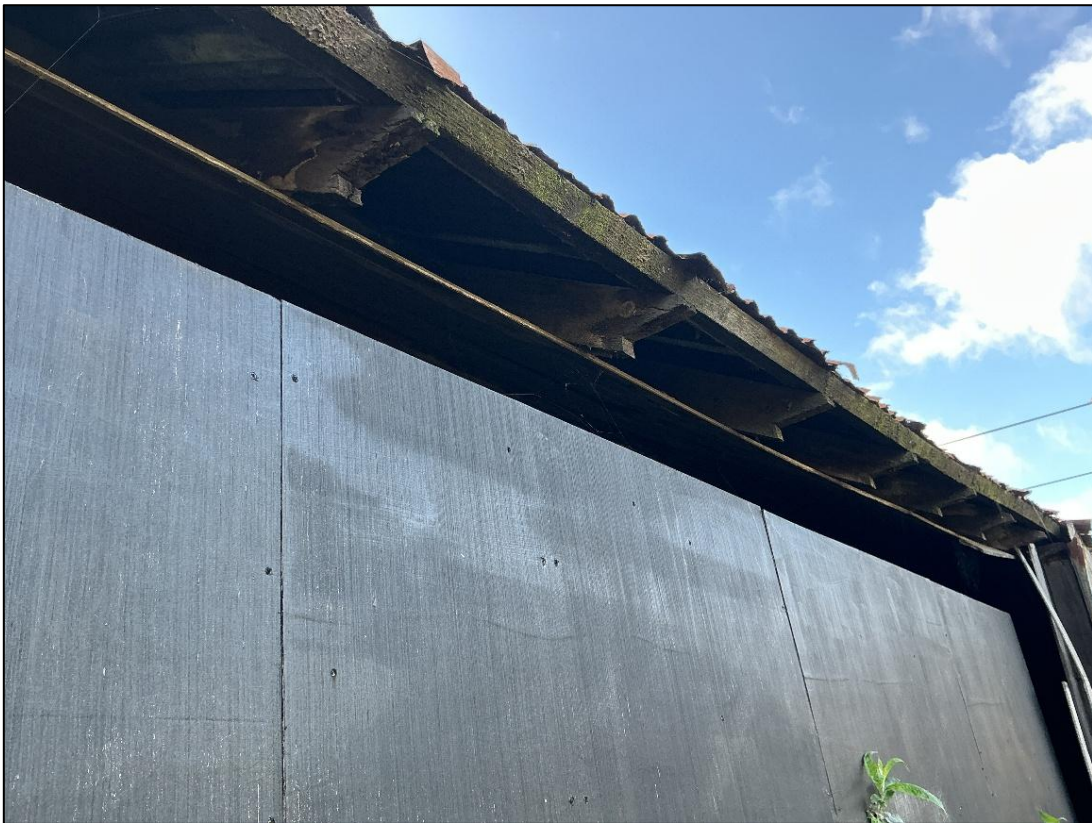
Figure 10: Roof Condition of Existing Steel Shed

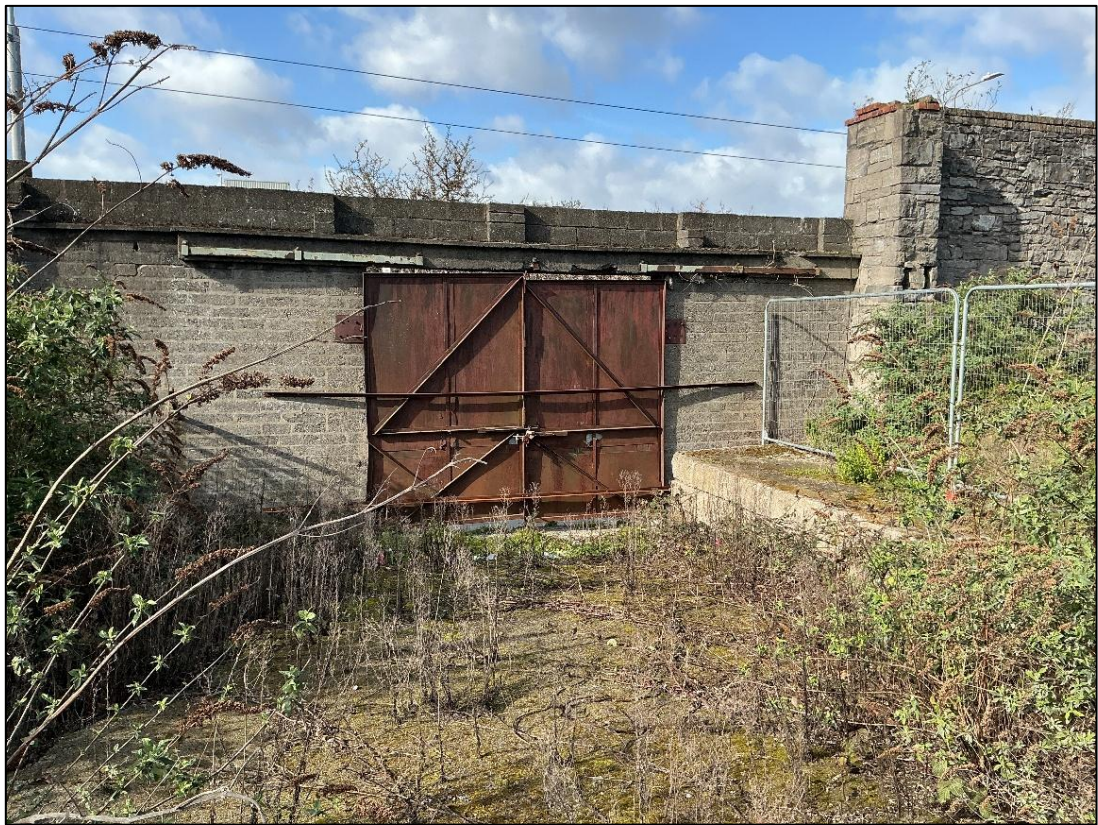
Figure 11: Northernmost Access Point to Steevens Lane – Looking West

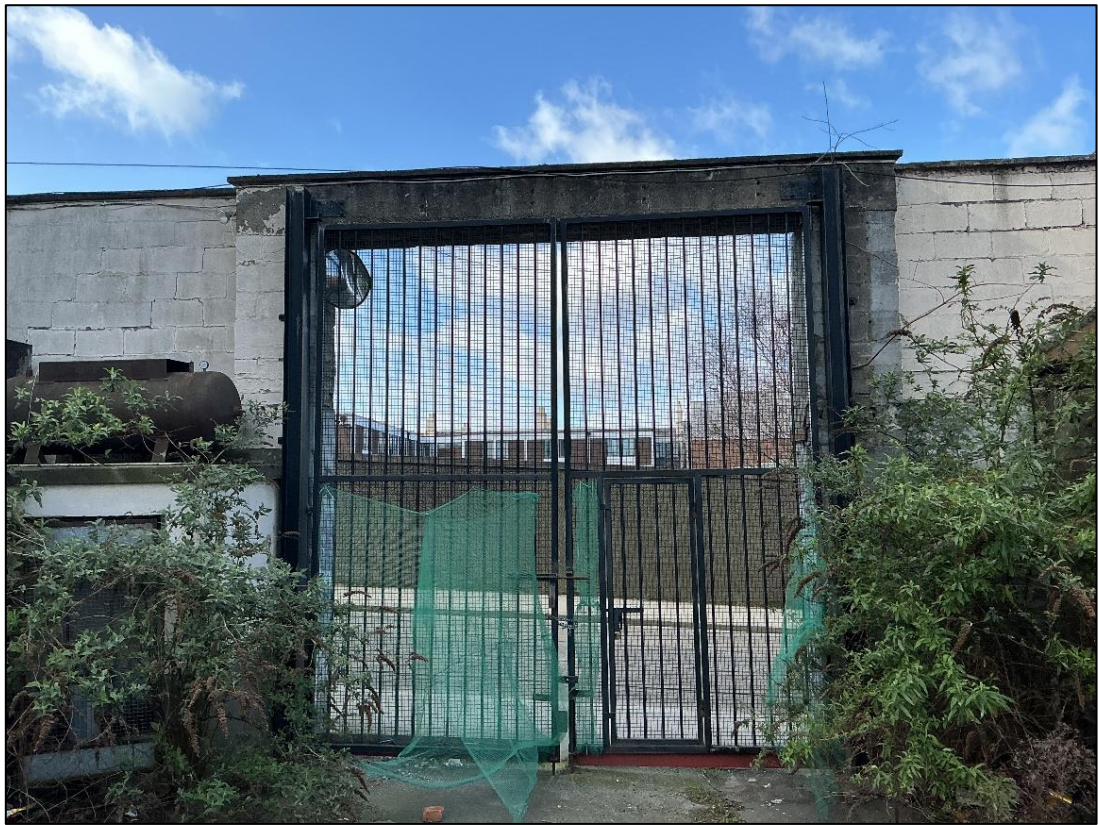
Figure 12: Steevens Lane Main Gate – Looking West

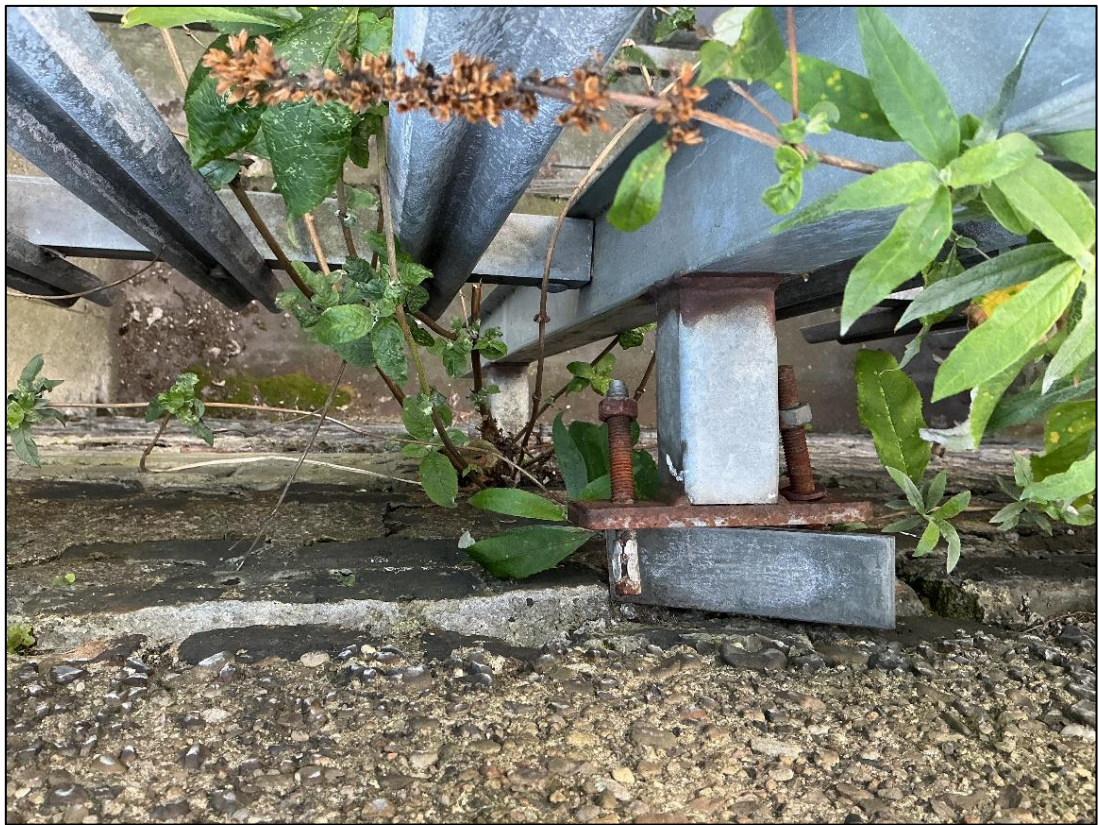
Figure 13: Steevens Lane Main Gate Structural Condition

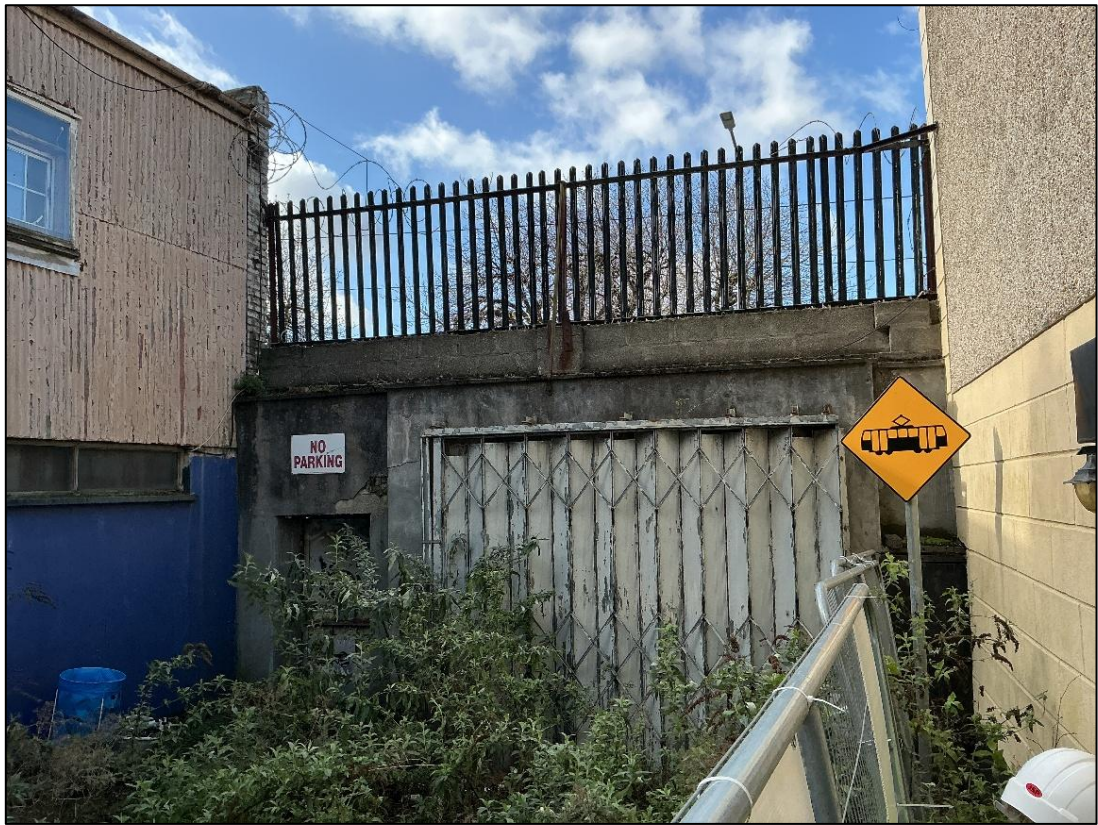
Figure 14: Southernmost Access Point to Steevens Lane (Looking West) and existing RoW

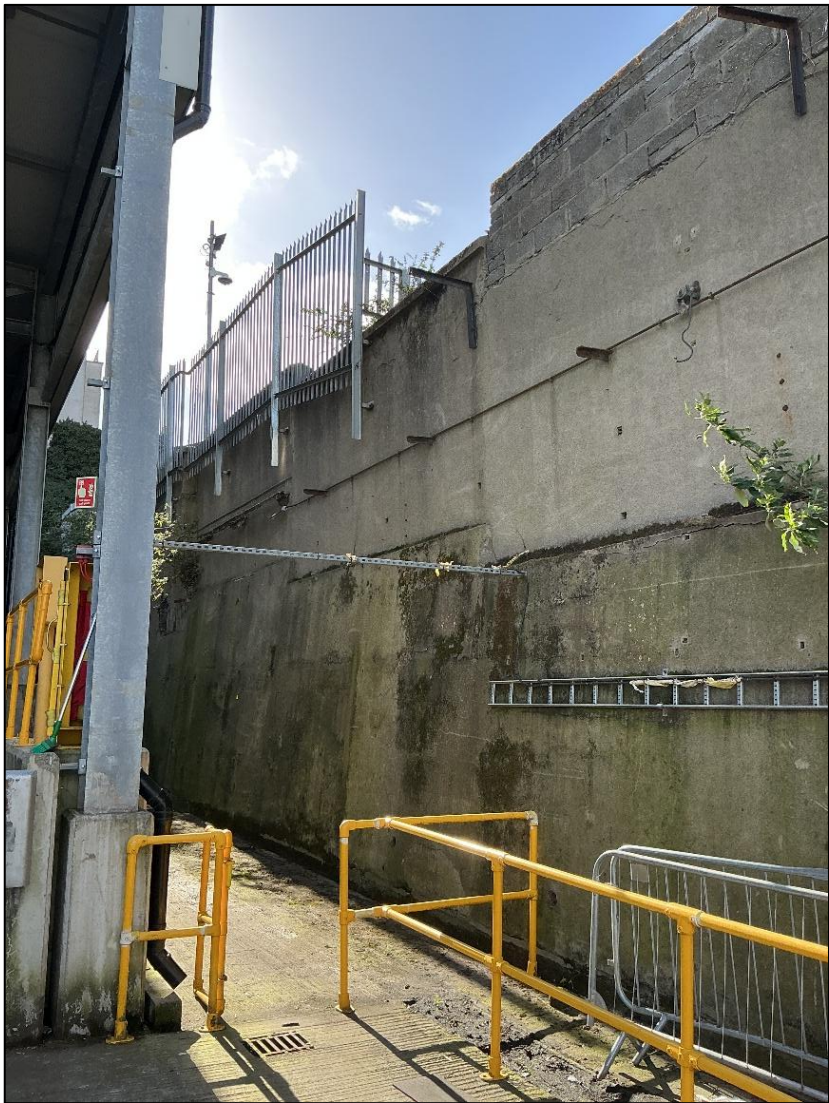
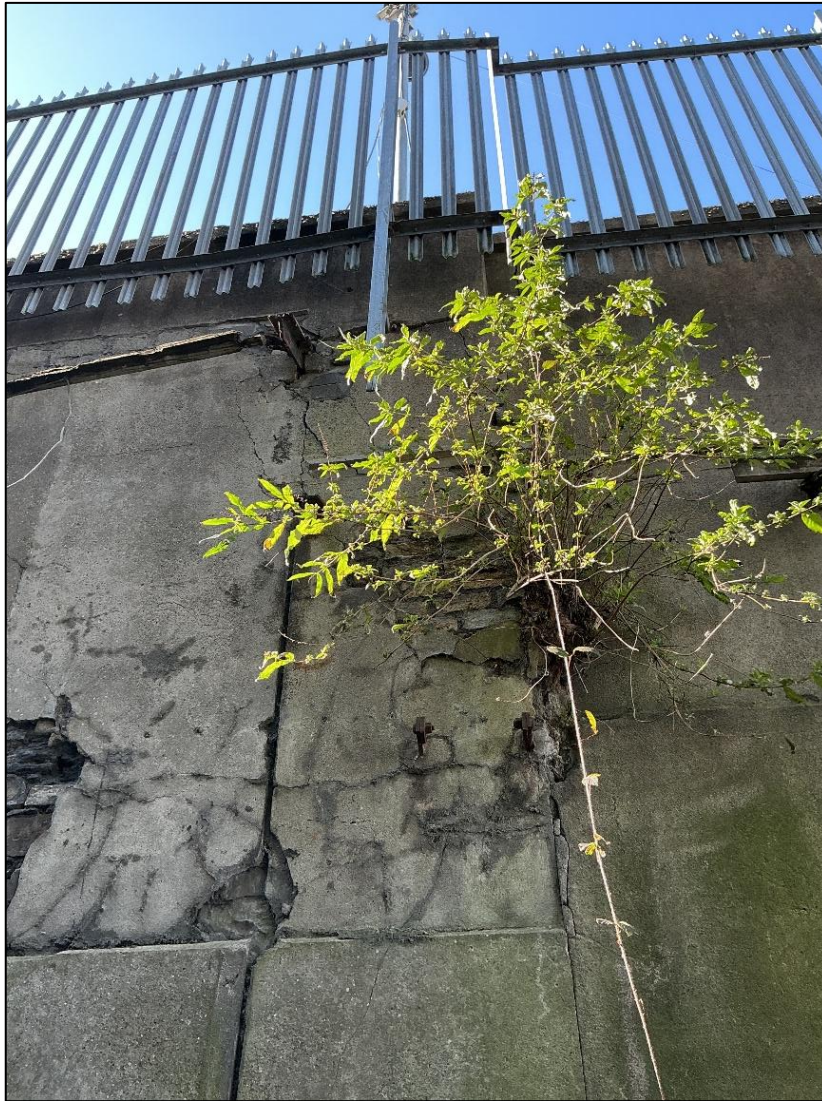
The eastern boundary is formed by a masonry retaining wall with a stone capping course. The wall is rendered; however, large sections of the render have detached, exposing the underlying masonry. A galvanised palisade fence has been fixed to the crest of the wall to increase its effective height, though the fence connections have failed at numerous locations.

Cracking and general deterioration are visible along the length of the eastern retaining wall. The construction type and foundation details are unknown. Given the current condition of this wall, it is advised that no additional surcharge loading be applied to the adjacent ground. A new retaining structure should be provided to accommodate the anticipated surcharge loads associated with the substation development.

Figure 15: Existing Retaining Wall – Eastern Boundary

Figure 16: Existing Retaining Wall – Eastern Boundary (zoomed in structural condition)

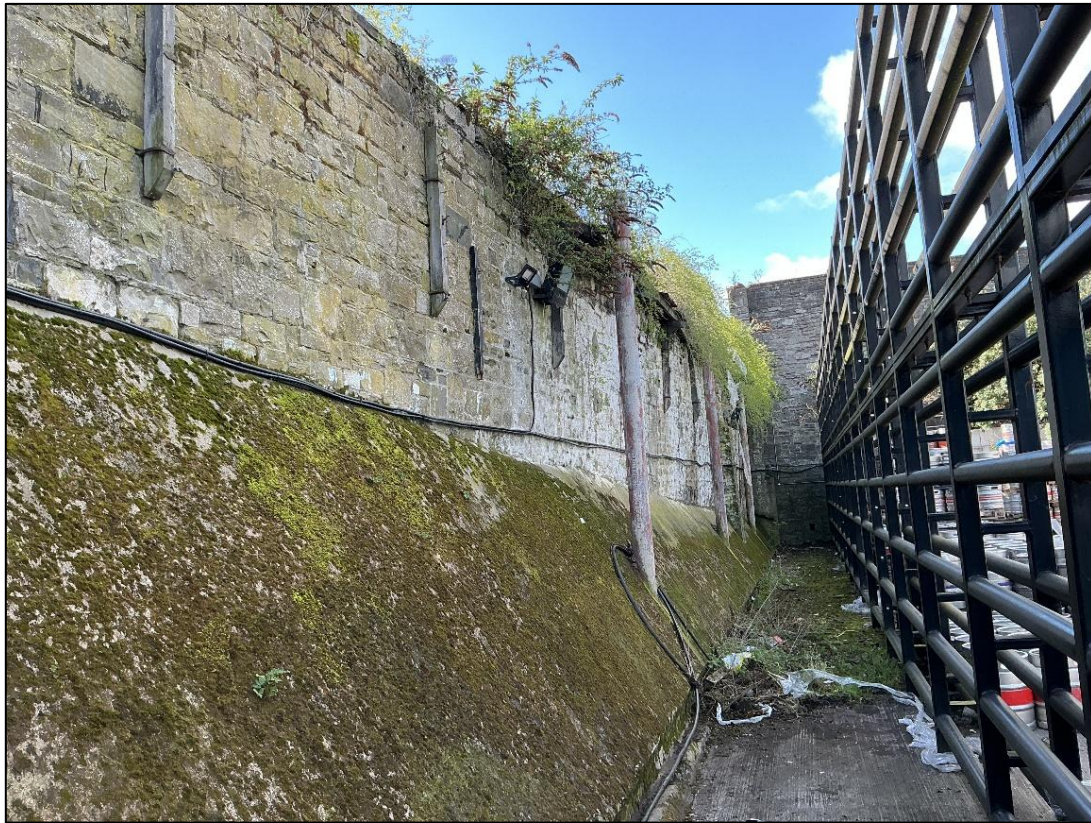
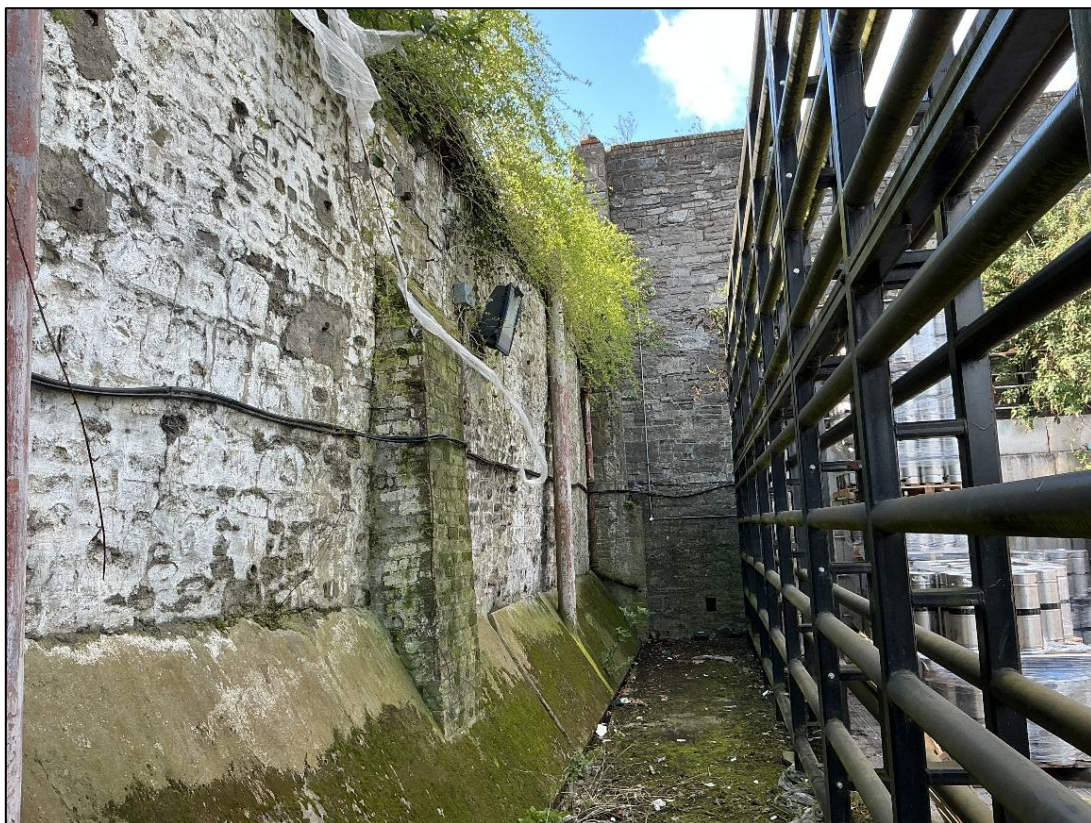
Along the northern boundary, adjacent to the keg storage yard, the retaining wall appears to be constructed from stone masonry and retains an approximate height of 5 m. A sloped concrete buttress is present at the base of the northern face; this feature does not appear to form part of the original construction and is likely associated with subsequent remedial or stabilisation works.

The northern retaining wall exhibits significant outward movement, with noticeable bulging along its length. General deterioration, including vegetation growth within the wall fabric, is also evident. Based on its current condition, the wall does not appear to have adequate capacity to sustain any future surcharge loading. It is therefore recommended that this retaining wall be demolished and replaced with a new structure designed to meet the requirements of the proposed substation layout.

Figure 17: Existing Retaining Wall – Northern Boundary

Figure 18: Existing Retaining Wall – Northern Boundary (zoomed in structural condition)

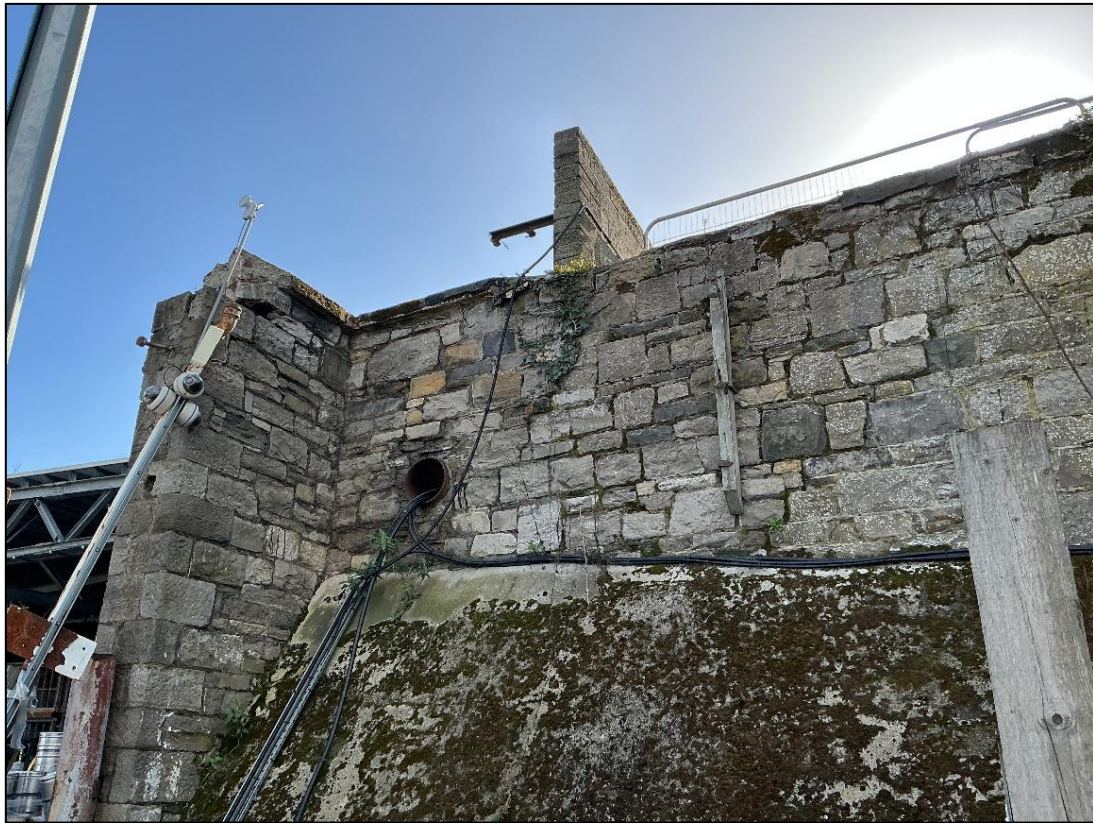
Figure 19: Retaining Walls at Intersection Point

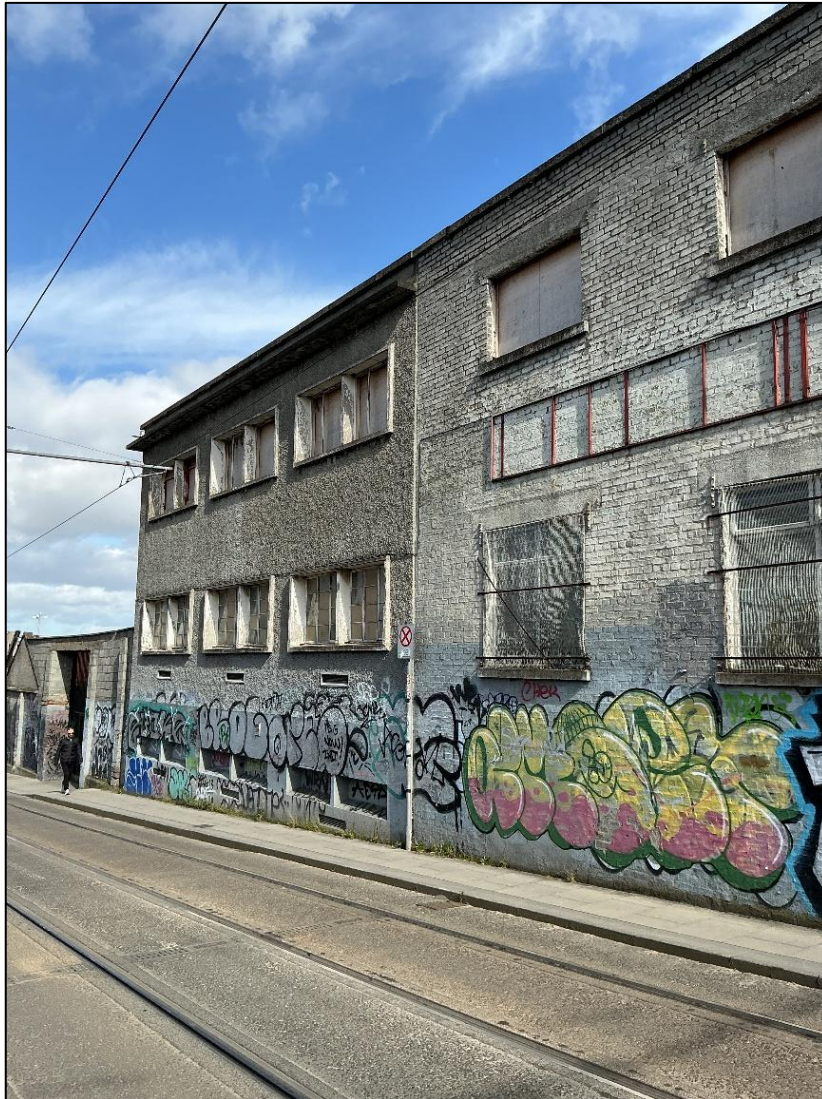
Figure 20: Western External Façade of Existing Building and Boundary Wall to Steevens Lane

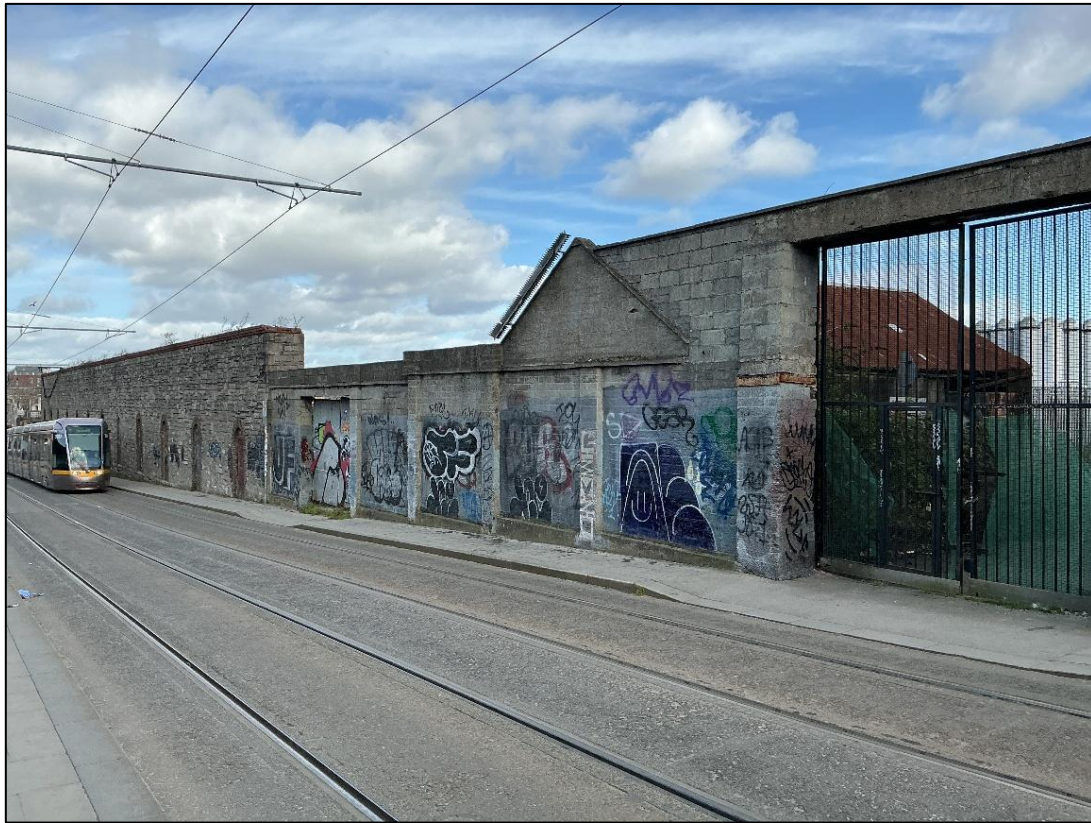
The western boundary of the site, along Steeven's Lane, is defined by a masonry block wall containing several openings that provide access to the lane. This wall is understood to be scheduled for demolition as part of the proposed substation development.

Figure 21: Boundary Wall to Steevens Lane – looking east

The wall is located in close proximity to the LUAS line. Accordingly, demolition works will need to be carefully planned and executed to ensure that no adverse impact occurs to LUAS infrastructure or operations. Appropriate coordination with the relevant transport authorities, along with suitable protective measures and controlled demolition sequencing, will be required to avoid disruption and maintain the integrity of the adjacent rail line.
