## **Stage 1 Road Safety Audit**

**Proposed Kellystown Wind Farm, Co Louth**

**On behalf of EDF Renewables Ireland Ltd.**

**August 2025**

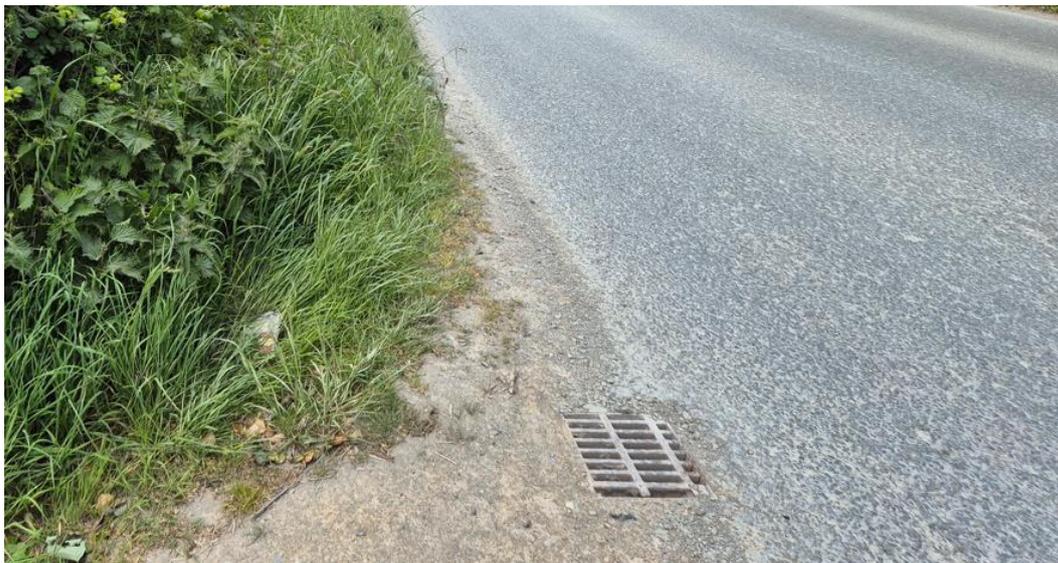
##### 3.3.1.2 Public Road Drainage

**Problem:** There is a drainage gully located within the mouth of the proposed junction. Slewing of heavy vehicles may dislodge the gully grating or frame.

**Hazard:** Public road traffic may hit the dislodged grating or open gully pot and lose vehicle control.

**Recommendation:** The Design Team should relocate the gully outside of the mouth of the junction. The Design Team should also ensure the works do not result in ponding occurring thin this area.

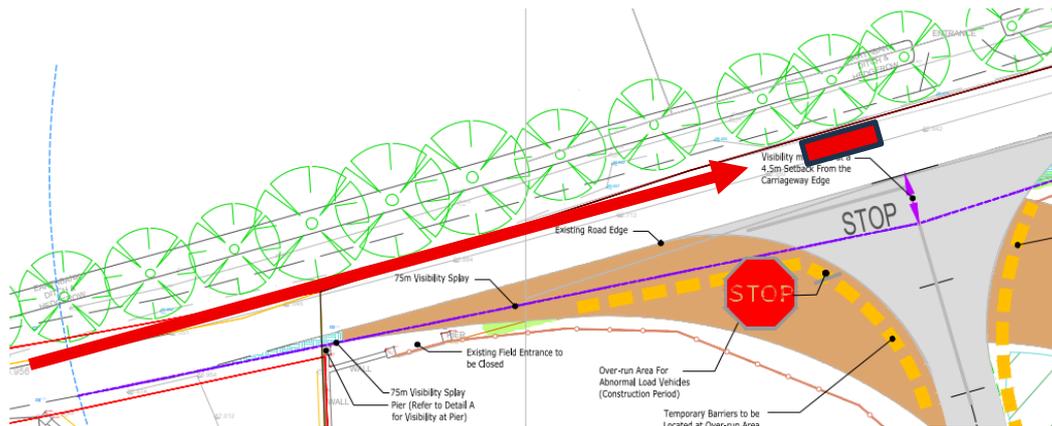
#### 3.3.2.1 Forward Visibility

**Problem:** The proposed junction is located to the north-east of the left-hand bend and dip on the public road. There is concern that maintenance vehicles waiting to turn right off of the public road into the development may be hidden from view of following traffic by roadside vegetation and possible the vertical alignment.

**Hazard:** Rear end shunts may result.

**Recommendation:** The Design Team should ensure suitable forward visibility is provided to users waiting in the public road.

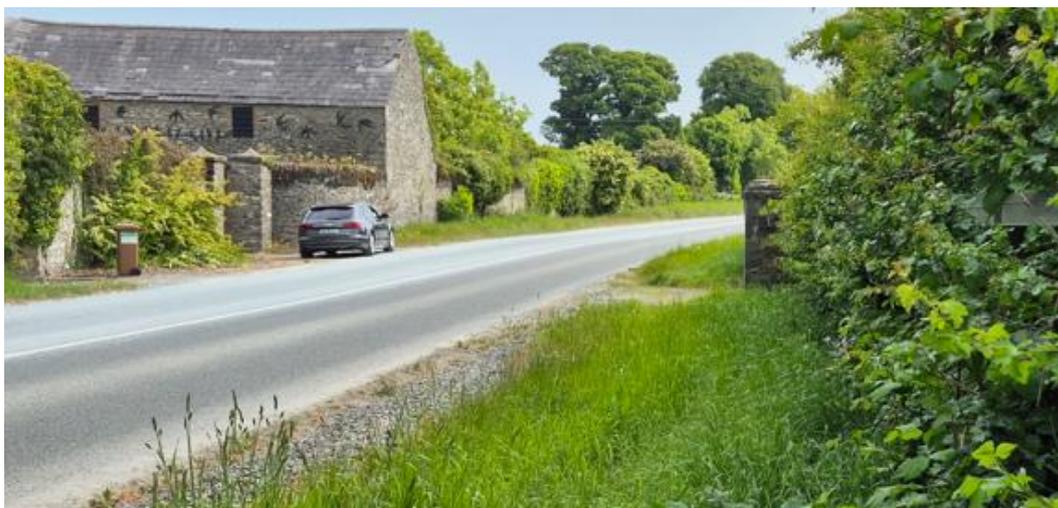
#### 3.3.2.2 Junction Visibility

**Problem:** The drawings indicate fencing to be set back to achieve junction visibility, however at this location there are masonry piers to both sides of the junction that also restrict visibility.

**Hazard:** Users may exit the development into the path of oncoming traffic.

**Recommendation:** The Design Team should remove or set back the masonry piers.

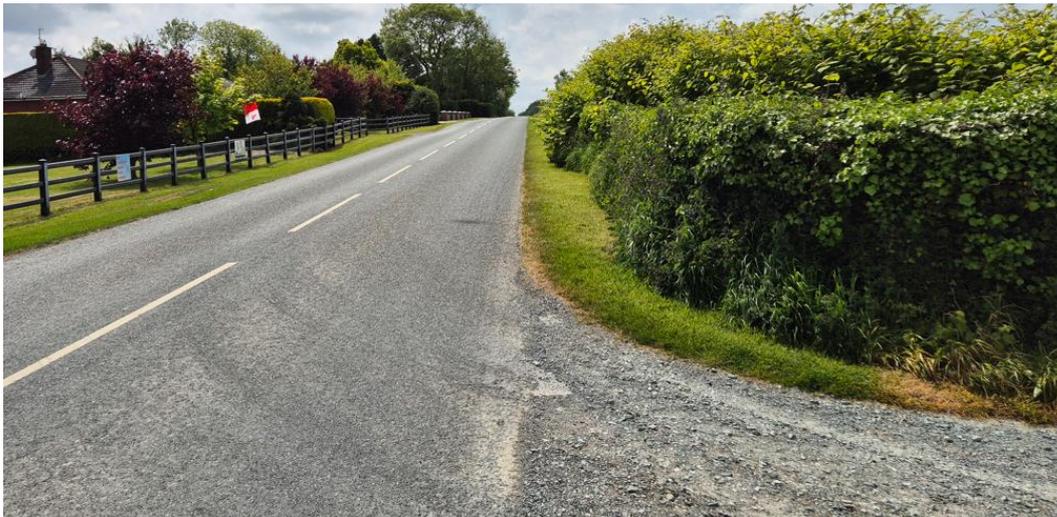
#### 3.3.4.1 Junction Visibility – Vertical

**Problem:** There is a crest of a hill to the right of the junction when exiting. There is concern visibility to approaching vehicles is restricted by the crest.

**Hazard:** Users may exit the development into the path of oncoming traffic.

**Recommendation:** The Design Team should ensure suitable vertical junction visibility is achieved.

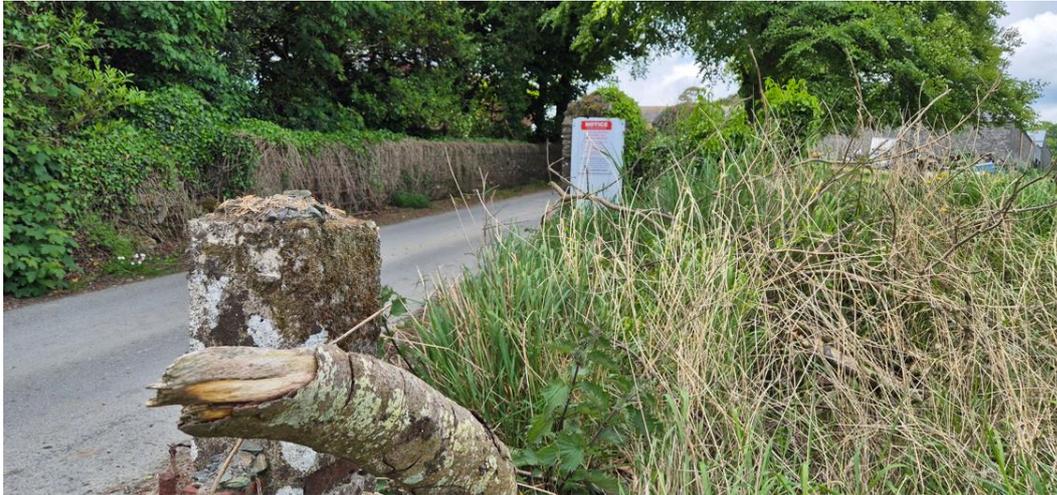
#### 3.3.5.1 Junction Visibility

**Problem:** Junction visibility to the right when exiting the access track appears to be restricted by a stone wall. The drawings do not indicate this wall as being removed or set back.

**Hazard:** Users exiting the access road may have poor visibility of vehicles approaching from their right. The user may exit into the path of oncoming traffic.

**Recommendation:** The Design Team should ensure adequate junction visibility is provided.
