**Appendix 14E- L1219, L1220 &
L1222 Local Roads Visual Pavement
Inspection Report
Ballynisky Wind Farm**

Ballynisky Green Energy Ltd

December 2025

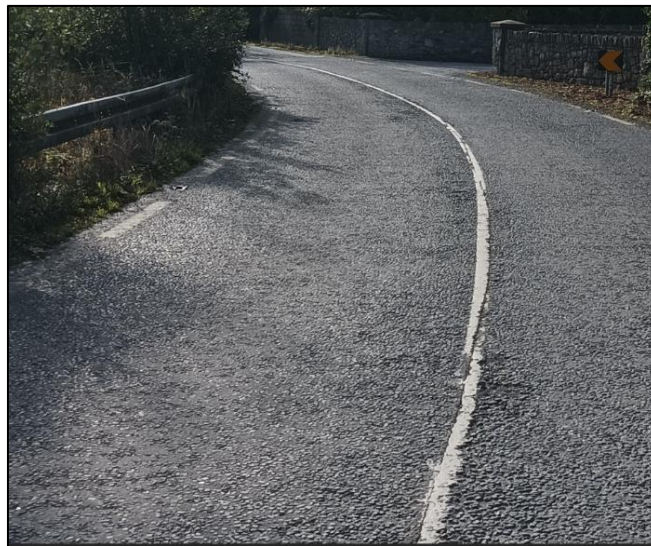
Photograph 1: View South of L1222 Ravelling from Southside of N69 Junction Area

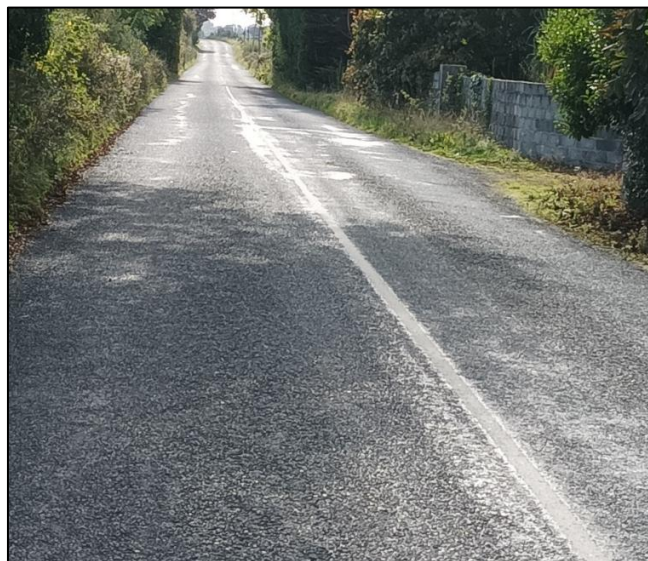
Photograph 2: View South of L1222 Ravelling

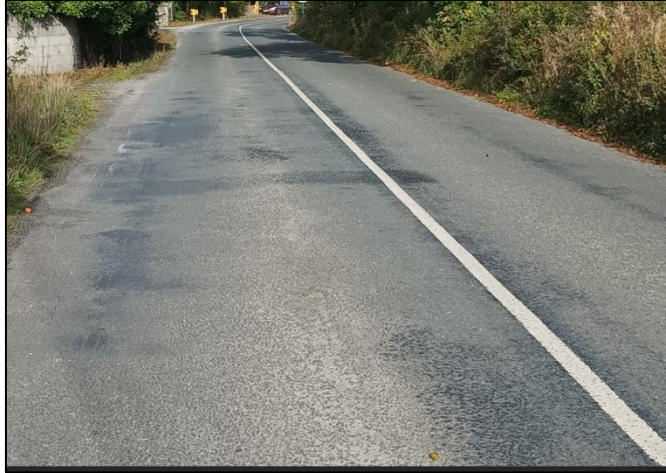
Photograph 3: View North of L1222 Fatting Up on Approach to N69 Junction Area

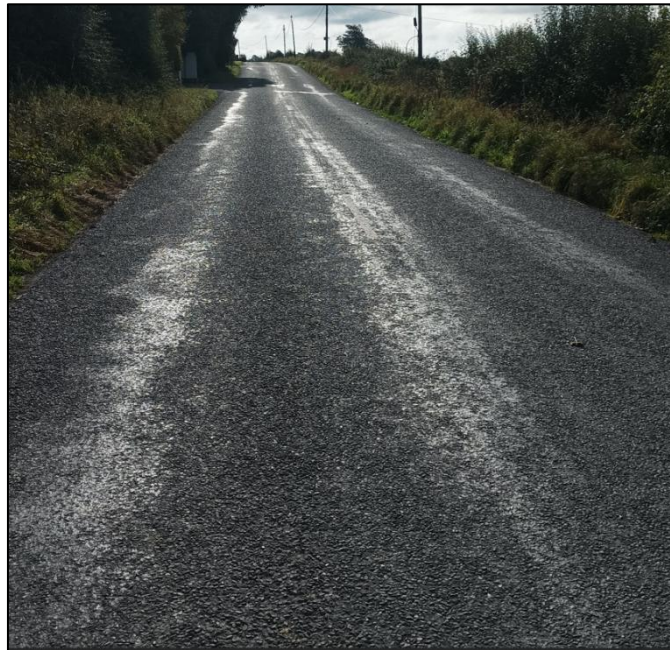
Photograph 4: View South of L1222 Ravelling

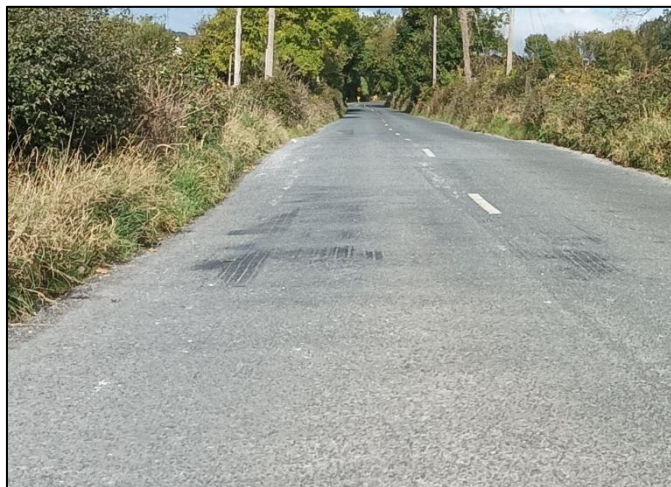
Photograph 5: View North of L1222 Surface Deterioration (Depression)

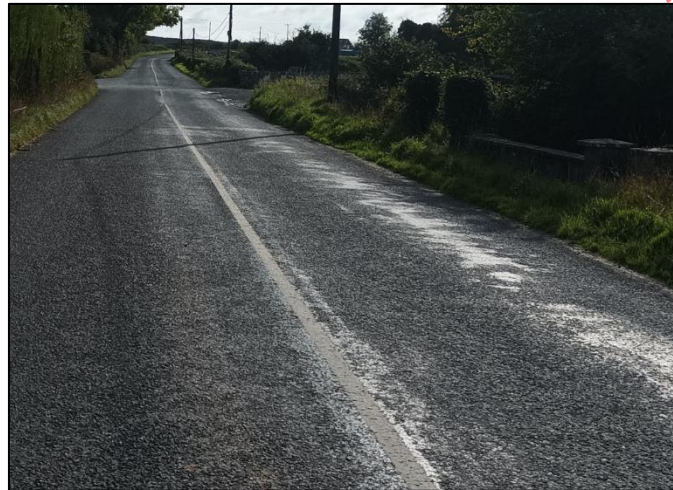
Photograph 6: View South of L1222 Ravelling on Immediate North Side of Greaney Concrete Products

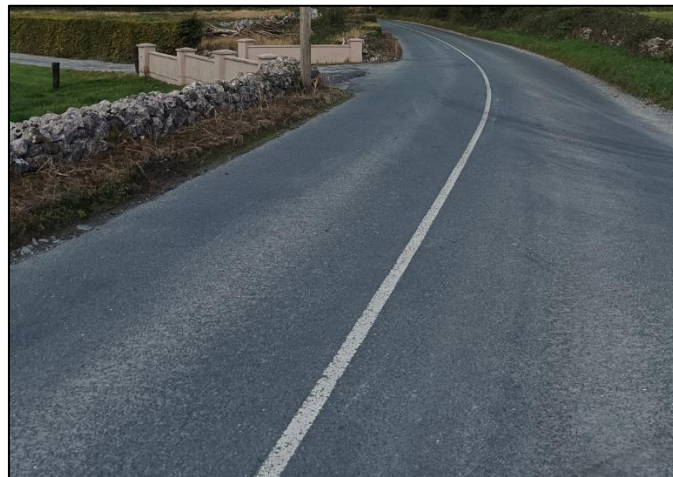
Photograph 7: View North of L1222 Ravelling

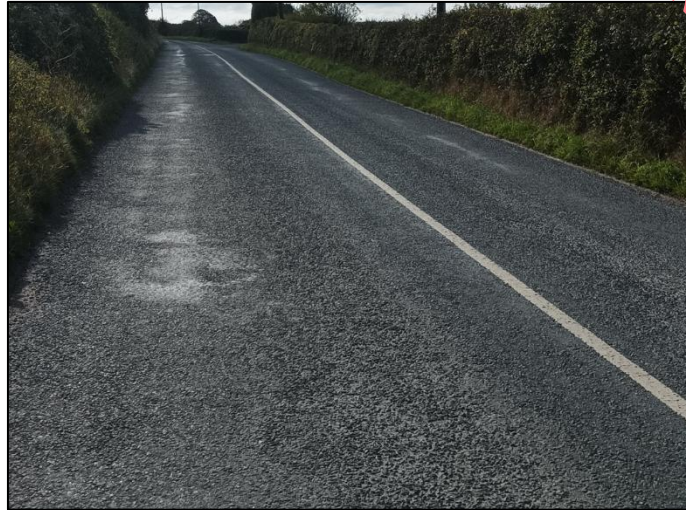
Photograph 8: View South of L1222 Rutting and Ravelling

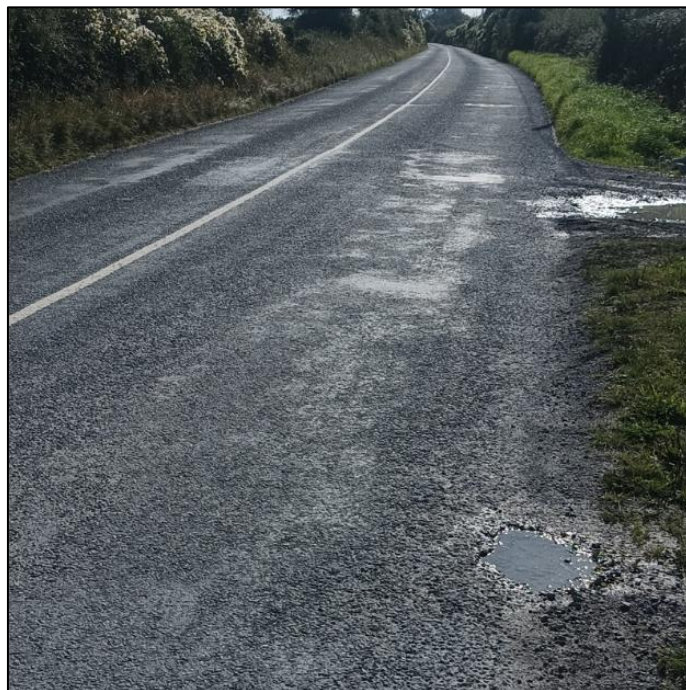
Photograph 9: View South of Potholes on West Edge of L1222

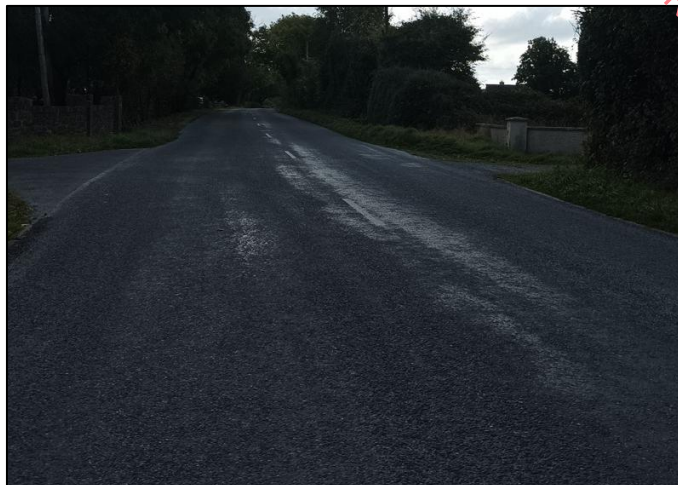
Photograph 10: View South of L1222 Ravelling

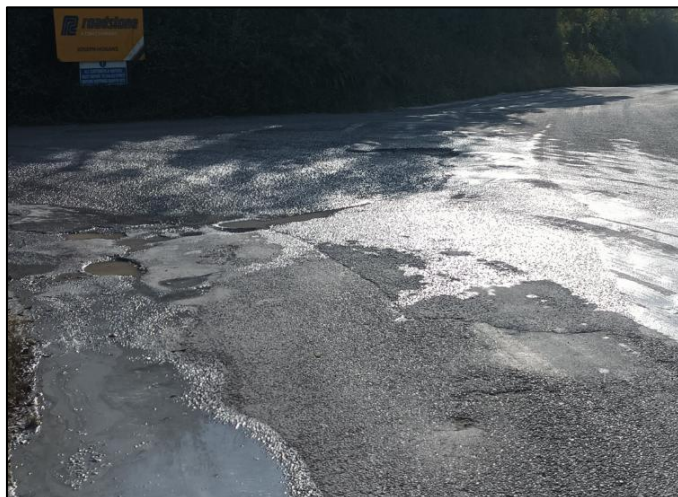
Photograph 11: View South of Potholes on East Edge of L1222 at Roadstone Joseph Hogans Quarry

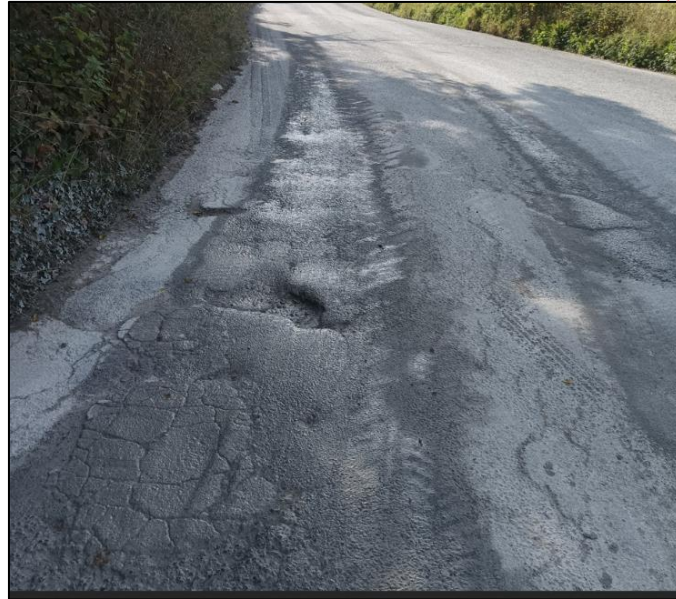
Photograph 12: View South of L1222 Potholes and Cracking on South Side of Roadstone Joseph Hogans Quarry

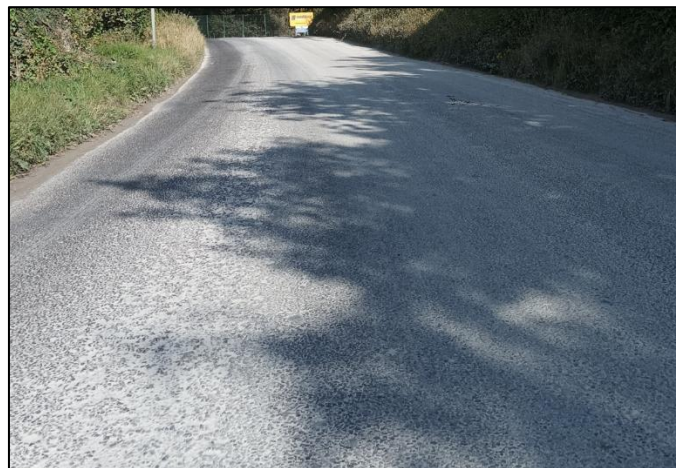
Photograph 13: View North to Roadstone Joseph Hogans Quarry of L1222 Ravelling

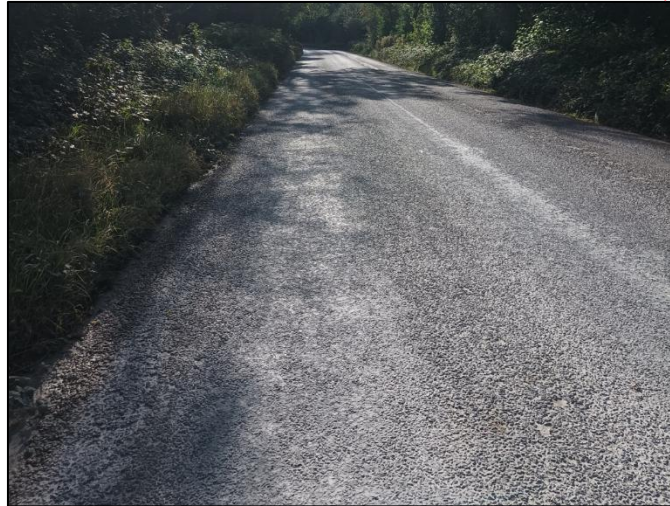
Photograph 14: View South of L1222 Ravelling

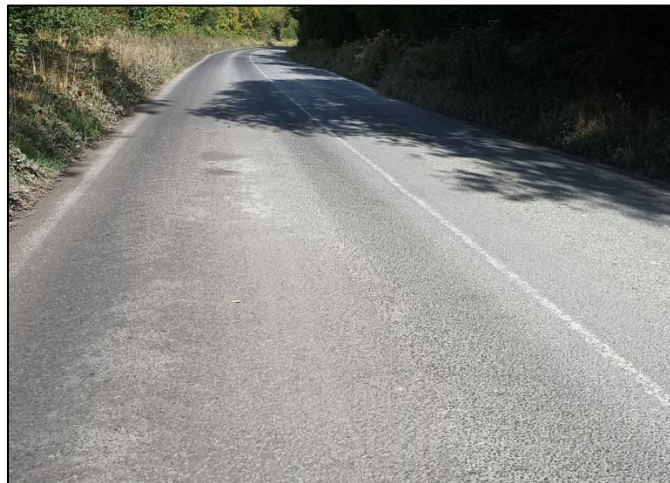
Photograph 15: View South of L1222 Ravelling

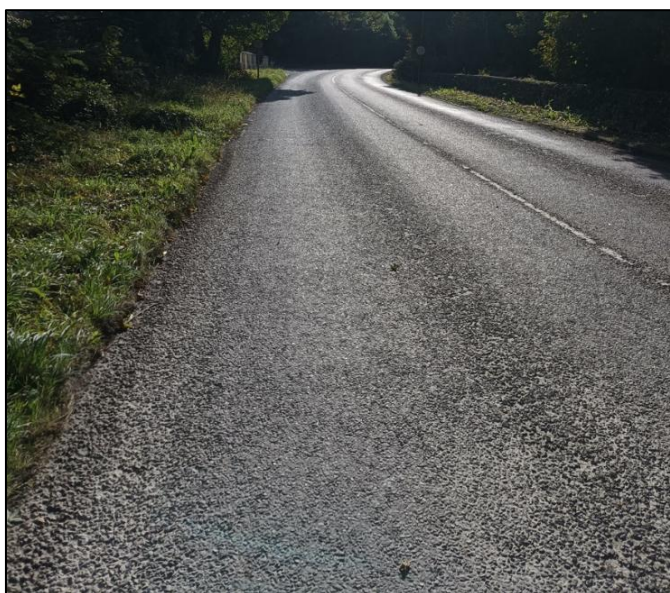
Photograph 16: View South to Creeves Cross 50 km/hour Signs of L1222 Ravelling

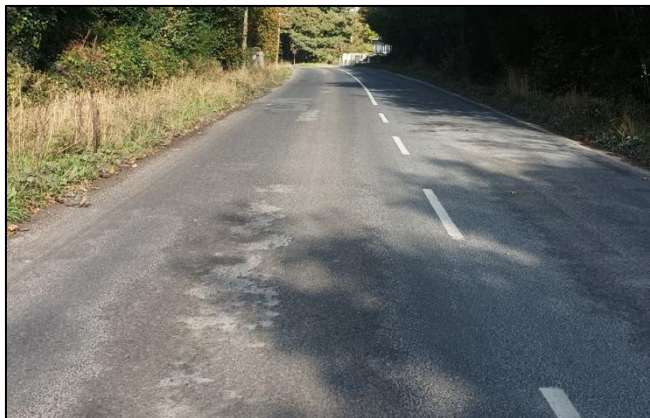
Photograph 17: View North Within Creeves Cross 50 km/hour Zone of L1222 Ravelling

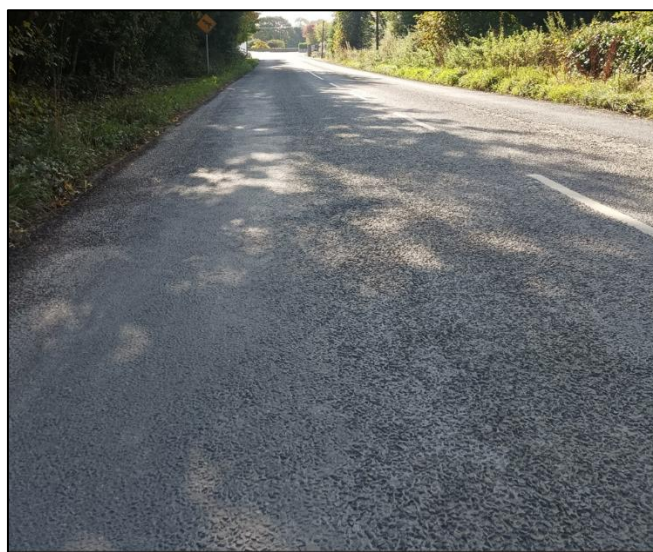
Photograph 18: View South Within Creeves Cross 50 km/hour Zone of L1222 Ravelling

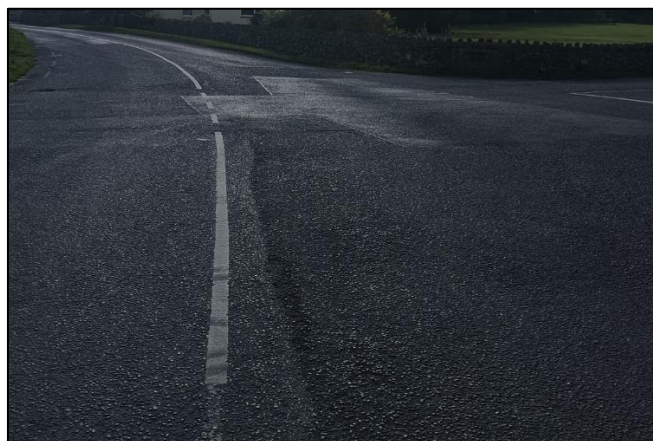
Photograph 19: View South of L1222 patching at L1220 Junction Area

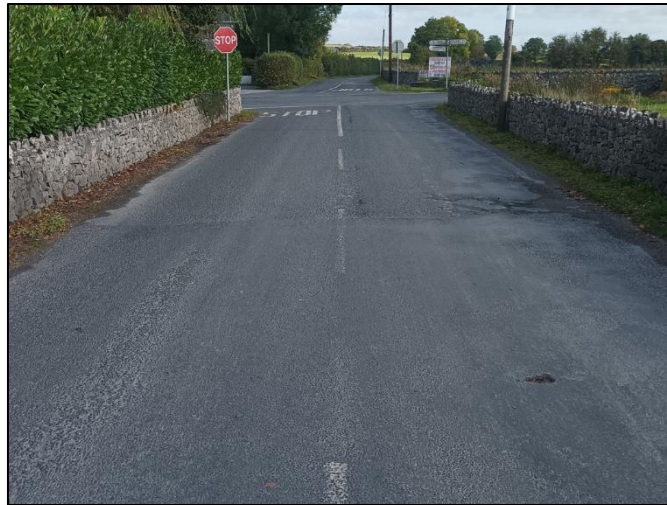
Photograph 20: View North Within Creeves Cross 50 km/hour Zone of L1220 Ravelling and Patching

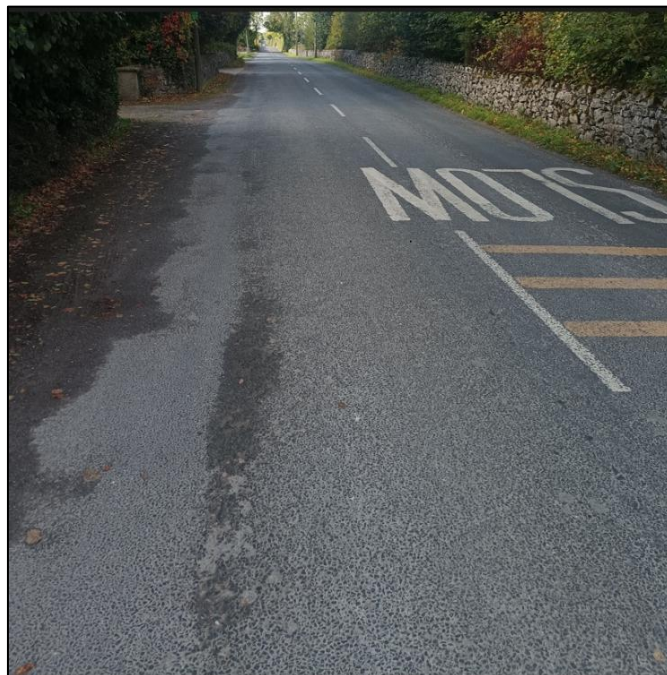
Photograph 21: View South Within Creeves Cross 50 km/hour Zone of L1220 Ravelling

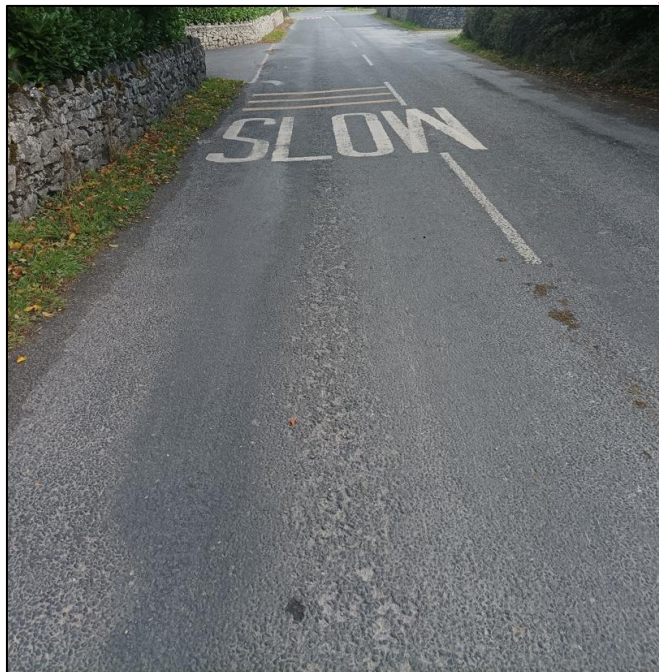
Photograph 22: View North Within Creeves Cross 50 km/hour Zone of L1220 Ravelling

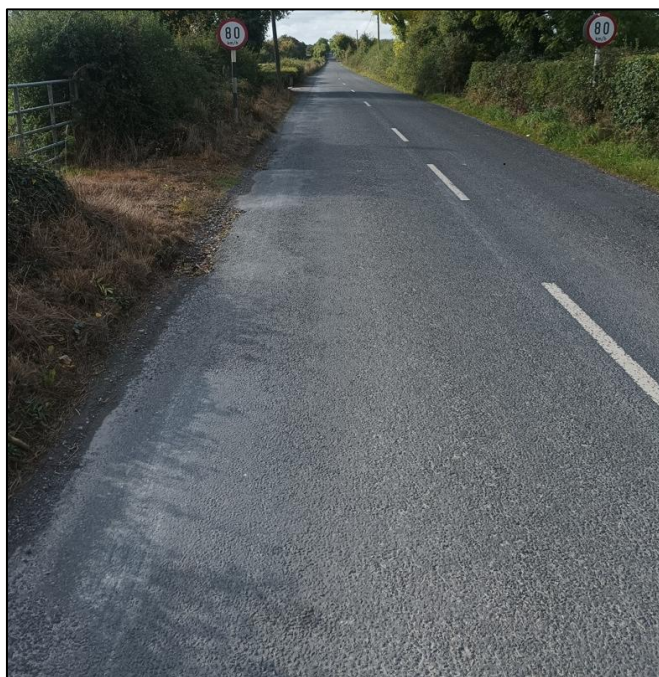
Photograph 23: View South Within Creeves Cross 50 km/hour Zone of L1220 Ravelling and Edge Breakup

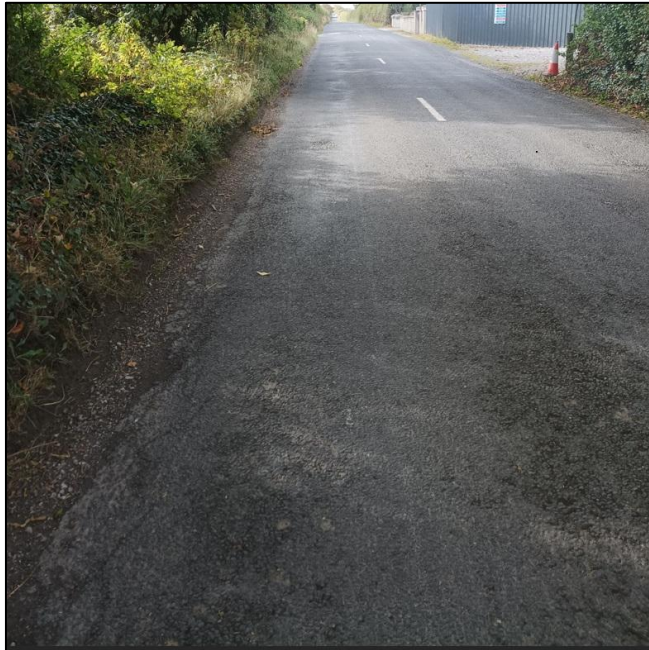
Photograph 24: View South of L1220 Ravelling and Edge Break Up

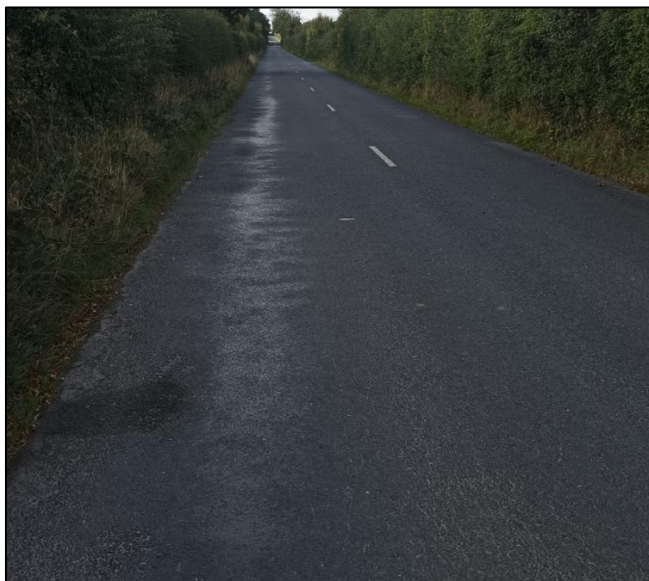
Photograph 25: View South of L1220 Ravelling, Rutting and Edge Break Up

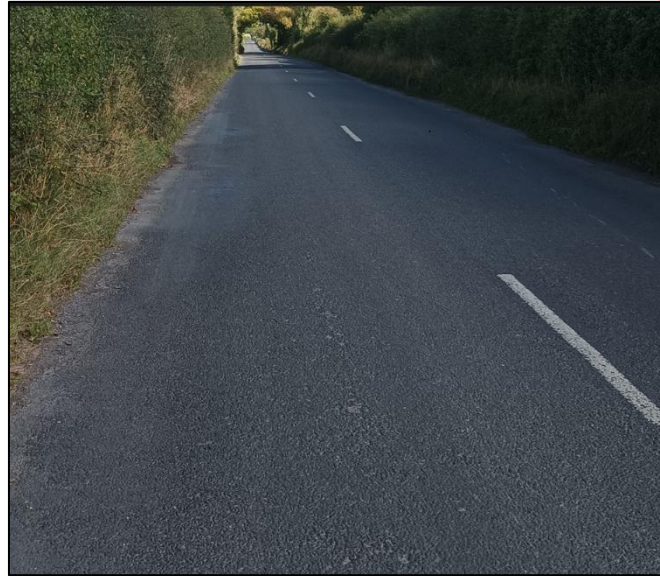
Photograph 26: View North of L1220 Ravelling and Edge Break Up

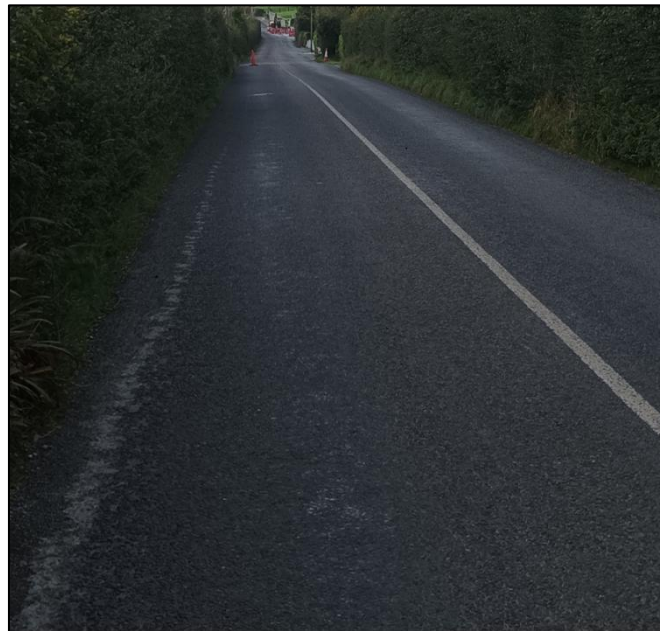
Photograph 27: View South of L1220 Ravelling

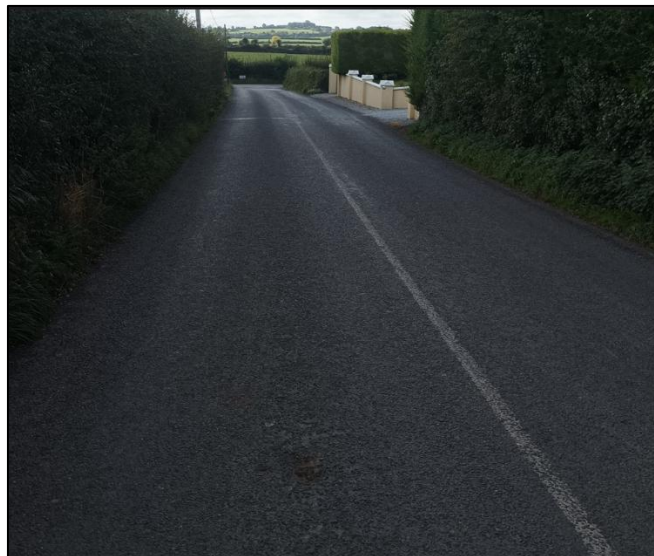
Photograph 28: View South to L1219 Junction of L1220 Ravelling

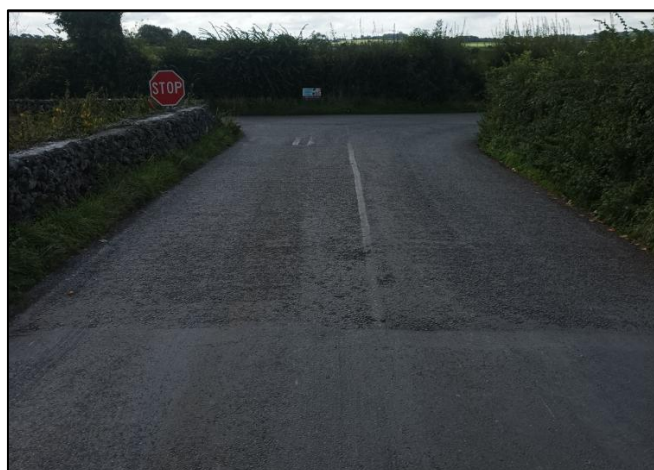
Photograph 29: View South to L1219 Junction of L1220 Patching and Ravelling

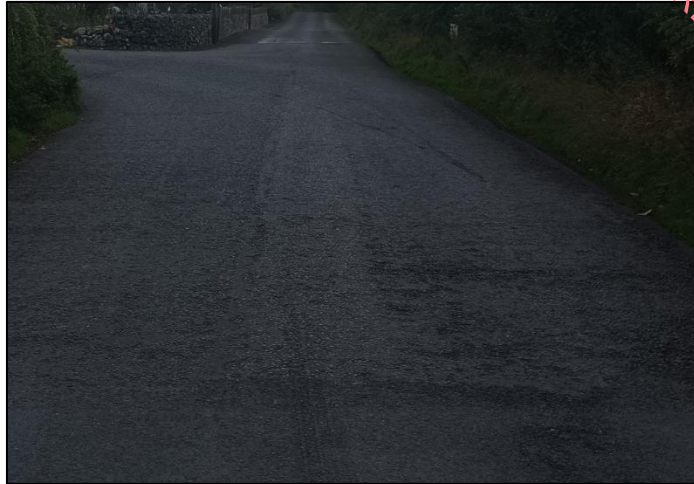
Photograph 30: View East of L1219 Ravelling and Patching

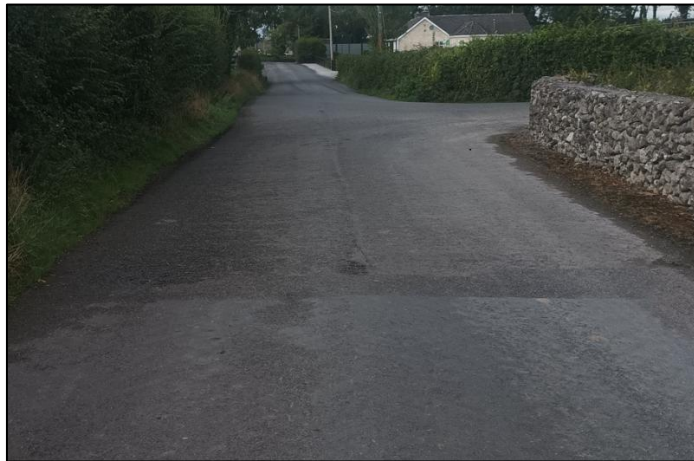
Photograph 31: View West of L1219 Ravelling and Patching
