Appendix 14F - Stage 1 Road Safety Audit

Ballynisky Green Energy Ltd.

December 2025

2.1 Problem – Crossroads Junction Layout (Temporary Construction Site Access)

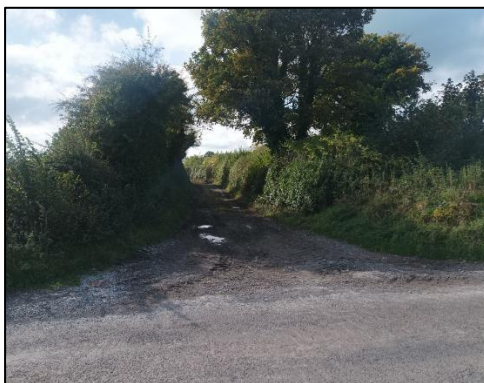
2.3 Problem – Possible Restricted Stop Sign Visibility (Permanent Site Access)

Although a Stage 2 audit item, the Stop sign shown for the proposed permanent site access junction may not be visible on approach for exiting operational maintenance vehicle drivers - the proposed permanent access is located at the existing site access which includes hedgerows along both sides of the existing access track, as shown in the hereunder photograph. This could increase the risk of exiting vehicles extending/turning out on to the L1219 road carriageway, into the path of other vehicles, resulting in potential collisions and consequent injuries for vehicle occupants.

Although a Stage 2 audit item, it is recommended that appropriate visibility to the Stop sign should be provided for exiting vehicle drivers.

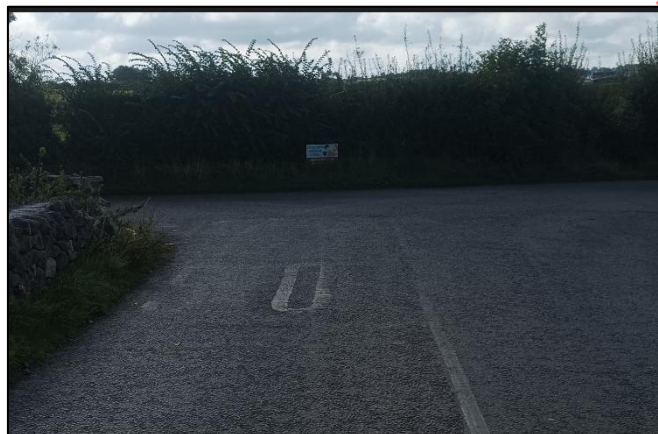
2.5 Problem – Faded Stop Line and Marking

The proposed temporary construction site access on the L1219 is a crossroads junction layout with the existing L1220 Local Road. Although a Stage 2 audit item, the existing Stop line and marking on the L1220 at the junction were observed faded during the site inspection, as shown in the hereunder photograph. This could reduce driver awareness of the Stop location and increase the risk of vehicles late braking and extending out onto the L1219 road carriageway, into the path of other vehicles, resulting in potential collisions and consequent injuries for vehicle occupants. Although located outside the extent of the proposed scheme for audit, it is envisaged that the proposed development would increase traffic volumes at the junction during construction, increasing the foregoing risks.

It is recommended that the existing Stop line and marking should be renewed and maintained, in consultation with Limerick City and County Council. Refer also to item 2.1 above.

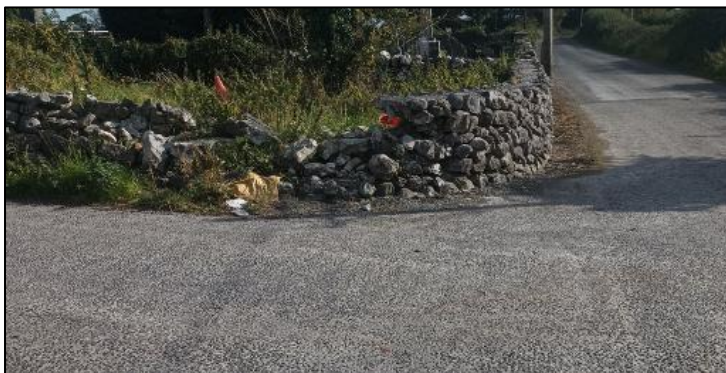
2.6 Problem – Loose Boundary Wall Stones at Junction

The proposed temporary construction site access on the L1219 is a crossroads junction layout with the existing L1220 Local Road. During the site inspection, the existing property boundary stone wall on the north-east side of the junction was observed deteriorated/collapsed, locally, with relatively large loose stones adjacent to the junction road carriageway area, as shown in the hereunder photograph. Stones dislodged onto the road carriageway are potential impact hazards for road users, particularly motorcyclists and cyclists, putting them at risk of material damage, loss of control, collisions and consequent injuries. Although located outside the extent of the proposed scheme for audit, it is envisaged that the proposed development would increase traffic volumes at the junction during construction, increasing the foregoing risks.

It is recommended that the existing boundary stone wall should be repaired and maintained, in consultation with Limerick City and County Council.
