**APPENDIX 3B - SROOLANE
NORTH BRIDGE –PRINCIPAL
INSPECTION REPORT**
Ballynisky Wind Farm Turbine Delivery Route

Ballynisky Green Energy Ltd.

December 2025

Project No.	Doc. No.	Rev.	Date	Prepared By	Checked By	Approved By	Status
22569	22569-MWP-SBR-RP-C-6017	P01	20/02/2025	AOD	SR	IB	For Information
22569	22569-MWP-SBR-RP-C-6017	P02	December 2025	AOD	SR	IB	For Information

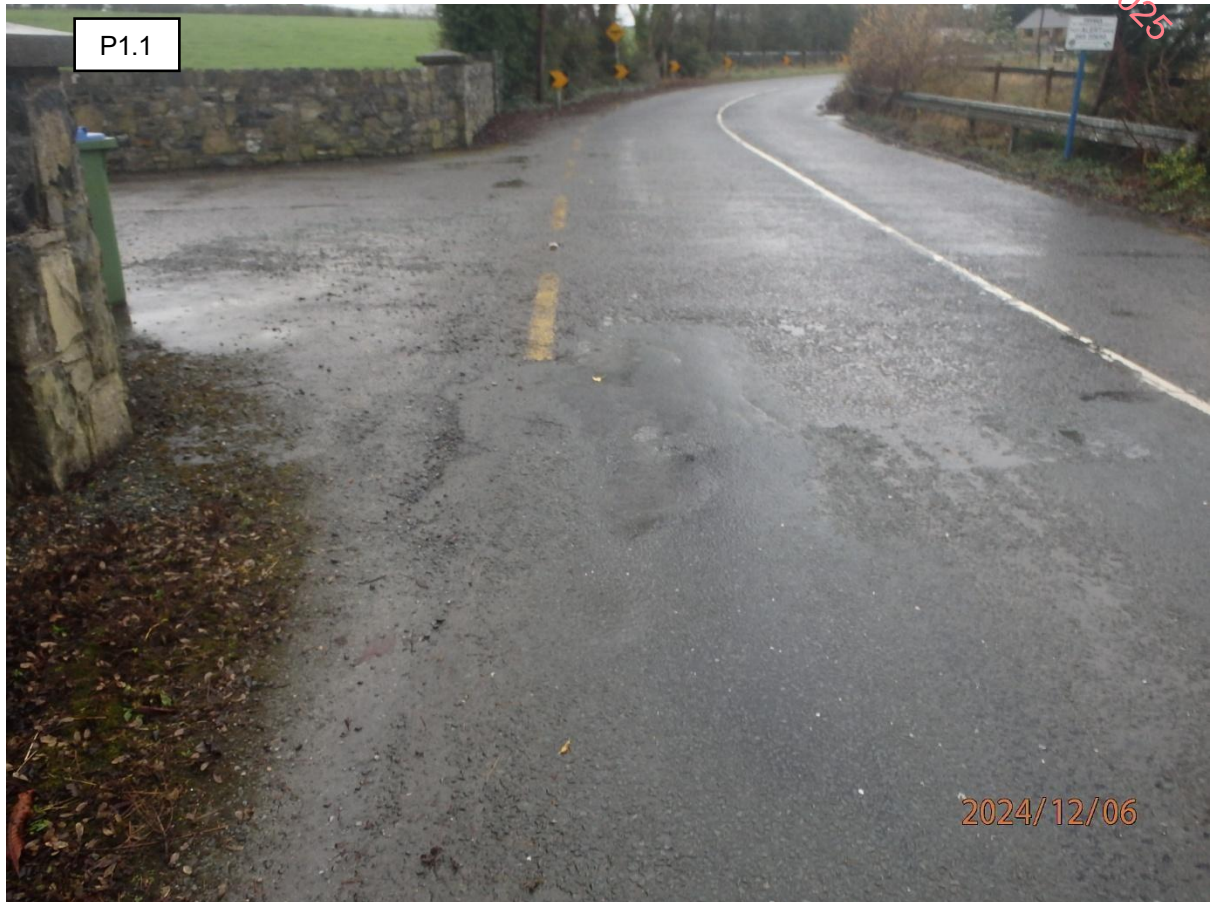
Component No. 1 Bridge surface

Patch repair on upstream side of road. See Photo 1.1 (looking left). Road markings are worn. Ponding noted on the downstream end. See Photo 1.2 (looking downstream)

Condition/Maintenance. 2/N

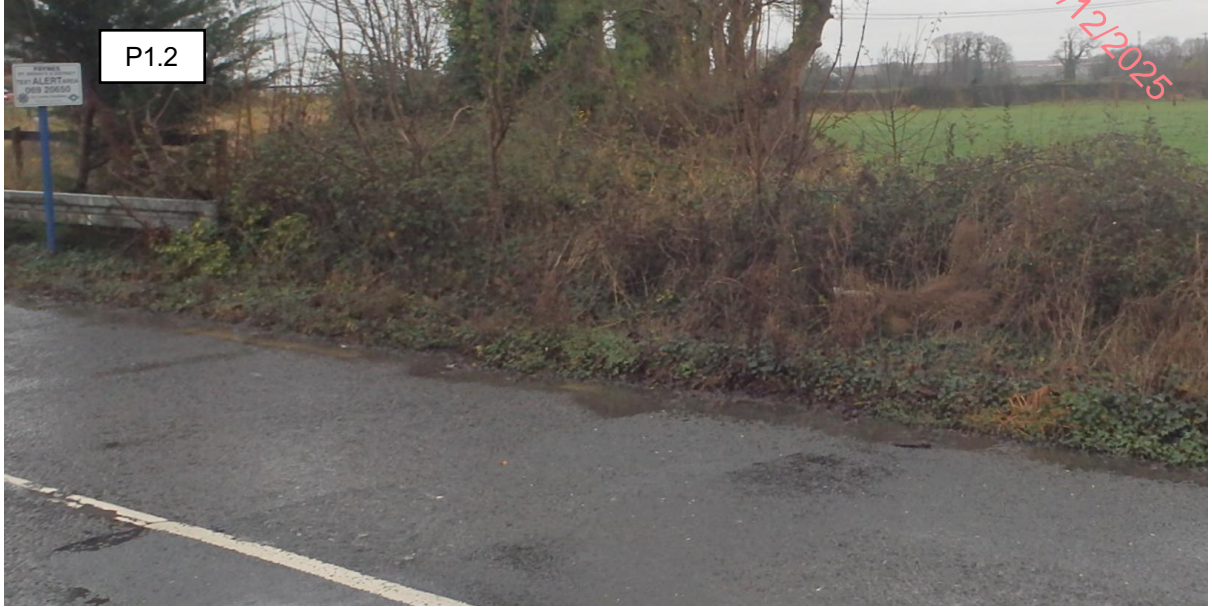
Patch repair on upstream side of road. See Photo 1.1 (looking left). Road markings are worn. Ponding noted on the downstream end. See Photo 1.2 (looking downstream)

Condition/Maintenance. 2/N

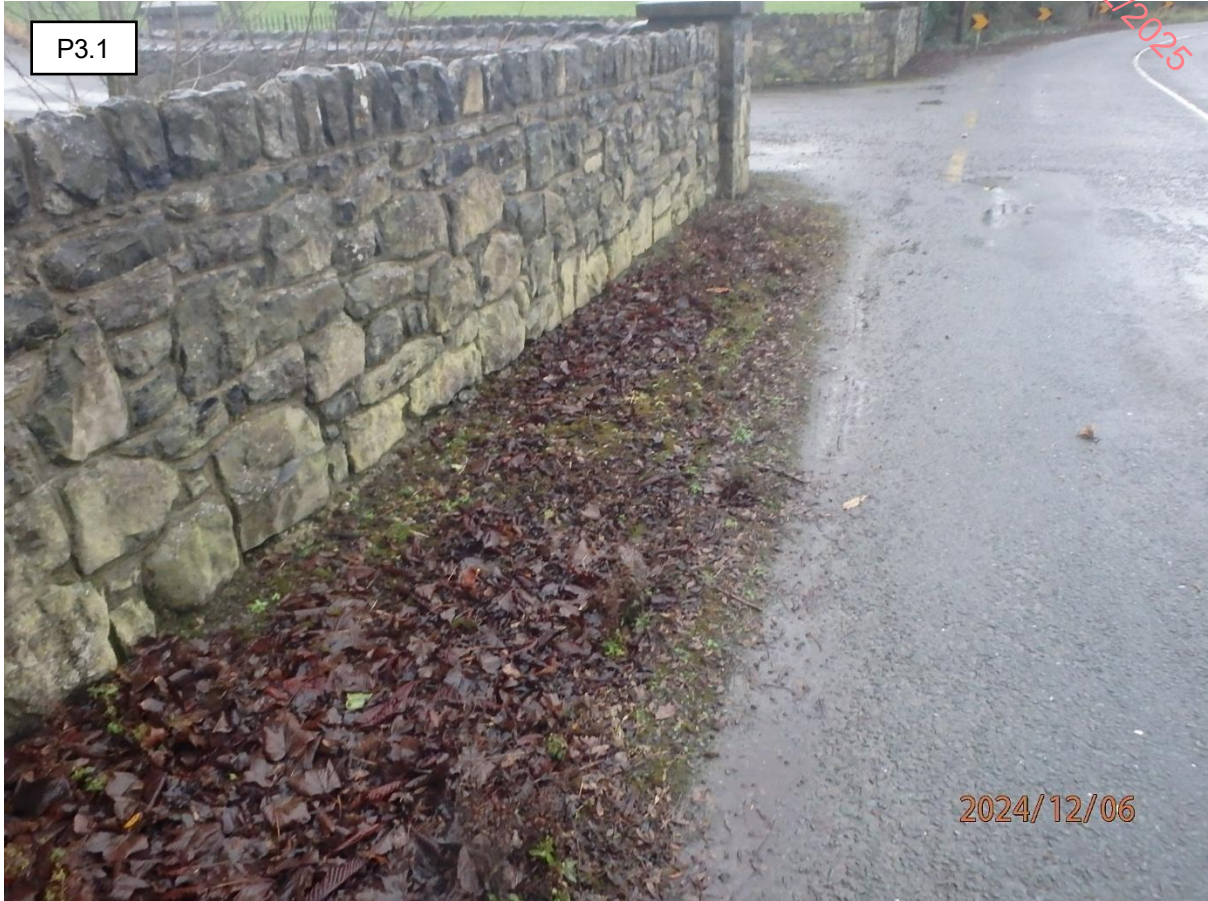
Component No. 3 Footways/Median

Ponding of water was noted. Vegetation and debris on the road verge were also noted. See Photo 3.1 (looking left)
Condition/Maintenance. 2/N

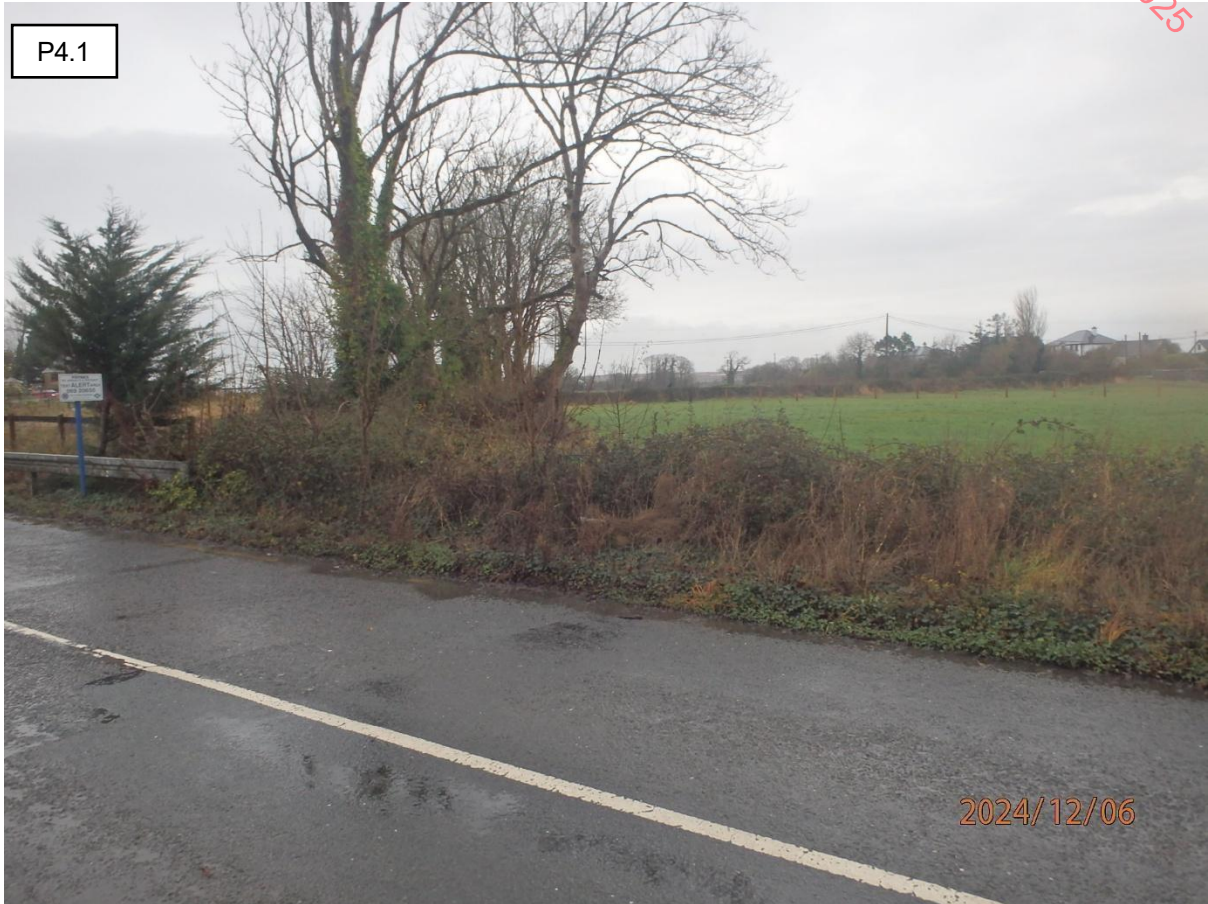
Component No. 4 Parapets/Safety barrier

The downstream parapet is in good condition. Significant vegetation growth has obscured any view of the upstream parapet. See Photo 4.1 (looking downstream)

Condition/Maintenance. ? / N

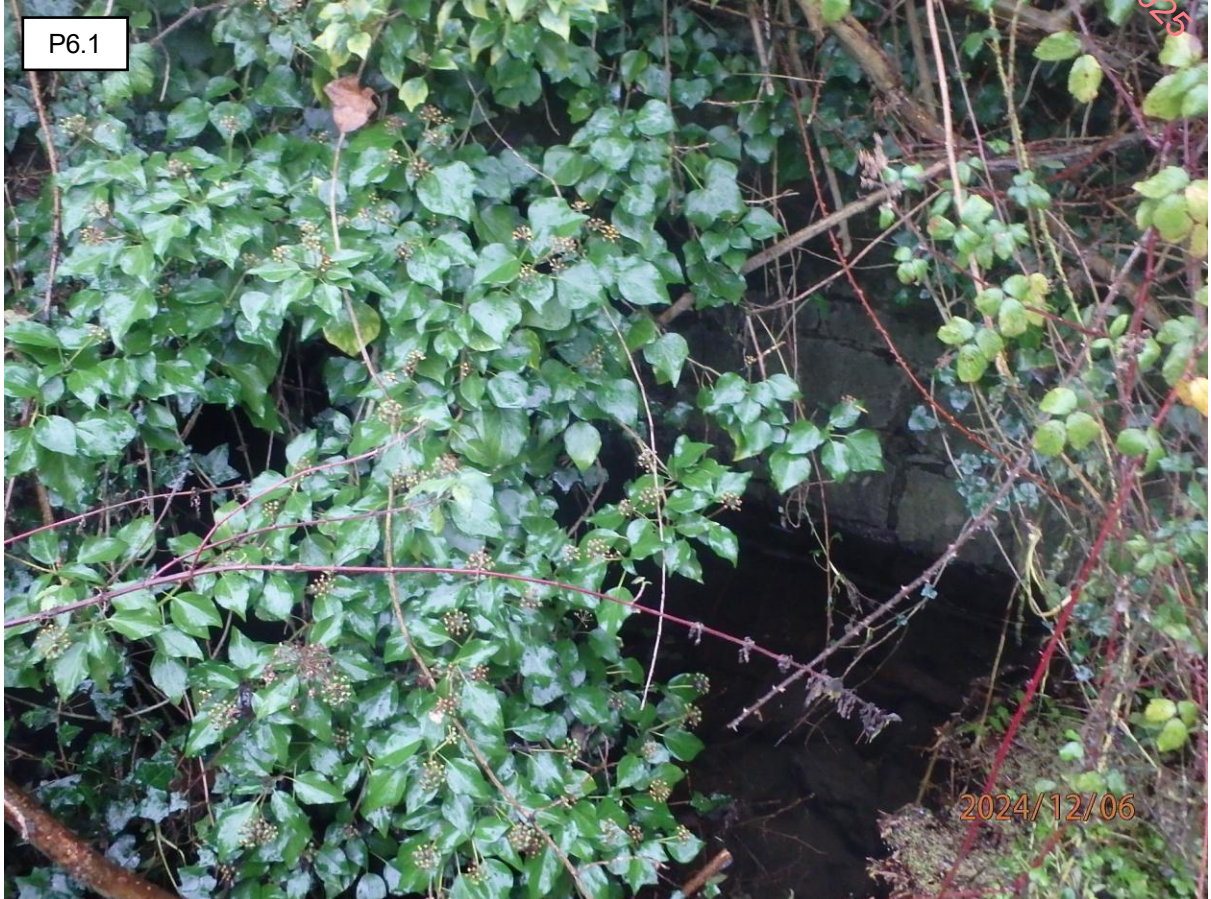
Component No. 6 Wingwall/Spandrel/Retaining Walls

Unable to make an assessment due to significant vegetation growth. No obvious defects were visible. See Photo 6.1 (looking upstream)

Condition/Maintenance. ?/N

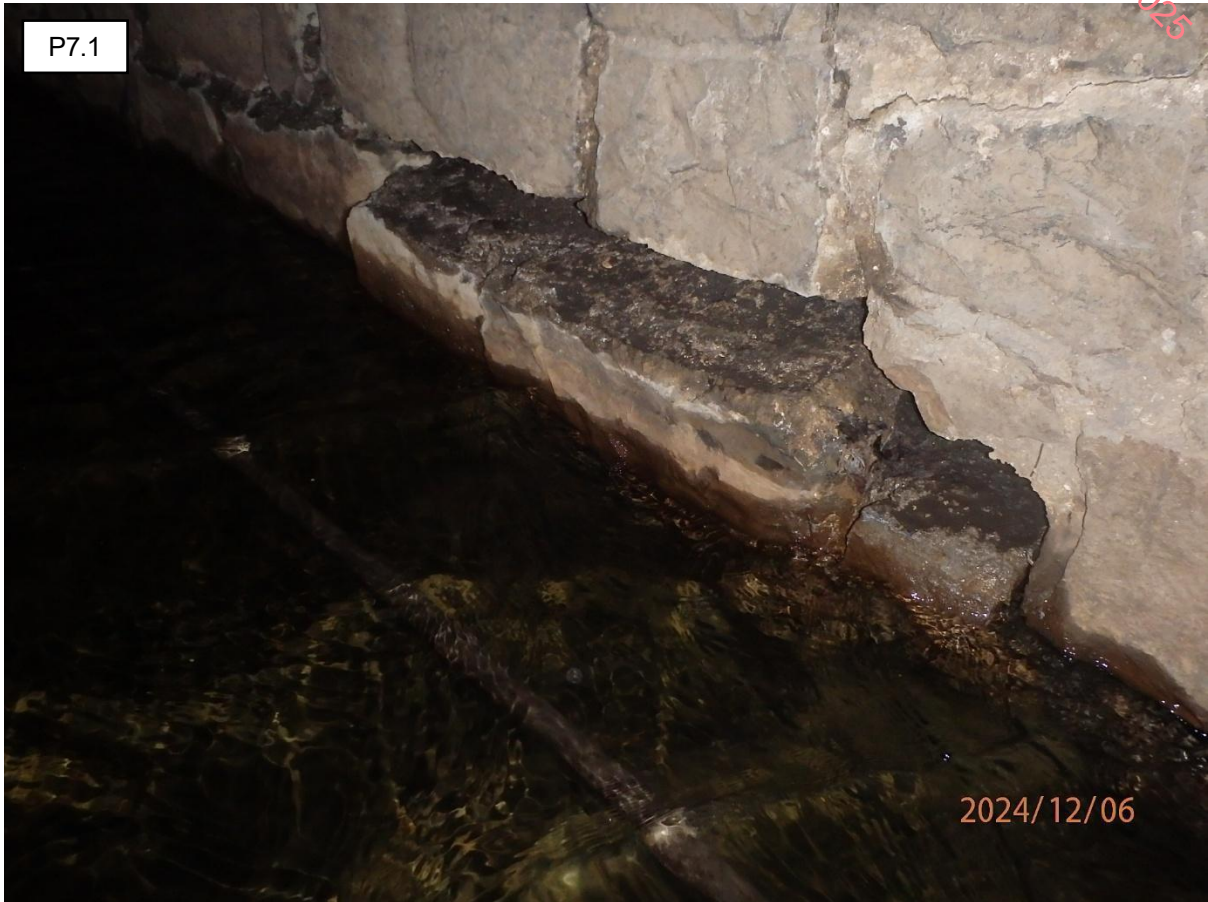
Component No. 7 Abutments

7	<u>Abutments</u> Dislodged and lost masonry noted at base of the abutments. Significant loss of pointing noted. See Photo 7.1 (looking upstream)	3	N	-	-	-	-	1
8	<u>Piers</u> -	-	-	-	-	-	-	-
9	<u>Bearings</u> -	-	-	-	-	-	-	-

Dislodged and lost masonry noted at base of the abutments. Significant loss of pointing noted. See Photo 7.1 (looking upstream)

Condition/Maintenance. 3/N

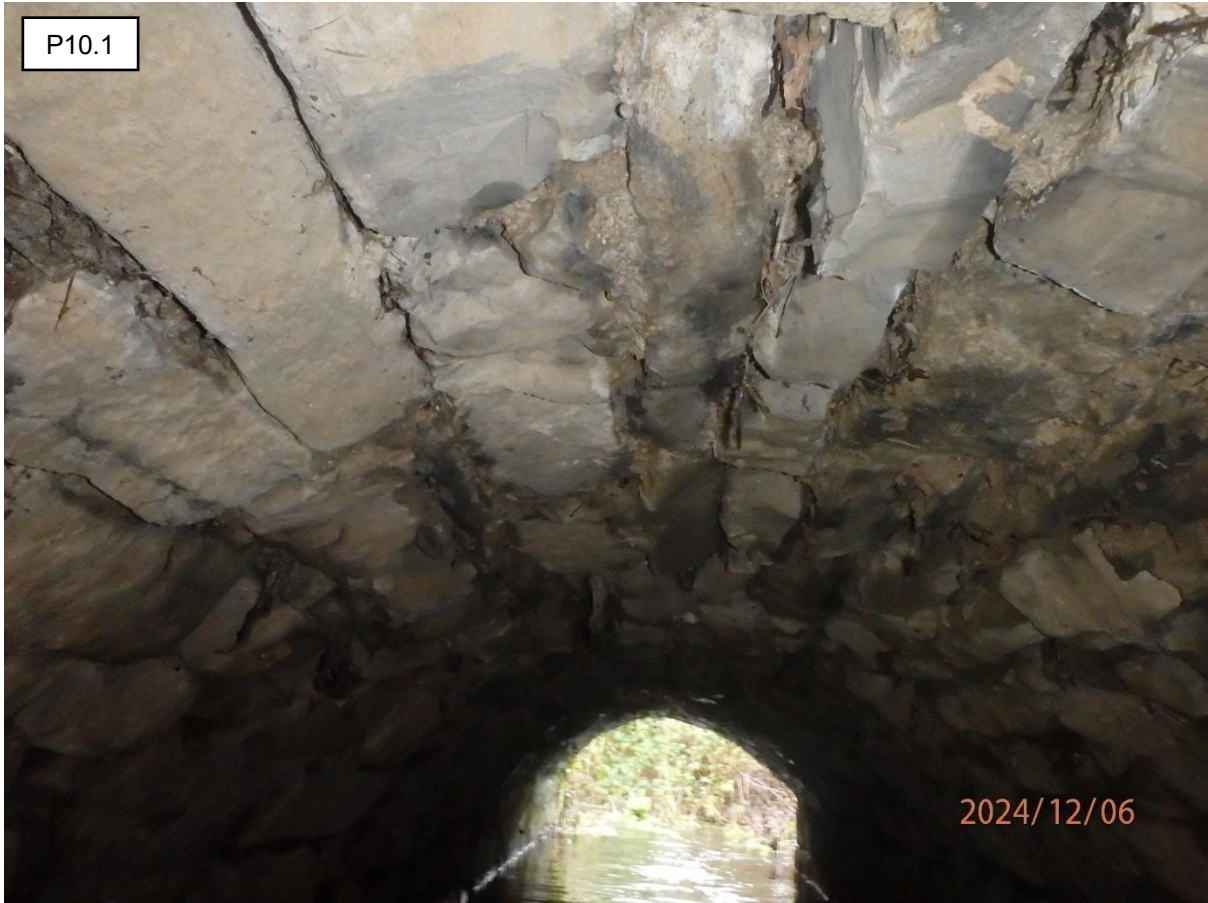
Component No. 10 Deck/slab/arch barrel

Arch barrel showing signs of deformation, particularly over 4m on the upstream side where 2 holes have formed in the arch. One of these holes has dimensions of 500mm x 450mm x 300 mm. Significant loss of pointing noted. See Photo 10.1 (looking upstream). Roots has dislodged masonry from the arch on the upstream side. See Photo 10.2. Water ingress visible through open joints. See Photo 10.3 (looking at arch barrel from downstream end)

Condition/Maintenance. 3/N

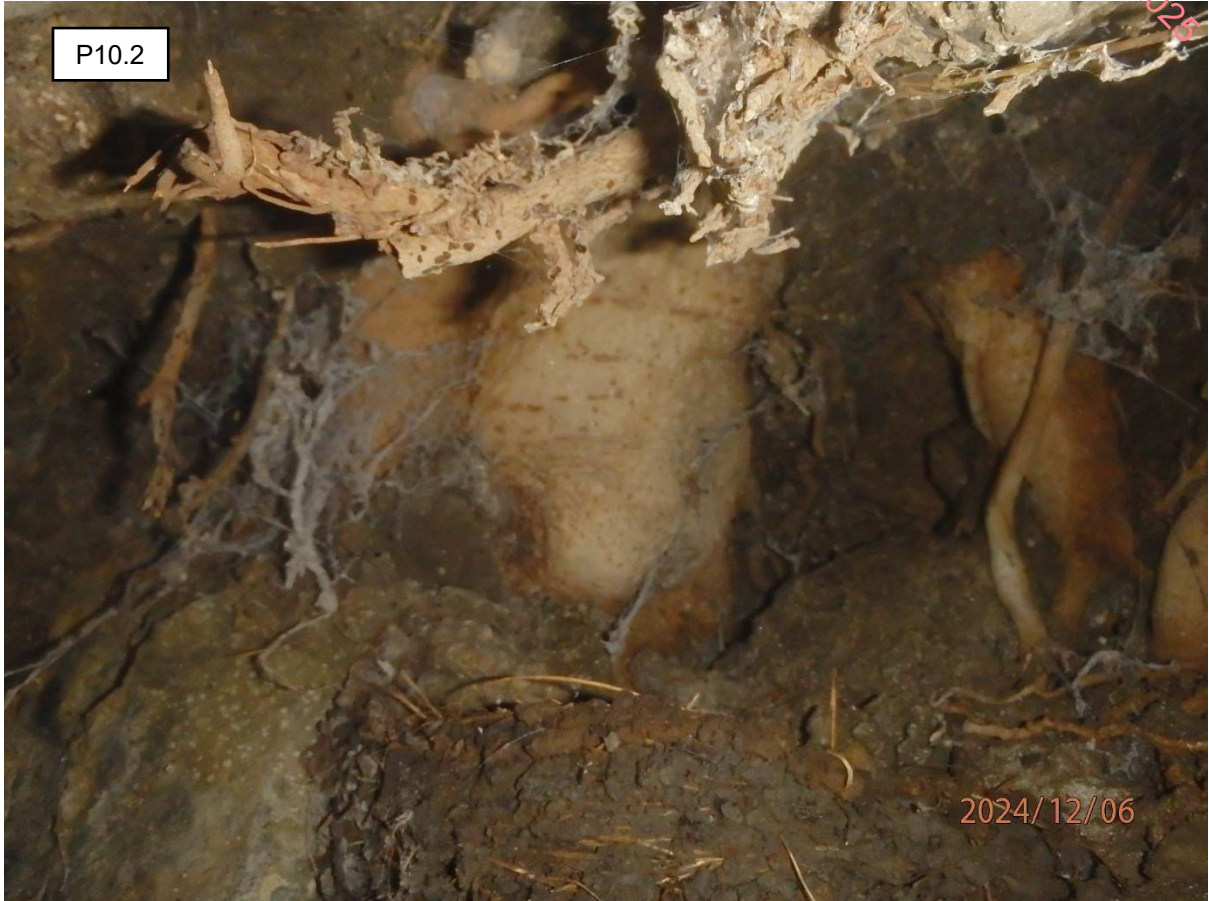
Arch barrel showing signs of deformation, particularly over 4m on the upstream side where 2 holes have formed in the arch. One of these holes has dimensions of 500mm x 450mm x 300 mm. Significant loss of pointing noted. See Photo 10.1 (looking upstream). Roots has dislodged masonry from the arch on the upstream side. See Photo 10.2. Water ingress visible through open joints. See Photo 10.3 (looking at arch barrel from downstream end).

Condition/Maintenance. 3/N

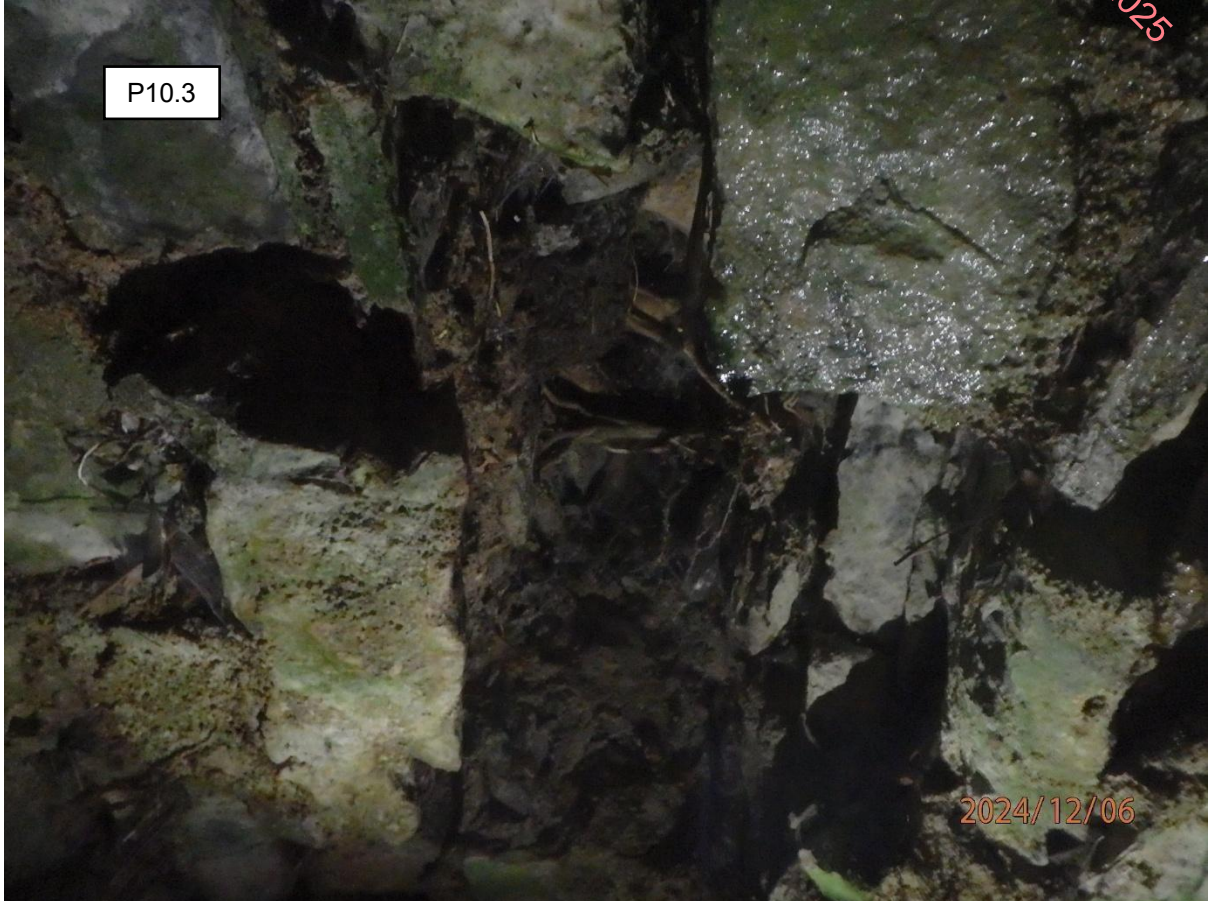
Arch barrel showing signs of deformation, particularly over 4m on the upstream side where 2 holes have formed in the arch. One of these holes has dimensions of 500mm x 450mm x 300 mm. Significant loss of pointing noted. See Photo 10.1 (looking upstream). Roots has dislodged masonry from the arch on the upstream side. See Photo 10.2. Water ingress visible through open joints. See Photo 10.3 (looking at arch barrel)

Condition/Maintenance. 3/N

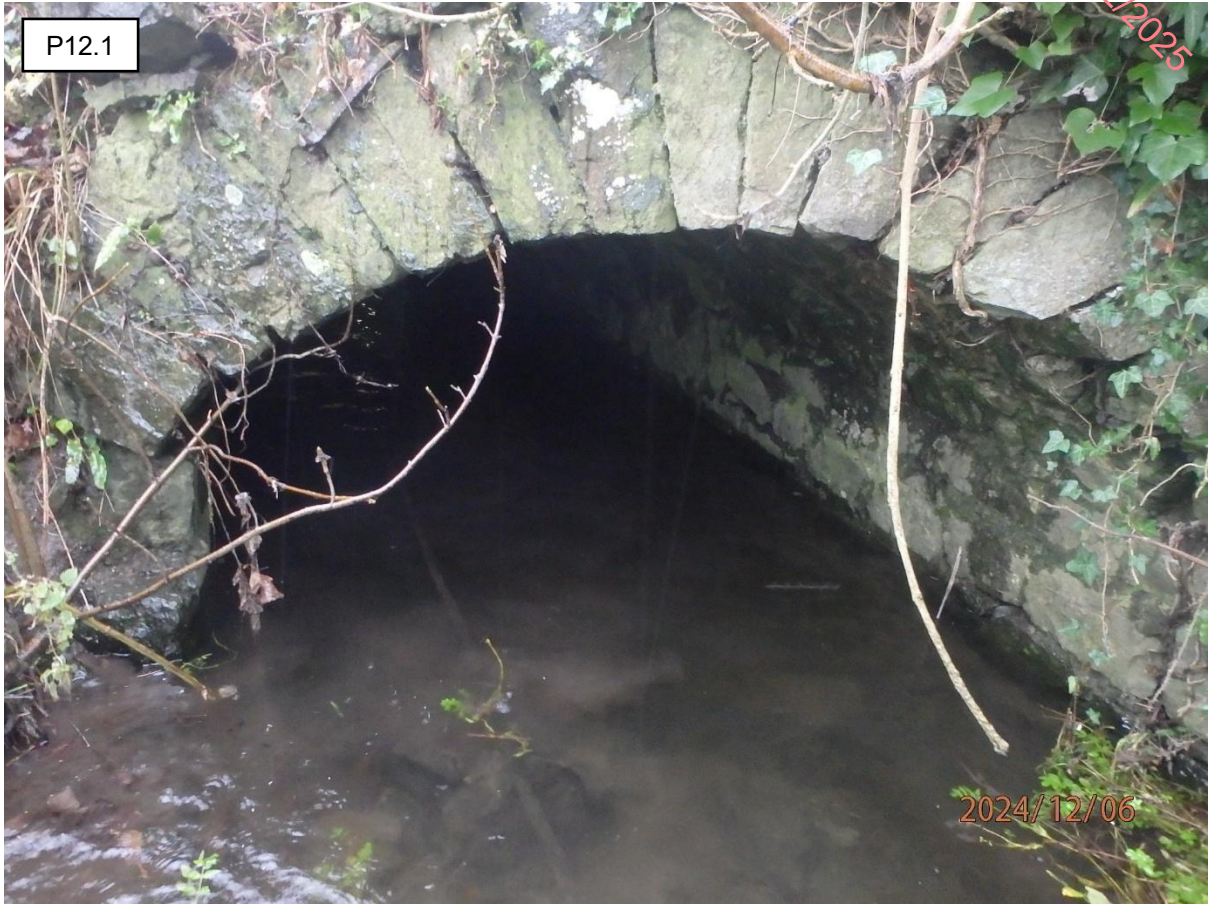
Component No. 12 Riverbed

Vegetation noted in riverbed. No scouring noted. See Photo 12.1 (looking downstream)

Condition/Maintenance. 1/N
