**Appendix 3C - Ahacronane Culvert –  
Principal Inspection Report**  
**Ballynisky Wind Farm Turbine Delivery Route**

**Ballynisky Green Energy Ltd.**

**December 2025**

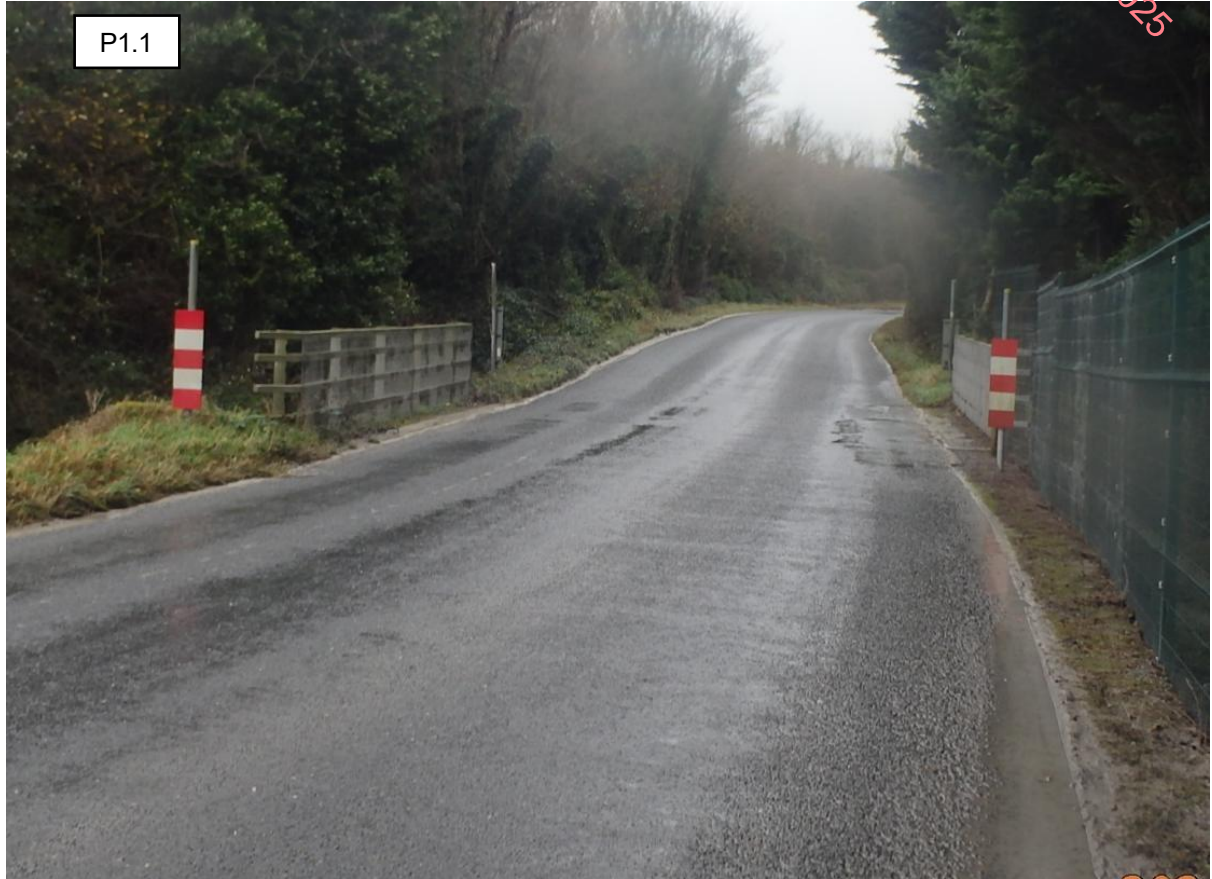
Component No.	1	Bridge surface
---------------	---	----------------

A patch repair to the road on the downstream end. Some ravelling noted on upstream end of road with ponding of water occurring in wheelpaths. Road markings are very faint. See Photo 1.1 (looking left)

Condition/Maintenance. 1/N

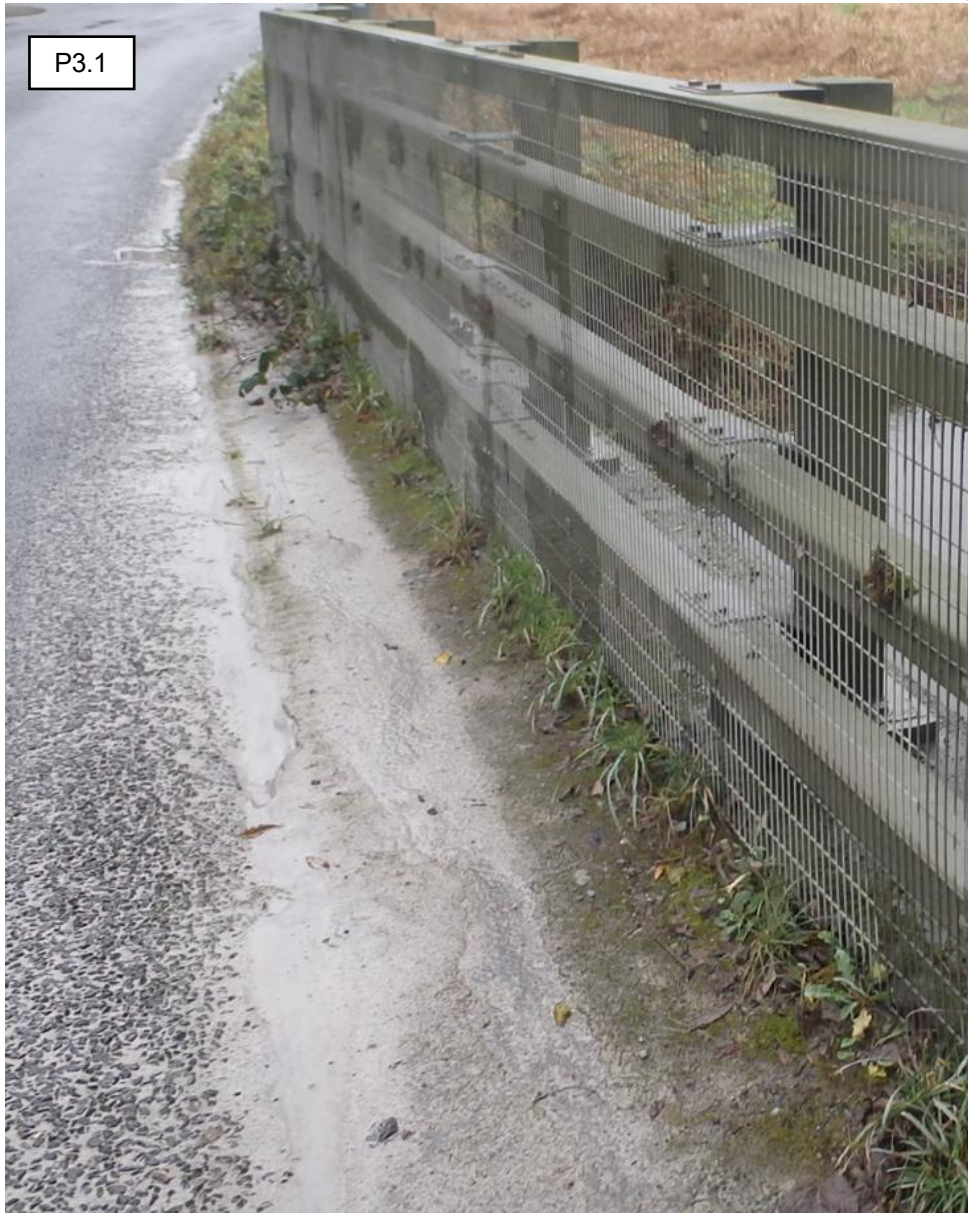
Component No. 3 Footways/Median

Footways are in good condition. Some vegetation and ponding of water noted. See Photo 3.1 (looking right)

Condition/Maintenance. 1/N

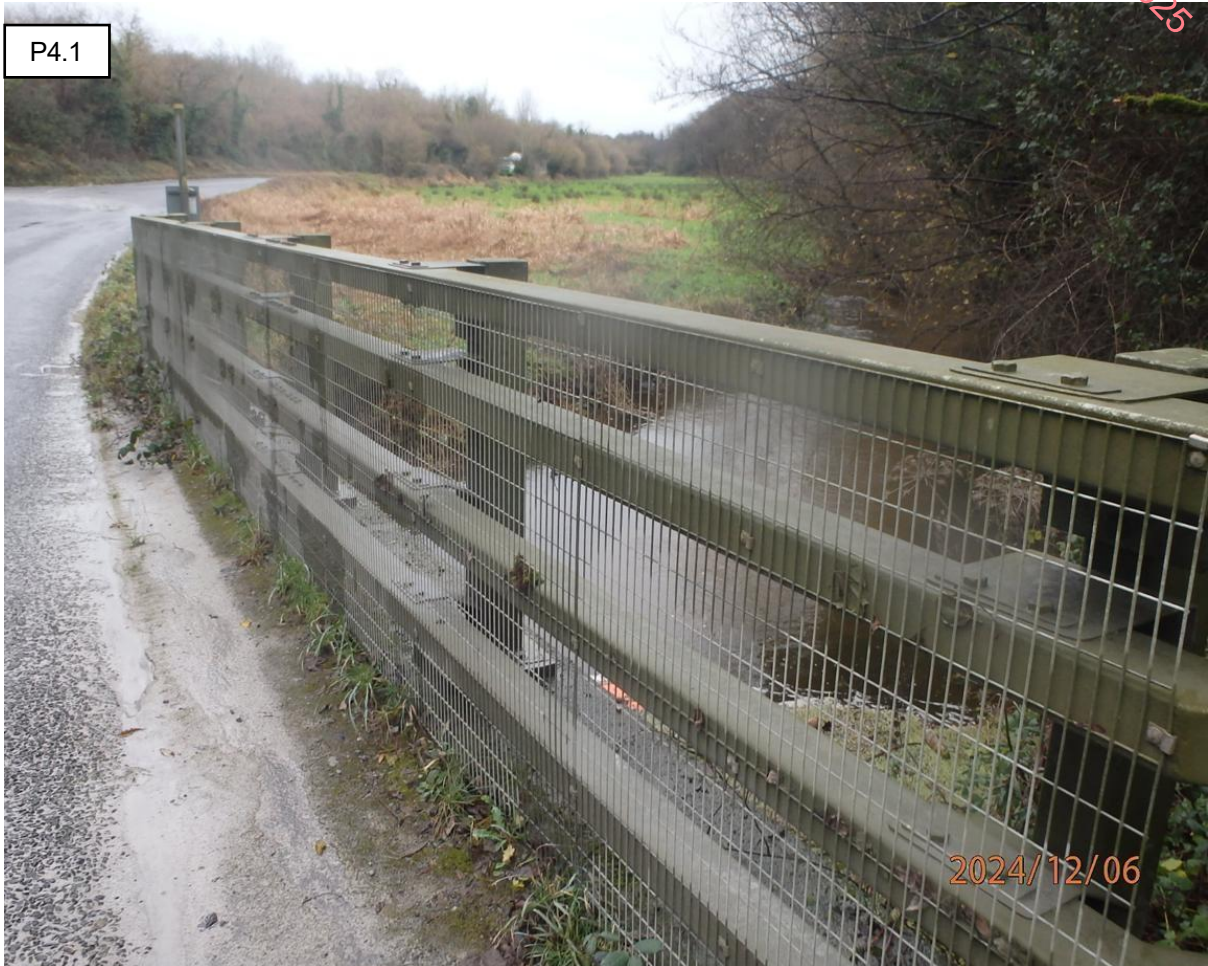
Component No. 4 Parapets/Safety barrier

Aluminium railing is in good condition with no signs of impact or damage to steel railing and posts. See Photo 4.1 (looking at upstream parapet)

Condition/Maintenance. 0/N

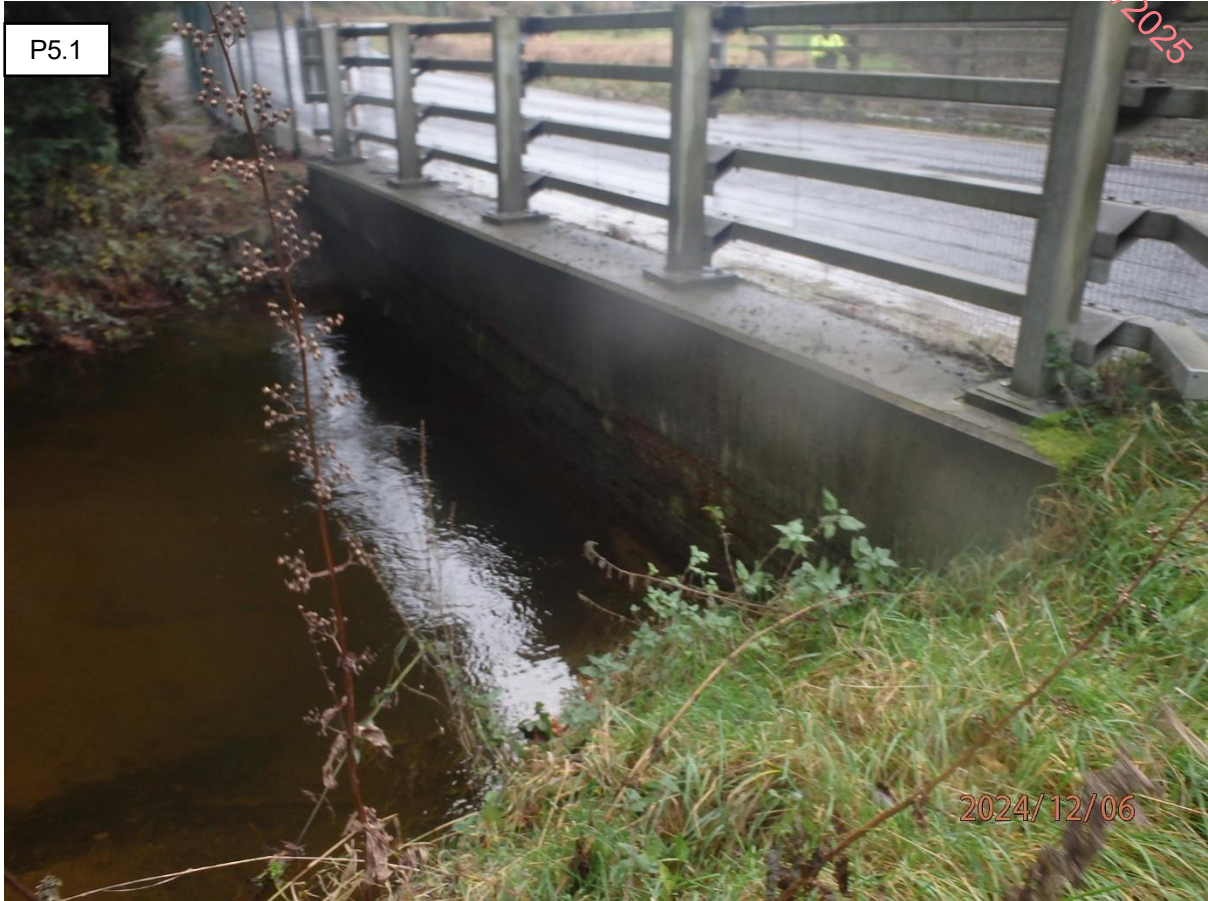
Component No. **5** Embankment/Revetments

Significant overgrowth present. See Photo 5.1 (looking right)

Condition/Maintenance. 1 /N

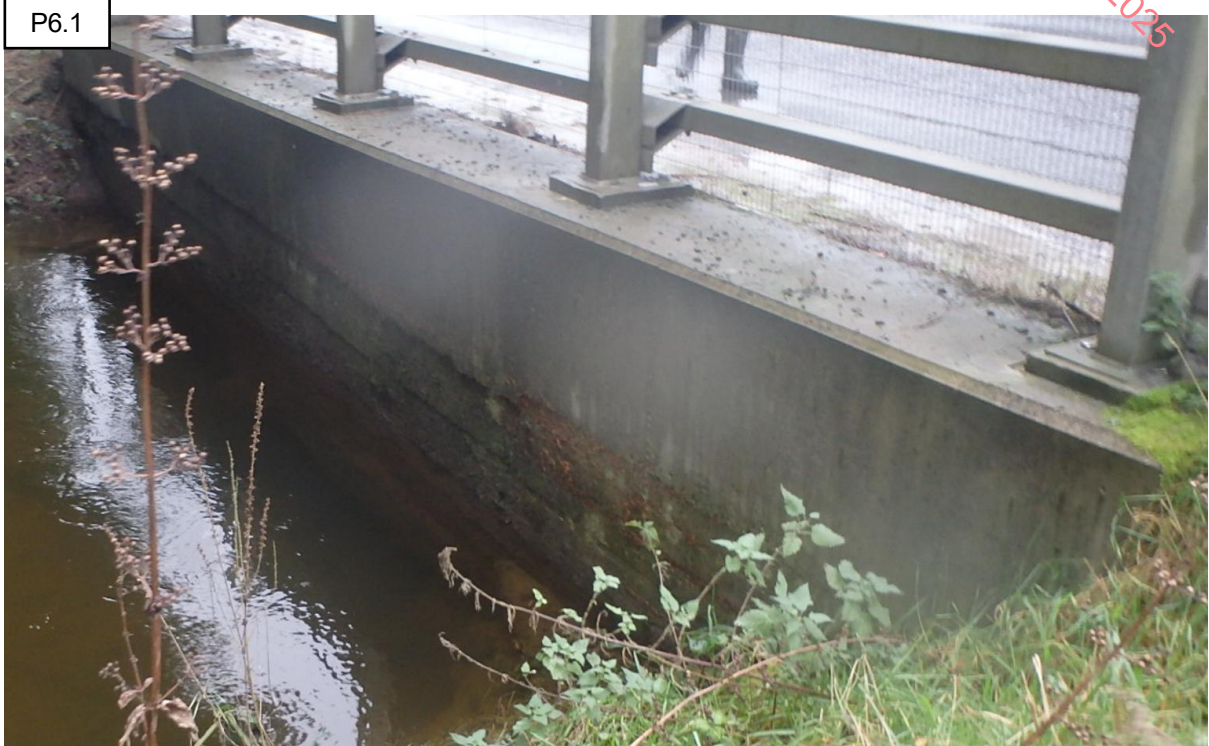
Component No. 6 Wingwall/Spandrel/Retaining Walls

Wing walls were submerged under water therefore an assessment could not be made. See Photo 6.1 (looking right)

Condition/Maintenance. ?/N

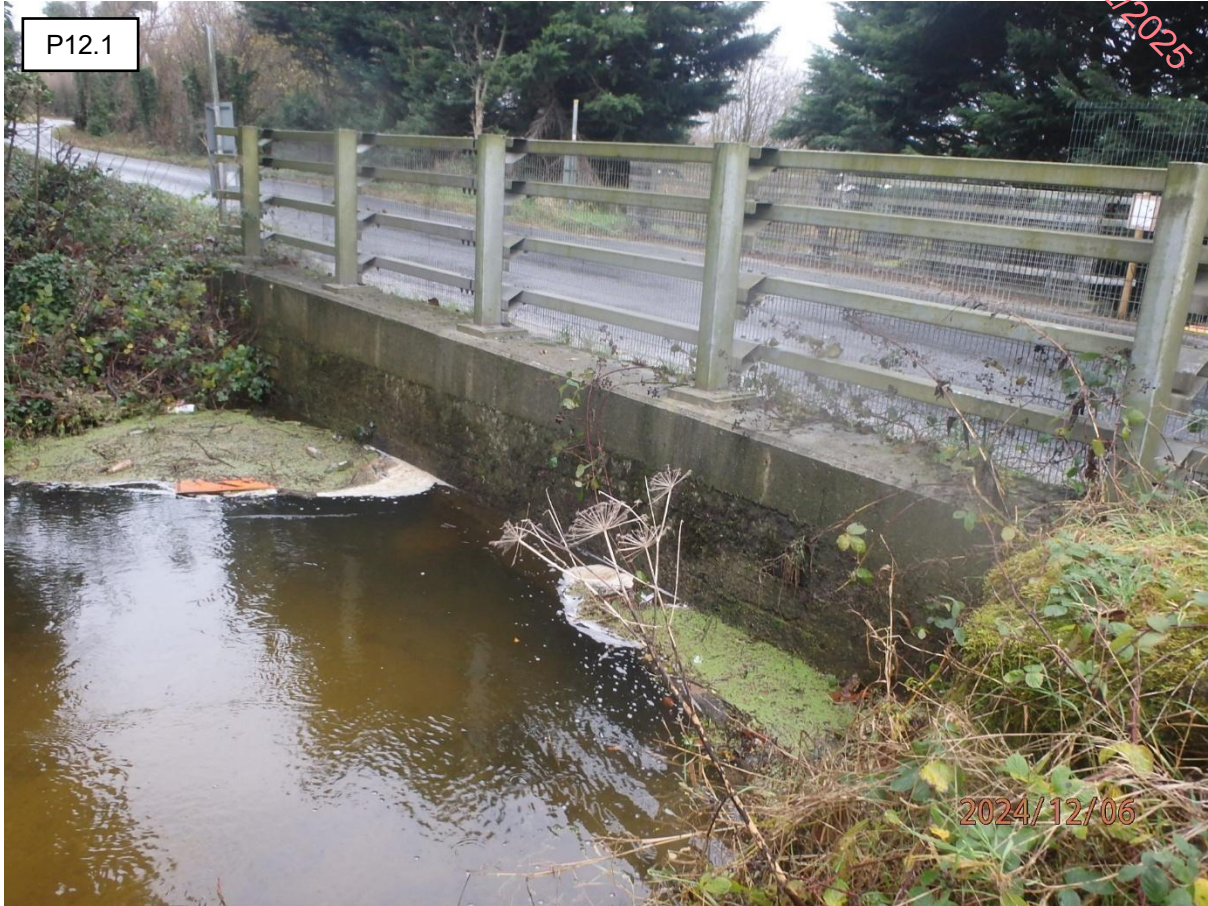
Component No. 12 Riverbed

The water level was above the soffit of the culvert. Debris buildup was visible. See Photo 12.1 (Looking upstream)

Condition/Maintenance. 1/N
