# APPENDICES INDEX

## Appendix 7-1      GSI & TII Scoping responses with Hydro-G technical responses

**Re: Proposed extension of limestone quarry, Kilree, Sheastown, Bennettsbridge, Co Kilkenny**

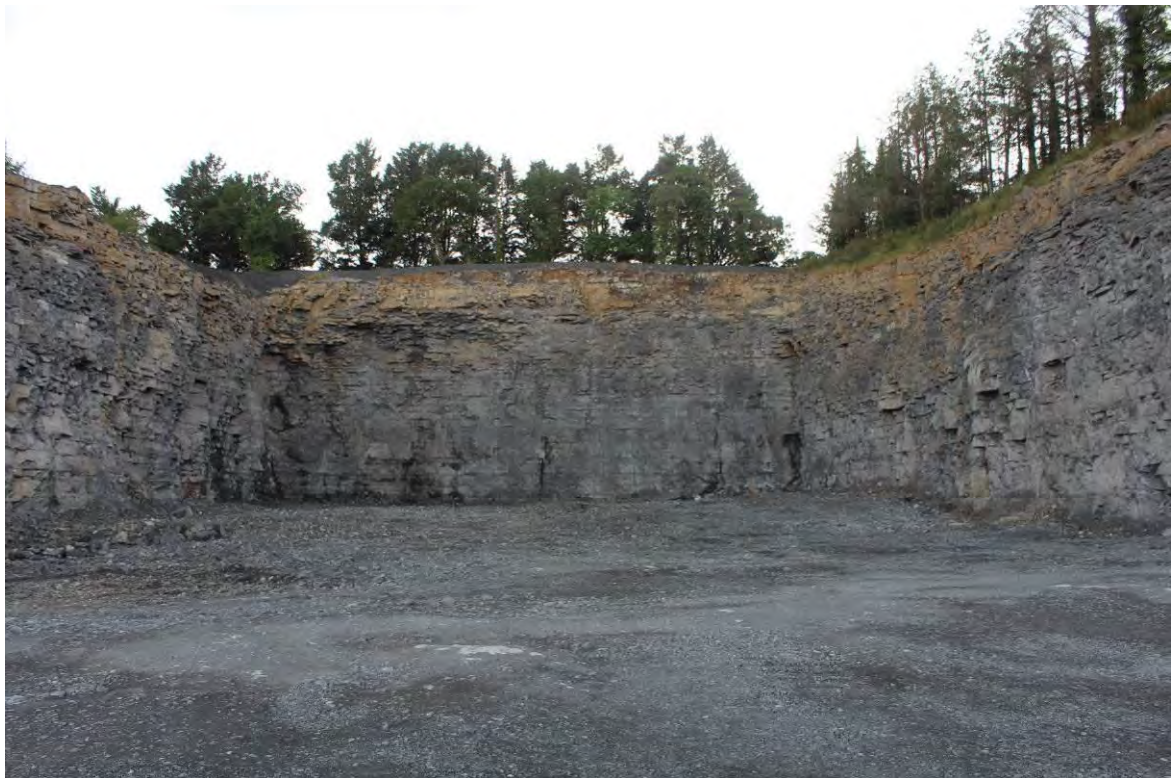
Since the last assessment the quarry has opened up an extension in the south west of the quarry. The rock in this section is of extremely good quality. There is little or no weathering and minimal structure despite some potential faults being identified in the geophysical investigation.

**Figure 7 South west extension upper face.**

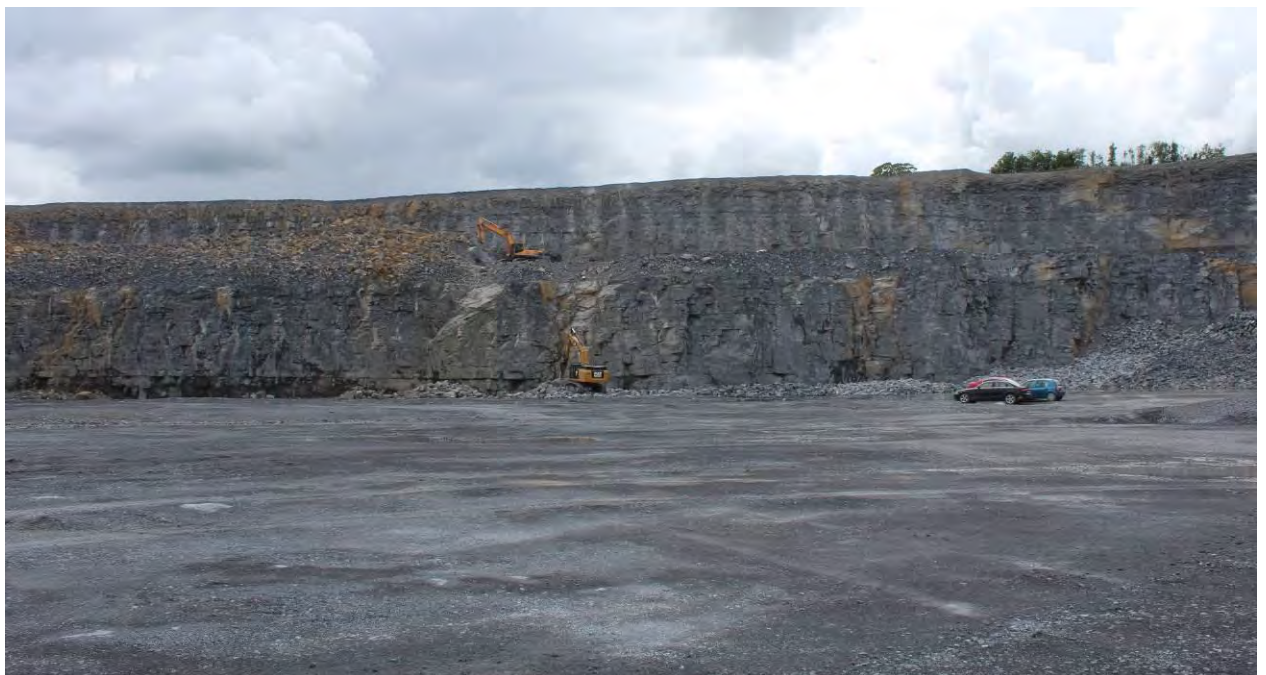
Although these is no deliberate contravention of the best practice for face stability in terms of face height a section of the East face has left an overall face height in excess of 20m and therefore this can be considered to be a significant hazard.

**Figure 10 The new south western side of quarry all benches under 20m in height**

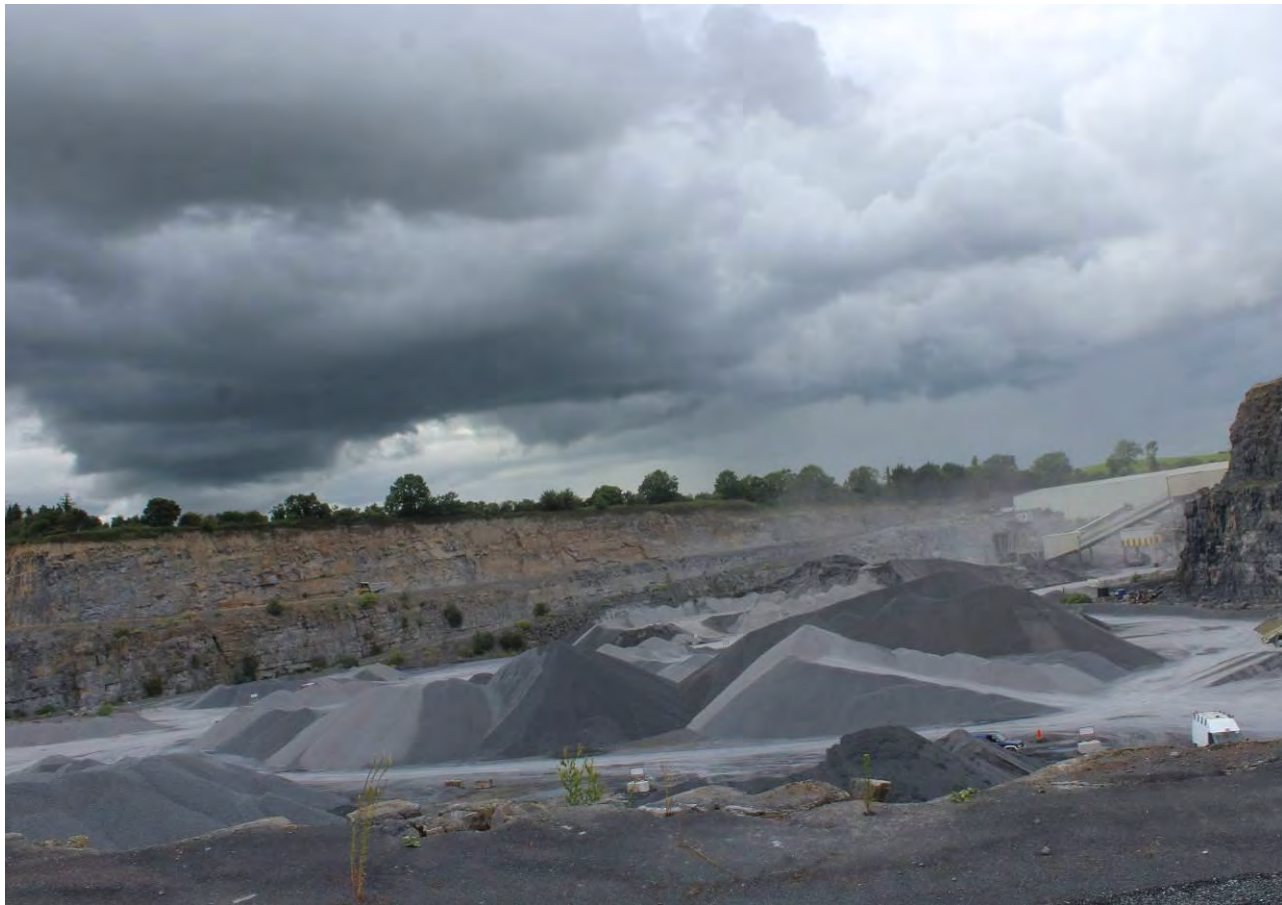
None of the stockpiles in Bennettsbridge Limestone quarry can be considered a significant hazard as part of the geotechnical appraisal.

**Figure 12 Showing the stockpiles in BBL Quarry**

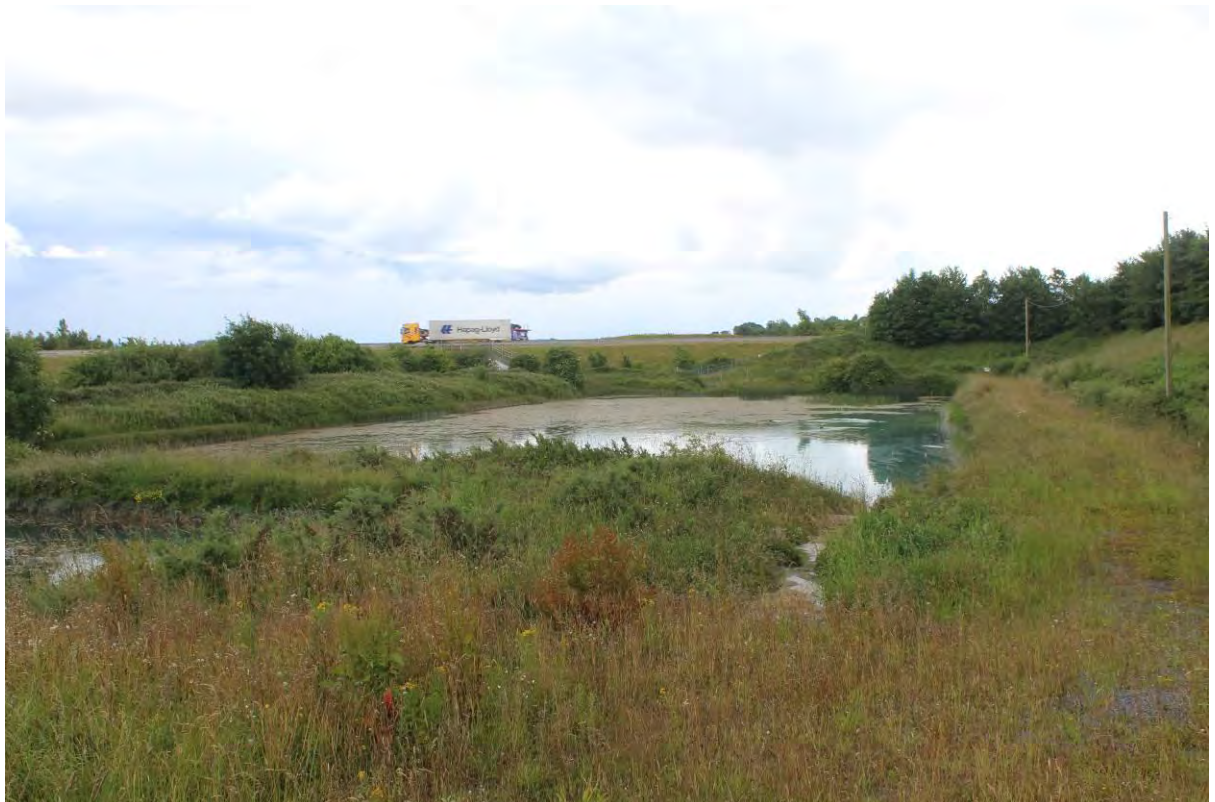
The size, location and orientation of the land around the lagoon are all within the accepted guidelines of the regulation and can be considered not to contain any significant hazards as per the geotechnical appraisal.

Figure 15 Showing larger settlement lagoon

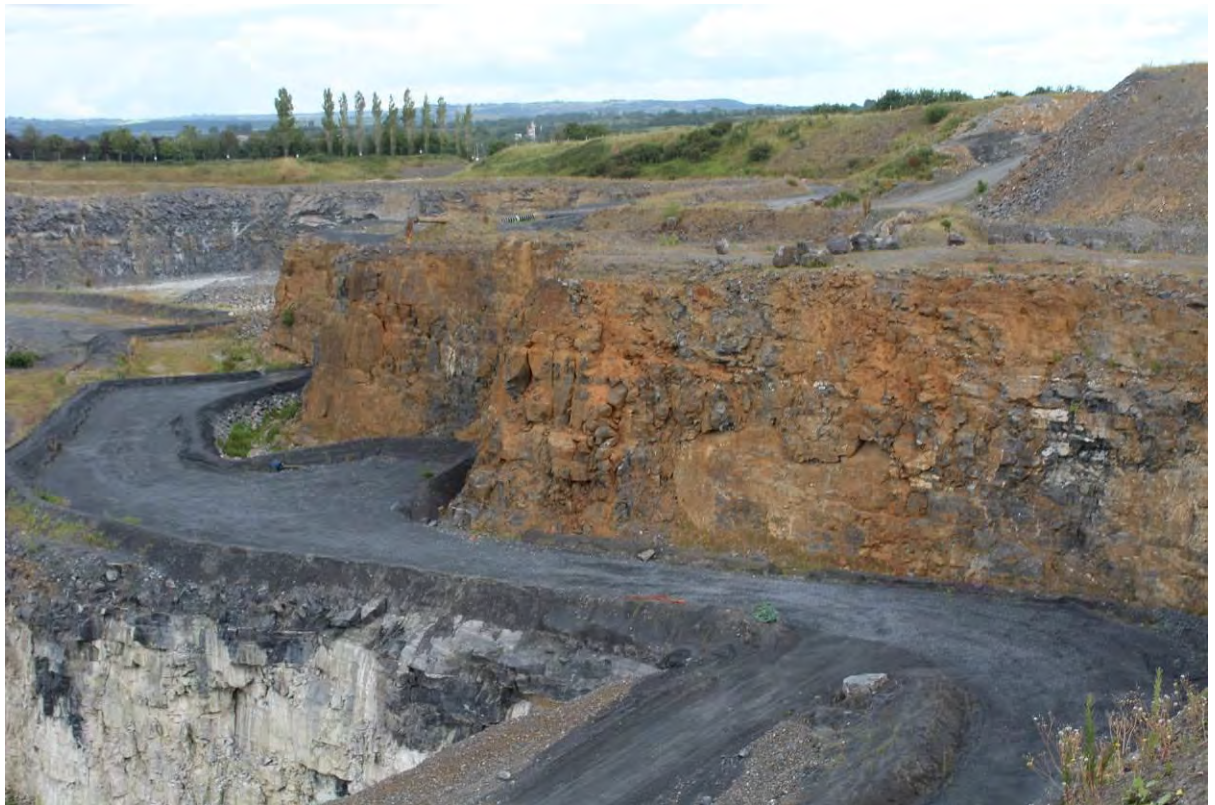
**Figure 17 Southern Upper Face**

Although there is very little exposure of quarry personnel to the southern upper face there appears to be loose present particularly on the corner to the left of the interim ramp access and in some other weathered portions of the face. There is also signs of previous small failures from the southern upper face and although small could be a sign that a larger instability is developing or that the face stability overall is deteriorating.

It is recommended that the rockfall bund and exclusion zone be increase in size or that the area be shut off completely and access be granted on an individual risk assessed basis when needed. The bund and exclusion zone need particular attention around the two corners identified on the image below:

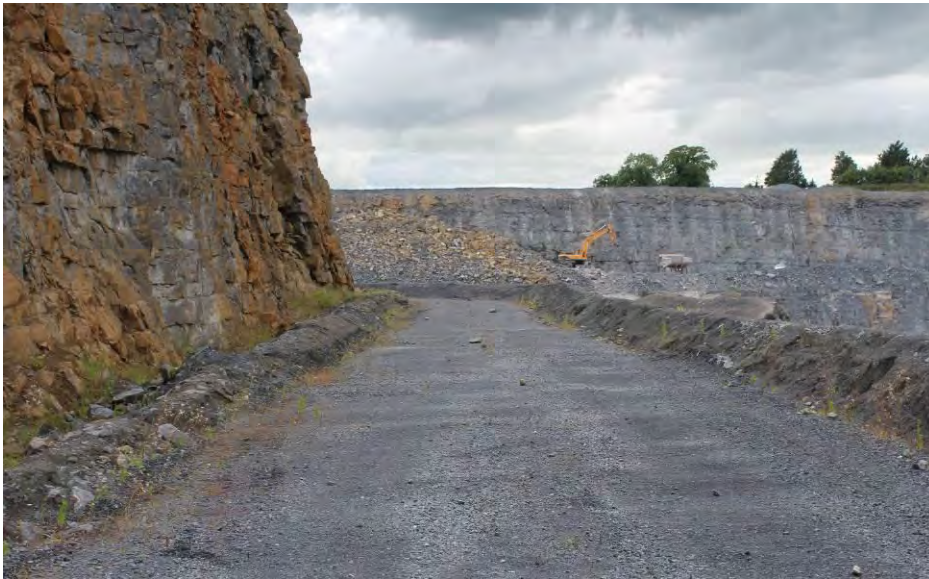
**Figure 18 Southern Upper Face weathered section and evidence of small loose rock**

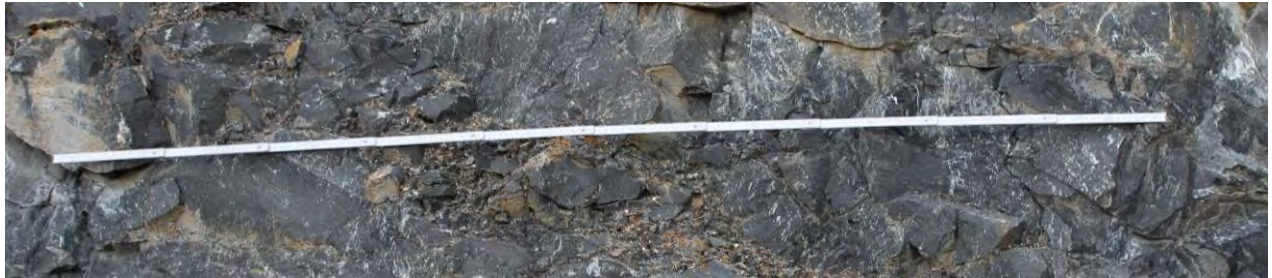
Aside from the visible loose on this face the rock is generally in good condition. There is some localised weathering around the primary joints set but the measured RQD at two locations is 75. All discontinuities were dry on the day of the site visit and have a medium to high persistence, high roughness coefficient and low aperture.

**Figure 20 RQD of Southern Upper face**

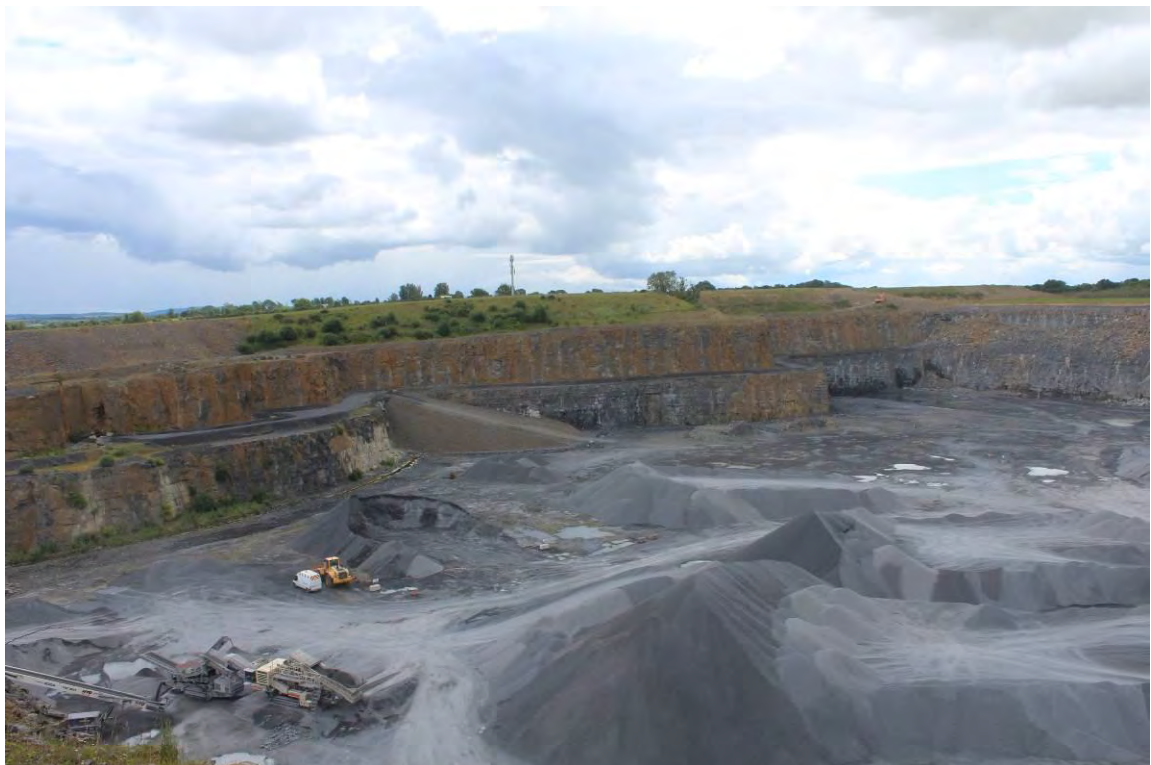
The lower southern face has not been significantly developed since the last AMS visit. It appears intact, unweathered and has a good face profile.

**Figure 21 Southern Lower face**

There is a large ramp obscuring a portion of the southern face but from what is visible there is no major geotechnical hazards observed.

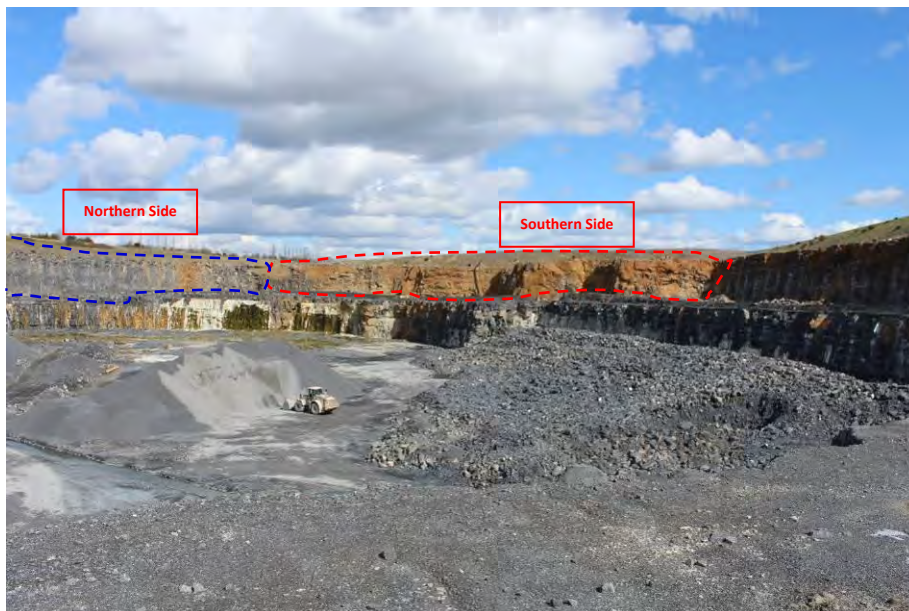
The Eastern upper face is essentially split into two distinct sections from a geotechnical perspective. The southern section highlighted in red in Figure 18 below is composed of a much more weathered rock as illustrated by the orange discoloration in the rock. The rock in this section of the quarry also has an increased dolomite content as it progresses towards neighbouring rock units. This face has remained entirely unchanged since the last assessment.

**Figure 22 Eastern Upper faces**

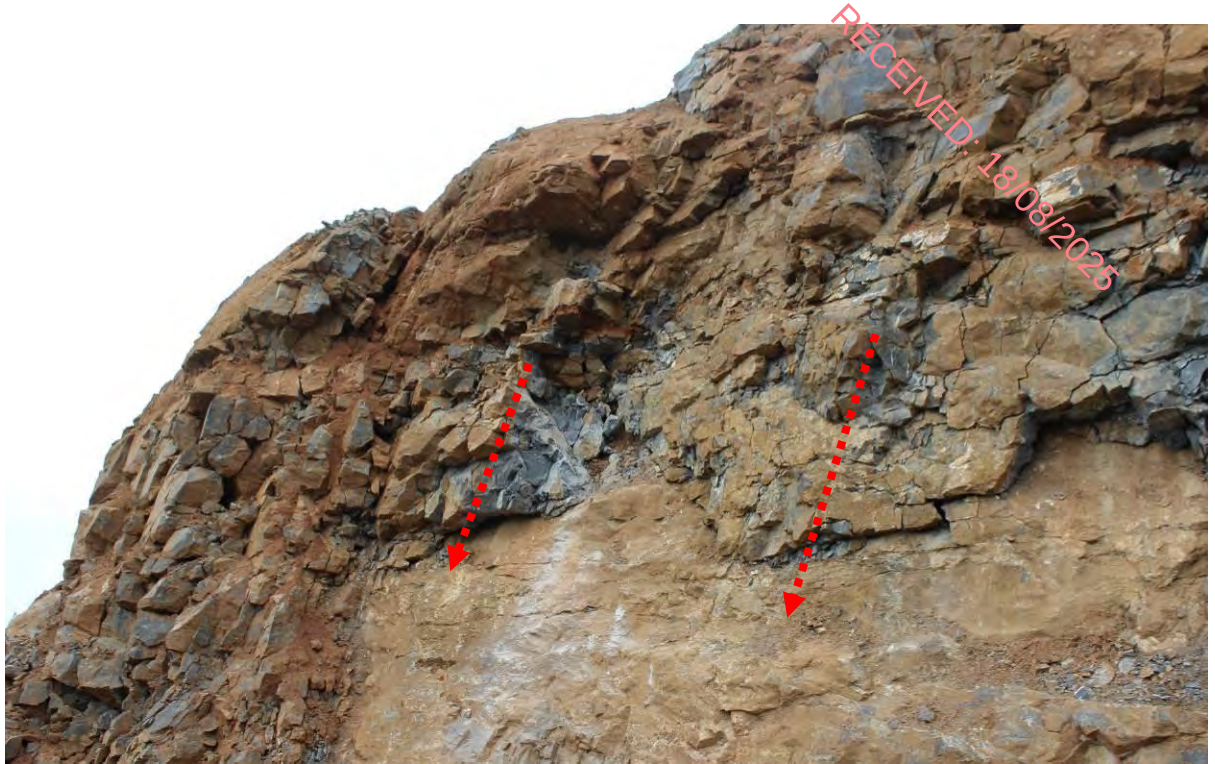
As has been highlighted in previous assessments there is a high degree of weathering in the southern upper east face but as access to this area has been limited the risk is low. Much like other faces there is a moderate amount of loose material in the upper sections of the face and some tension cracks at the top of the bench.

**Figure 23 Loose Material in Eastern upper face as evidenced from previous assessment**

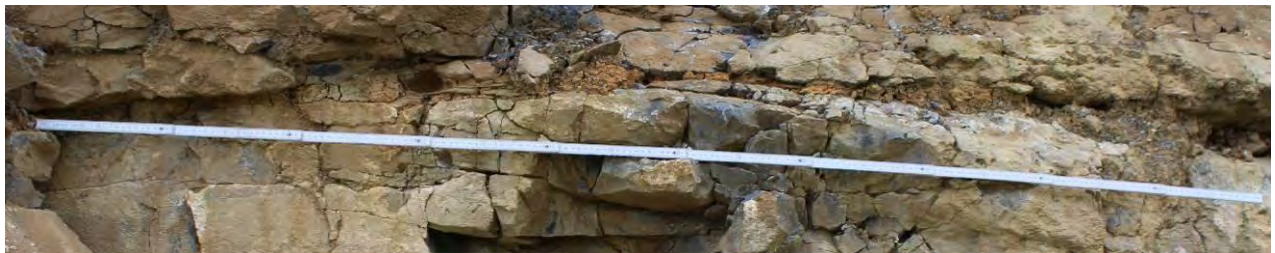
The measured RQD at two locations is 49. All discontinuities were dry on the day of the site visit and have a medium to high persistence, high roughness coefficient and low aperture. This rock is much more subject to degradation over time and as such should be subject to more regular face inspections.

**Figure 24 RQD of weathered section of eastern upper face.**

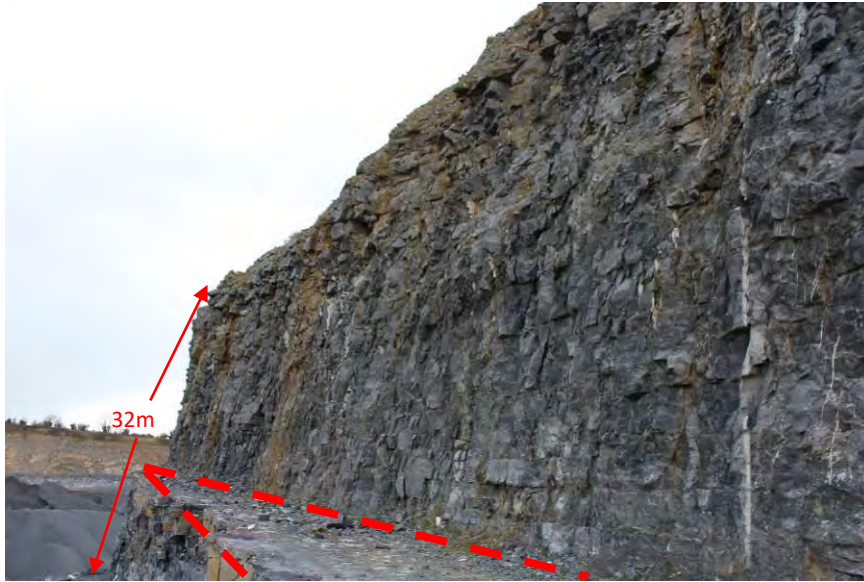
The northern section of the east upper face which runs from the far eastern corner of the quarry around to the lookout point is in a better condition than the weathered southern section. However, there is a greater degree of loose material particularly at the top of the face and there is also a short section where the middle bench reduces to a width that is too small to be considered as two separate faces making it a singular face that is 32m in height. By the 2008 regulation this is considered to be a

significant hazard. The 2016 assessment identified this hazard and recommended the quarry place an exclusion zone beneath this face. This exclusion zone remains in place to this day and access is restricted. There is evidence of loose rock that has fallen and been retained by this exclusion zone so this is working.

Figure 25 Eastern Upper face showing decreasing middle bench width

1. Increase and extend bund beneath the southern portion of the Eastern face particularly on the two corners identified in the assessment.

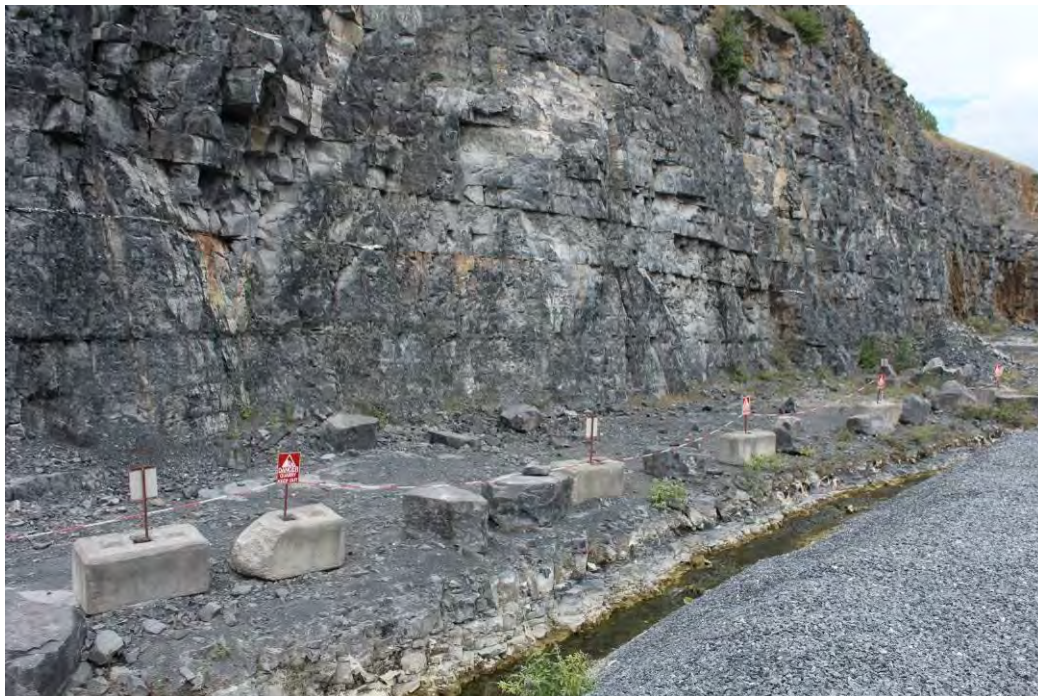
Figure 26 Beneath high face showing rockfalls.

The measured RQD at two locations is 90 making it a competent rock however the development of large loose blocks is clear in the upper sections of the face. All discontinuities were dry on the day of the site visit and have a medium to high persistence, high roughness coefficient and low aperture.

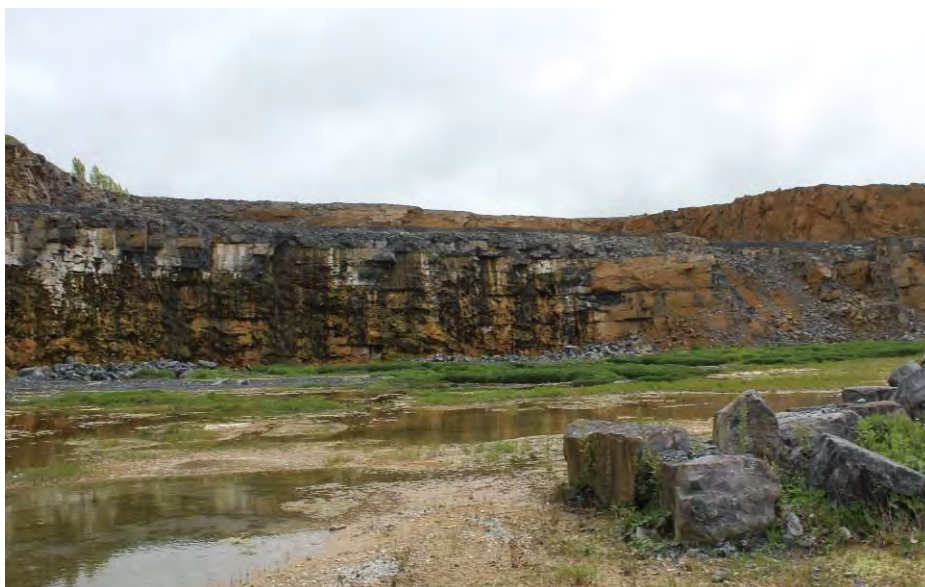
The lower eastern face has not been worked since the last assessment. This face is noticeably the wettest face in the quarry and also is visibly more weathered than most lower faces. The rock in this section also appears to be more dolomitic in composition than the rest of the quarry. Despite the weathered nature of the rock and the presence of water which always adds to stability concerns this face appears to have less loose material than others. This could be down to the fact that additional face dressing/ scaling has been conducted or due to the fact that the face has a noticeably shallower angle than most of the other faces which are vertical.

**Figure 27 Eastern Lower Face**

There is little or no work going on in this area and AMS has no further stability recommendations for this face.

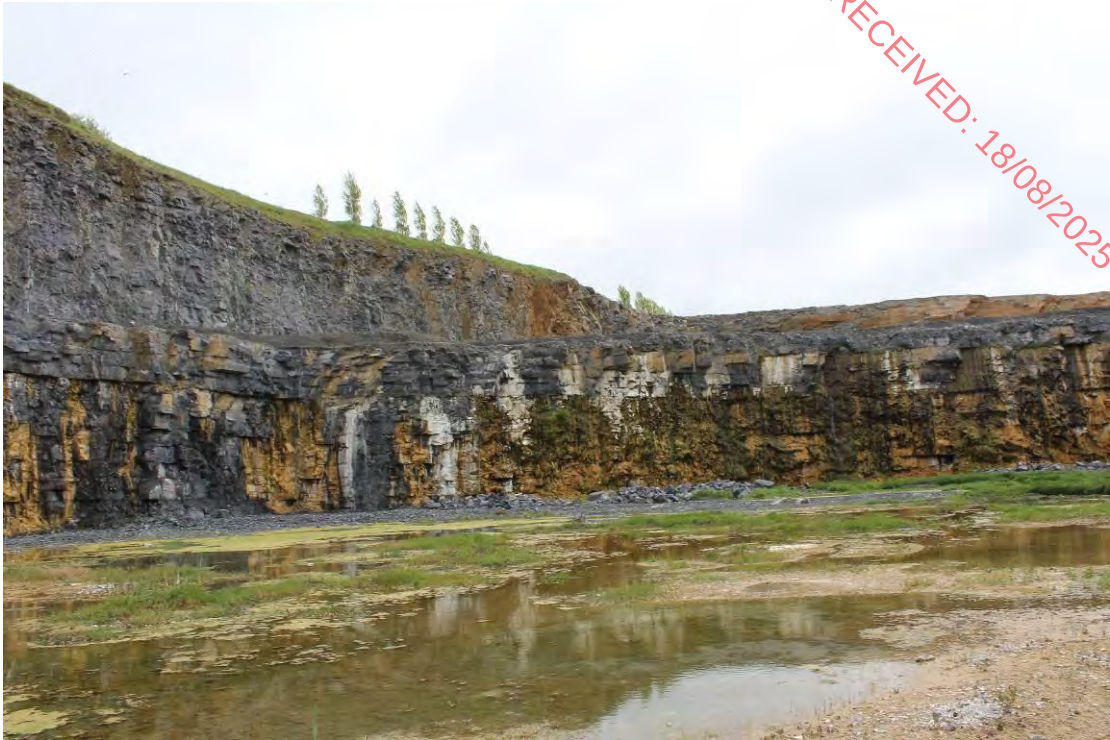
**Figure 28 Eastern Lower Face water infiltration**

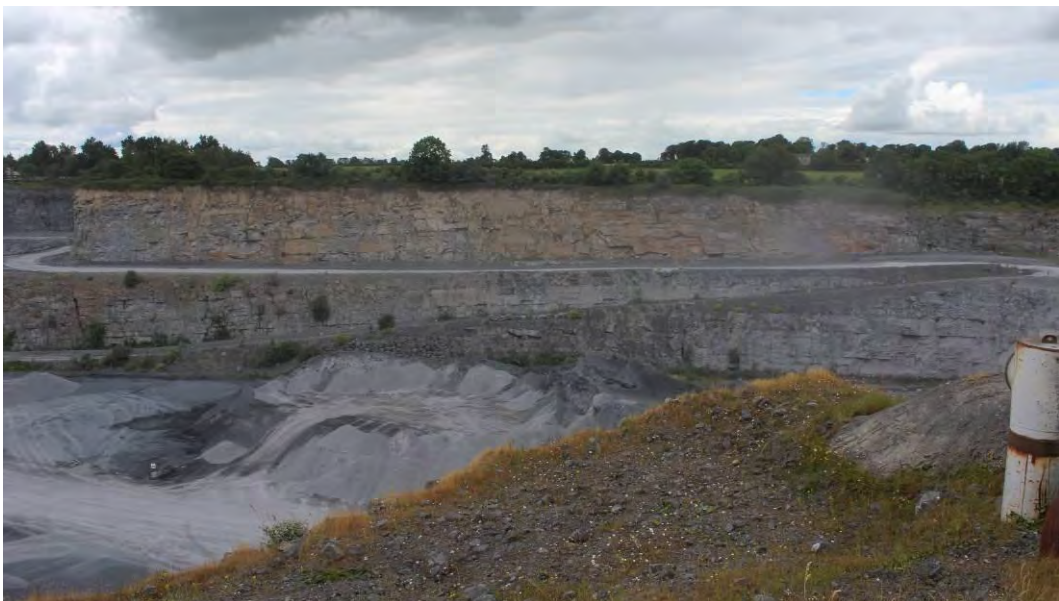
**Figure 29 The western face (northern portion)**

The northern portion of the western faces in Bennettsbridge Limestone Quarry shown above have been in place and stable for quite some time. They are not considered active faces and have not been for a number of years. The majority of the activity is now in the southern western face. Some hazards have been identified in this area in previous geotechnical assessments specifically relating to a large overhang in the upper benches and the main fault system but these hazards have been recognised and control measures in the form of catch trenches and bunds have been put in place.

Other than monitoring the faces underneath which the rock is being hauled from the south western portion of the quarry AMS has no further recommendations for the northern portion of the west face

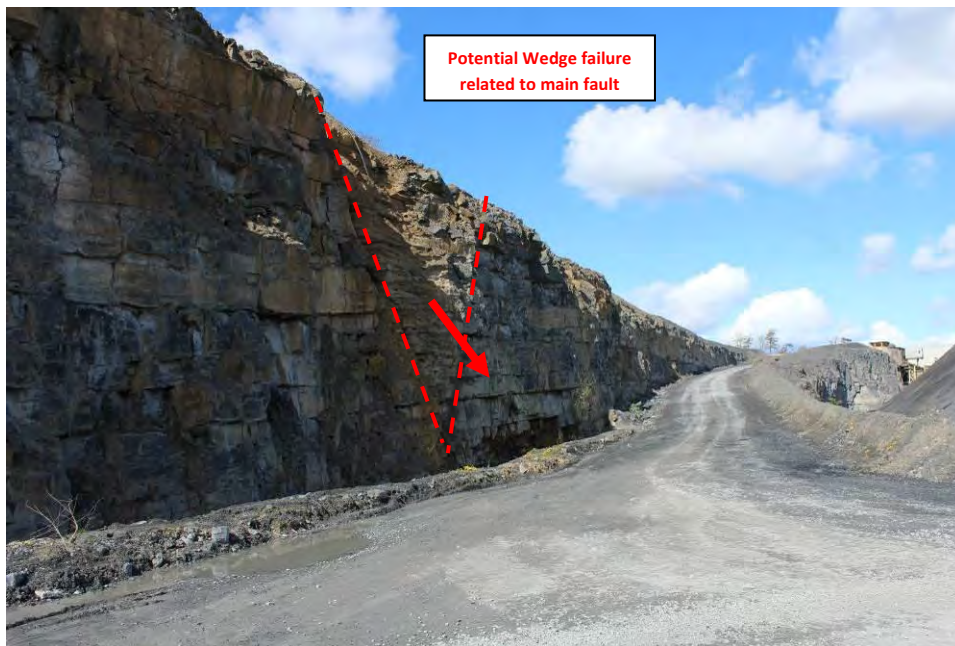
**Figure 30 Potential Wedge failure related to main fault**

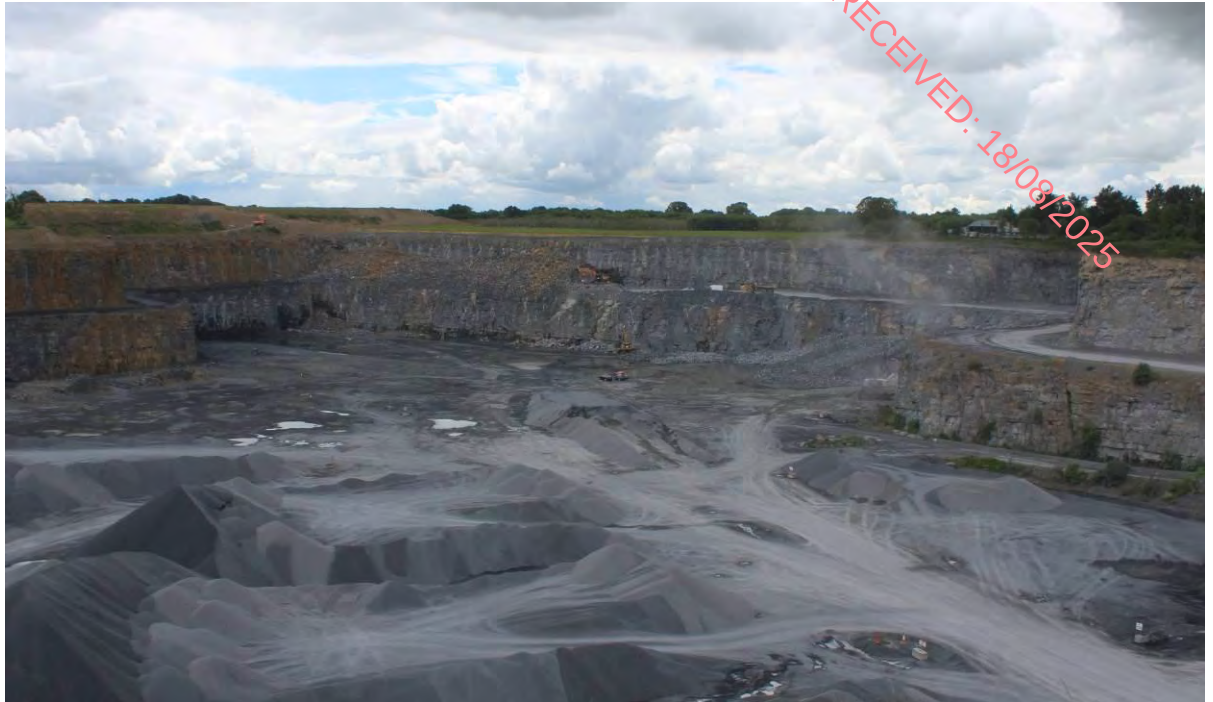
The southern portion of the western face is the most recently active in the quarry and is where the majority of the development has been conducted for a number of years. More recently the quarry has stripped off overburden heading westwards either side of a farm building and quarried the upper bench westwards. A visual assessment of this area shows it to be stable and the individual face heights are within acceptable parameters.

**Figure 31 South Western face**

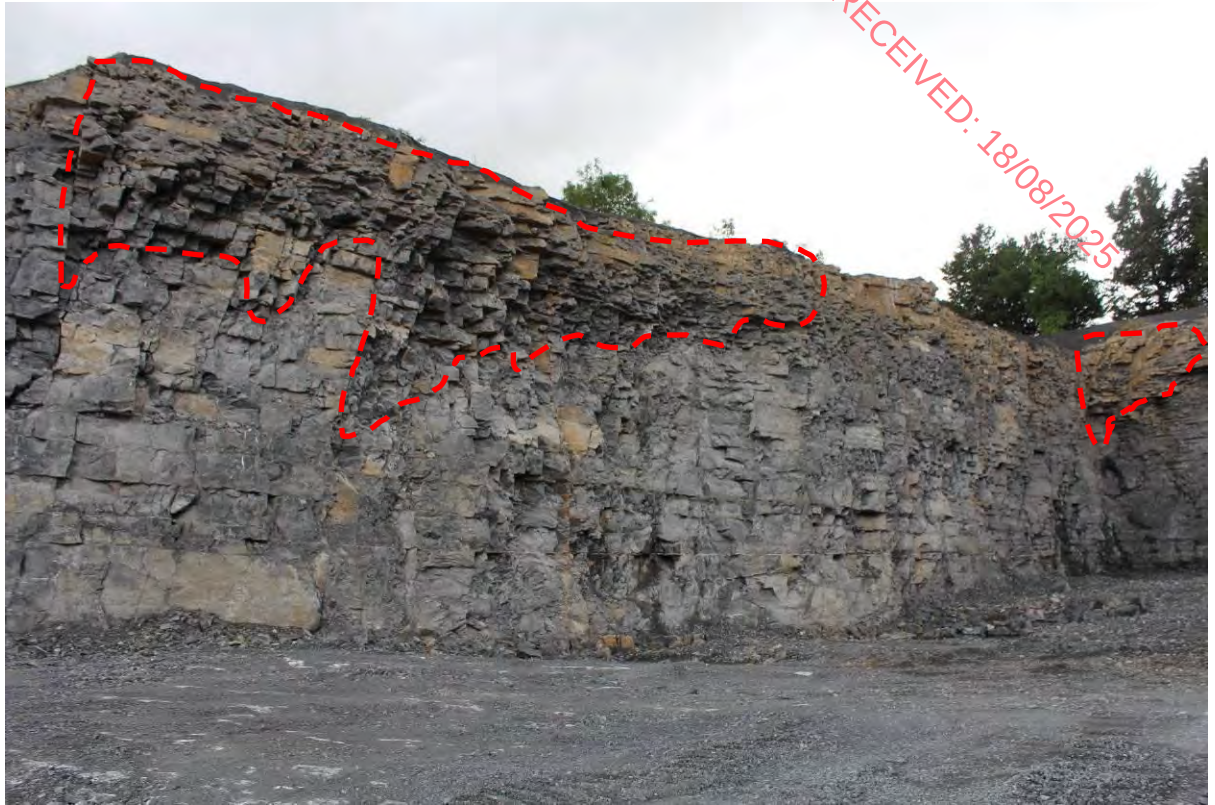
The only observable way in which that stability of the faces in the south west corner could be improved is the presence of overhangs at the very top of some of the faces.

**Figure 33 Overhang in south west corner**

Over time the sugar cube like jointing in the overhang can deteriorate creating a loose rock hazard. This can be avoided by reducing the stemming in blast holes or by dumping the blast holes forward more than 10 degrees. This ensures a stable face profile and is also more efficient for blast fragmentation by directing more blast energy upwards.

Other than dumping future blast holes forwards AMS has no further recommendations for this face.

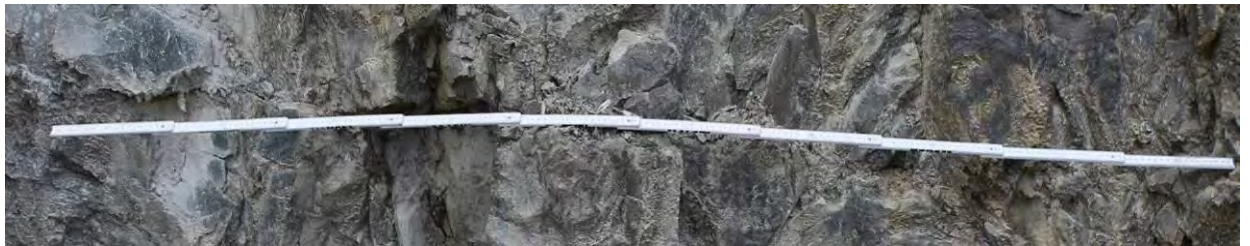
The measured RQD at two locations in the Northern faces is 92 making it a competent rock. All discontinuities were dry on the day of the site visit and have a medium to high persistence, high roughness coefficient and low aperture.

**Figure 35 Northern Upper face RQD**

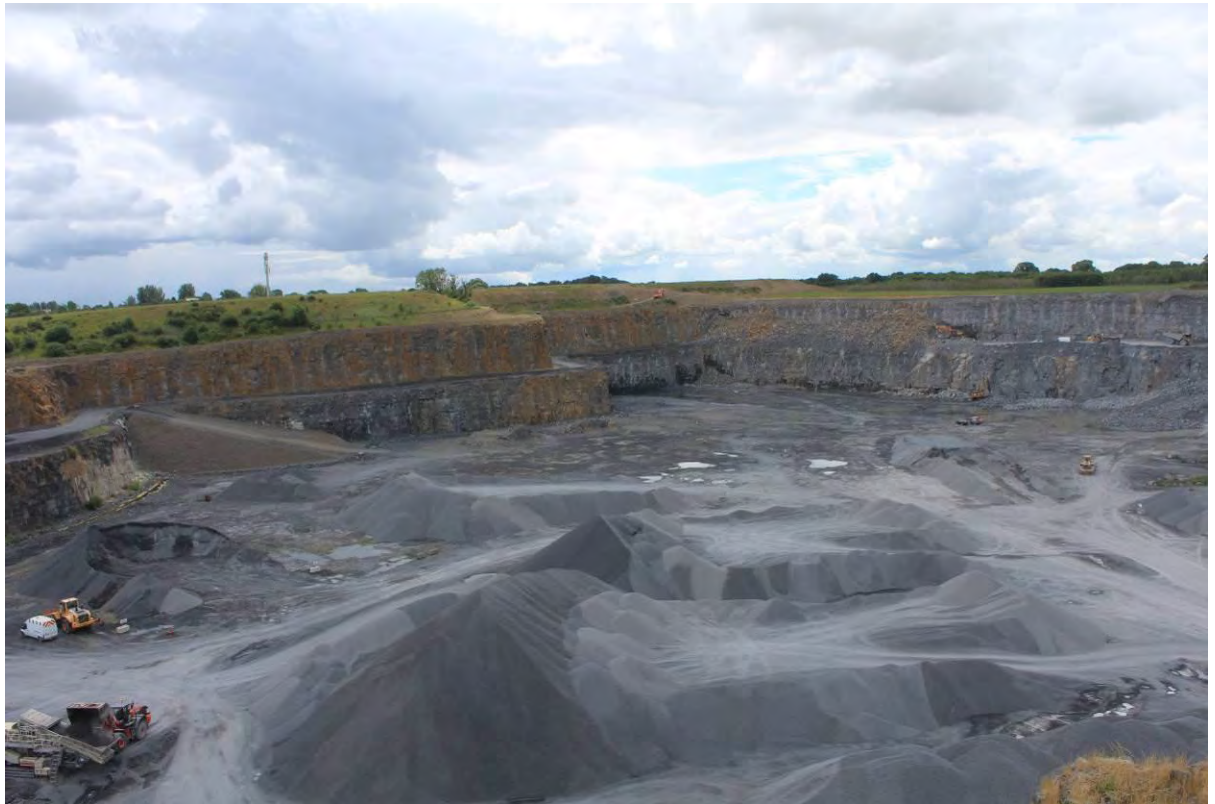
From the site investigation/ geotechnical appraisal it was noted that all stockpiles appear to conform to the guidelines set out in the 2008 regulations. All stockpiles are below 20m in height, do not cover an area greater than 10,000m<sup>2</sup> and are sufficiently drained so as not to cause liquefaction.

All stockpiles are bring loaded and unloaded correctly and there appears to be good awareness of stockpile management amongst management and staff at BBL.

**Figure 36 Showing stockpiles at BBL**

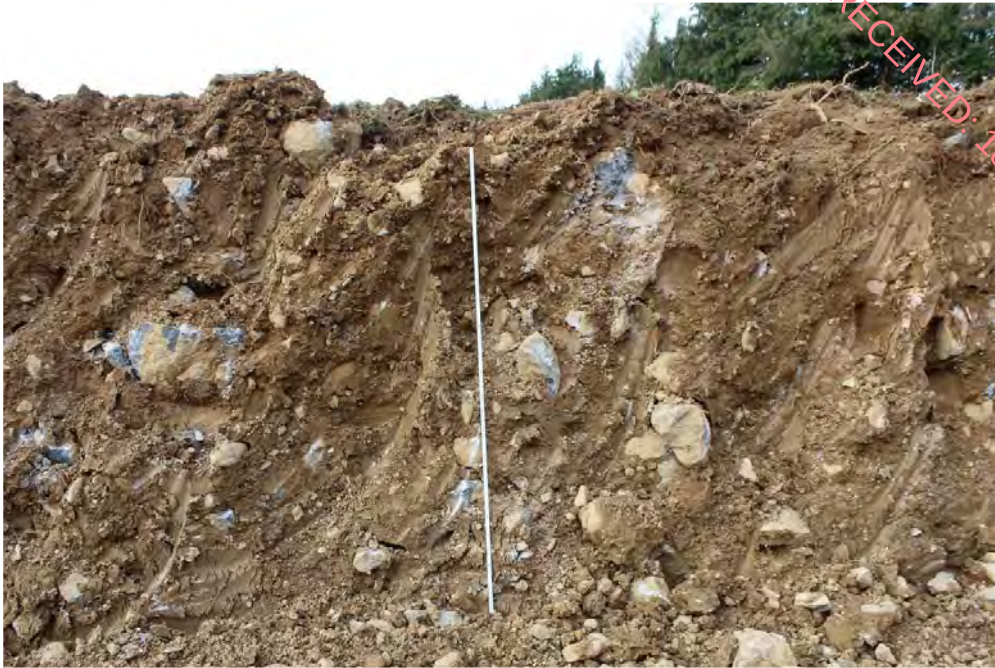
Since the last assessment a significant bund has been placed to the south of the quarry site along the boundary with the M9 motorway. During construction material was excavated from the south western extension of the quarry. The material was found to be a medium brown, sandy, gravelly CLAY with intermittent grey to blue limestone cobbles.

**Figure 37 Excavated material used in bund construction**

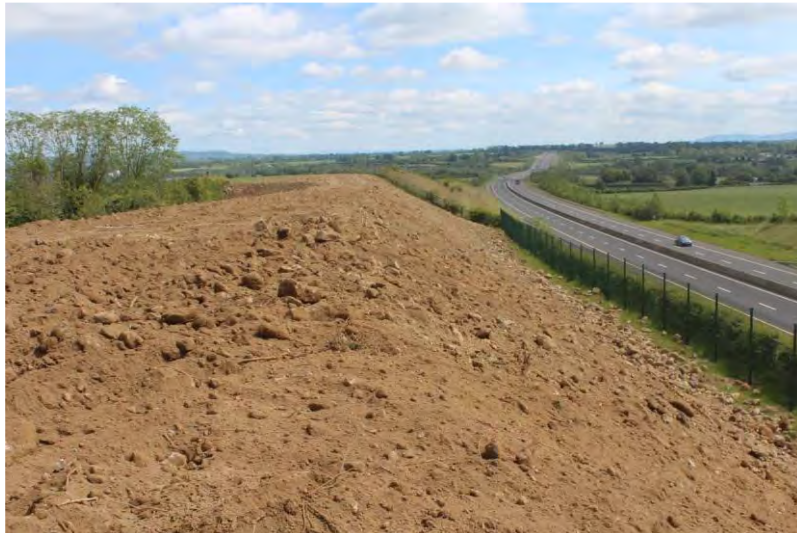
**Figure 40 Bund on completion**

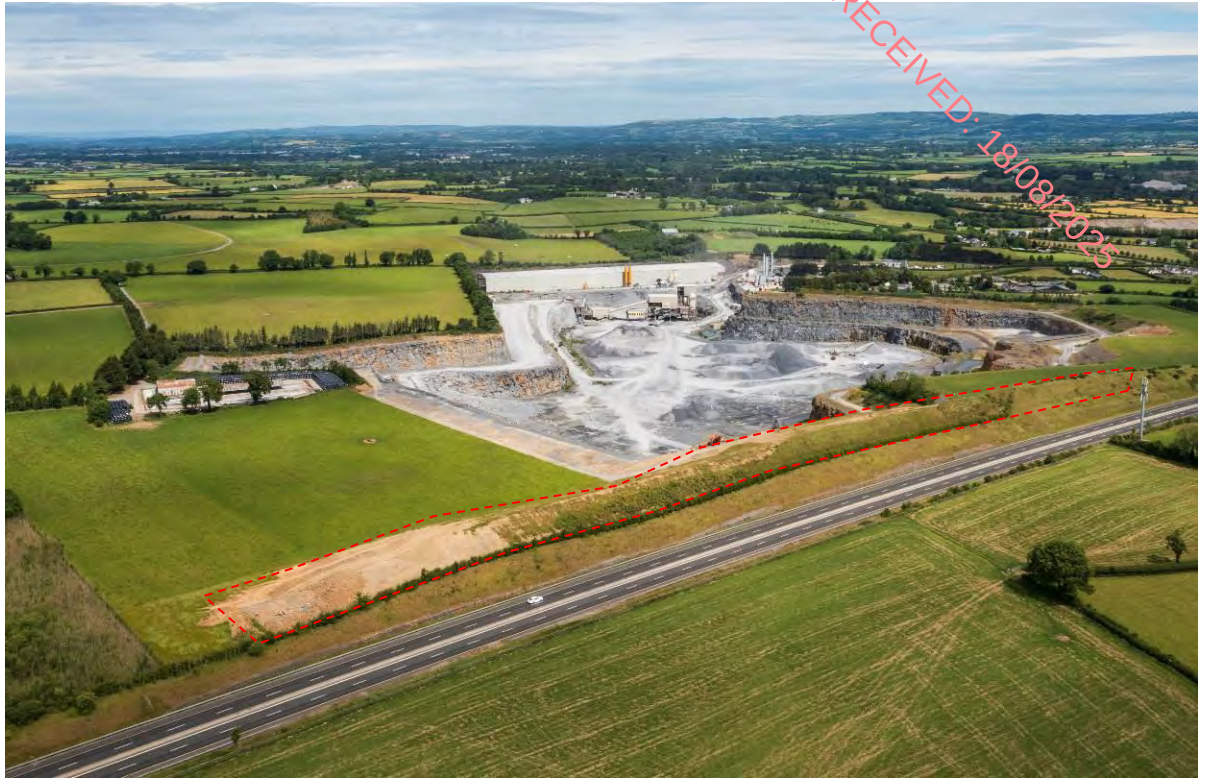
Since the last AMS visit vegetation has started to take hold which will further aid stability. AMS has no further recommendation relating to the bund and it will be re-assessed during the next geotechnical assessment.

**Figure 41 Showing Bund at BBL**

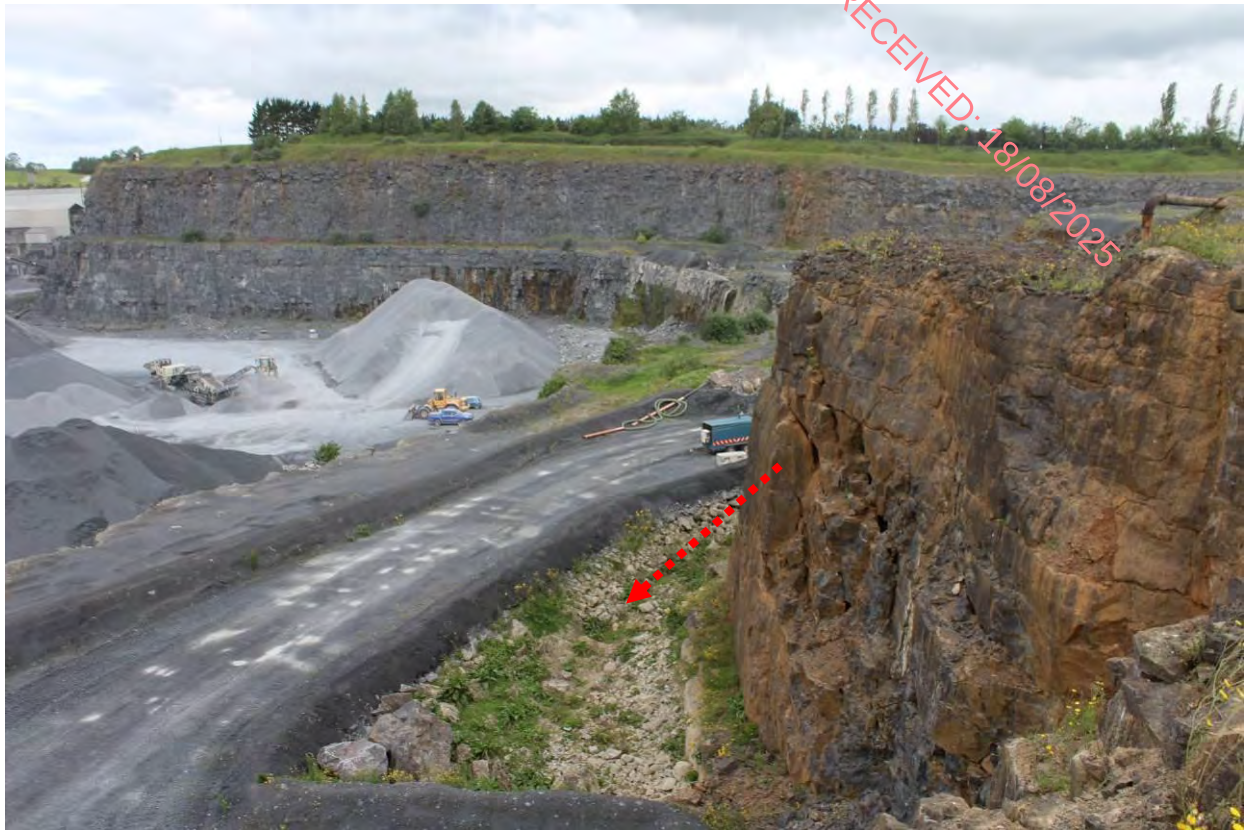
**Figure 21 Loose Material in Eastern upper face**

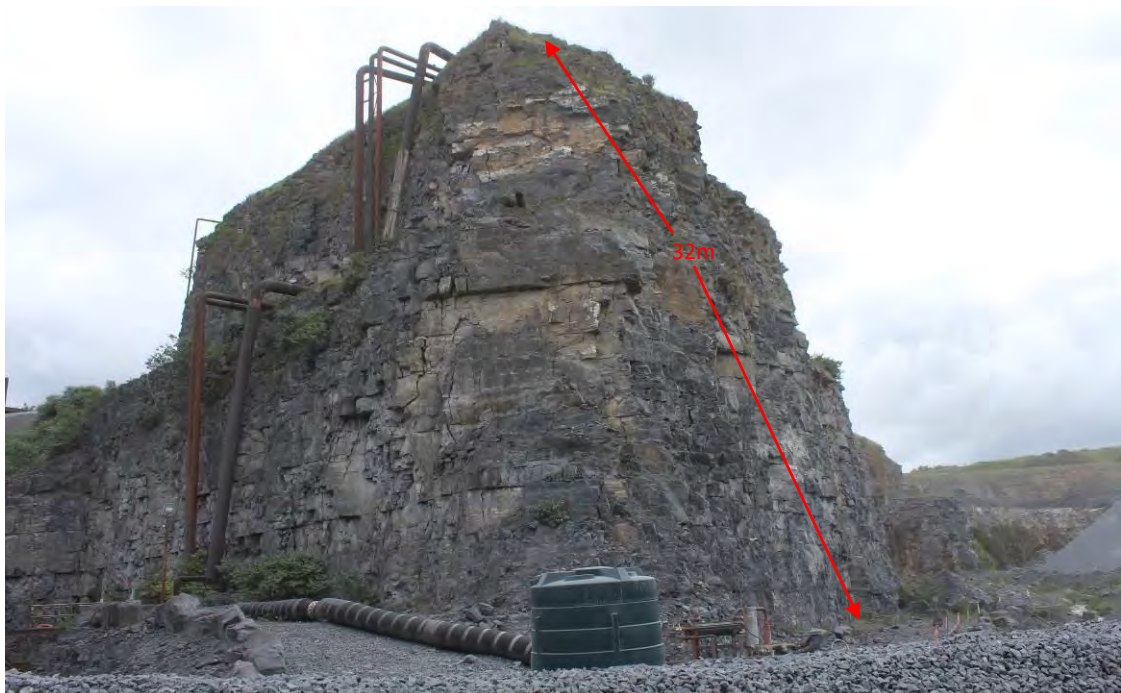
**Figure 23 Eastern Upper face showing decreasing middle bench width**

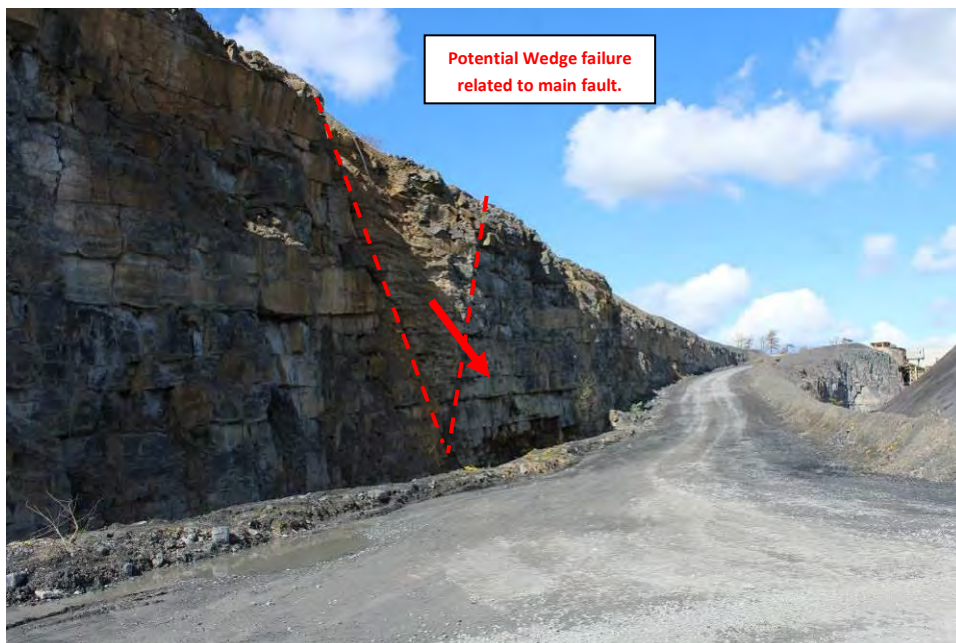
**Figure 28 Potential Wedge failure related to main fault**

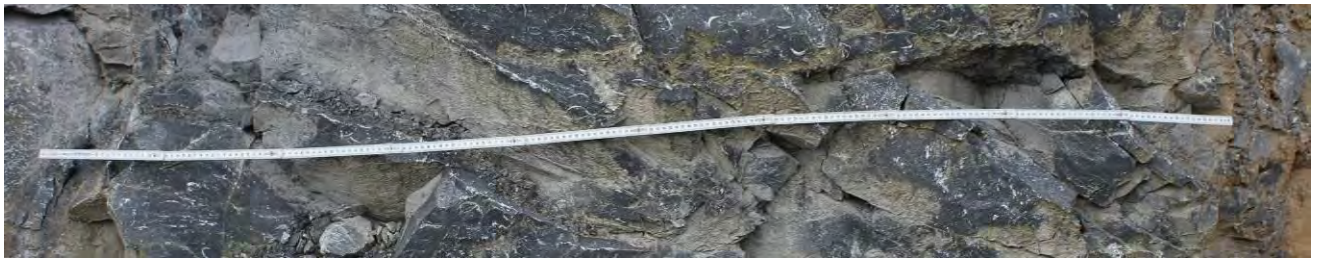
Upper South Western face: Minor Weathering. medium thick bedded limestone. Medium to large joint spacing. Low joint aperture with some light brown staining. RQD-78.
