# APPENDICES INDEX

## Appendix 7-1      GSI & TII Scoping responses with Hydro-G technical responses

**Re: Proposed extension of limestone quarry, Kilree, Sheastown, Bennettsbridge, Co Kilkenny**

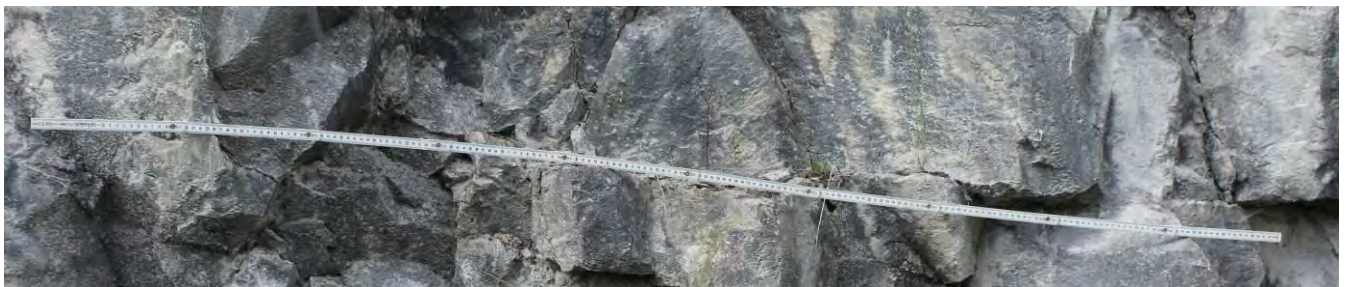
Middle South Western face: Unweathered, medium thick bedded limestone. Medium joint spacing. Low joint aperture with clean joint surface. RQD-82.

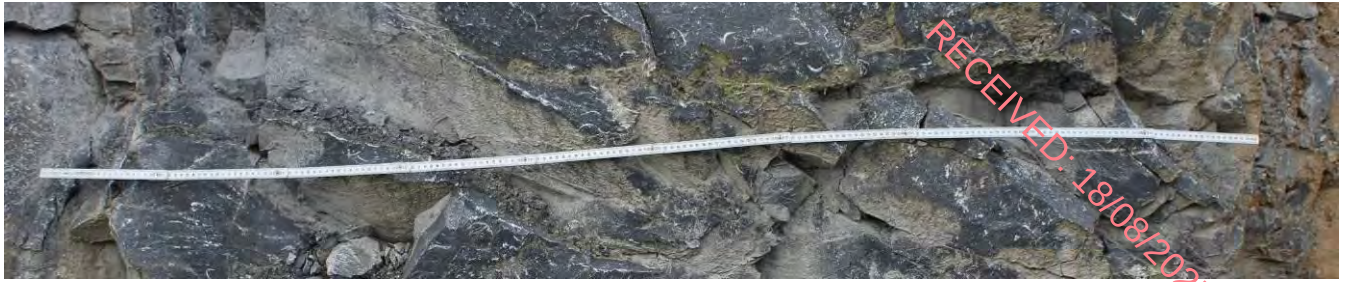
Upper North Western Face: Minor Weathering, medium thick bedded limestone. Medium to large joint spacing. Low joint aperture with some light brown staining. RQD-84.

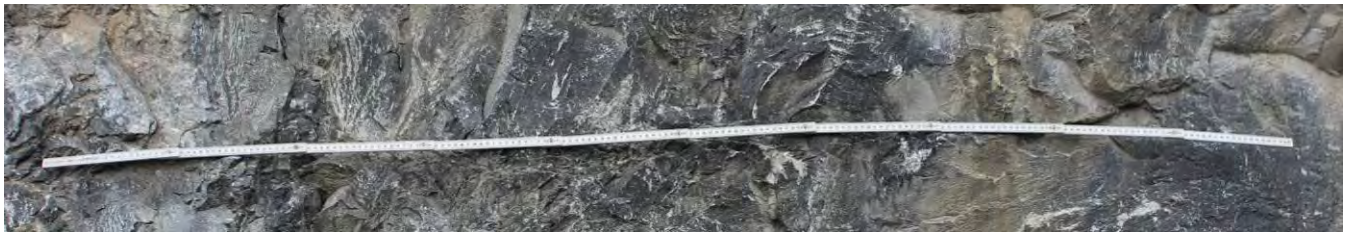
Upper North Western Face: Unweathered, medium thick bedded limestone. Medium joint spacing. Low joint aperture with some light brown staining. RQD-88.

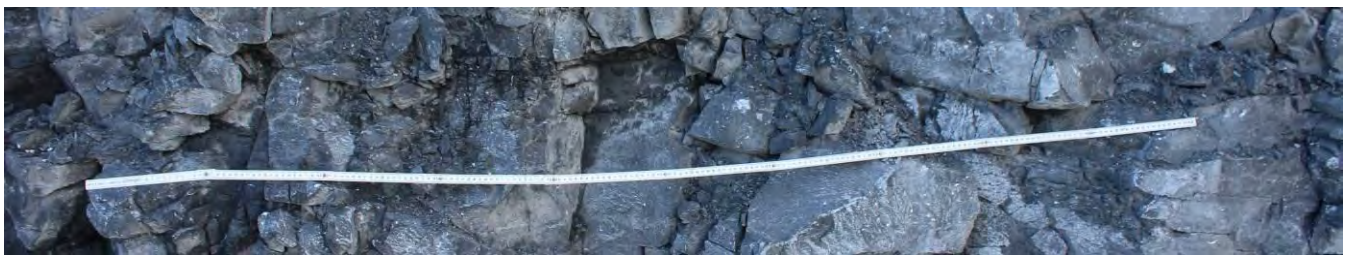
Upper North Western Face: Unweathered, medium thick bedded limestone. Medium joint spacing. Low joint aperture with clean joint surface. RQD-76.

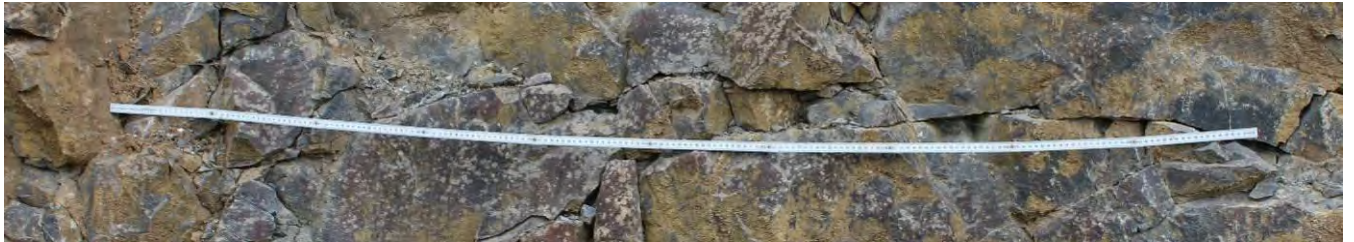
Middle North Western Face: Minor Weathering, medium thick bedded limestone. Medium to large joint spacing. Low joint aperture with orange staining. RQD-86.

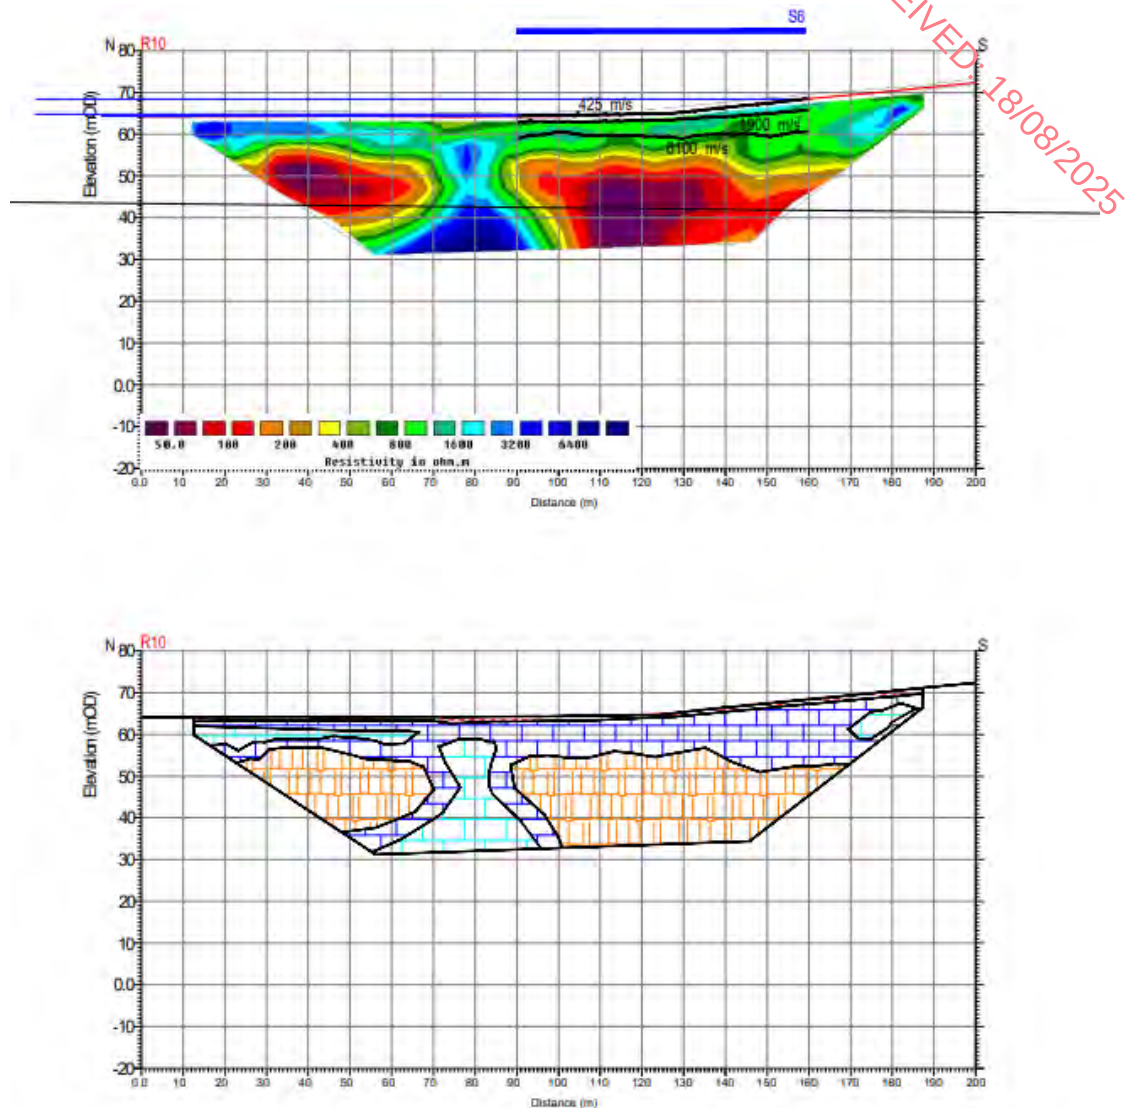
**R10**

The interpreted inverse resistivity profiles show large areas of clean limestone throughout. In the north west area of the extension there is an area of highly weathered limestone towards the south which correlates with the orientation of the existing known structure highlighted in Figure 5. Although this structure has some aperture and clay infill the weathering surrounding this structure is highly localised and it will pose little stability issues to blasting operations if handled in a similar manner to how it has been managed to date.
