## NOTIFICATION OF REQUEST FOR CLARIFICATION OF FURTHER INFORMATION

D26A/0408/WEB

10, Carysfort Downs, Stillorgan, Co Dublin, A94X544

21 August 2026

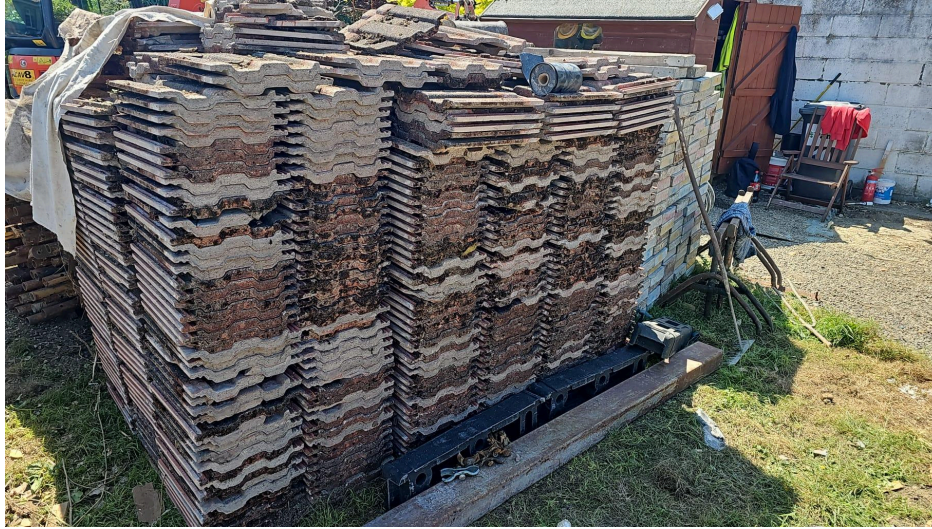
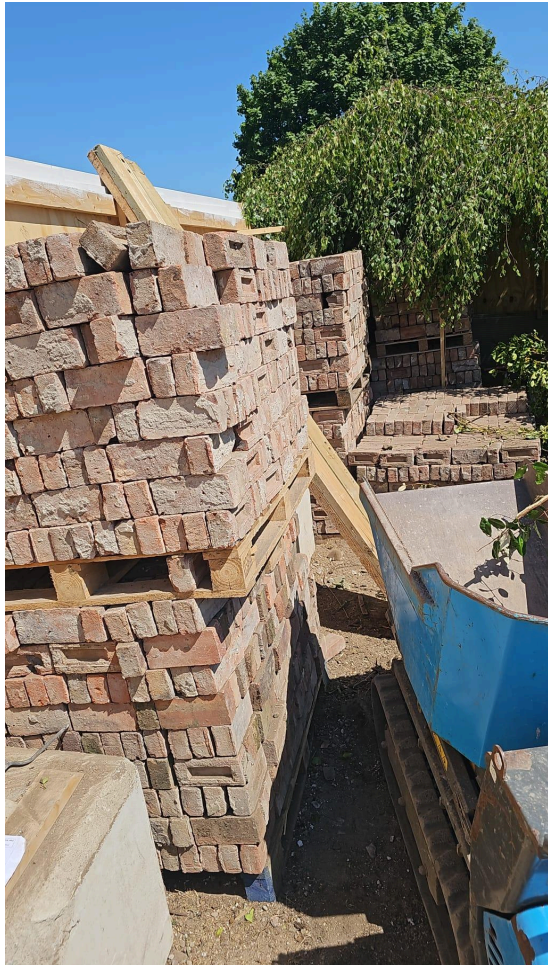
*Salvaged brick and tile on stored on site*

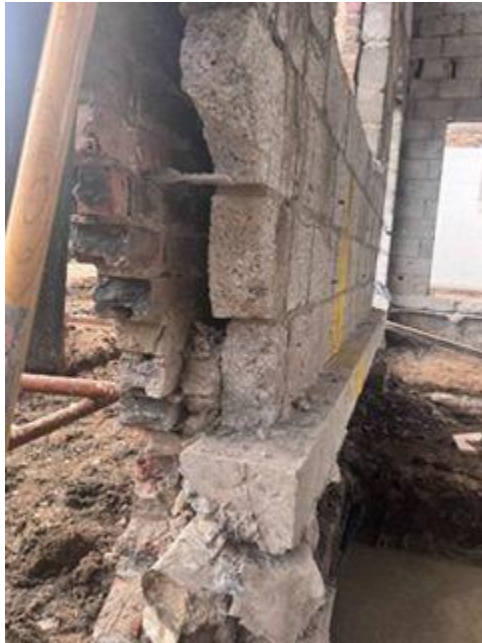
As described above, the primary defect uncovered in the structure was that the mortar bond had failed. In simple terms, the blocks and bricks did not adhere to each other. They could be easily removed from the walls by hand, the entire walls flexed or wobbled and this can be seen in this [video](#) taken at first floor. This failure was extensive and observed on both floors on all external walls. Please refer to photographs in [Appendix B](#)

*Original house wall construction showing cavity wall present 12 May 2016*

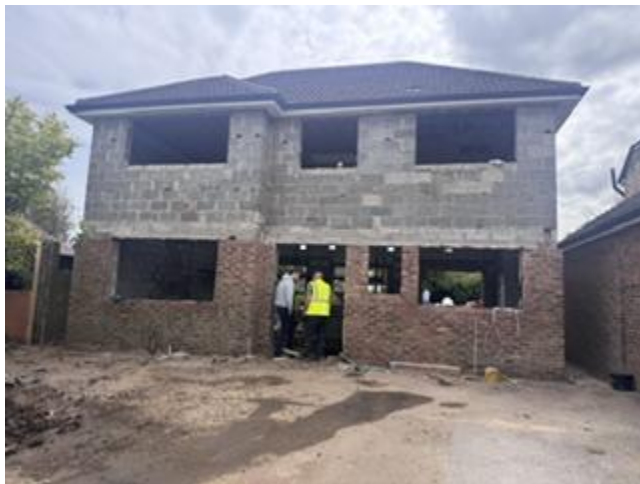
*Original house - stripped for refurbishment 12 May 2016*

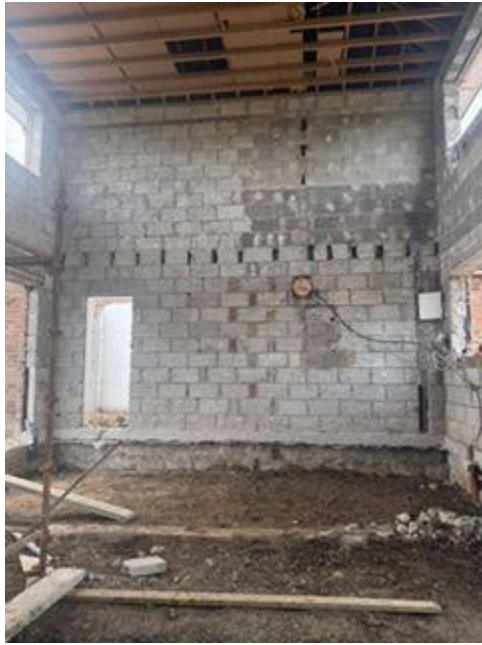
*Original house - stripped for refurbishment 12 May 2016*
