DART+ West Project
Section B: M50 to Barberstown

Stage 1 Road Safety Audit

Document Ref:	P22-021-PSW2-RP-001
----------------------	----------------------------

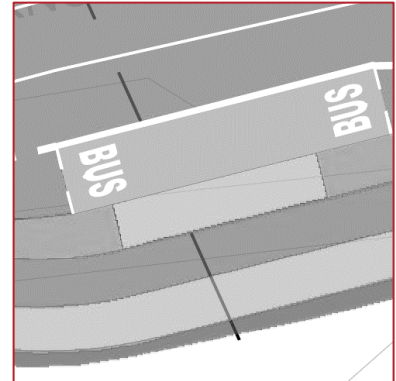
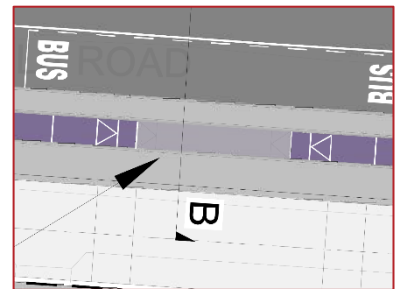
3.1.1 Problem

Summary: Potential for cyclist-pedestrian collisions and slips, trips, and falls where bus passengers are required to cross the cycle track when boarding or disembarking buses throughout the Scheme.

Bus stops have been indicated on some arms of the Castleknock Road and Clonsilla Road Junctions and at the Clonsilla Level Crossing. The road layout at the bus stops requires passengers boarding or disembarking the bus to cross the cycle track to access the bus stop/footpath. The segregated cycle track is indicated as being continuous through bus stop locations at both junctions while at the Clonsilla Level Crossing the cycle track is terminated either side of the bus stop to permit access to/from the bus.

Pedestrians, particularly the visually and mobility impaired, may be unable to safely access the bus stop resulting in an increased risk of being struck by a cyclist, or trips and falls at the vertical separation between the footway and cycle track.

Where a link between the footpath and bus stop has been indicated (Clonsilla Level Crossing), tactile paving has not been indicated at the cycle track terminations which may lead to visually impaired pedestrians inadvertently accessing the cycle track and being struck by a cyclist.

The segregated cycle track should transition to a shared use footpath upstream of bus stop locations. Ladder and tramline tactile paving, as well as relevant signage, should be provided at the transitions between the cycle track and shared use footpath.

Note, the use of uncontrolled crossings between the footpath and island bus stop may not support visually impaired pedestrians, as they will be unable to locate the tactile paving when disembarking the bus.

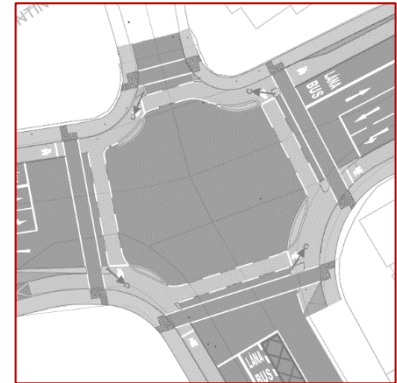
3.1.2 Problem

Summary: Swept paths at proposed signalised junctions have not been provided to the Audit Team and it is therefore unclear if all vehicles can safely complete turning manoeuvres within the extents of their traffic lane.

Information regarding swept path analysis has not been provided to the Audit Team. As the proposed junction upgrades include the introduction of physical islands within the junction layout, the width of the carriageway will be reduced in places. It is therefore unclear if HGVs and buses will be able to complete turning manoeuvres within the carriageway extents. If turning manoeuvres cannot be undertaken within the extents of the traffic lane there is a risk of kerb strikes, collisions with other road users or collisions with items of roadside furniture.

Ensure the swept path of all vehicles can be accommodated safely at all upgraded junctions.

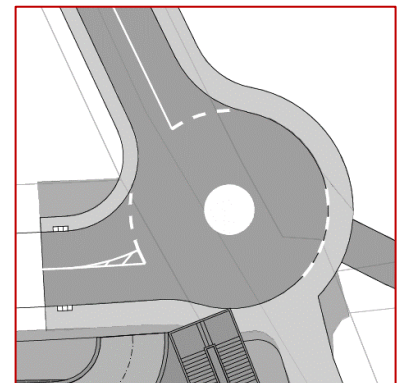
3.1.3 Problem

Summary: Unclear if the proposed roundabouts can safely accommodate the swept path of large vehicles.

It is proposed to terminate the road on both sides of the Clonsilla, Coolmine and Porterstown Level Crossings and to provide a roundabout on one side for U-turn manoeuvres. Information regarding the swept path of vehicles turning at these roundabouts has not been provided to the Audit Team and it is therefore unclear if these vehicles can undertake U-turn manoeuvres at these locations. If these roundabouts cannot accommodate the swept path of large vehicles (e.g. buses) there is a risk that they may overhang the footpath as they manoeuvre through the roundabout which may lead to a collision with a pedestrian or cyclist or collisions with items of roadside furniture.

A swept analysis should be undertaken to ensure all vehicles can be safely accommodated at the roundabouts.

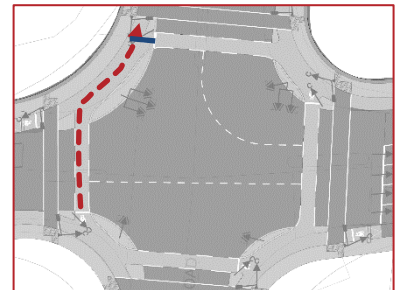
3.1.5 Problem

Summary: Right-turning cyclists may block straight through cyclists at signalised junctions.

Protected cycle lanes are indicated at a number of signalised junctions within the Scheme. However, it is unclear from the drawing if there will be sufficient space at stop lines to allow cyclists to wait outside the path of an adjacent cyclist. Should there be insufficient space for a cyclist to pass a stationary cyclist, there is a risk of collisions between cyclists or to cyclists entering the carriageway, to pass a stationary cyclist, at locations where drivers may be less attentive to a cyclist entering the carriageway increasing the risk of collisions.

Ensure sufficient space is provided at cyclist stop lines for a stationary cyclist to wait out of the path of an oncoming cyclist.

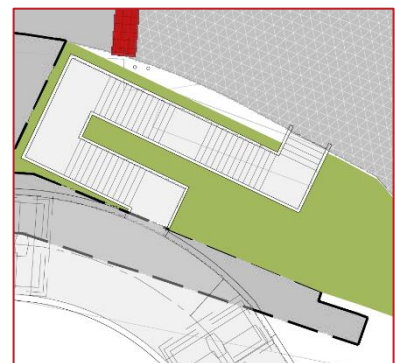
3.1.6 Problem

Summary: Tactile paving has not been indicated at the top and bottom of steps at the pedestrian and cyclist bridges which may lead to visually impaired pedestrians being insufficiently aware of the height hazard.

Tactile paving has not been indicated at the top and bottom of the proposed steps to pedestrian/cyclist bridges at the upgraded level crossings and also at an existing set of steps within the footpath at the Castleknock Road Rail Bridge. This may lead to visually impaired pedestrians being insufficiently aware of the height hazard resulting in them continuing towards the steps and falling from a height, and suffering serious injuries, or tripping on the bottom step, and suffering personal injuries.

Corduroy hazard tactile paving should be provided at the top and bottom of steps within the scheme.

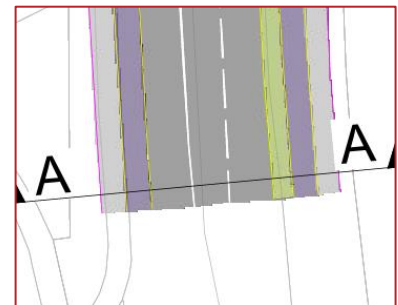
3.1.8 Problem

Summary: It is unclear in all instances if the proposed upgrade works sufficiently tie-into the existing road network.

At all sites within the Scheme, with the exception of the Castleknock Road Rail Bridge and Navan Road Bridge, amendments to the existing road layout, in particular at junctions, have been indicated. It is unclear if, in all instances, the amended traffic lanes tie-into the existing traffic lanes at the scheme extents at each site. The amended lanes are not indicated as aligning with the existing lanes at a number of locations on the background mapping, particularly where the number of lanes has been amended, although it is unclear how accurate this mapping is regarding the centre/edge of the carriageway. If the proposed upgrades do not sufficiently tie-into the existing road layout there is a risk that drivers will be directed into adjacent, or opposing, traffic lanes where there is an increased risk of side swipe or head-on collisions respectively.

Additionally, if safe transitions between the new cross section and the existing cross section are not fully considered at this early stage, there is a risk that locked-in land and road constraints may lead to unsafe road layouts being developed at the next design stage.

Ensure the amended sections of carriageway sufficiently align with the existing road layout at the scheme tie-ins ensuring a smooth transition between the upgraded sections of carriageway to the old sections of carriageway.

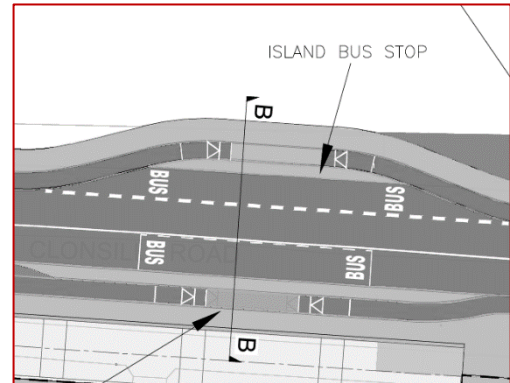
3.2.1 Problem

Summary: Insufficient effective width at island bus stop.

Island bus stops are indicated on both sides of the Clonsilla Road. It is unclear what the effective width of the footpath will be at the island bus stops, although they appear to be relatively narrow on the drawings provided. Should the islands be too narrow to accommodate waiting pedestrians there is a risk of pedestrians waiting for a bus within the path of cyclists where there is an increased risk of being struck by a cyclist.

This could be exacerbated during peak times when large volumes of pedestrians are likely to congregate while waiting for a bus.

As per the Recommendation in Problem 3.1.1, a shared use footpath should be provided at bus stops within the Scheme. Also, ensure the shared use footpath at this bus stop is of a sufficient width to accommodate waiting pedestrians such that they will not encroach into the path of cyclists.

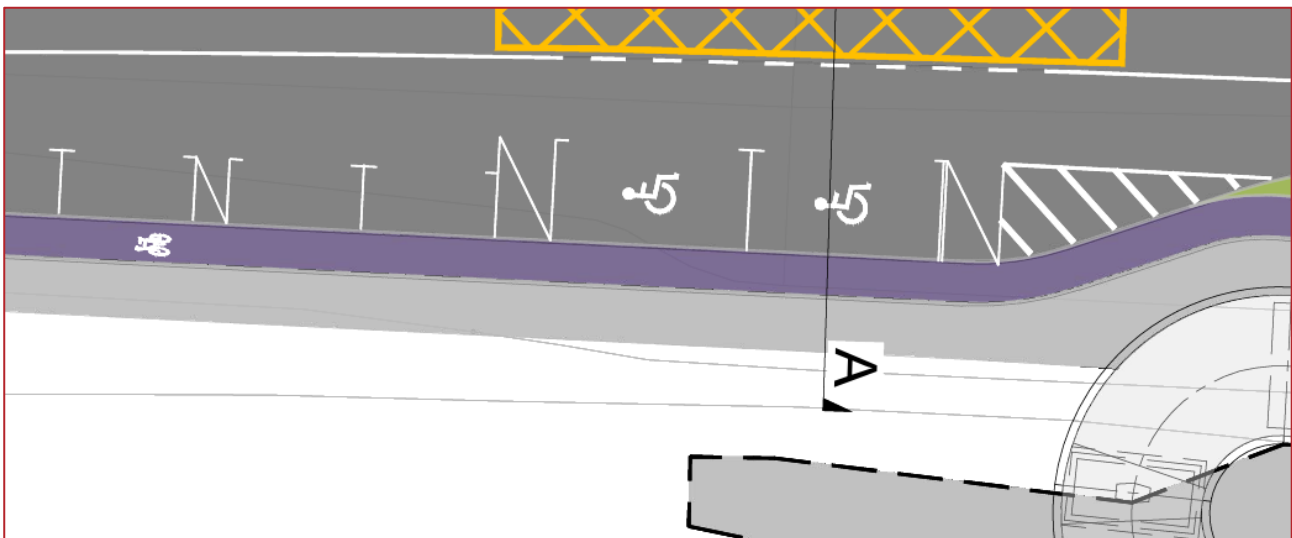
3.2.2 Problem

Summary: No safe access route to footpath from parking spaces.

Parking spaces have been indicated on the southern side of Clonsilla Road, including two mobility impaired parking spaces. To access the adjacent footpath, drivers/passengers would be required to cross the cycle track where no crossing has been indicated. A lack of a formal crossing may lead to an increased risk of pedestrians being struck by a cyclist when travelling between the parking spaces and footpath.

Also, it is assumed that there will be a kerb at the edge of the carriageway adjacent the parking spaces. A lack of a dropped kerb may present accessibility issues for mobility impaired pedestrians when accessing the footpath.

A safe pedestrian route from the parking spaces to the footpath should be provided.

Additionally, a dropped kerb, and tactile paving, should be provided adjacent the mobility parking spaces to allow mobility impaired users access the footpath.

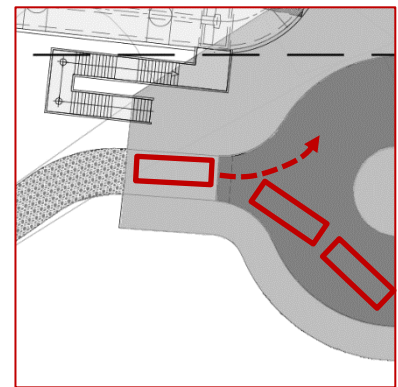
3.2.3 Problem

Summary: Junction control has not been indicated at the western arm of the roundabout leading to the Beech Park Allotments.

The western arm of the proposed roundabout to the south of the Clonsilla level crossing provides access to the Beech Park Allotments. Junction control and thus priority, has not been indicated at the entrance to the roundabout. The absence of clear priority on this arm, via signs and/or road markings, may lead to drivers being insufficiently aware of who has priority at the junction. This could lead to drivers approaching the junction on different arms believing that they have priority resulting in them entering the junction at the same time as an opposing vehicle and side-on collisions.

Additionally, the access is relatively narrow, and it is unclear if it will facilitate two-way traffic. If sufficient space is not available it may lead to a vehicle waiting within the roundabout circulating carriageway where there is an increased risk of collisions.

Junction control and priority should be provided on this arm of the roundabout.

Also, ensure the access is wide enough to facilitate two-way traffic.

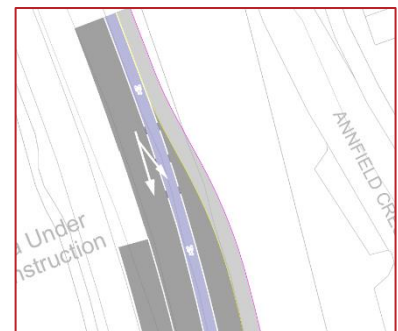
3.3.1 Problem

Summary: Left-turning drivers may be insufficiently aware of straight-ahead cyclists on their nearside prior to entering the left turn lane approaching the Porterstown Road junction.

On the southbound approach to the Porterstown Road junction the cycleway is indicated between the straight-ahead and left-turn traffic lanes.

Left-turning drivers, approaching the junction in the through traffic lane may be insufficiently aware of a cyclist approaching on their nearside as the existing cycle facilities upstream are off-road. This may lead to drivers failing to take due care and consideration of cyclists approaching from the footway when changing lane, increasing the risk of vehicle-cyclist collisions.

If the expected traffic volumes do not require two lanes, the existing layout with only a single lane should be retained.

Alternatively, the off-road cycle track should transition to the carriageway in greater advance upstream of the left-turn lane development to increase a driver's awareness of cyclists on the carriageway. The weaving area

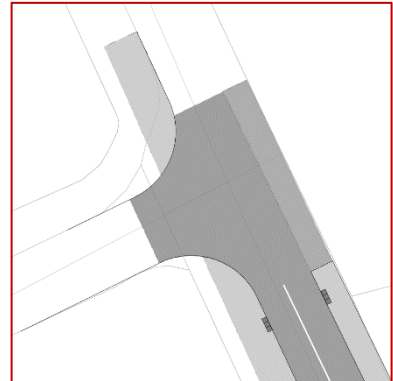
3.4.2 Problem

Summary: Absence of pedestrian crossing across ‘The Village’ side road.

A formal pedestrian crossing point has not been indicated, nor is one currently provided, across ‘The Village’ side road, at the northern extents of the scheme. A failure to provide a formal crossing point could lead to visually, and mobility, impaired pedestrians being unable to safely and independently cross to the opposite footpath. This could result in slips, trips, or falls as these pedestrians attempt to descend the kerb, or an increased risk in visually impaired pedestrians unintentionally entering the carriageway where they could be struck by a vehicle.

An uncontrolled pedestrian crossing, including dropped kerbs and tactile paving, should be provided across ‘The Village’ side road at its junction with Porterstown Road.

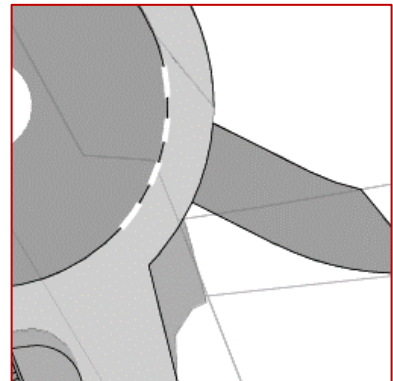
3.4.3 Problem

Summary: It is unclear if the access will be gated and, if so, if the gates will be sufficiently set back to permit a vehicle to fully exit the circulating carriageway when opening/closing the gates.

There is an existing gated access on the eastern side of Porterstown Road which is proposed to form the eastern arm of the upgraded roundabout. Gates have not been indicated on this arm and it is therefore unclear if the access will continue to be gated following construction and where these gates will be located if provided.

If the gates are not sufficiently set back from the carriageway, a driver may be unable to fully exit the roundabout circulating carriageway when opening/closing the gates, resulting in possible rear-end shunts or side-on collisions between oncoming traffic and a vehicle overhanging the carriageway.

The access gate, if provided, should be sufficiently set back from the carriageway to ensure a driver can completely exit the roundabout circulating carriageway when opening/closing the gates.

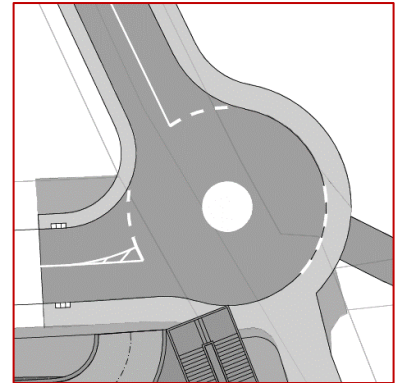
3.4.4 Problem

Summary: Insufficient lateral clearance between the footbridge and the roundabout circulating carriageway.

The corner of the footbridge indicated at the Porterstown level crossing is located in close proximity to the roundabout circulating carriageway where it is at risk of being struck by high-sided vehicles resulting in potential structural damage to the footbridge.

Ensure the steps of the footbridge are sufficiently offset from the circulating carriageway, such that high-sided vehicles, or errant drivers, are unable to conflict with the structure.

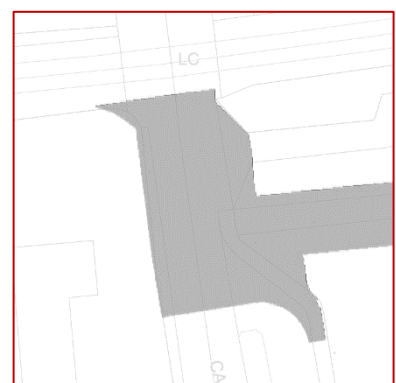
3.5.2 Problem

Summary: It is unclear how the carriageway will be terminated on the southern side of the Coolmine level crossing.

It is proposed to terminate Carpenterstown Road on both sides of the Coolmine level crossing. While a roundabout has been indicated on the northern side of the crossing it is unclear how the carriageway on the southern side will be terminated. If the end of the carriageway is not sufficiently defined drivers approaching the crossing may be insufficiently aware that there is no through route, particularly during the hours of darkness, resulting in an increased risk of overshoot type incidents and collisions with items of roadside furniture or the boundary/gates at the railway line.

The road layout on the southern side of the level crossing should be clearly defined such that drivers are aware of the carriageway termination.

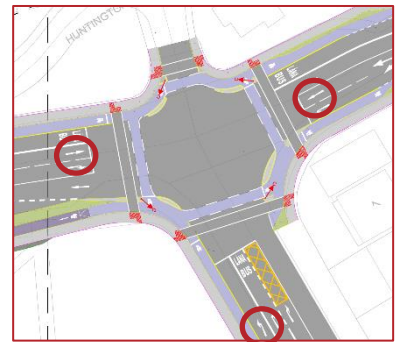
- 4.3 Arrow road markings for movements into Huntington Lodge have not been indicated within the traffic lanes on the approaches to the Castleknock Road Junction. Whilst it is likely that entry and exit manoeuvres into this small residential development will be infrequent these movements are not prohibited at the junction. The following measures should be provided: -

- Western arm: A straight-ahead and left-turn arrow in lieu of the straight-ahead only arrow indicated.
- Southern arm: A straight-ahead and left-turn arrow in lieu of the left-turn only arrow indicated.
- Eastern arm: A straight-ahead and right-turn arrow in lieu of the straight-ahead only arrow indicated.

Additionally, the signal phasing should be reviewed to ensure these movements do not lead to conflicts with other streams of traffic.

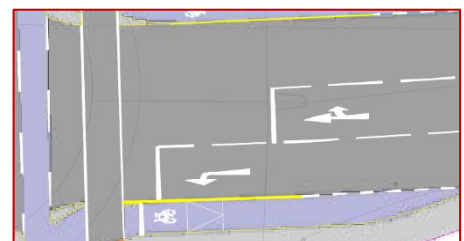
- 4.4 The stop line in the straight-ahead and right-turn lane on the eastern arm of the Clonsilla Road junction is set back presumably to allow for buses turning left into this arm. A Yellow box should be provided on the carriageway between the stop line and the crossing to ensure drivers do not mistakenly overshoot the stop line and obstruct the swept path of incoming large vehicles.

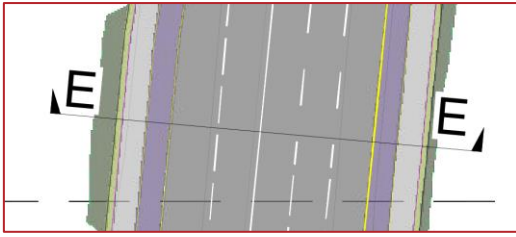
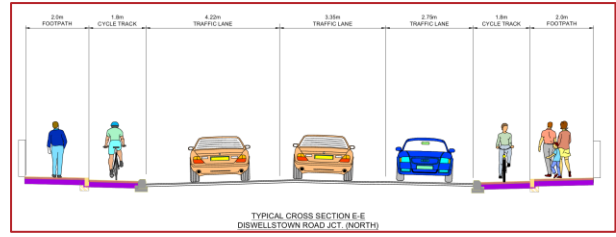
- 4.5 Cross sections D-D, E-E, and F-F for the Diswellstown Road Junction do not sufficiently convey the proposed road layout with the incorrect number of traffic lanes indicated. The drawings should be amended to ensure consistency with the plan drawings and to prevent confusion during construction.

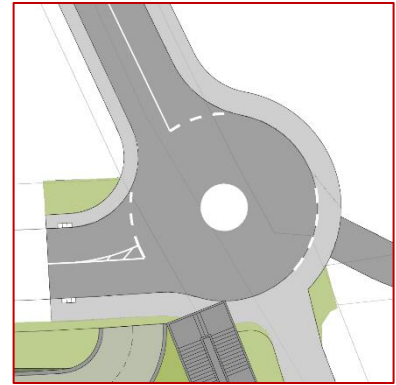
4.7 Junction control has not been indicated at the proposed roundabout on the northern side of the Porterstown level crossing. Yield road markings should be provided at the entrance to the roundabout circulating carriageway on all arms to clearly advise drivers of the priority at the roundabout.
